Effect of Bacillus Subtilis Bacteria on the mechanical properties of corroded self-healing concrete

Citation: Nindhita, K. W., Zaki, A., Zeyad, A. M., Effect of Bacillus Subtilis Bacteria on the mechanical properties of corroded self-healing concrete, *Frattura ed Integrità Strutturale*, 68 (2024) 140-158.

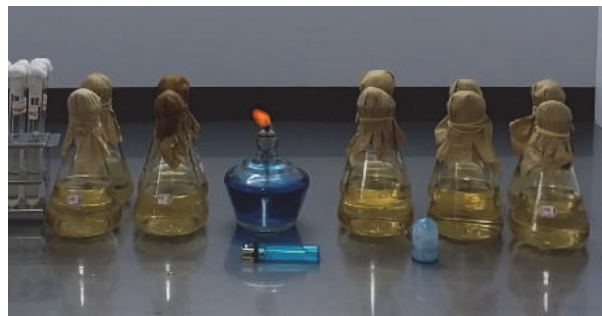
Figure 1: *Bacillus subtilis* bacteria solution.

The encapsulation method used in this study was hydrogel encapsulation using the addition of a mixture of CMC or Carboxy Methyl Cellulose. The mix ratio between the bacterial solution and CMC powder is 1 milliliter to 3 grams or 1:3. The bacterial encapsulation process starts by mixing the bacterial solution with CMC powder. Then, it formed with a 5-15 mm diameter and arranged spaced on the tray. The pieces are allowed to dry naturally indoors for 2-4 days. The texture of the bacterial encapsulation, which was originally soft, will harden into pebbles after being air-dried. This bacterial encapsulation will become soft again when it reacts with water so that the bacteria contained in the encapsulation can fill the voids in the cracks in the concrete [18]. The *Bacillus* bacteria solution before encapsulation is shown in Figure 1, while the encapsulated *Bacillus subtilis* bacteria is shown in Figure 2.

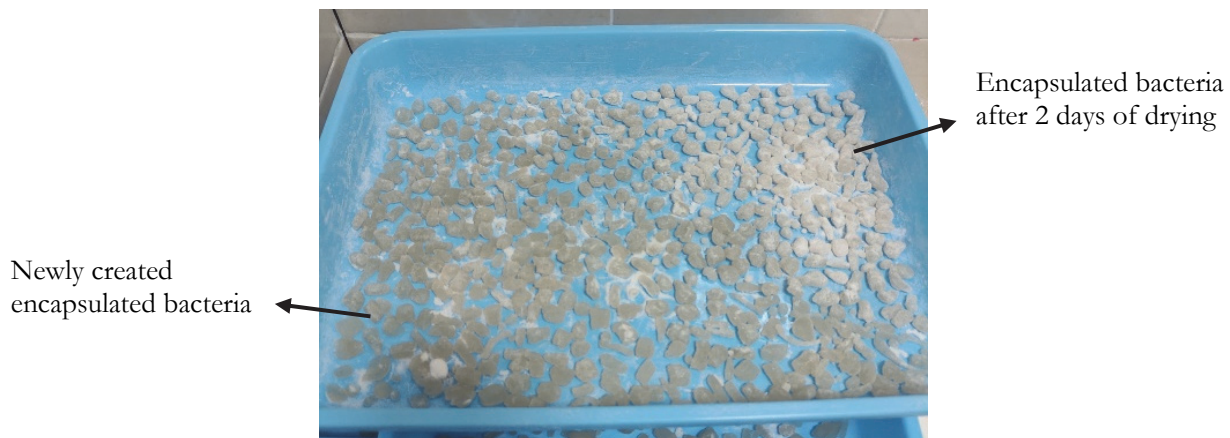
Figure 2: Encapsulated *Bacillus subtilis* bacteria.

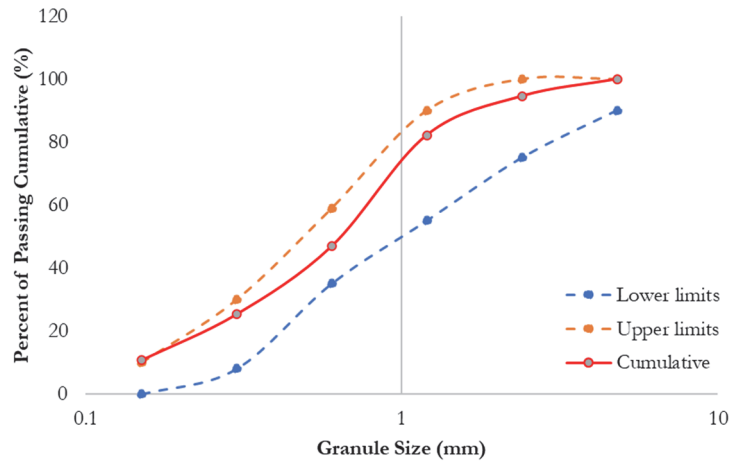
Figure 3: Fine grain gradation chart.

Before the mix design process and the manufacture of the specimens are carried out, several tests are carried out: a specific gravity test, water absorption test, gradation test, abrasion test, and sludge content test. From the results of the sand test, it was found that the fine modulus value was 2.403, and the gradation criteria met the requirements, as shown in Figure 3 and Table 1. Meanwhile, the gravel test results are shown in Table 2.

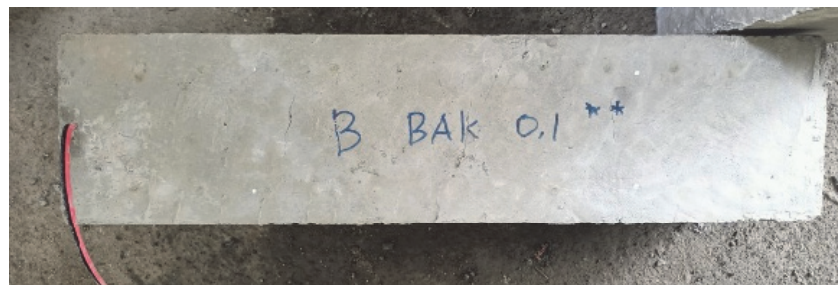
Figure 6: Example of a specimen before the corrosion acceleration process.

Test specimens of reinforced beams measuring 620x150x150 mm are used to test the concrete's corrosion, self-healing, and flexural strength. Meanwhile, cylindrical specimens measuring 150x300 mm are only used to test concrete's compressive strength. All specimens were printed, cured using normal water, and then tested at 28 days. Details of the test specimens for beams and cylinders can be seen in Figure 4 and Figure 5. The test specimens for beams have a main reinforcement diameter of 8 mm and stirrups of 6 mm, which are attached to small wires on the reinforcement as a channel for the accelerated concrete corrosion process with the help of a DC power supply. The concrete cover is designed at 20 mm. Bacteria are not directly mixed when mixing fresh concrete but when pouring fresh concrete into the formwork. This aims to ensure that the encapsulation of bacteria is not damaged during the mixing process of fresh concrete due to the addition of water and collisions between aggregates. The example specimens after the age of 28 days or before the corrosion acceleration process are shown in Figure 6 below.

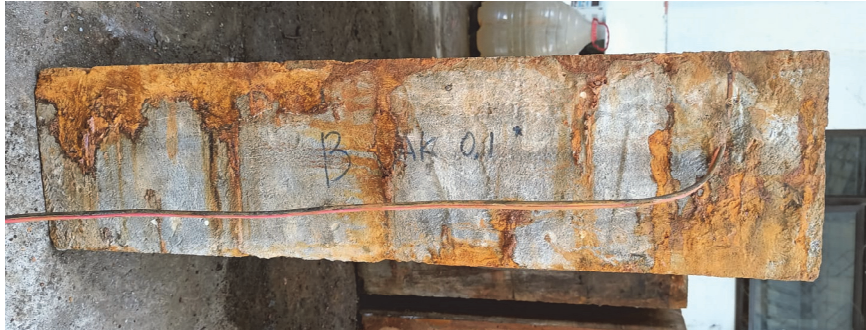
Figure 9: Example of beam specimen after the corrosion acceleration process.

The beam specimens were corrosion accelerated with a design target corrosion rate of 20%. After the corrosion acceleration, self-healing, and flexural strength tests have been completed, concrete demolition is carried out to determine the final reinforcement weight after the corrosion test. Figure 9 shows the example of a beam specimen after the corrosion acceleration process.

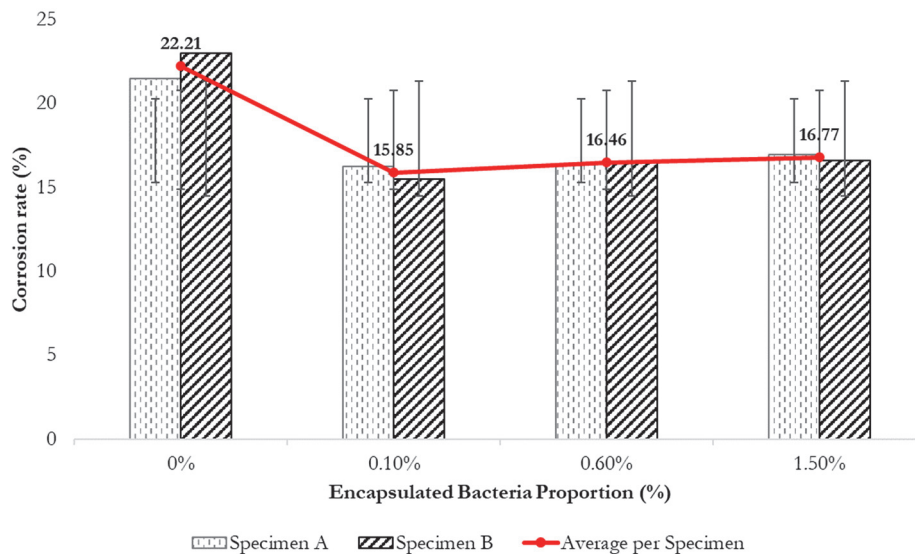
Figure 10: Concrete corrosion test results.

From the results, the comparison of the planned corrosion rate to the actual corrosion results is not too different, namely in the 2-5% range. In addition, adding various bacteria also inhibits the corrosion rate in reinforced concrete. This can be seen from the results of the 0% bacterial variation, which shows the highest level of corrosion rate. The average corrosion rate of the 0% bacterial variation is 22.21%, then the corrosion rate decreased to 15.85% or has a difference of around 6.36% with the addition of 0.1% bacterial variation. However, additional bacterial variations at 0.6% and 1.5% indicate no enhancement in the concrete corrosion rate. The overall summary of the corrosion test results is shown in Figure 10 below.

From the results of this research, adding bacterial encapsulation to concrete can reduce corrosion in reinforced concrete. A decrease in the level of corrosion of self-healing concrete using encapsulated bacteria can occur due to the formation of CaCO_3 in the concrete cavity. As is known, bacterial encapsulation can be active due to a reaction with water or a solution due to the dissolution of the CMC-based capsule, so the bacteria can be active and form CaCO_3 deposits that fill the voids in the concrete. In this case, the encapsulated bacteria may be active and form CaCO_3 deposits during the corrosion acceleration process due to the immersion process in the NaCl solution. As a result of the formation of CaCO_3 , it is possible to inhibit the corrosion process in self-healing concrete reinforcement because calcite formation can act as a passive

Based on the research and analysis of corrosion levels, the results showed that the lowest level of corrosion was demonstrated by adding a 0.1% variation in bacterial encapsulation, and corrosion increased slowly along with the addition of variations in bacterial encapsulation levels. The linear increase in the level of corrosion with the additional level of bacterial encapsulation can be caused by the increasing number of cavities in the concrete and the increase in bacterial encapsulation in the concrete. In this case, the bacterial encapsulation has the property of shrinking quickly when exposed to water or liquid. This effect can be worse if the bacterial encapsulation is located on the outer part of the concrete and is in direct contact with the surrounding conditions. During the curing process, the encapsulated bacteria will come into contact with water so that it becomes soft for a long time. Then, when lifted into the air, the encased bacteria still need time to dry and harden under suitable conditions. If it is too dry, the water in the bacterial encapsulation will quickly evaporate, and the capsule will become brittle quickly. This can result in the formation of cavities in the concrete, which will increase its permeability and cause the reinforcement in the concrete to experience corrosion and rust processes more quickly. So, from this case, the most optimal variation in adding bacterial encapsulation as a corrosion inhibitor is 0.1% of the total weight of sand, where the density level of the concrete is still at a normal level, which then increases with the addition of bacterial encapsulation as a self-healing agent on concrete.

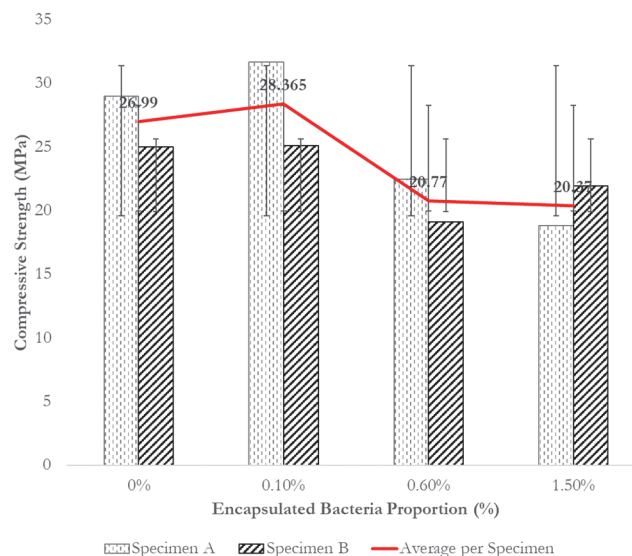
Figure 14: Concrete compressive strength test results.

The compressive strength test was carried out on cylindrical concrete specimens after reaching the age of 28 days—compressive strength testing using a Compression Testing Machine. The results of the concrete compressive strength test are shown in Figure 14.

From the results of the compressive strength test in Figure 14, there is an increase in the compressive strength value of 0.1% bacterial variation concrete compared to 0% variation concrete from 26.99 MPa to 28.365 MPa, with a difference of 1.375 MPa. Adding *Bacillus subtilis* bacteria to the concrete only gives little enhancement to the compressive strength of concrete, maybe due to microbial precipitation of calcium carbonate [21]. However, this increase in compressive strength values is not too different from the strength of normal concrete. This is possible because the size of the bacterial encapsulation is still relatively large, so they are less able to fill each other's cavities in the concrete. However, the calcite formation process can still occur, especially during the curing process in a water-soaking bath and during the initial setting. There is a decrease in the compressive strength value as the bacterial variation in the concrete increases. This can be caused

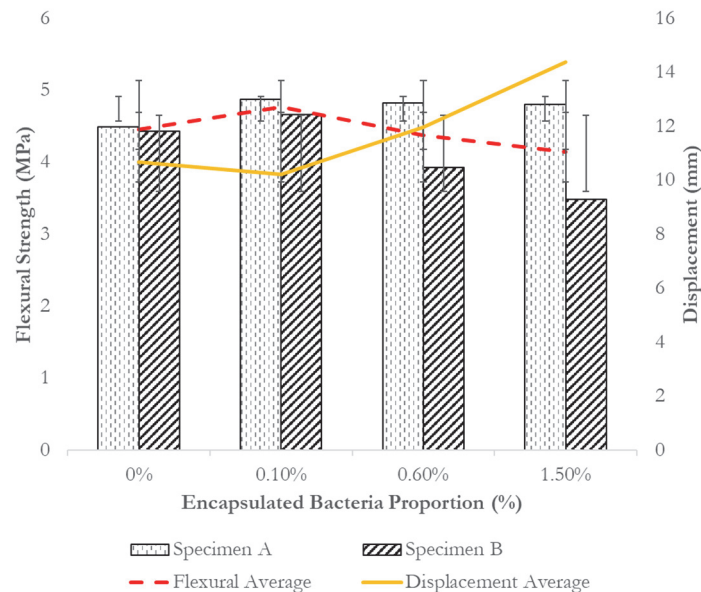
Figure 15: Flexural strength and displacement test results.

The results of the flexural strength test of corroded concrete with a mixture of various bacteria are shown in Figure 15 below. These results indicate that adding 0.1% bacterial variation to concrete can increase the flexural strength value of concrete by 0.31 MPa compared to normal concrete or 0% bacterial variation. However, the addition of 0.6% bacterial variation to concrete resulted in a lower flexural strength value compared to 0.1% bacterial variation concrete. Meanwhile, adding 1.5% of bacterial variation causes a decrease in the flexural strength of concrete. Thus, more and more variations of bacteria are added to the concrete, causing its flexural strength to decrease. From these results, the most optimal addition of encapsulated bacteria to concrete is 0.1%. This is in line with the results of the optimal value of concrete compressive strength, which will influence the flexural strength value of concrete due to calcite formation in the concrete cavity [13, 24].

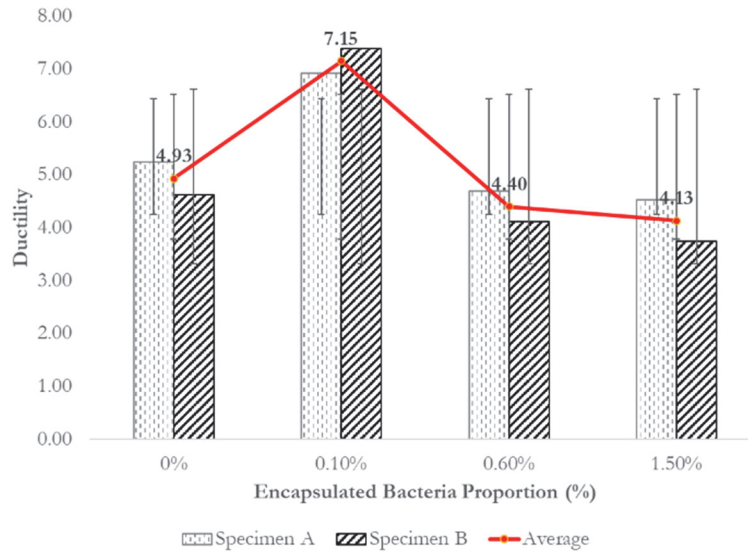
Figure 16: Concrete ductility test results.

Figure 16 shows that adding 0.1% bacterial variation causes an increase in the ductility value in concrete with a difference of 2.22 compared to normal concrete (0% variation). However, adding 0.6% bacterial variation to concrete resulted in a decreased ductility value compared to adding 0.1% bacterial variation with a decrease difference of 2.75. Meanwhile, adding 1.5% bacterial variation resulted in the smallest ductility value among all bacterial variations. It showed a decreasing trend after reaching its peak at the addition of 0.1% bacterial variation. This is caused by calcite precipitation or the formation of lime cells that fill the voids in the concrete. Thus, the concrete becomes denser and more compact [41]. However, from the study's results, it was found that adding more than 0.1% of bacterial variations resulted in decreased ductility due to the encapsulation nature of bacteria, which easily expands and shrinks when exposed to water. Thus, the most optimal level of encapsulated *Bacillus subtilis* bacteria as a self-healing agent is 0.1%.

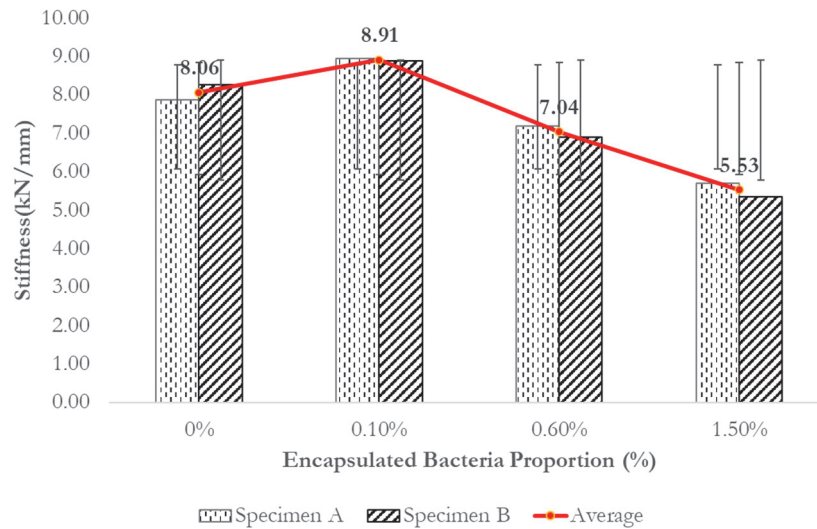
Figure 17: Concrete stiffness test results.

Stiffness is the ratio between the maximum load and the displacement in concrete [42]. Concrete stiffness can be calculated by comparing concrete's maximum force and maximum deflection [43]. The stiffness formula is shown in Equation (4), where K is stiffness (kN/mm), F is maximum force [44], and δ is maximum displacement (mm). The stiffness value of self-healing concrete with 20% corrosion can be seen in Figure 17.

Figure 17 shows the results of the stiffness values, where adding a bacterial variation of 0.1% increases the concrete stiffness value of 0.85 kN/mm when compared to 0% bacterial variation concrete (normal concrete). Meanwhile, adding 0.6% bacterial variation decreased the stiffness value compared to 0.1% bacterial variation concrete, and the stiffness value decreased when the concrete was given an additional 1.5% bacterial variation. This is caused by bacterial precipitation that accumulates and fills the concrete voids after cracks occur so that the concrete becomes denser and can withstand greater loads with small deflections [24]. However, the addition of bacteria to concrete reached an optimal point of 0.1% due to the effect of the encapsulated bacteria swelling when exposed to water. Thus, it also affects the cavity's size if the bacteria's encapsulation increases in the concrete.

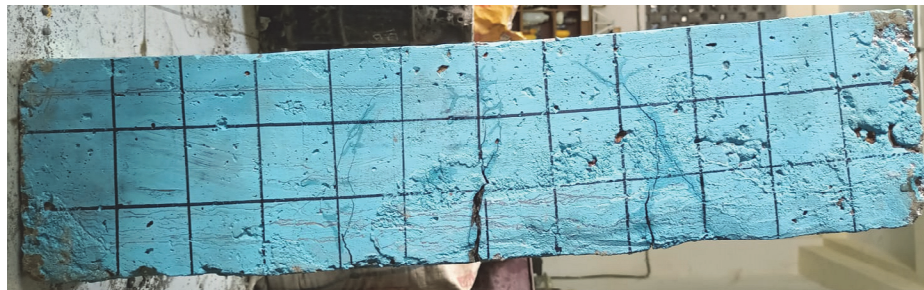
Figure 18: Failure pattern specimens (a) B1 and (b) B2.

Figure 18 shows that the crack pattern of a concrete beam with a variation of 0% bacterial encapsulation (normal concrete) shows that the concrete beam experienced shear cracks. Cracks in concrete are initiated from hairline cracks in the pure bending areas of concrete due to load application. Crack propagation continues in the concrete until a diagonal crack forms. In this case, the crack is close to the concrete beam. This indicates that the load received by the concrete beam is distributed evenly throughout the concrete, especially the reinforcement. The load the concrete beams can accept will reach its maximum point and cause cracks in the stirrups concrete area because of the existing load distribution. From the visual observations, the stirrup concrete area experienced macro cracks due to the reinforced concrete design, which would end the distribution of the overall load received by the concrete in the stirrup concrete.

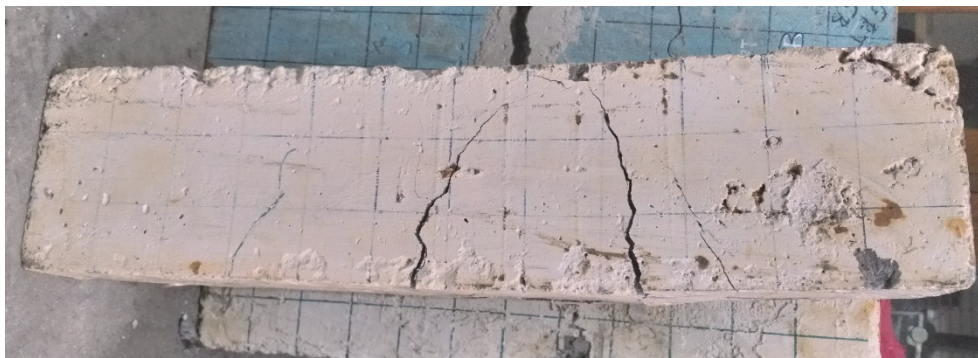
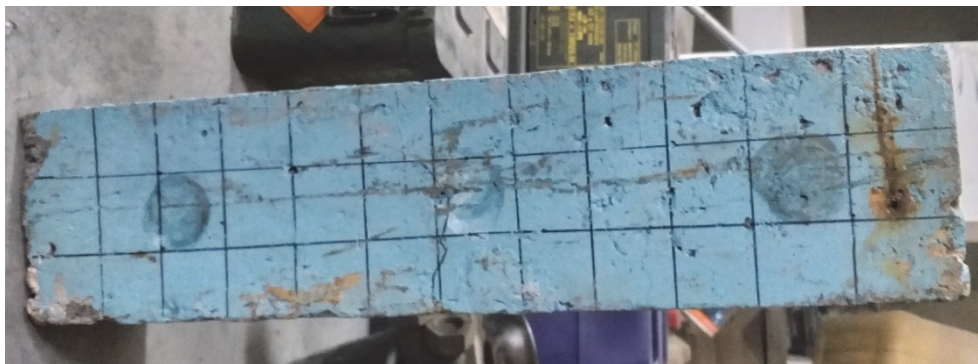
Figure 19: Failure pattern specimens (a) B3 and (b) B4.

Figure 19 also shows that the failure pattern of reinforced concrete beam structures with a bacterial variation of 0.1% shows more shear crack patterns due to the propagation of the load received. Macroscopic beam cracks show the result in cracks in the beam stirrup reinforcement, similar to normal concrete beam damage. The test results show that the macroscopic damage between normal concrete beams and the 0.1% bacterial encapsulation variation is not too different. This is caused by the test results for flexural strength values, which do not differ significantly. Apart from that, it is also possible that the density of concrete pores between 0% and 0.1% variations of encapsulation bacteria in concrete is not too different so that its strength in bearing loads and failure patterns can still be categorized at the same level.

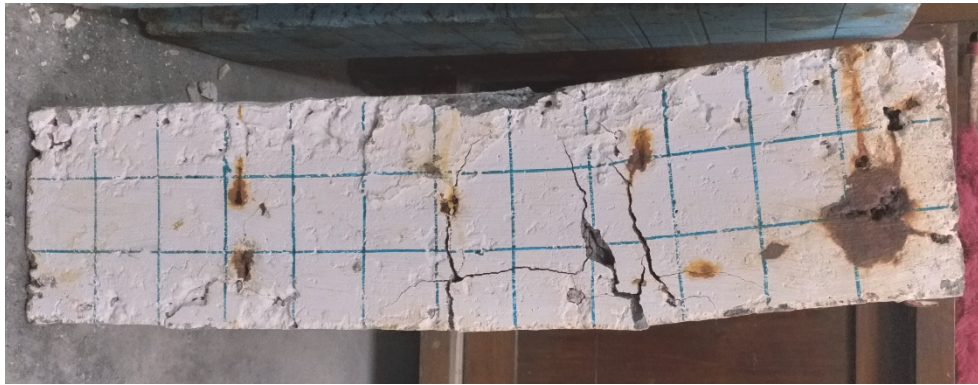
Figure 20: Failure pattern specimens (a) B5 and (b) B6.

The results of the crack pattern of concrete beams with the addition of 0.6% bacterial encapsulation variations shown in Figure 20 show that the beams experience the same type of crack pattern as concrete variations of 0% and 0.1%. The crack pattern in the concrete with a bacteria variation of 0.6% shows a shear crack pattern from the final propagation of the load on the stirrup reinforcement. However, Figure 20 (a) (beam B5) also shows parts of the concrete cover almost peeling off or experiencing delamination due to accelerated corrosion. The concrete crack pattern that previously only formed in the area around the stirrup reinforcement spread to become horizontal cracks due to the corrosion process. The appearance of these cracks can be caused by the pore density level of the 0.6% variation concrete, which is lower when compared to the 0% and 0.1% variation concrete. Although the test results for the reinforcement's corrosion level based on the reinforcement concrete's remaining mass show that the 0.6% variation has a lower corrosion level than the 0% variation, the density of the concrete pores is not as dense as the 0% concrete variation. This case is also proven by the results of the compressive

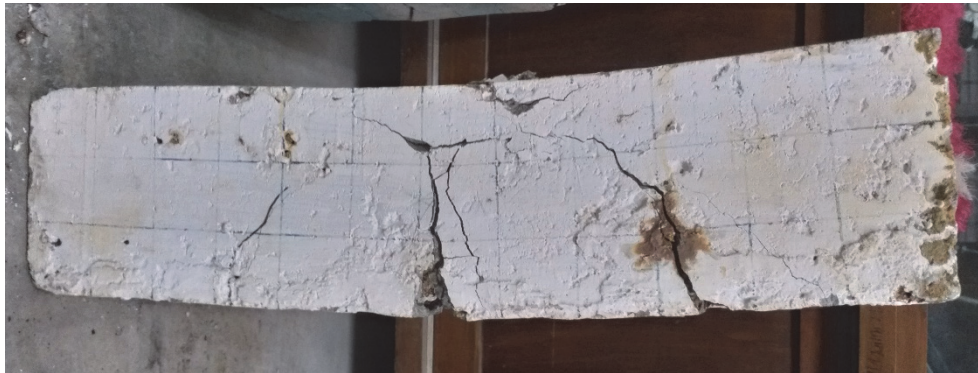
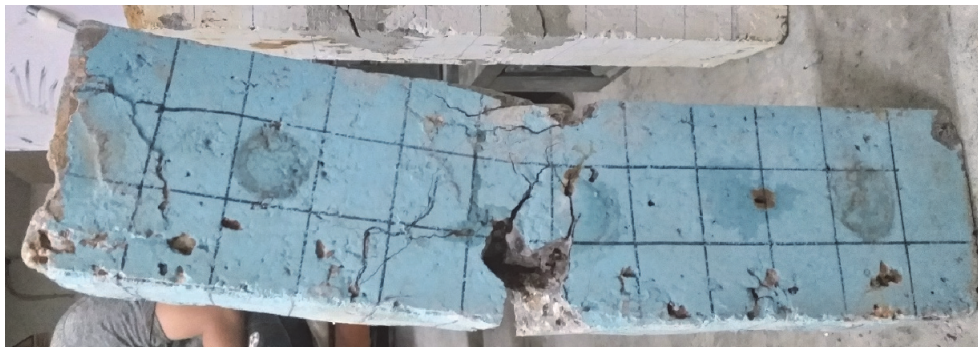
Figure 21: Failure pattern specimens (a) B7 and (b) B8.

Figure 21 shows the crack pattern experienced by concrete blocks with variations in adding 1.5% bacterial encapsulation. The crack pattern in concrete beams is generally similar to the concrete crack pattern, with a variation of 0.6%. However, when observed visually, concrete with a bacterial encapsulation variation of 1.5% had a more severe crack pattern than concrete with a variation of 0.6%. This concrete variation will also likely experience more severe damage due to corrosion, as shown in Figure 21 (b) (beam B8). Beam B8 indicated the same type of damage as beam B5, where the beam experienced initial damage in the stirrup reinforcement area, eventually spreading horizontally due to the corrosion process. However, on beam B8, damage in the form of peeling of the concrete cover or spalling has occurred. This peeling damage to the concrete blanket can also indicate that the level of concrete density due to the addition of 1.5% bacterial variation is decreasing and affecting the density of the concrete pores. As a result, concrete becomes more easily damaged or fails when under load. The reduction in concrete density due to the addition of bacterial encapsulation of 1.5% is shown in Figure 21 (b) (beam B8), which has holes from bacterial encapsulation on the surface of the concrete beams, which can result in a decrease in the compressive strength and density values of the concrete beams, especially beam B8. As previously explained, in this case, the bacterial encapsulation has the property of shrinking easily when exposed to water or liquid. Especially if the bacterial encapsulation is located on the outer part of the concrete and is in direct contact with the surrounding conditions. The encapsulated bacteria still need time to dry and harden under suitable conditions. If it is too dry, the water in the bacterial encapsulation will quickly evaporate, and the capsule will become brittle quickly.
