## **Danish EPA-NR pilot studies**

# Overall report on the pilot projects

**Energy Performance Assessment  
of Existing Non-Residential Buildings**

# Overall report on pilot projects

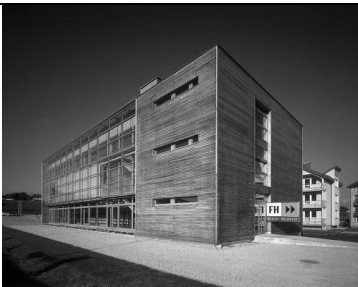
<p><b>Austria</b></p> <p>Gross area: 6156 m<sup>2</sup> Year of construction: 2002</p> </div>	<div style="text-align: center;">

</div> <p><b>Building envelope:</b> Wooden-frame construction with static elements (inside) made by concrete/ High insulated outer wall components/ .Steel-glace cladding in the southwest (climate-cladding).</p> <p><b>Heating/cooling:</b> The pellets boiler plant, which is fully automated, guarantees the energy supply for heating and ventilation/ radiators for heating emission/ air conditioned cold water is used for cooling units on the second floor / The change from heating to cooling happens automatically by the room thermostat/ The whole regulation of the heating and ventilation system works on a DDC-System. Handling of the power control is done by a central building control system.</p> <p><b>Ventilation :</b> The toilets on each floor are vented by ventilators. In the laboratories on the basement two exhaust air plants are installed - The exhausted air is re-feed by the two-staged delivery air plant in every single room. Both of the lecture rooms and the seminar room at the ground floor are equipped with an independent delivery and exhaust air plant with heat recovery.</p> <p><b>Lighting:</b> Conventional fluorescent tube lighting with manual switching.</p>

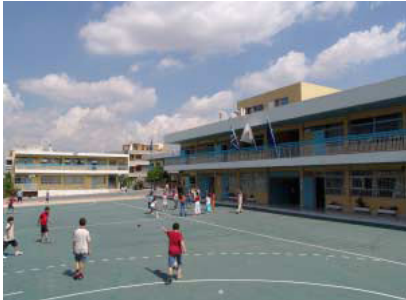
Location And general information	Photo
  <p><b>Athens/Greece</b></p> <p>Primary school and Kindergarten Gross area: 2709 m<sup>2</sup> Year of construction: 5 buildings, built in different stages 1970, 1976 and 1989</p>

<p><b>Building envelope:</b> Among the five buildings only one is thermally insulated, the other four have only roof insulation. Brick walls with concrete rendering. Single glazed windows with aluminium frames and internal curtains.</p> <p><b>Heating/cooling:</b> Two central oil fired boilers for space heating/ electric heaters for DHW/ceiling fans in offices.</p> <p><b>Ventilation:</b> Natural ventilation.</p> <p><b>Lighting:</b> Fluorescent tubes.</p>

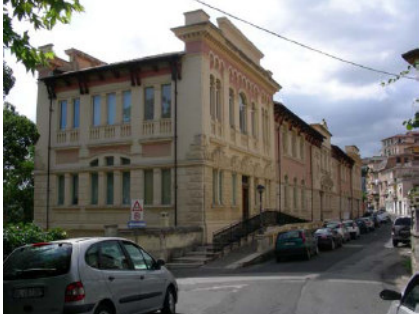
<p><b>Fiuggi/Italy</b></p> <p>Gross area: 2380 m<sup>2</sup> Year of construction: 1932</p>

<p><b>Building envelope:</b> No insulation / double glazed windows with no thermal break aluminium frame.</p> <p><b>Heating/cooling:</b> One standard boiler and radiators without any control/ Distribution systems runs inside the walls.</p> <p><b>Ventilation:</b> Mechanical ventilation.</p> <p><b>Lighting:</b> New fluorescent lamps manually controlled.</p> <p><b>Specific aspect:</b> The walls are very thick and heavy, this gives the building a high thermal capacity, the high between floors and ceilings is important (4.20m).</p>

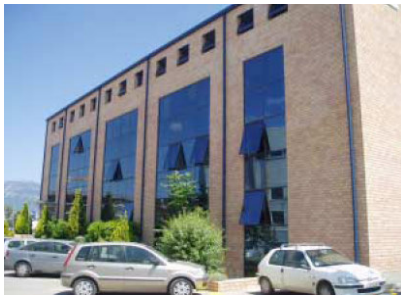
<p><b>Athens/Greece</b></p> <p>Gross area: 1910 m<sup>2</sup> Year of construction: 2000</p> </div>	<div style="text-align: center;">

</div> <p><b>Building envelope:</b> Thermally insulated building. Brick walls with decorative bricks. Reinforced concrete sloped roof, covered with iron sheet. High efficiency double glazed windows with aluminium frames and internal blinds.</p> <p><b>Heating/cooling:</b> Nine VRV heat pumps for heating and local air handling units for space heating and cooling/ electric tankless heaters for DHW.</p> <p><b>Ventilation:</b> Mechanical ventilation by air handling units.</p> <p><b>Lighting:</b> Fluorescent tubes and spots</p>
<div style="text-align: center;">

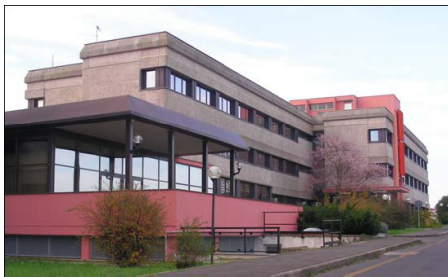
<p><b>Rome/Italy</b></p> <p>Gross area: 3200 m<sup>2</sup> Year of construction: 1990</p> </div>	<div style="text-align: center;">

</div> <p><b>Building envelope:</b> External insulation/reflective double glazing windows with aluminium frame without thermal break/ no insulation in concrete ground floor.</p> <p><b>Heating/cooling:</b> Gas boiler for heating and chillers with cooling tower for cooling/ fan coil units are used as emission system/ electric boilers for DHW.</p> <p><b>Ventilation:</b> Two air handling units are installed for offices, these AHU are also used for heating and cooling and ventilation for conference room.</p> <p><b>Lighting:</b> Fluorescent lamps.</p> <p><b>Specific aspect:</b> The stairs volume should be in principle separated by the heated volume by double glazed doors but in practice these doors are always open.</p>

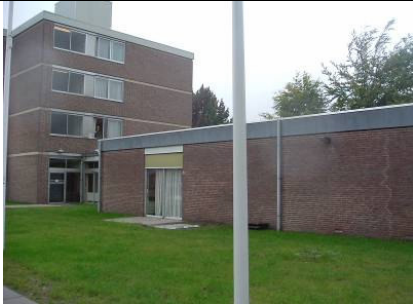
<p><b>Apeldoorn/The Netherlands</b></p> <p>Gross area: 3108 m<sup>2</sup> Year of construction: 1974</p>

<p><b>Building envelope:</b> Opaque walls are not insulated/ windows consist of double layered glass in second and third floor and single glazed in the two first floors.</p> <p><b>Heating/cooling:</b> Gas fired high efficiency (condensing) heating system with radiators/ part of building is provided with air conditioning units.</p> <p><b>Ventilation:</b> Natural ventilation except for toilet and kitchen where exhaust ventilation is installed.</p> <p><b>Lighting:</b> Conventional fluorescent tube lighting.</p> <p><b>Specific aspect:</b> Poor indoor air quality due to the low ventilation rates, natural ventilation by opening the windows in winter is not adequate/ the single pane glazing in the two first floors have large dimensions, it's not comfortable in winter.</p>

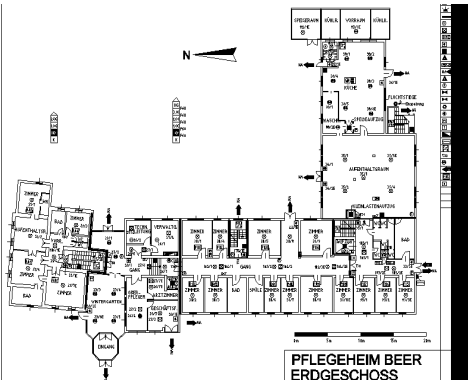
<p><b>Austria</b></p> <p>Gross area: 6156 m<sup>2</sup> Year of construction: 1920</p>

<p><b>Building envelope:</b> Poor insulation (4cm)/ windows are single-glazed. The thermal properties of the claddings are in accordance with building standards of the 70ies.</p> <p><b>Heating/cooling/DHW:</b> Central oil burner heating system with radiators; no cooling system. 135 m<sup>2</sup> solar collectors for the domestic hot water.</p> <p><b>Ventilation:</b> No ventilation system (beside simple ventilation in bathrooms).</p> <p><b>Lighting:</b> Conventional fluorescent lamps with manual.</p>

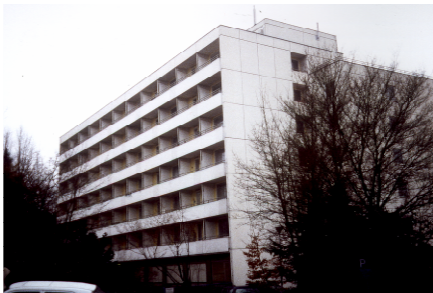
<p><b>Stuttgart/Germany</b></p> <p>Gross area: 9647 m<sup>2</sup>  Year of construction: 1965</p>

<p><b>Building envelope:</b> No insulation of opaque walls. Double paned windows in wooden frames. The roof includes a minor cork insulation.</p> <p><b>Heating/cooling:</b> Two gas boilers. Radiators with thermostats.</p> <p><b>Ventilation:</b> Mechanical supply and exhaust ventilation system including electrical heating without heat recovery in the bathrooms and corridors at the inner core.</p> <p><b>Lighting:</b> Incandescent lamps in the patient rooms, fluorescent lamps in corridors.</p>

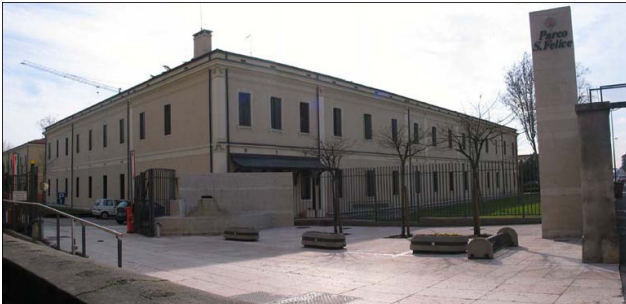
<p><b>Vicenza/Italy</b></p> <p>Gross area: 1320 m<sup>2</sup> Year of construction: early 20<sup>th</sup> century</p>

<p><b>Building envelope:</b> Very poor insulation/simple double glazing windows with wooden frame.</p> <p><b>Heating/cooling:</b> Single group of conventional boilers serving a group of 10 buildings for heating, air handling units and DHW/ radiators without local control/ Single chillier serving the group of buildings, it produces cold water for batteries of AHU/ the chillier is not designed to satisfy the whole cooling demand but to cool down the air entering into the building through the mechanical ventilation system.</p> <p><b>Ventilation:</b> Mechanical ventilation system feeds all the rooms with heat/cool recovery.</p> <p><b>Lighting:</b> Fluorescent lamps manually operated.</p> <p><b>Specific aspect:</b> The walls are very thick and heavy, this give the building a high thermal capacity.</p>

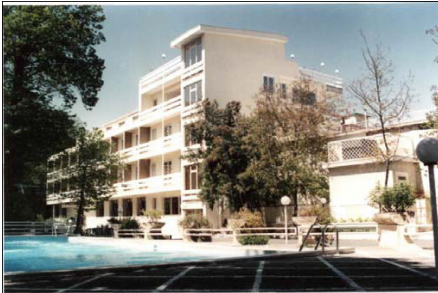
<p><b>Fiuggi/Italy</b></p> <p>Gross area: 3200m<sup>2</sup>            Year of construction: late 70' +            a new part in 2000</p> </div>	<div style="text-align: center;">

</div> <p><b>Building envelop:</b> Old part has a double layer of hollow bricks with air gap , single glazed windows with aluminium frames/ new part has thick alveolar brick with reinforced plastering, double glazing windows with aluminium frames.</p> <p><b>Heating/cooling:</b> Two gas boilers feed the heating and DHW systems/ A chiller feeds the fan coil units in the hall and in new rooms and the Air handling units of the restaurant/ radiators in old rooms.</p> <p><b>Ventilation:</b> Mechanical ventilation system feeds all the rooms with heat/cool recovery.</p> <p><b>Lighting:</b> From obsolete incandescence lamps to compact fluorescent lamps fluorescent lamps manually operated.</p>

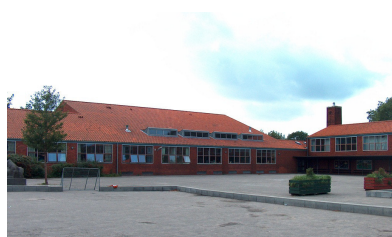
<b>EDUCATIONAL BUILDING</b>

The school is the first of its kind in Denmark, in only one plan. It was constructed in 1950-52 as a traditional brick work with cavity wall insulation. The core of the buildings has not been upgraded but the facilities in the class rooms are in a good condition. Most windows are double glazed with a few exceptions with single glazing, mainly in the entrances and the gymnasium. Insulation material have been placed in the attic and improved to 125 mm recently. Compared to today's Danish standard this is not sufficient and additional insulation material can easily be installed.

- Decrease of DHW circulation temperature
- Upgrade of roof insulation to 300 mm incl. replacement of 10 % of the existing insulation
