GEOLOGICAL AND CLIMATIC SURVEY
CAMP BOWIE MILITARY RESERVATION
BROWNWOOD, TEXAS

Texas National Guard

Bureau of Economic Geology
W. L. Fisher, Director
The University of Texas at Austin
Austin, Texas 78713-7508

June 1993

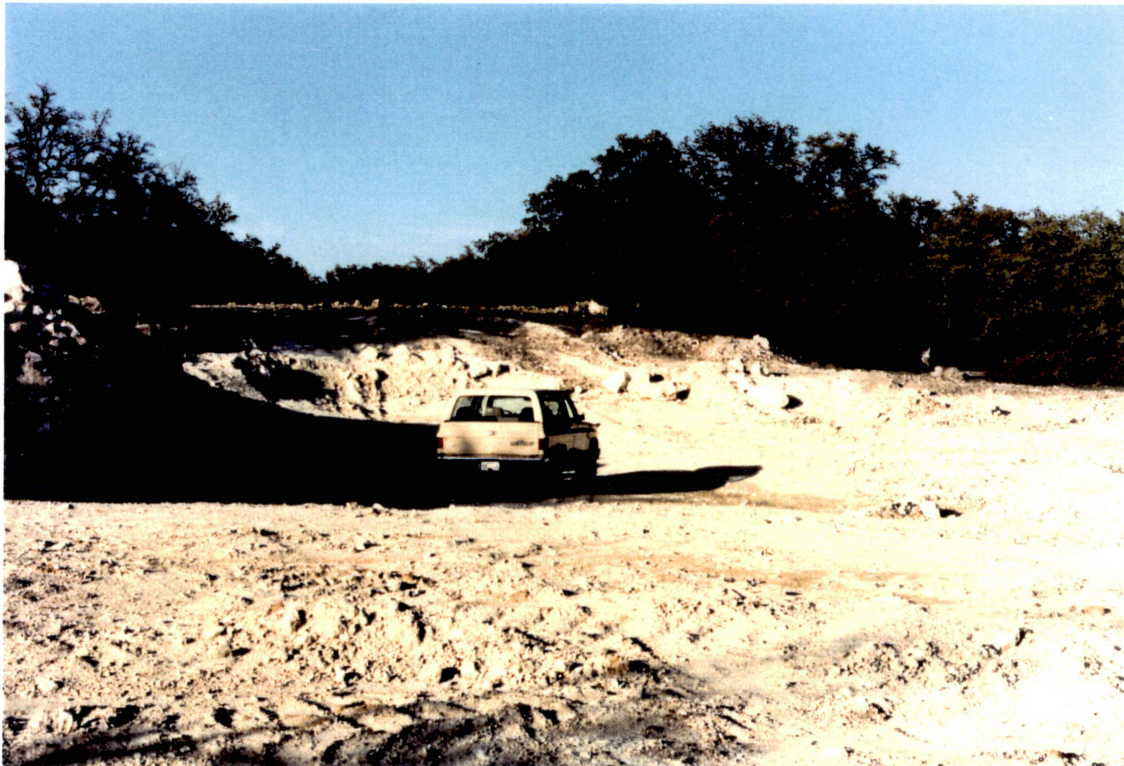
Figure 3. (a) Photograph of part of quarry (gravel pit) at top of Travis Peak Formation in northernmost part of original reservation, east of camp facilities (see plate NW); (b) photograph of part of quarry (gravel pit) at top of Travis Peak Formation in westernmost part of original reservation (second quarry to the south on plate NW).

Most Camp Bowie grounds are relatively undisturbed and vegetated. Degraded areas are mainly concentrated at and near four quarries, or "gravel pits" (fig. 1; plate NW), developed in limestone-rich Travis Peak deposits on the ridge tops. The most extensively degraded area lies at, and to the southeast of, the gravel pit and a large pond, which is east of and adjacent to the area that contains buildings, parking lots, and firing ranges (figs. 1, 3a, and 4; plate NW).

(figs. 1 and 3b). In these areas rock has been excavated, resulting in local relief of as much as 10 ft in the quarries. Much less intense but more widespread degradation has occurred in the form of vehicle tracks that crisscross the highland areas (fig. 5). These are most abundant in the north-central part of the original reservation. In lowlands, degradation mainly consists of relatively deep vehicle tracks. Thin coverage by grasses also suggests a history of livestock overgrazing.

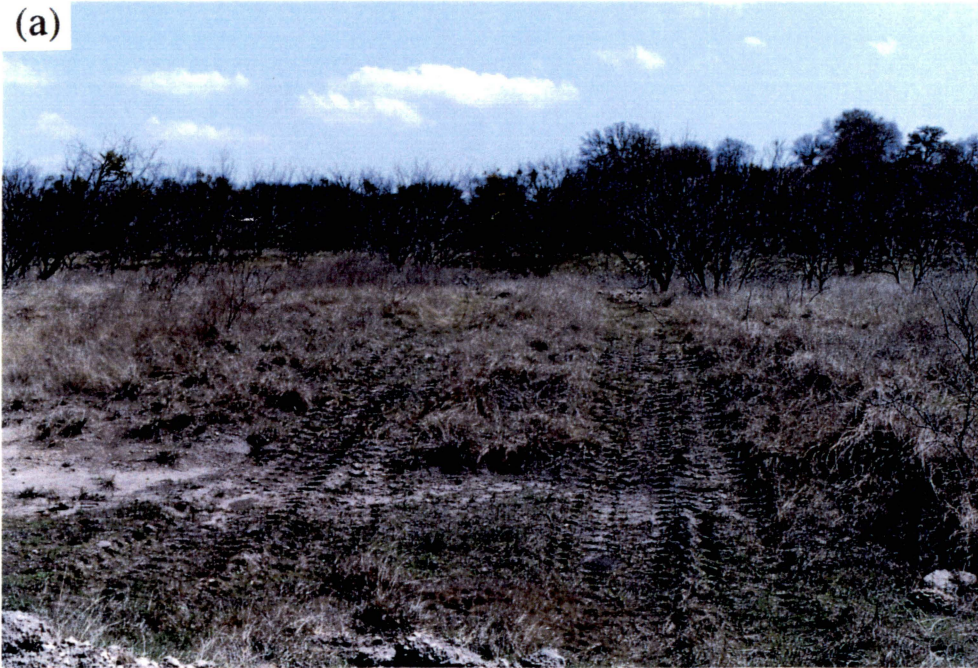
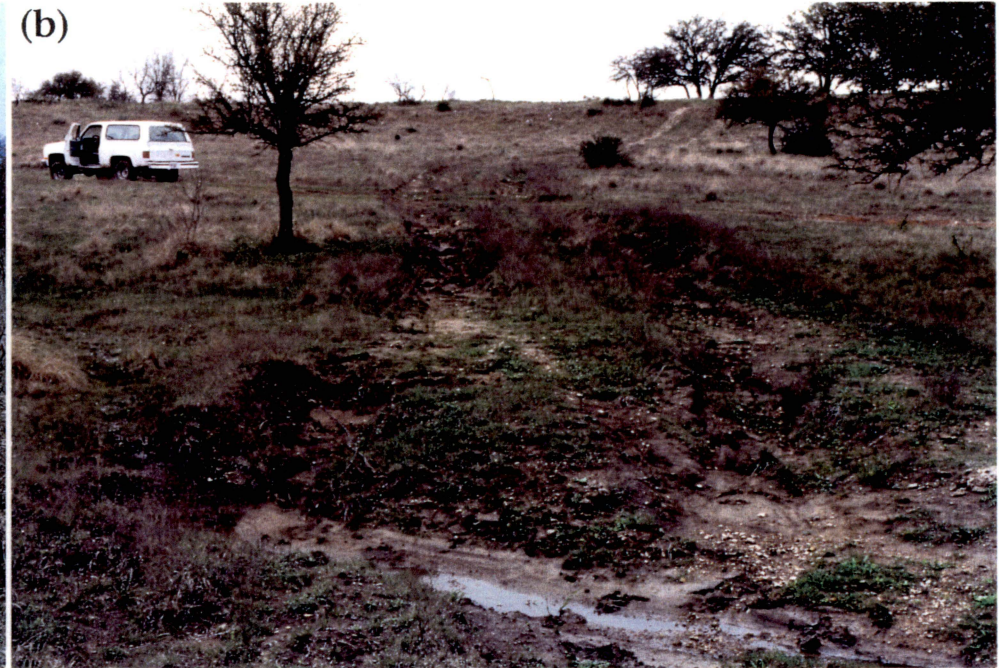
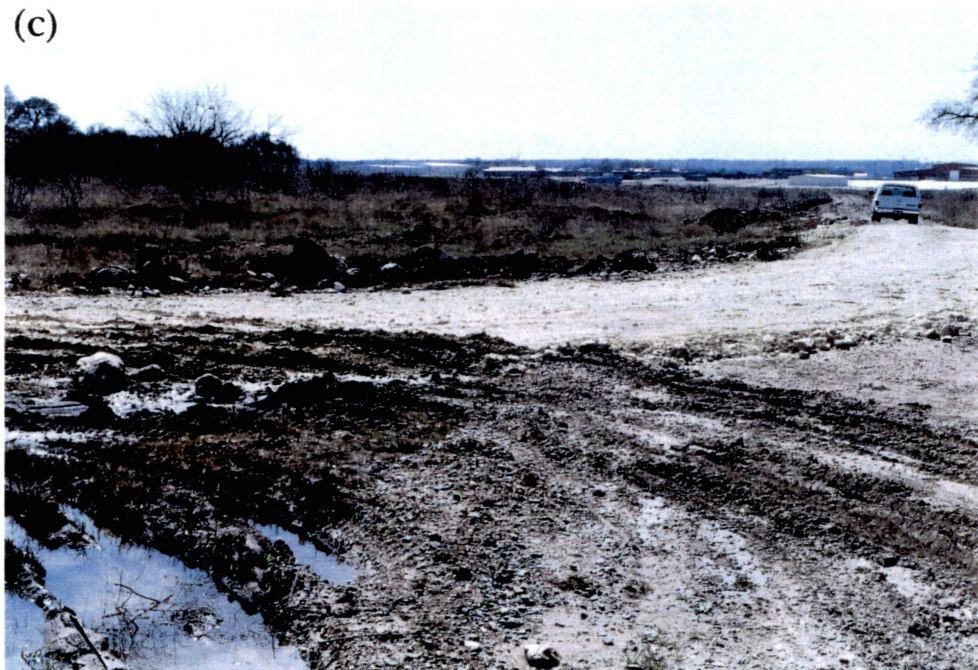
Figure 5. Vehicle tracks in soil developed on Strawn Group: (a) early stage of degradation, (b) more advanced degradation (tracks 1.5 ft deep) containing small amount of pooled water, (c) quite advanced degradation showing signs of heavy traffic and much pooled water.

Vehicular traffic on the two general soil types has very different results (figs. 5 and 8). On thin upland soil, grass is destroyed by repeated traffic, leaving it vulnerable to erosion during runoff. Vegetation, once destroyed, recovers slowly, especially on slopes that are episodically swept by runoff during rainstorms. On clay rich lowland soils, deep tracks develop, especially when wet, and commonly pool water in flat areas (fig. 5). The shrink-swell behavior of clays in lowland soils often causes shrinkage (desiccation) cracks to form as they dry. These cracks allow rain to penetrate 20 inches or more in places, until the cracks close by swelling as they get wetter. These soils have high water-storage capacity and tend to stay damp for extended periods, resulting in their reduced strength.

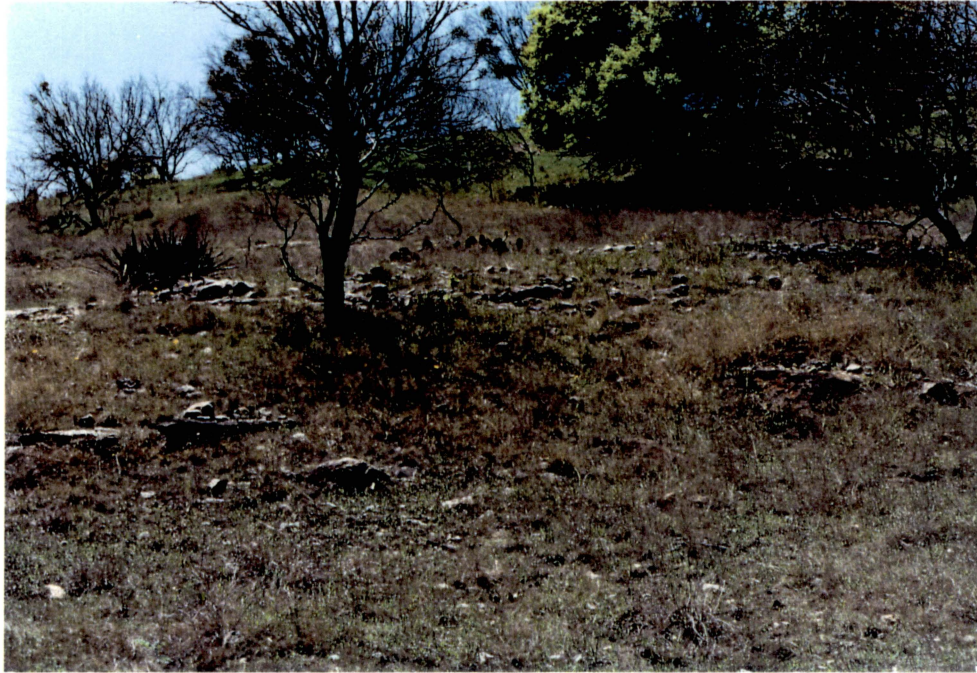
Figure 7. (a) Photograph of upper part of Strawn Group. Beds in foreground are sandstone and limestone. At the horizon in upper left part of photo is a limestone bench at the top of the Strawn. (b) Photograph of top of resistant fossiliferous limestone bed that forms top of bench.

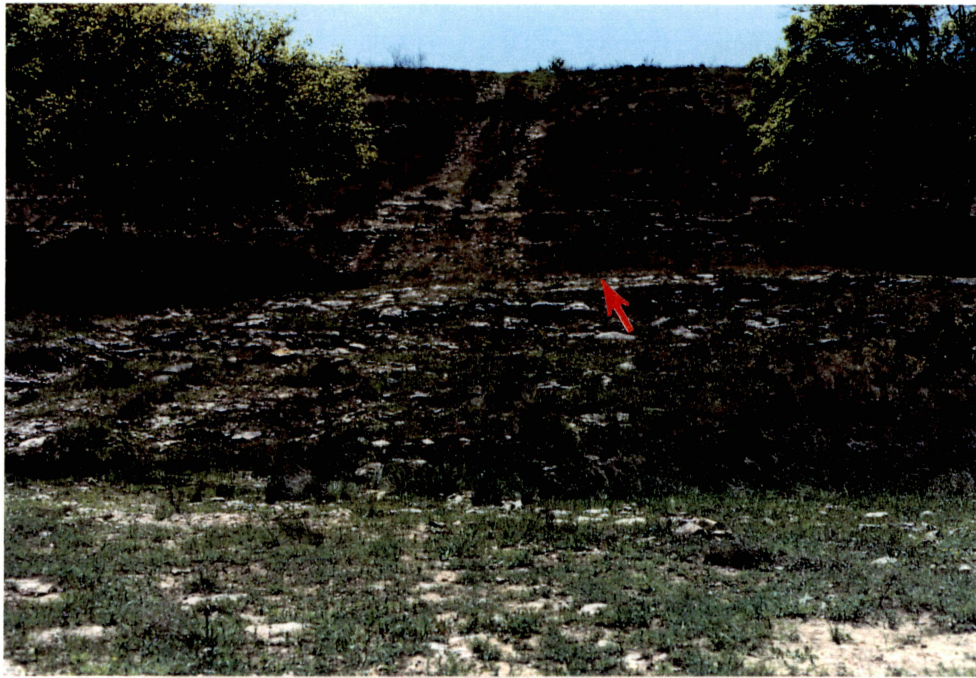
Figure 8. Photograph of contact (arrow) between Travis Peak and underlying Strawn Group. Note slight divergence to left of Strawn beds (beneath arrow) and Travis Peak beds demonstrating angular unconformity. This is laterally equivalent to top of Strawn bench shown in figure 7a. Note that vehicle tracks up Travis Peak slope are shallow and stony, contrasting with deeper tracks in Strawn soils (figs. 4 and 5).

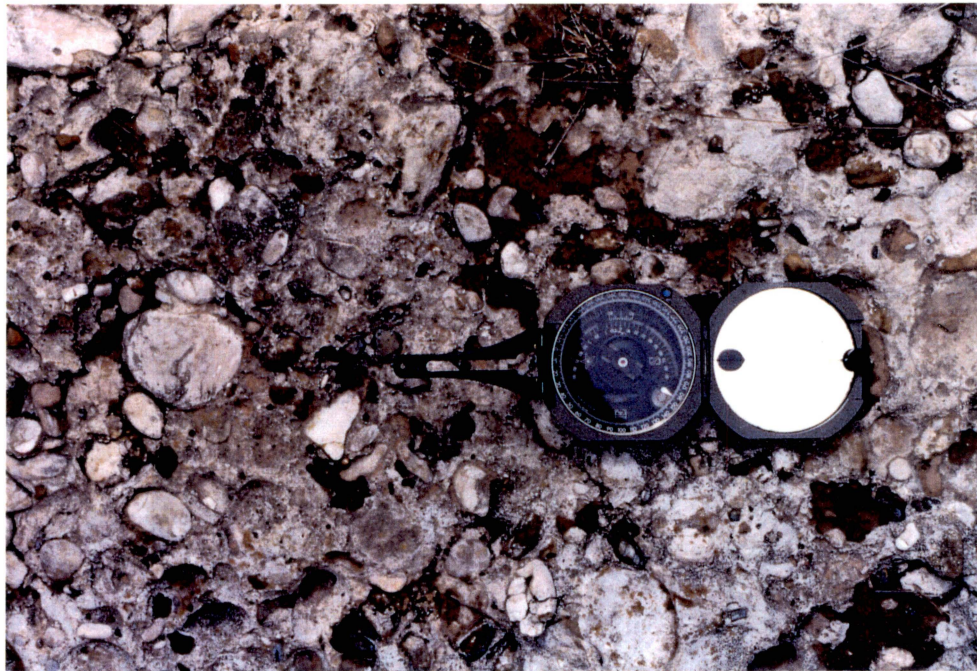
Figure 9. Photograph of well-cemented pebble conglomerate at base of Travis Peak Formation. Compass 2.75 inches in diameter.

The Travis Peak Formation lies unconformably on the Strawn Group: 170 million yr elapsed between (1) deposition of the Strawn sediments (during which the Pennsylvanian rocks were uplifted) and (2) erosion of a relatively flat surface having local channels (Wichita Peneplain) on top of the Strawn, with subsequent Travis Peak deposition. This unconformity is regionally angular; that is, because the Pennsylvanian surface was tilted to the east during uplift, before deposition of the originally flat-lying Cretaceous rocks, the bedding planes of Strawn rocks are at an angle to Travis Peak bedding planes (fig. 8). Today even the Travis Peak tilts slightly to the east. However, the angles of tilt are fairly low at Camp Bowie (only a few degrees), and the unconformity appears essentially level in the cross section (fig. 6). This bedding tilt has caused asymmetry in the erosion of hill slopes that formed on the Travis Peak; slopes are significantly steeper on the west sides of ridges than on the east. The Travis Peak Formation is generally composed, from bottom to top, of conglomerate, sandstone, and limestone. The conglomerate (fig. 9) is composed of pebbles and small cobbles as much as

4 inches in diameter. The size of these clasts tends to decrease upward in the interval, and they are composed mostly of rounded fragments of quartz-rich sandstone. The sandstone fragments were originally eroded from exposed Pennsylvanian rocks to the west and delivered to their final sites of deposition by early Cretaceous-age rivers that had been entrenched in the landscape (Wichita Peneplain). The thickness of this conglomeratic interval varies from <1 ft to ~50 ft or more in thickness. Thicker deposits probably lie near the deepest parts of ancient river channels, whereas thinner deposits lie off to the sides of the main channels. An example of thicker conglomerate deposits is found on the east-northeast-trending, steep-sided ridge near the easternmost corner of the original reservation (at the end of the word "reservation" on the topographic map [fig. 1]). The ridge probably reflects the easterly course of a large Cretaceous river channel.

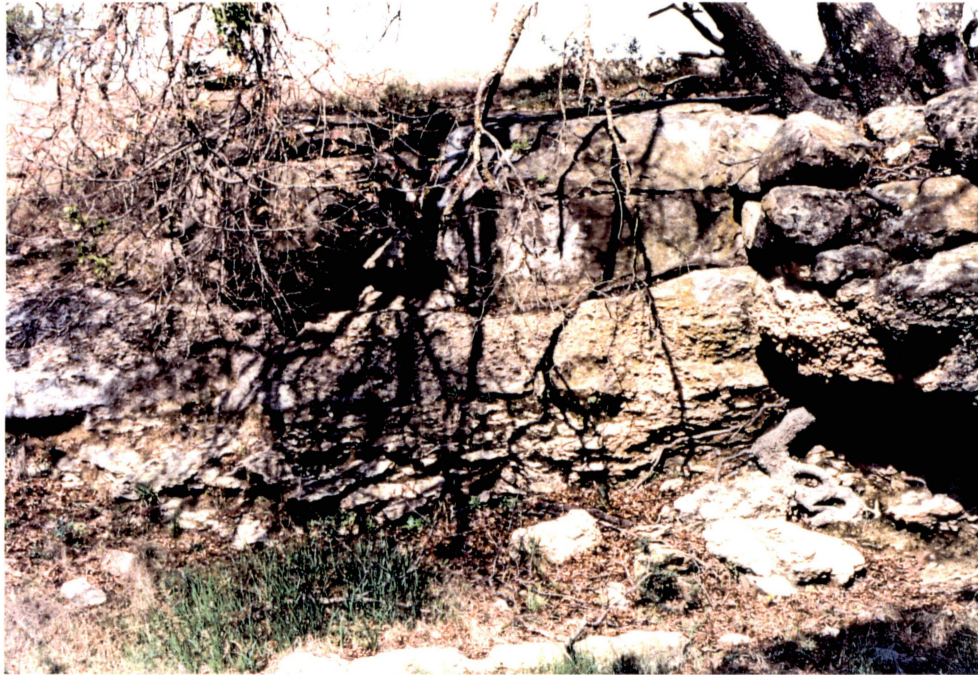
Figure 10. Photograph of lowermost Travis Peak conglomerate (pebbly texture) that has a channel cut into top, which is filled by crossbedded sandstone. These are Cretaceous-age river deposits. Outcrop approximately 6 ft high.

Overlying the conglomerates are sandstones (figs. 10 and 11) that generally fine upward in grain size and are crossbedded (that is, they have angular internal laminations that occurred during sand deposition in rapidly flowing river water). Where no conglomerates are present and the underlying material is Pennsylvanian shale, the lowermost Cretaceous sandstones (in some places) contain Pennsylvanian fossils (crinoids, fig. 12) eroded from the shale. Above the lowermost Travis Peak sandstone, thin limestone beds appear and are interbedded with more sandstone (fig. 13). The occurrences of limestone beds increase in number and thickness upwards in the Travis Peak, limestone becoming the dominant rock type at the tops of ridges.

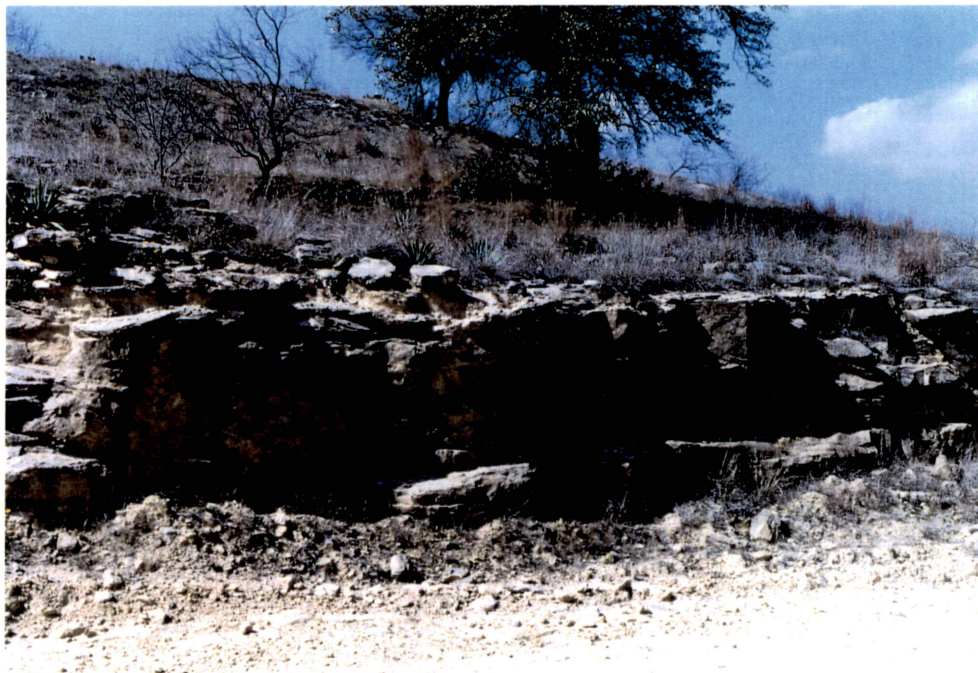
Figure 11. Photograph of crossbedded channel sandstone unit, Travis Peak Formation. Most overlying rocks to the horizon are limestone. Outcrop approximately 5 ft high.

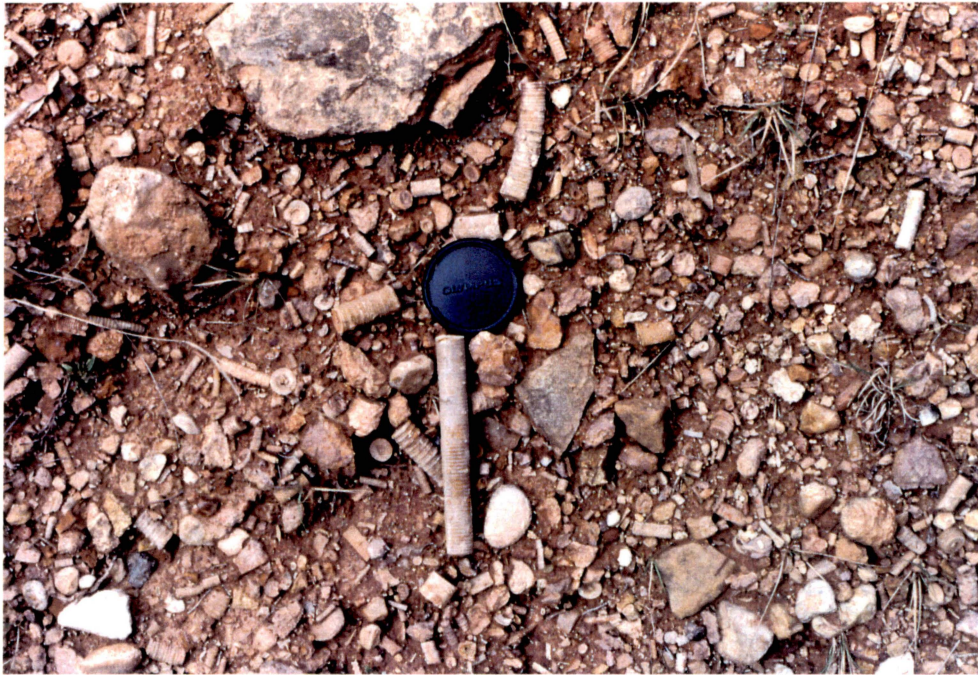
Figure 12. Photograph of Strawn Group shale that has fossils (crinoid stems) weathering from outcrop. Longest stem 4.75 inches long.

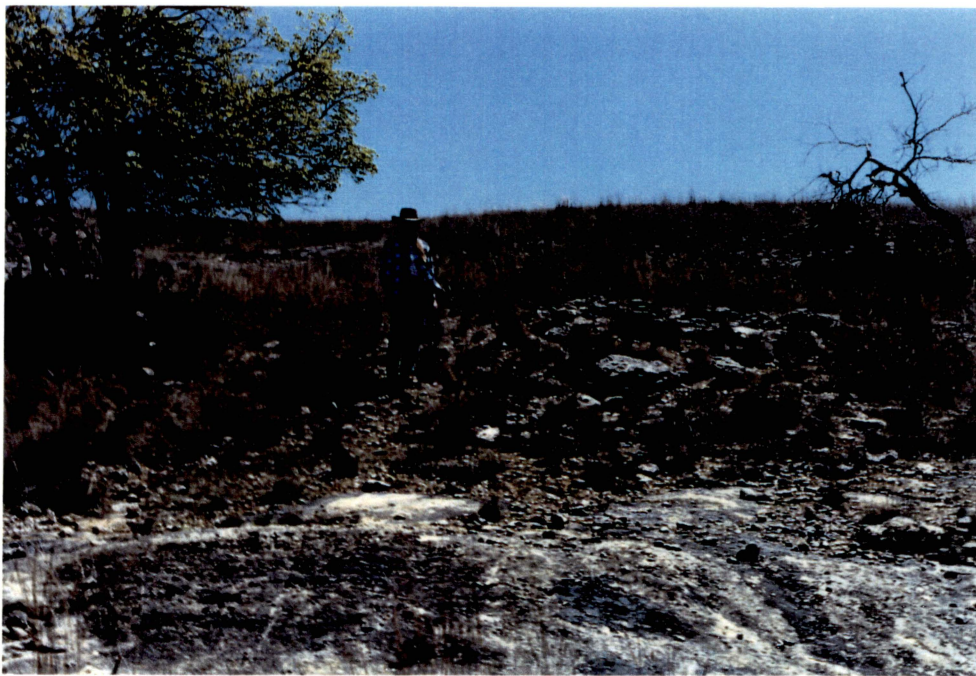
Figure 13. Photograph of sandstone-limestone couplets near top of Travis Peak Formation. Foreground sandstone; person standing next to limestone bed; receding slope behind person contains more sandstone having limestone present to horizon at the top of the Travis Peak Formation.

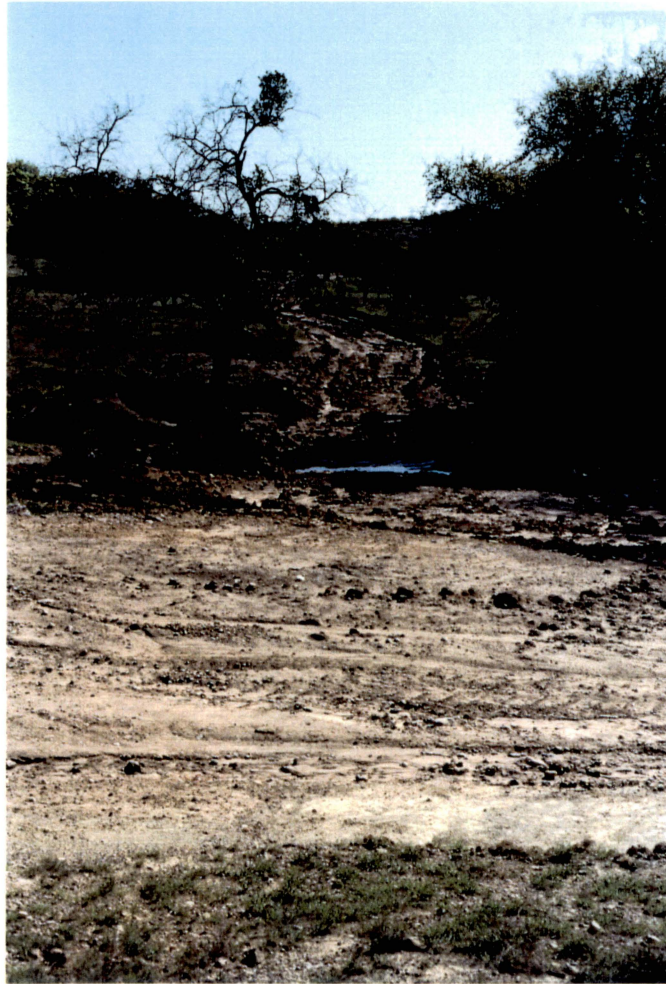
Figure 15. Photograph of road across flowing stream. Runoff from heavy rain will wash abnormal amounts of sediment into stream from defoliated areas.
