ANNUAL REPORT

East Texas and Western Louisiana Coastal Erosion Study

Year 3

**Prepared for the U.S. Department of Interior
U.S. Geological Survey**

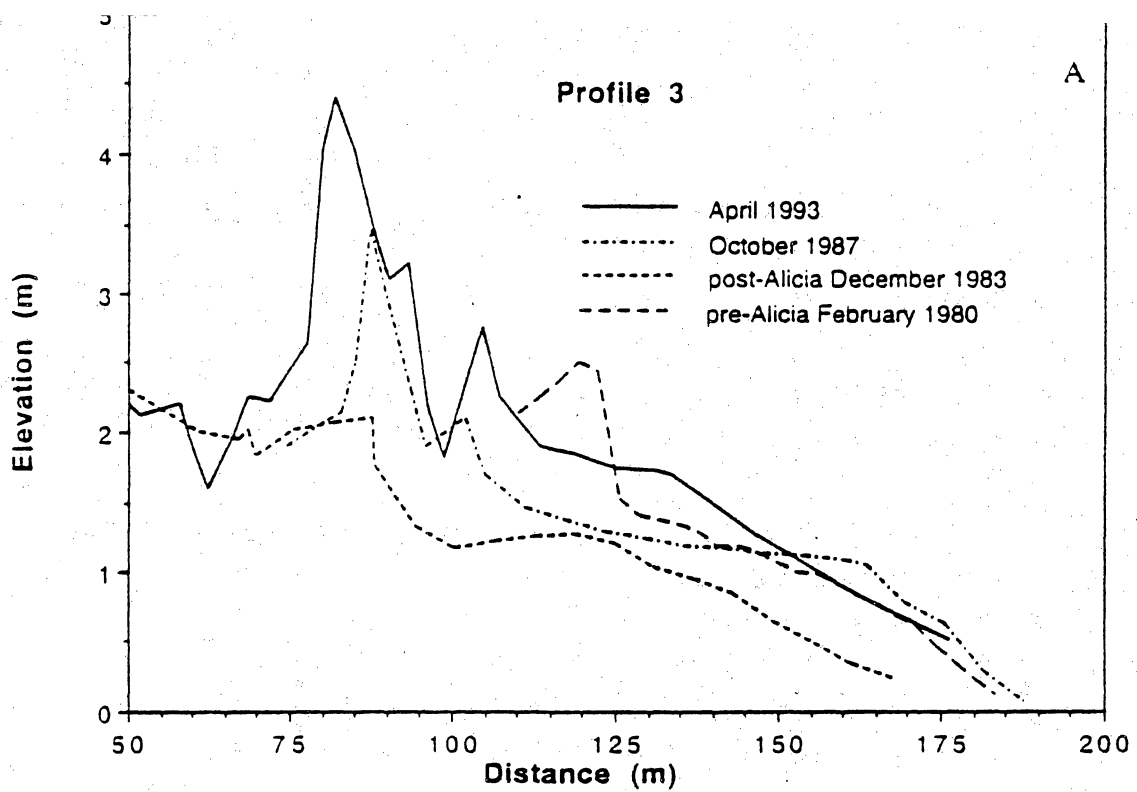
Figure 6. Summary of beach changes at Profile 3 from (A) 1980 to 1993 and (B) 1983 to 1987.
