Düzce University Journal of Science & Technology

Research Article

Structural Health Monitoring Application of Aviation Composite Materials Using Microscopic Techniques

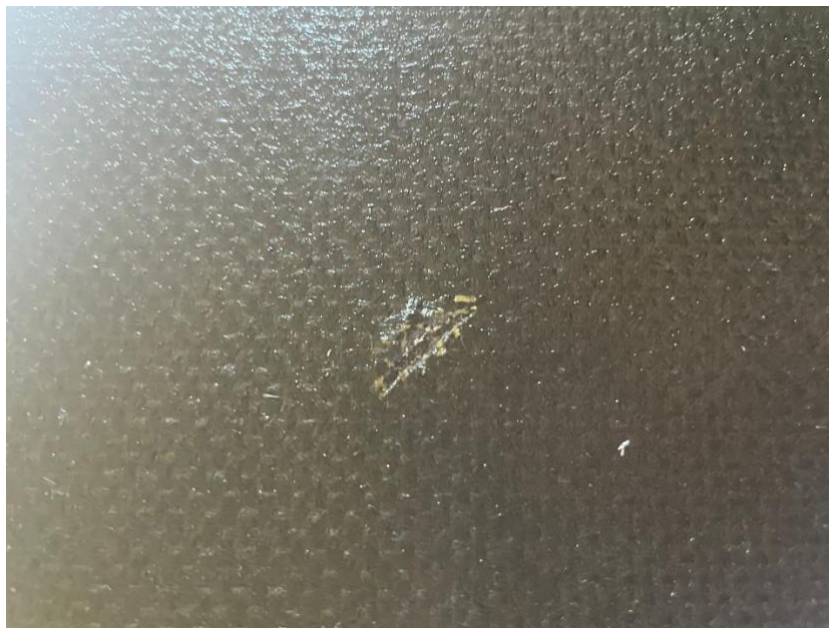
Figure 1. The general appearance of the damage

The general appearance of the damage is illustrated in Figure 1.

During the service life of an aircraft, a section of the outer skin of the body encountered impact damage. The impact resulted in visible damage, which was subsequently identified during routine inspections. The dimensions of the affected area were measured in terms of width, length, depth, and total area.

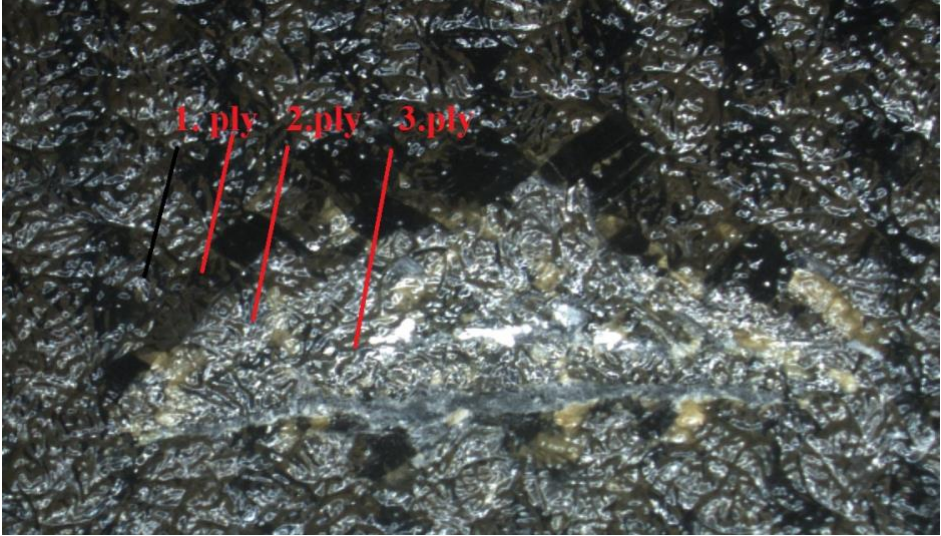
Figure 2. General appearance of the damage_16x

Figures 2, depict the damaged area as observed under the stereo microscope. This inspection disclosed that the initial three layers of the composite exhibited damage, with numerous fragmented fiber particles observed on the part's surfaces. The boundaries of the damage were sharply delineated, with no evidence of similar damaged regions detected elsewhere on the surface of the component. The dimensions of the damaged area measured approximately 16.2 mm in maximum length and 4.3 mm in maximum width, with a depth of approximately 0.6 mm. Notably, the damage extends to a depth nearing half of the part's total thickness. It is worth emphasizing that the utilization of stereo microscopes permits a more

comprehensive collection of information and facilitates precise measurements, surpassing the capabilities of on-site visual inspections conducted at the aircraft's location.

The investigations conducted on the damaged component have yielded valuable data regarding the mechanism of damage initiation and its effects on the part. The examination using a stereo microscope has provided significant insights. The well-defined and localized boundaries of the damage, coupled with the absence of any external damage in the proximity, suggest that the part has incurred damage characteristic of a hard-body impact.

Furthermore, the preliminary assessment through stereo microscopy, later confirmed by SEM analysis, has revealed that the damage extends to a depth of approximately half the thickness of the part. The SEM examination has also confirmed the presence of fiber breakage, delamination, and matrix cracking within the part.

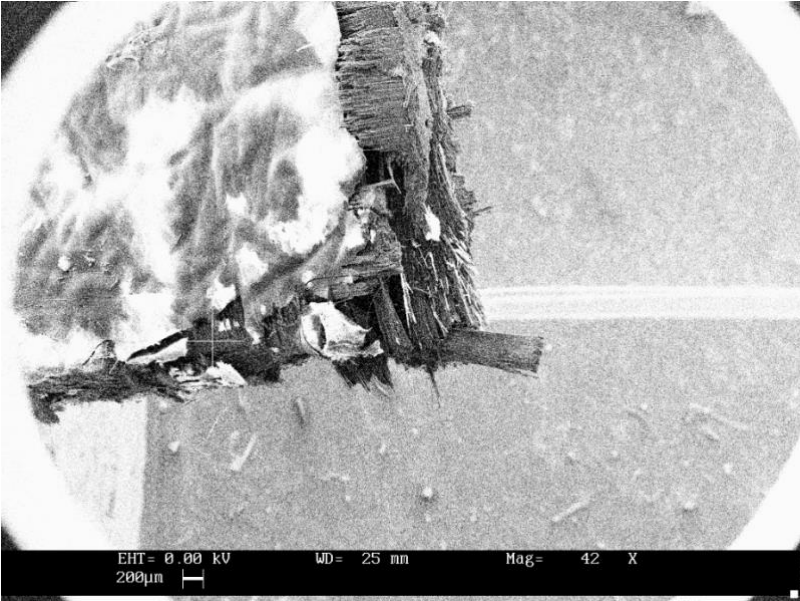
Figure 3. (a) and (b) the SEM secondary detector images of the damage area_50x.

The SEM examination unveiled the presence of fiber breakage, delamination, and matrix cracking at the site of damage. Additionally, broken fiber particles were observed in SEM Secondary detector images. These specific damages are depicted in Figure 3a and b.
