Multidimensional HAM conditions

Measurements on full-scale wall elements in the large climate simulator at SBi

Ernst Jan de Place Hansen

Serial title SBi 2010:06 Edition 1 edition Year 2010

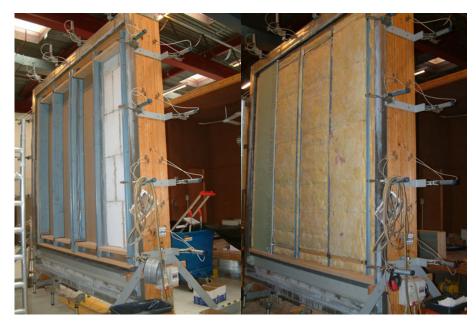
Figure 2. The test rig with the four elements seen from the outdoor side before (left) and after (right) mounting the thermal insulation. Element 4 at right.

Figures 2, 3 and 4 show the test set-up. Additional photos are placed in Appendix A. Data for the different materials are given in Appendix C.

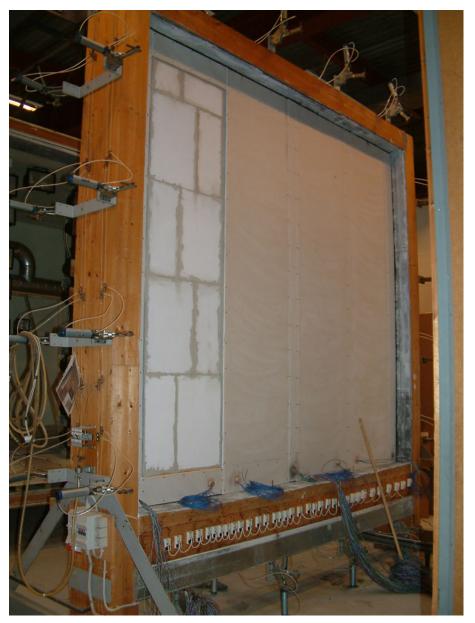
Figure 3. The test rig with the four test elements seen from the indoor side with gypsum board as inner cladding at three of the four elements. The wires coming from the sensors inside the elements are seen at the bottom of each element.

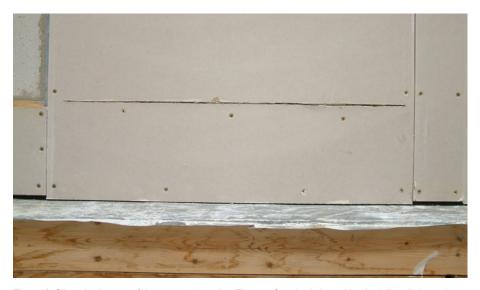
Figure 4. Slit at the bottom of the gypsum board at Element 3 at the indoor side. A similar slit is made at the top of in the wind barrier at the outdoor side. Condition before mounting the vapour barrier.

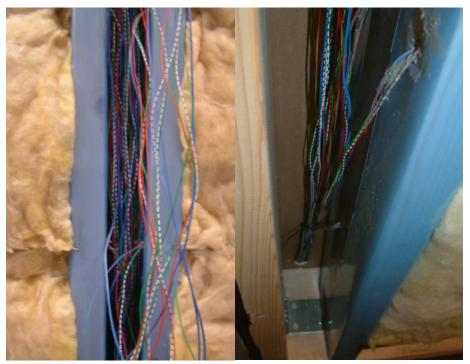
Figure 6. Duct for cables between Elements 2 and 3 (left) and next to Element 1 (right) seen from the outdoor side. The timber studs framing the elements are wrapped in a (blue) vapour barrier in order to ensure that they do not affect the moisture transport through the elements.

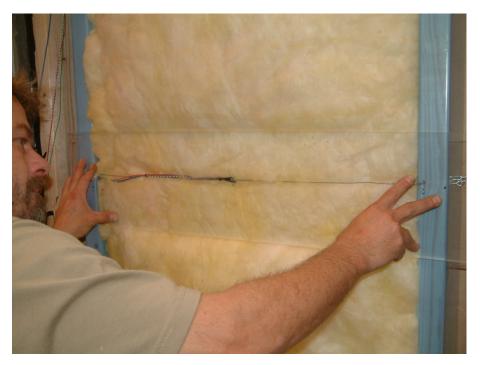
Figure 7. Placement of moisture sensors in fixed positions in the insulation layer.

Figure 7 shows how the sensors placed in the thermal insulation are fixed by means of wires stretched between the two timber studs on each side of an element. Figure 8 shows how sensors are fixed on the gypsum boards, in this case the wind barrier. All the holes made in the frames for leading the wires are sealed afterwards.

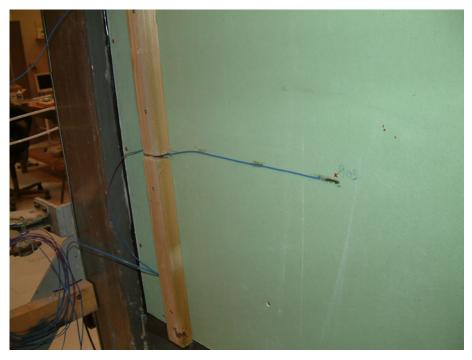
Figure 8. Fixing of sensors at the outdoor side of the wind barrier.

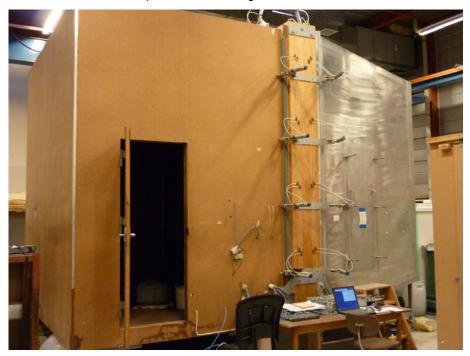
Figure A8. Climate simulator at SBi. Indoor side at left, outdoor side at right.

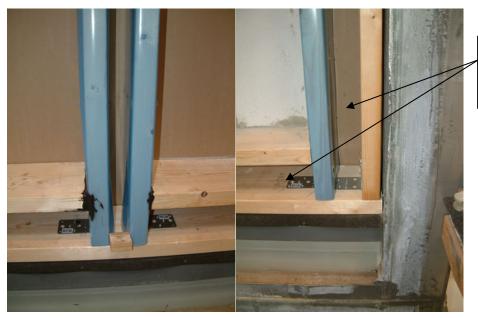
Later filled with thermal insulation to reduce 3D effects

Figure A9. Duct for cables between the two vertical Figure A10. Reducing 3D effects. studs.

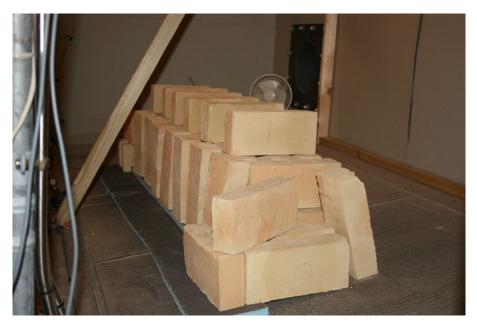
Figure A11. Placement of bricks at the outdoor side to increase the thermal mass for stabilising the temperature. Fans are added in order to ensure that the bricks are activated as thermal mass.

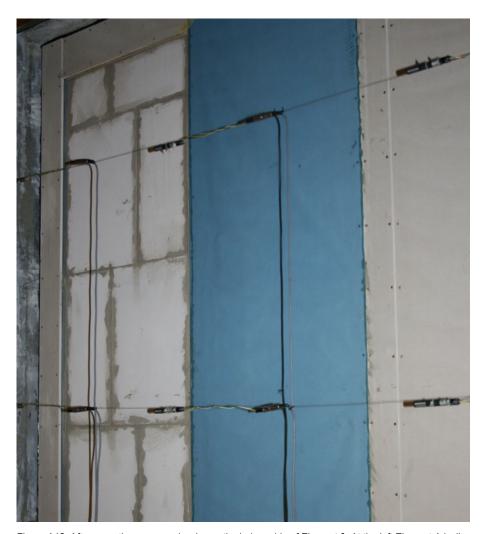
Figure A12. After mounting a vapour barrier on the indoor side of Element 3. At the left Element 4 (cellular concrete), at the right Element 2 where no vapour barrier was mounted. Suspended RH sensors (Rotronic) are seen in front of the elements.

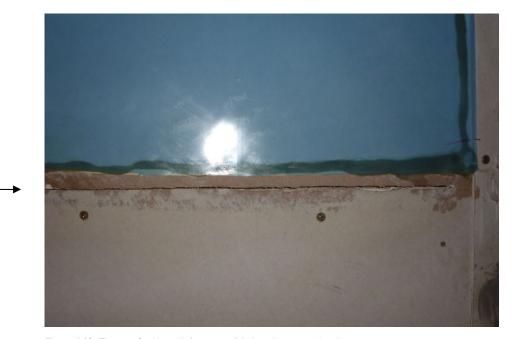
Figure A13. Element 3 with a slit (see arrow) below the vapour barrier.

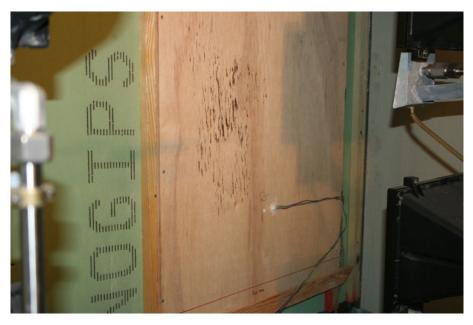
Figure A14. Element 4 seen from the outdoor side after mounting the cladding. The sensors are fixed at the back (indoor) side of the cladding while the wires are led on the outdoor side in order to disturb the conditions in the cavity as little as possible.

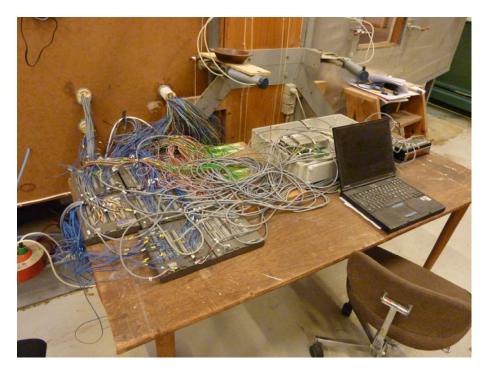
Figure A15. Table with data-loggers, wires, computer, etc.

Three data-loggers were used to collect data from the different sensors, named CR10_1, CR10_2 and CR10X1. Each of these could contain data from about three days of measurements. Two or three times a week the content of the data-loggers were transferred to a computer.

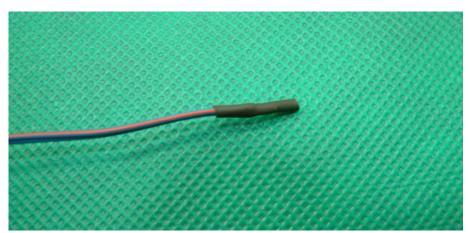
Figure A16. Thermocouple. Specifications: see Table A1.

Sensor	Position	Characteristics	Picture
Thermocouple	At different depths in the elements, cf. Ap- pendix D	Standard copper-constantan thermocouple Range: -250 °C - + 350 °C Accuracy: +/- 0,1 °C at 100 °C	See Figure A16
RH sensor	Same	Manufacturer: Honeywell Model: HIH-4000-004 Humidity Sensor Range: 0 – 100 % RH Accuracy: +/- 3,5 % RH	See Figure A17
RH sensor	In front of the elements at the indoor (500 mm) and outdoor sides (750 mm)	Manufacturer: Rotronic Model: HygroClip Range: 0- 100 % RH Accuracy: +/- 1,5 % RH at 23 °C	See Figure A18

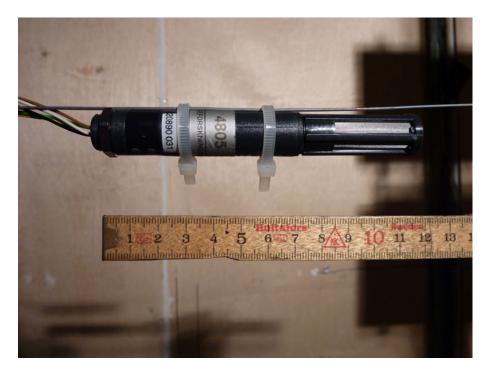
Figure A18. RH sensor (Rotronic). Specifications: see Table A1.

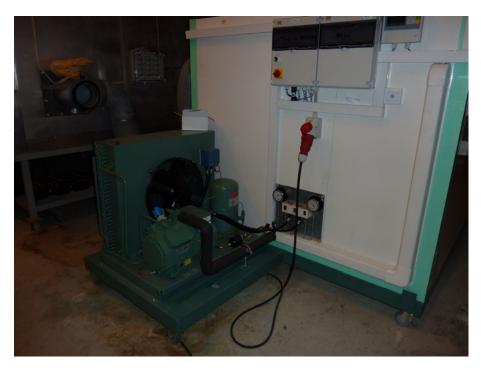
Figure A19. Cooling machine and compressor.

Compressor performance at -30 °C/+27 °C: 5220 kW

Evaporator type: SEARLE KME 80-8L Ventilator type: Øland GTHB-031-B Ventilator max performance: 2100 m³/h

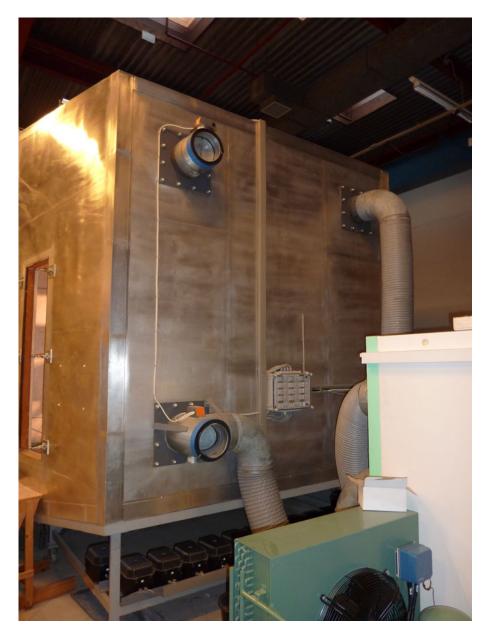
Figure A20. Climate simulator with inlet (top) and outlet (bottom) at the outdoor climate chamber for air from and to the cooling machine.
