## Parametric and Machine Learning-Based Analysis of the Seismic Vulnerability of Adobe Historical Buildings Damaged After the September 2017 Mexico Earthquakes

Rafael Ramírez Eudave, Tiago Miguel Ferreira, Romeu Vicente, Paulo B. Lourenco & Fernando Peña

In September 2017, two strong earthquakes hit the central region of Mexico, producing substantial damage to the historical buildings. A retroactive analysis for assessing the pre-event seismic vulnerability of these constructions allowed for testing the suitability of an existing parameter-based approach based on material and geometrical features. More than 160 adobe buildings in four municipalities of the State of Morelos were surveyed and included in a vulnerability-oriented GIS database. Data were collected on-site and managed by resorting to open-source GIS software combined with a Python-based database management tool and a cloud-based platform for onsite data collection using mobile devices. The parameter-based approach was used for assessing the analytical seismic vulnerability of the buildings and implementing a secondary, more conservative assessment that considers uncertainties associated with the data acquisition proc

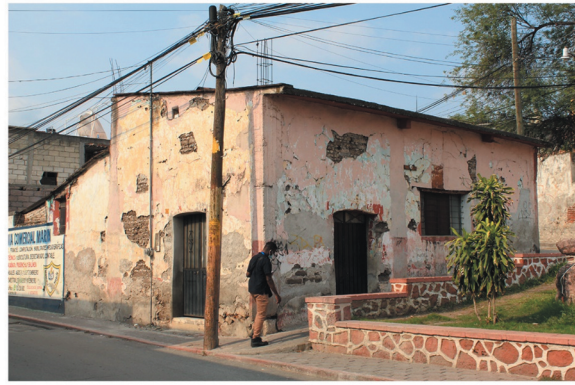
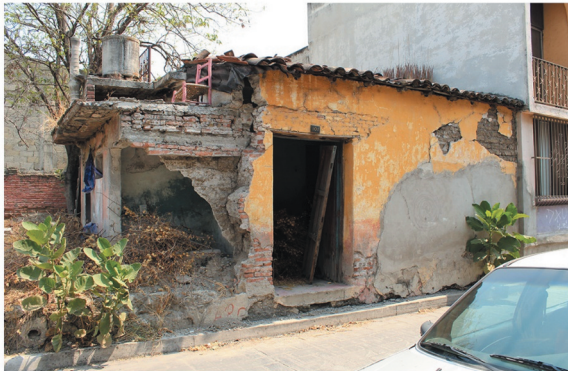
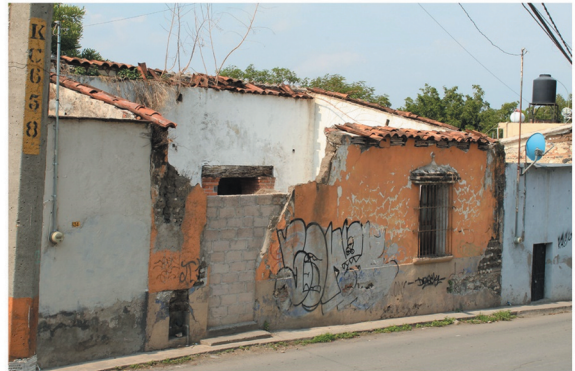
**Grade 1: Negligible to slight damage (no structural damage, slight non-structural damage).**

Hair-line cracks in very few walls.  
Fall of small pieces of plaster only.  
Fall of loose stones from upper parts of buildings in few cases.

**Grade 2: Moderate damage (slight structural damage, moderate non-structural damage).**

Cracks in many walls.  
Fall of fairly large pieces of plaster.  
Partial collapse of chimneys.

**Grade 3: Substantial to heavy damage (moderate structural damage, heavy non-structural damage).**

Large and extensive cracks in most walls.  
Roof tiles detach. Chimneys fracture at the roof line; failure of individual non-structural elements (partitions, gable walls).

**Grade 4: Very heavy damage (heavy structural damage, very heavy non-structural damage).**

Serious failure of walls; partial structural failure of roofs/floors.

**Grade 5: Destruction (very heavy structural damage)**

Total or near total collapse.

**Figure 3.** EMS-98 five damage grade scale (Centre Européen de Géodynamique et de Séismologie 1998) and examples of buildings with corresponding damage grades from 1 to 5 in the studied municipalities.

- (iii) Damage questionnaire to the owners/users of the constructions. Besides communicating the goal and procedure of the fieldwork, the users were asked to describe the type of damage that structures had after the 2017 Earthquakes. The diagram that illustrates the classification of damage to masonry buildings in the EMS-98 scale (Centre Européen de Géodynamique et de Séismologie 1998) was shown to better classify the level of damage (see Figure 3).

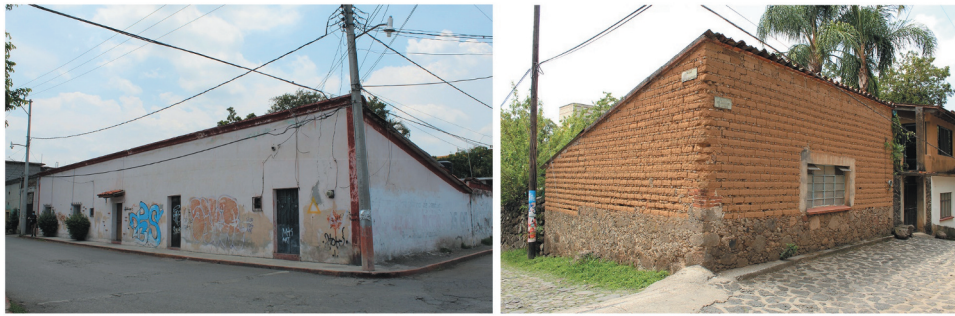
**Figure 4.** Examples of urban (left) and rural (right) houses.

Although there is a certain variability throughout the sample, most of the assessed constructions (see Figure 4) share several characteristics.

urban houses present a series of rooms of similar sizes, internally connected and aligned with the street (Figure 4).

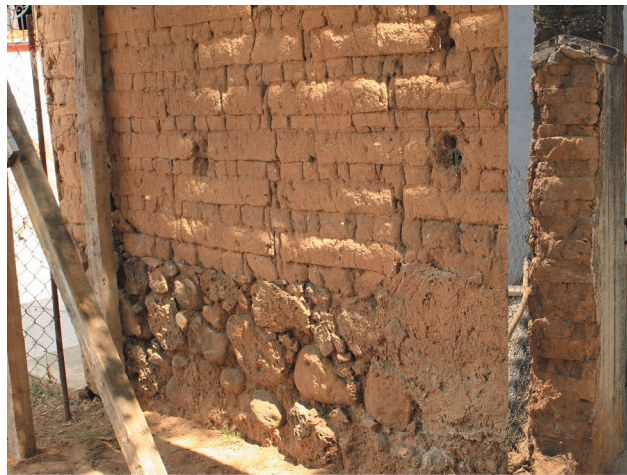
Figure 6. Typical adobe configuration in a house in the municipality of Tlayacapan.

The most common structural solution is one-leaf adobe walls built with units of ca. 52 cm in length, 36 cm in width, and 9 cm in thickness. Although there are no additional means of reinforcement or strengthening, there is good interlocking and layering and most constructions have visible stone foundations. Most foundations reach a height of between 0.50 and 1.00 m from the level of the street, mainly as a strategy for isolating the adobe walls from the soil humidity and rainwater (Figure 5). The most common roof solution is a plane-pitched roof that facilitates rainwater collection by the means of dedicated ceramic pipes. The openings in

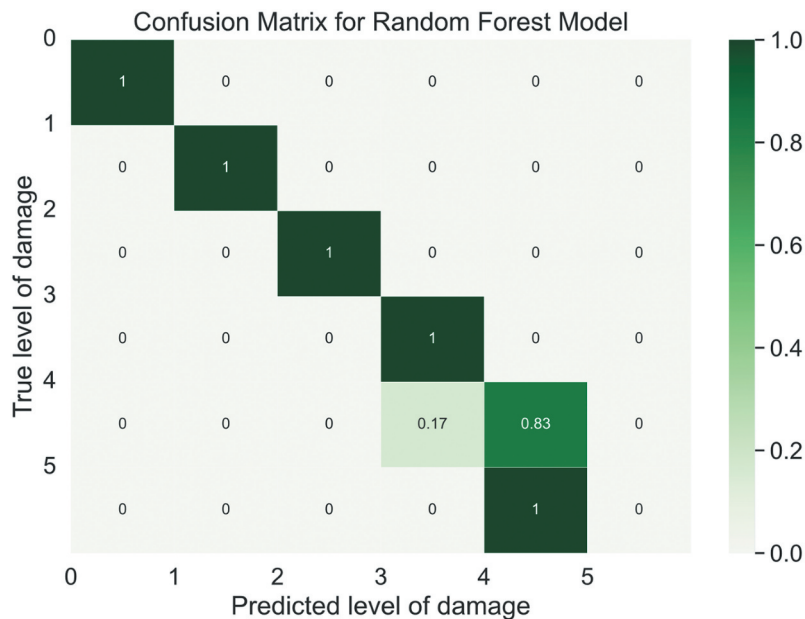
Figure 17. Confusion matrix. True values correspond to observed levels of damage.

An explicit representation of the results is the confusion matrix, in which the correspondence between the true and predicted labels (i.e., discrete levels of damage) is shown in Figure 17. This confusion matrix exhibits how most of the classes were correctly identified by the model, but there is a lack of representativeness in identifying the highest level of damage  $D_K = 5$ . This phenomenon can be easily associated with the relatively small number of samples used for training purposes in this class (4 out of 167, 2.4%; however, it appears only once in the test split of the sample) since this is the most infrequent class, it is expected to be less likely recognized by the algorithm.

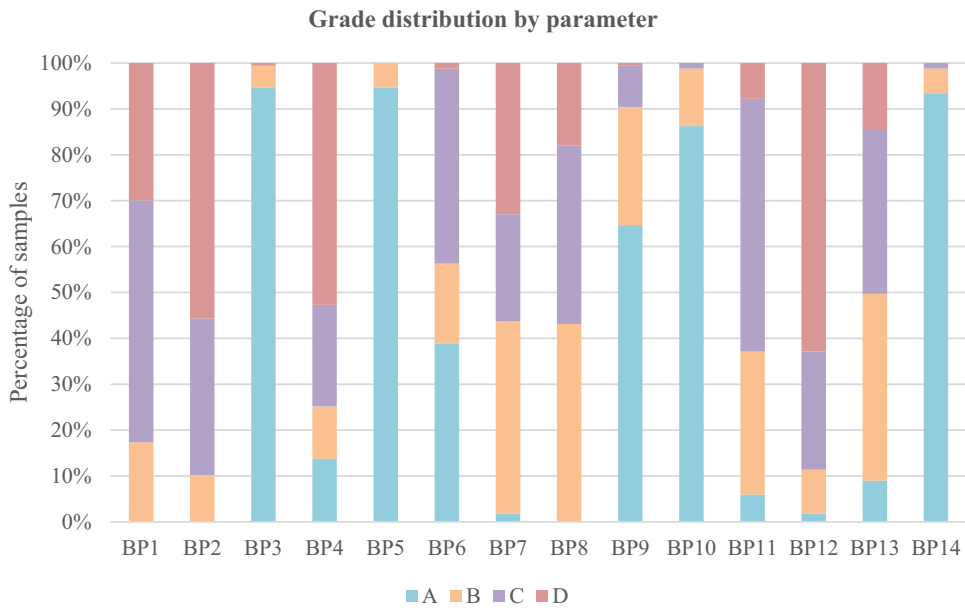
Figure 18. Vulnerability class distribution per parameter.

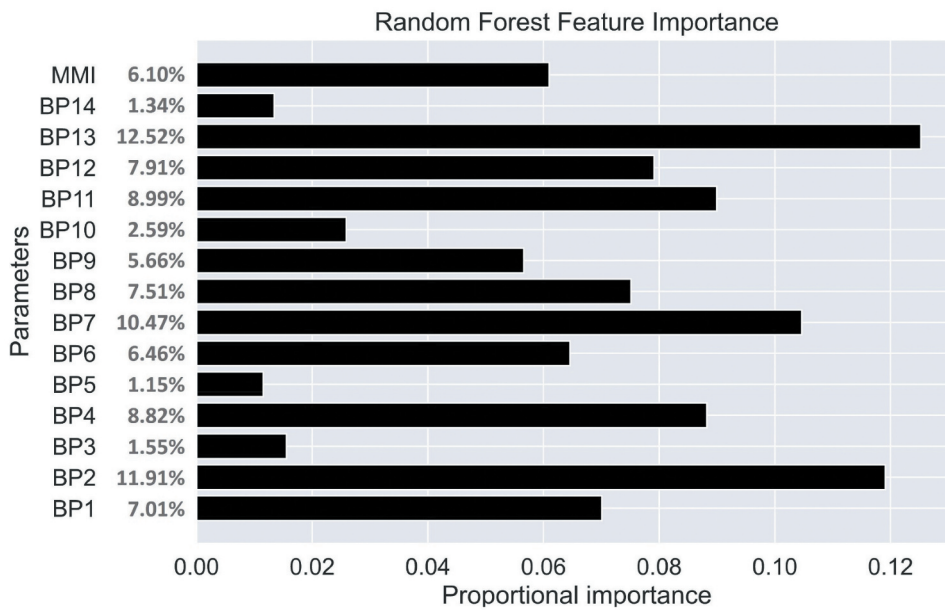
Figure 19. Relative importance by feature according to the RFC model.
