Development and Demonstration of a HBIM Framework for the Preventive Conservation of Cultural Heritage

Building Information Modelling (BIM) methodology is becoming widespread with many potential uses, such as facility and asset management for new buildings. Recently, it has also been applied for the maintenance of built heritage, within the so-called Historical BIM (HBIM) field. A BIM model, empowered by detailed embedded information, is an excellent tool to monitor and infer on the behaviour, performance, and deterioration of heritage buildings, collecting and classifying diverse data that can co-exist in an asset model. However, three main issues must be tackled: lack of standardization, insufficient interoperability and inherent complexity of the information. It is essential to balance model's geometrical and non-geometrical features, such as the level of detail accuracy and the quantity of linked information, to make the methodology cost-effective and hence more attractive for end-users. The present work focuses on the development of easy-to-implement strategy to report and monitor damage evolution over time. Standardization and simplification of the procedures are pursued by

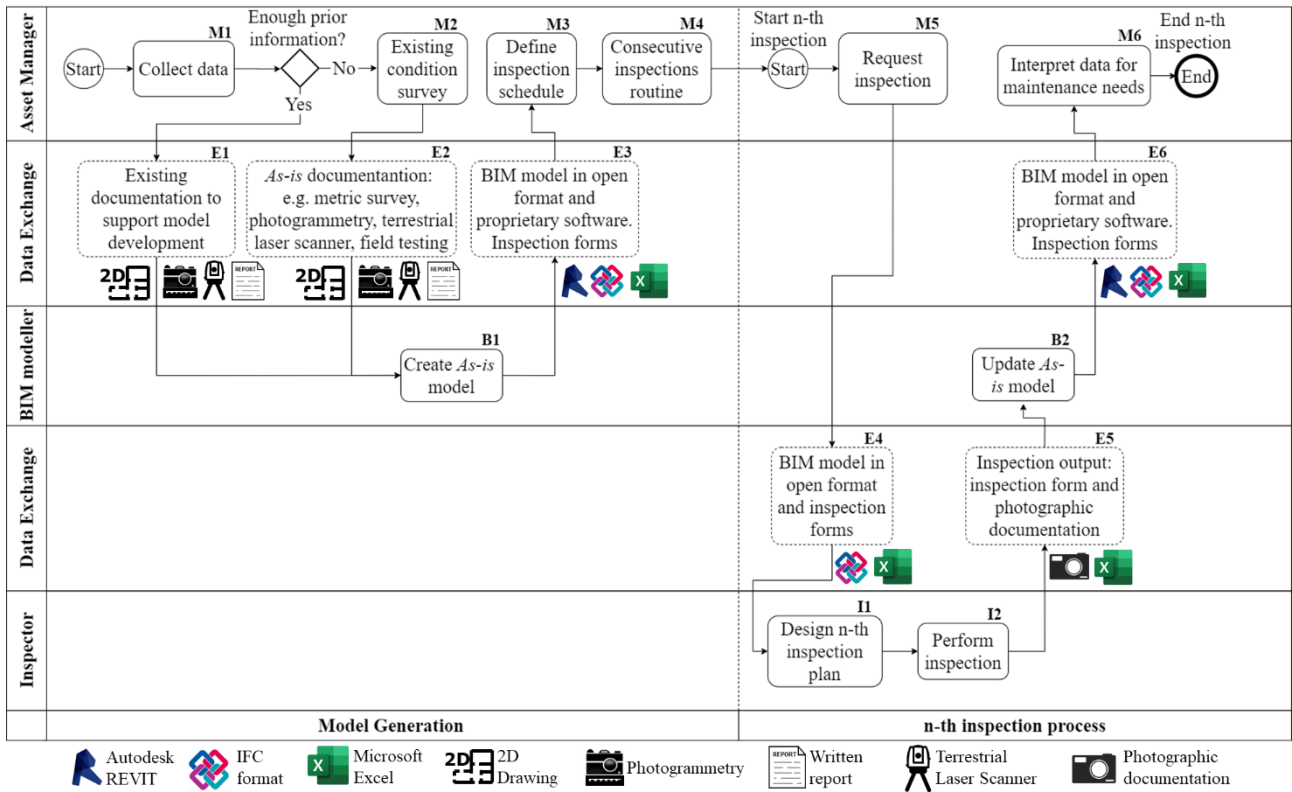
Figure 1: Process Map illustrating the workflow of the BIM methodology for damage surveying and monitoring.

start directly with the second stage. Following the illustration of the process map in Figure 1, it is possible to identify the tasks of each party, the data that are exchanged between them and the interoperable software used to manage and exchange the information. The asset manager promotes the process by collecting all the existing information on the building and its assets (task M1). If the information is enough to develop a BIM model, the manager sends it to the modeller (data E1), otherwise, a survey is firstly requested to complete it (task M2) and then sends the information (data E2). The exchanged data include any kind of graphical representation of the metric survey, images and written reports. An accurate data acquisition through photogrammetry or terrestrial laser scanner can be performed if the involved practitioners are able to correctly implement the methodologies and process the records. The BIM model is generated based on such data (task (B1) on a proprietary software (in the present study Autodesk REVIT has been used). If the building or its assets are already affected by anomalies, these are represented in the ‘*as-is*’ model according to the strategy described in sections **Erro! A origem da referência não foi encontrada.** and **Erro! A origem da referência não foi encontrada.**. The modeller sends to the asset manager the model in the proprietary format, for future editing and/or further analyses, and in an open format, to support the inspections (Data E3). Additionally, the modeller generates and shares a set of inspection forms, namely standard editable spreadsheets distinctively recognised through a unique identification code of the BIM object of the element to be inspected and the BIM object of the existing anomaly to be monitored. This can be the Global Unique Identifier (GUID), or, as in the case study, the element unique identification code generated by the proprietary software.. The template of the spreadsheet is customised based on the requirements of the asset manager and the inspectors and it is structured according to the PDT (see section **Erro! A origem da referência não foi encontrada.**) in order to automatize the model updating process by transferring the information after the inspection into the BIM platform. Finally, the asset manager defines the inspection schedule based on the characteristics and the condition of the building (task M3). Each inspection follows the same process reported in Figure 1 as n-th inspection process. In due time, the asset manager requests the inspection (task M5) by appointing

After the generation of the model (task B1 in Figure 1), the BIM modeller generates the inspection forms and relates each of them to a specific existing object of the model, either asset or existing anomaly, by naming the spreadsheet and reporting in the specific field of the form the unique identification code (ID) of the object. The form of a specific asset can be used to record new anomalies that affect it or report the effect of interventions, whereas the form of an anomaly is used for its monitoring. Blank forms are available to describe and reference within the building new elements or assets. Hence, the inspector always works on a familiar software and with a familiar template and does not need any BIM knowledge. Moreover, using any available software free of license which is able to read the IFC format, the inspector can navigate the model for queries, for instance related to the ID of the objects or to the results of previous inspections. To this end, the BIM modeller generates also a version of the model in the open format (task B1 in Figure 1). After the inspection, when the information is to be updated (task B2 in Figure 1), the parameter values can be tracked down easily as the structure of the template does not change, and the instance to be updated is identified through the ID. An example of these procedures is to be shown in section 3.4.

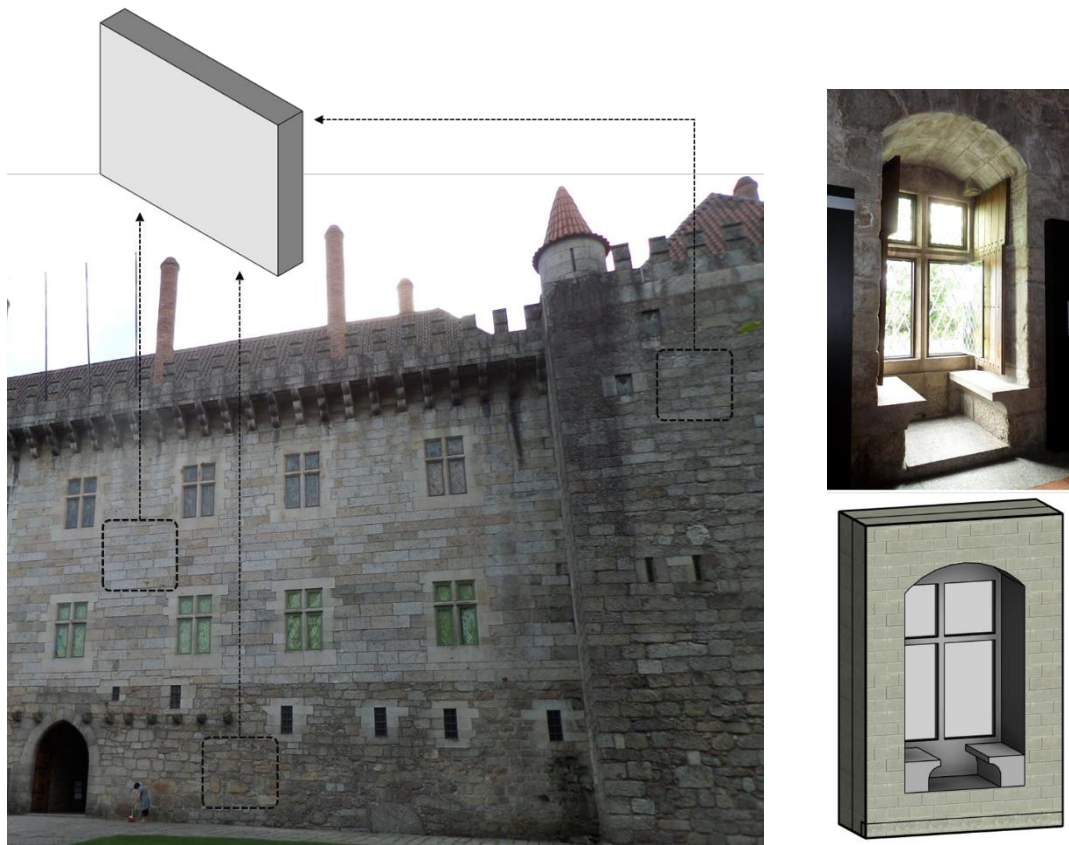
(a)
Figure 2: BIM objects: (a) wall element; (b) windows element.

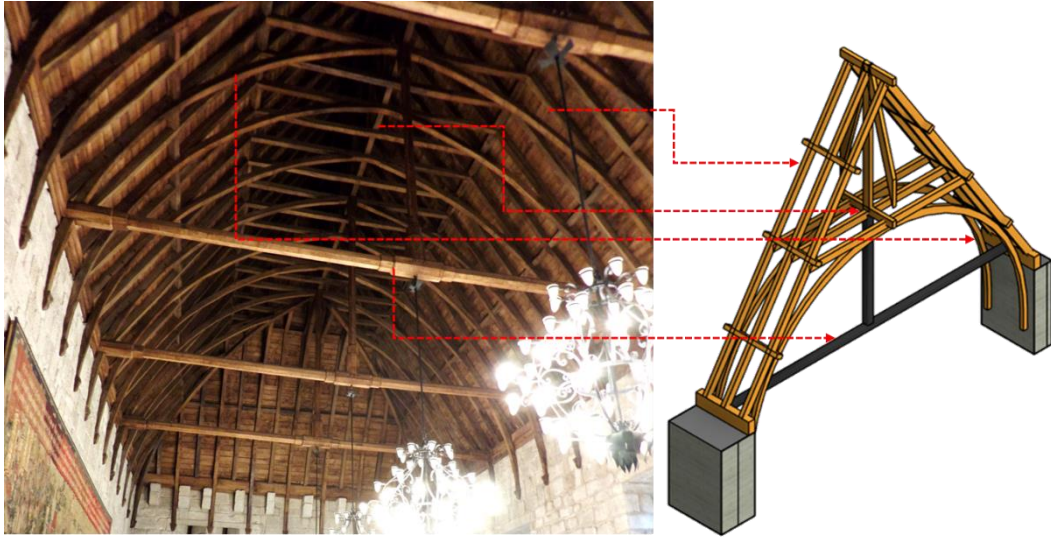
Figure 3: BIM objects: timber roof.

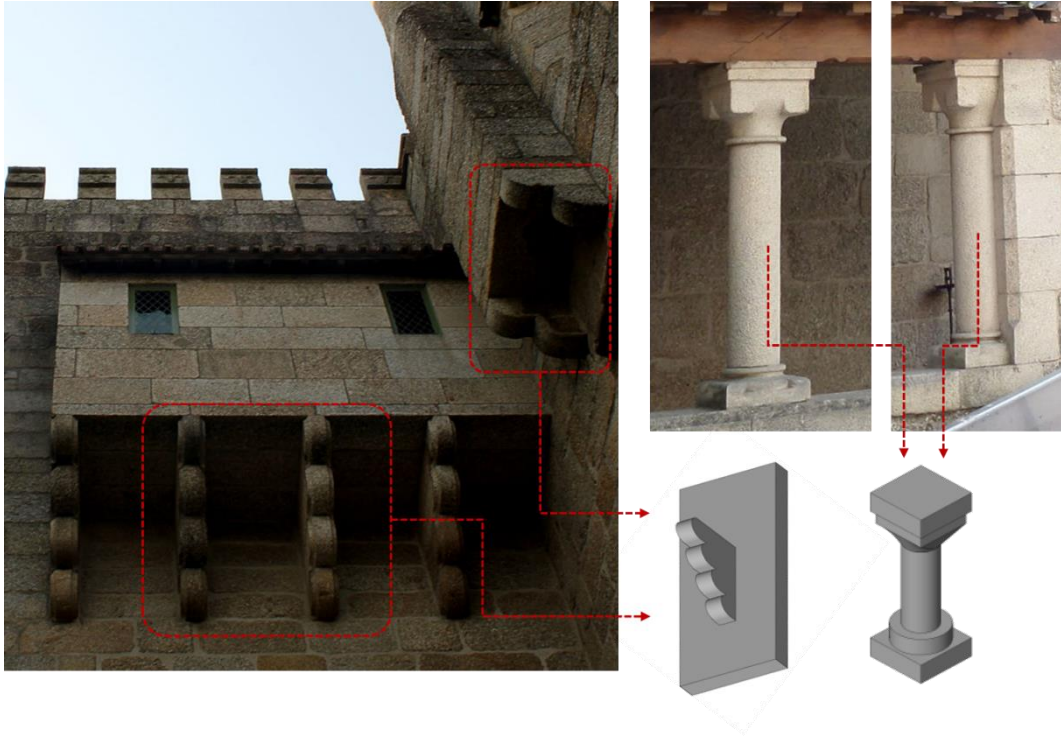
Figure 4: BIM objects: corbels and columns.

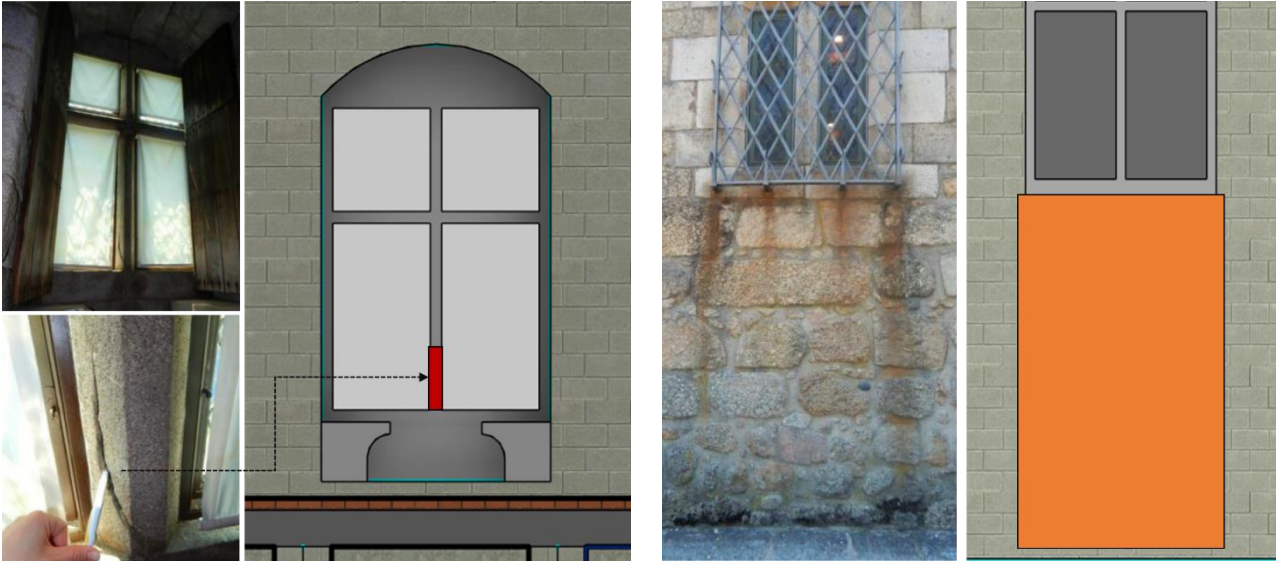
Figure 5: Patch-type object to represent anomalies: (a) crack in the window's frame; (b) stain due to water below a window.

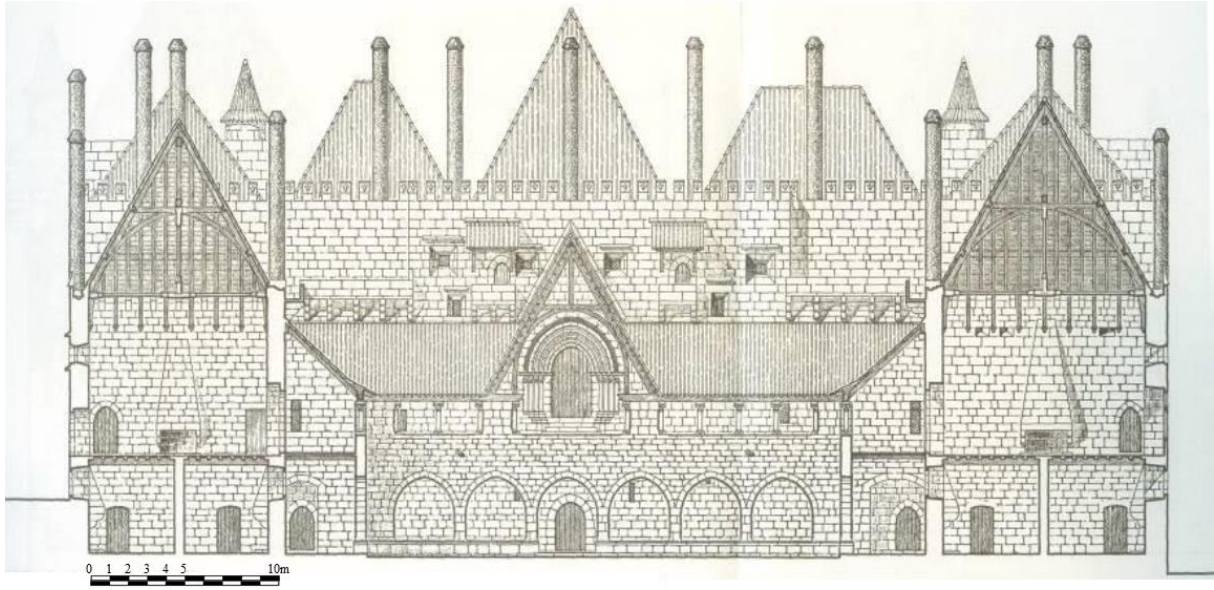
Figure 6: Section of Ducal Palace, adapted from [35].

The global geometry was first defined according to the available evidences, such as drawings obtained from the reconstruction and documentation in literature (Figure 6 and Figure 6) [35]. Using the symmetry of the building in the two-principal axes, the survey has been carried out only in the quarter hosting the administrative offices (South wing). Among the 23 spaces of this area, there is also the principal dining room. The inspected rooms were labelled according to the following notation: the first number refers to the level and the second to the room. In Figure 7, the inspected rooms are highlighted in yellow and red, where the red indicates the location of the tower. In each inspected room, digital pictures of the construction elements and spherical panoramas were taken, with 36 distinct construction elements being identified.

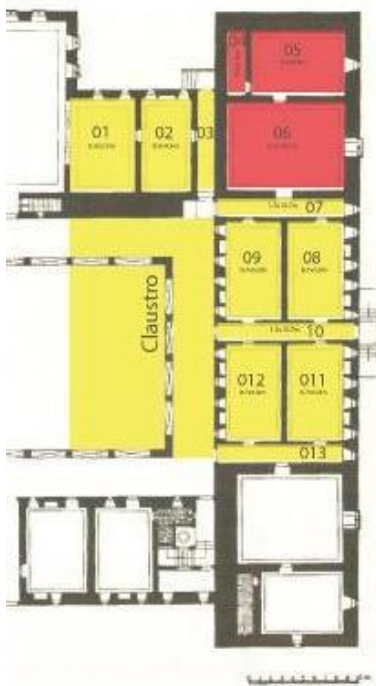
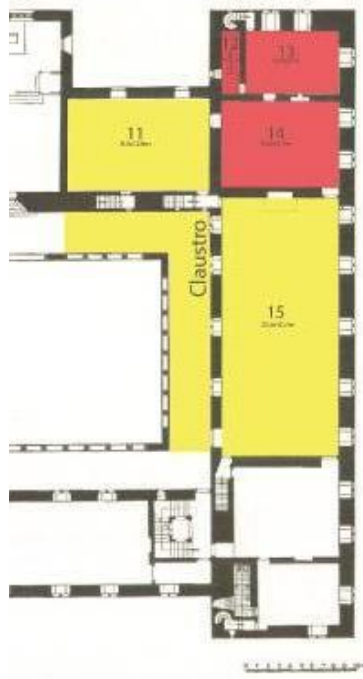
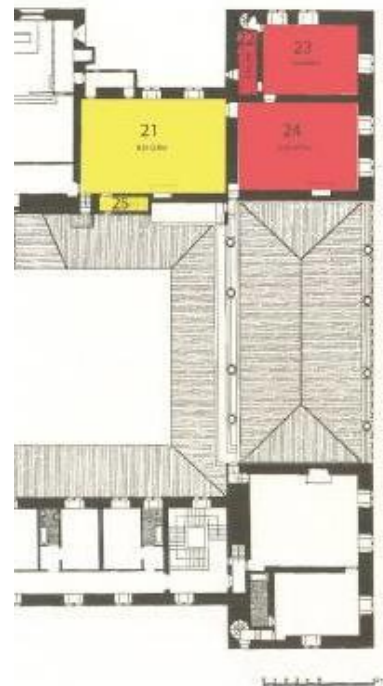
Figure 7: Plans of the Ducal Palace (South wing) adapted from [35]. Left: Ground floor. Middle: First floor. Right: Second floor.

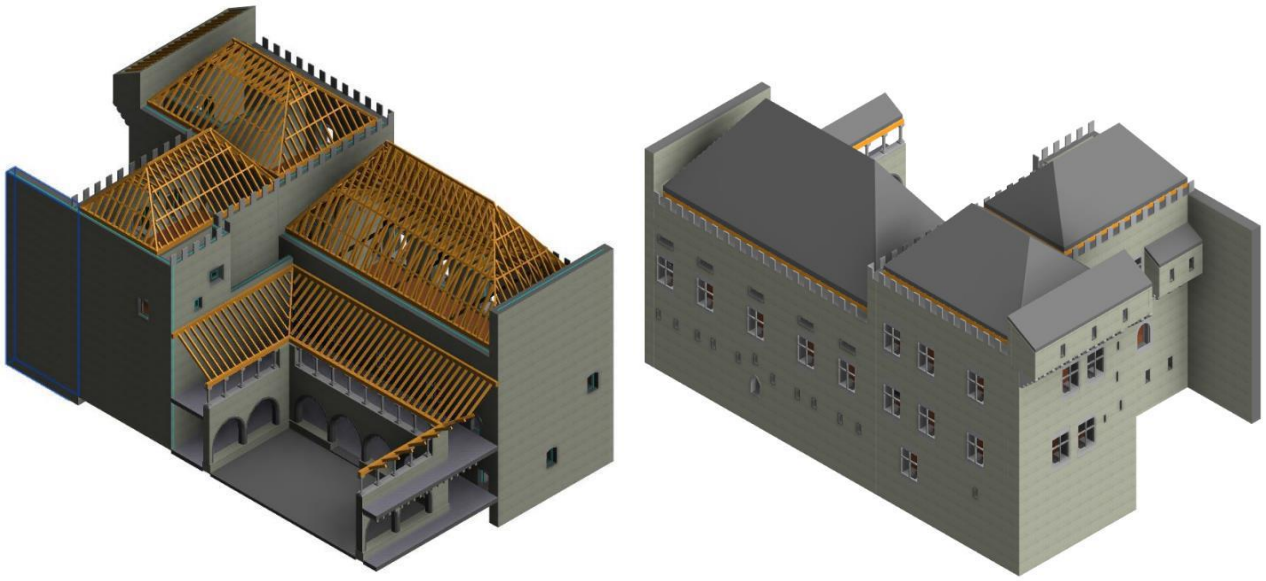
Figure 8: Global isometric view of the BIM model, with a detail of the timber roofs.

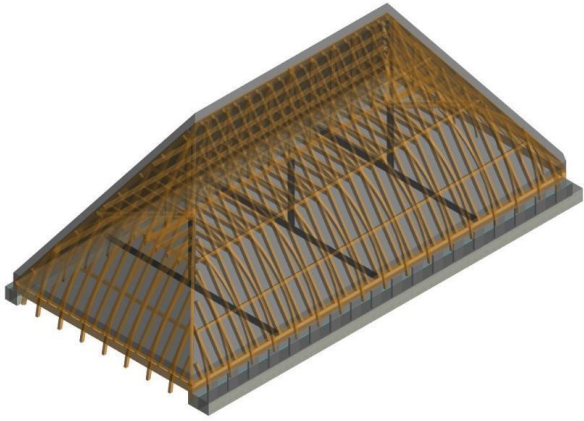
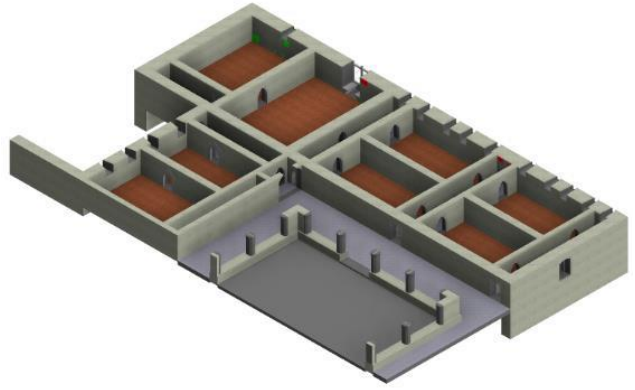
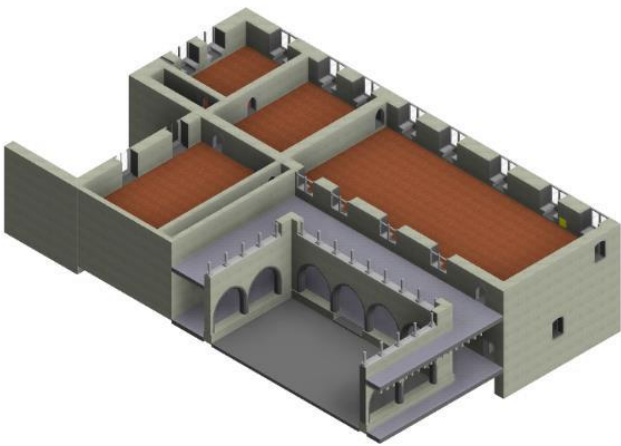
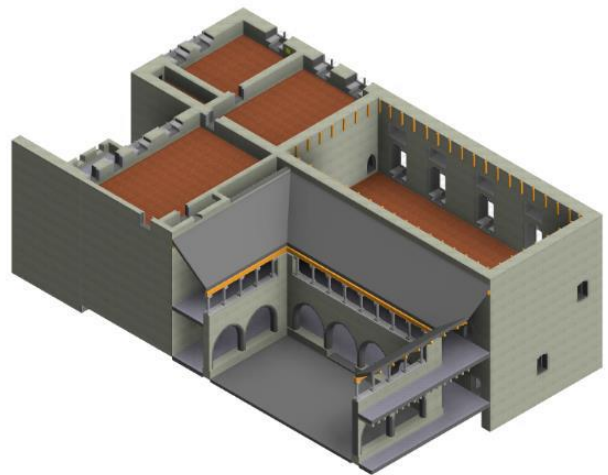
Figure 9: BIM model isometric view: (a) Timber roof; (b) Horizontal cut ground floor; (c) Horizontal cut first floor; (d) Horizontal cut second floor.

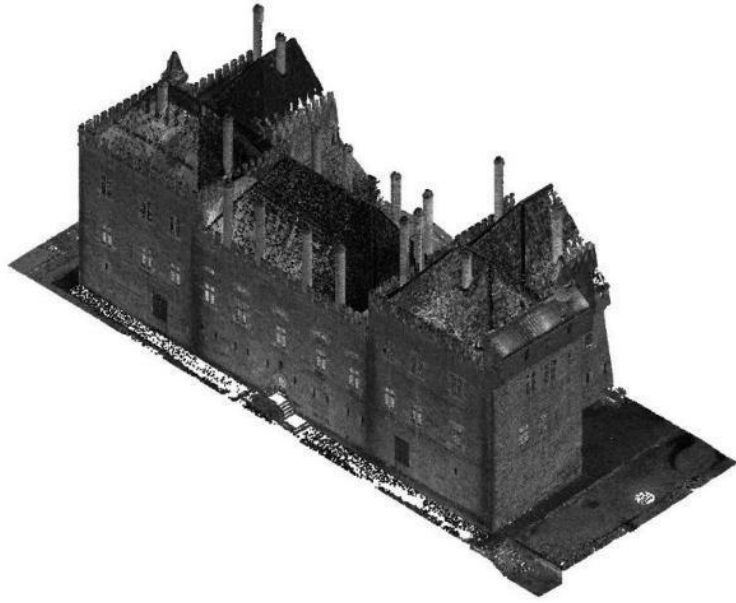
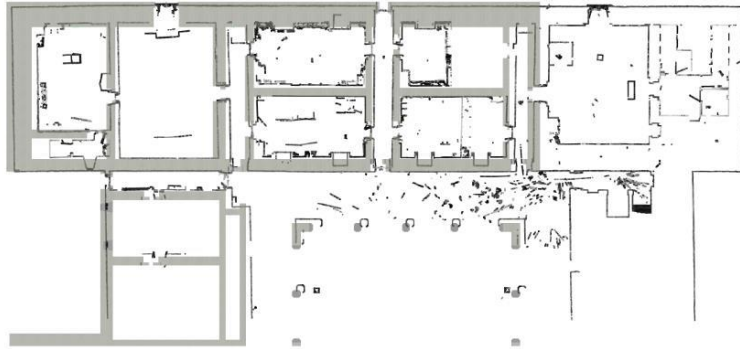
Figure 10: Point cloud of the Ducal Palace (South wing): (a) South-West elevation; (b) Horizontal section compared to the BIM model.

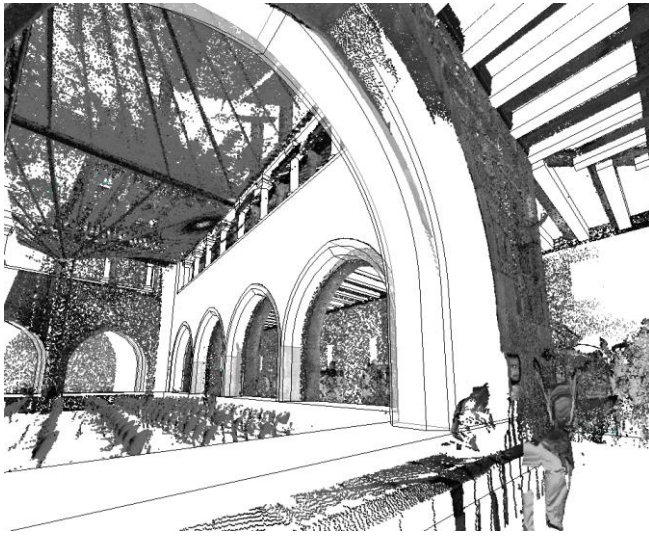
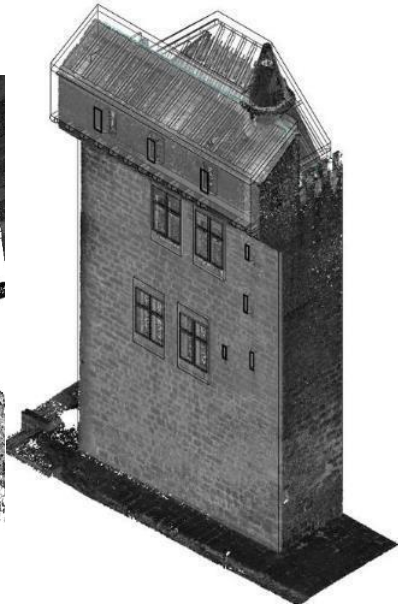
Figure 11: BIM Model and point cloud overlapping: (a) cloister; (b) outer wall.

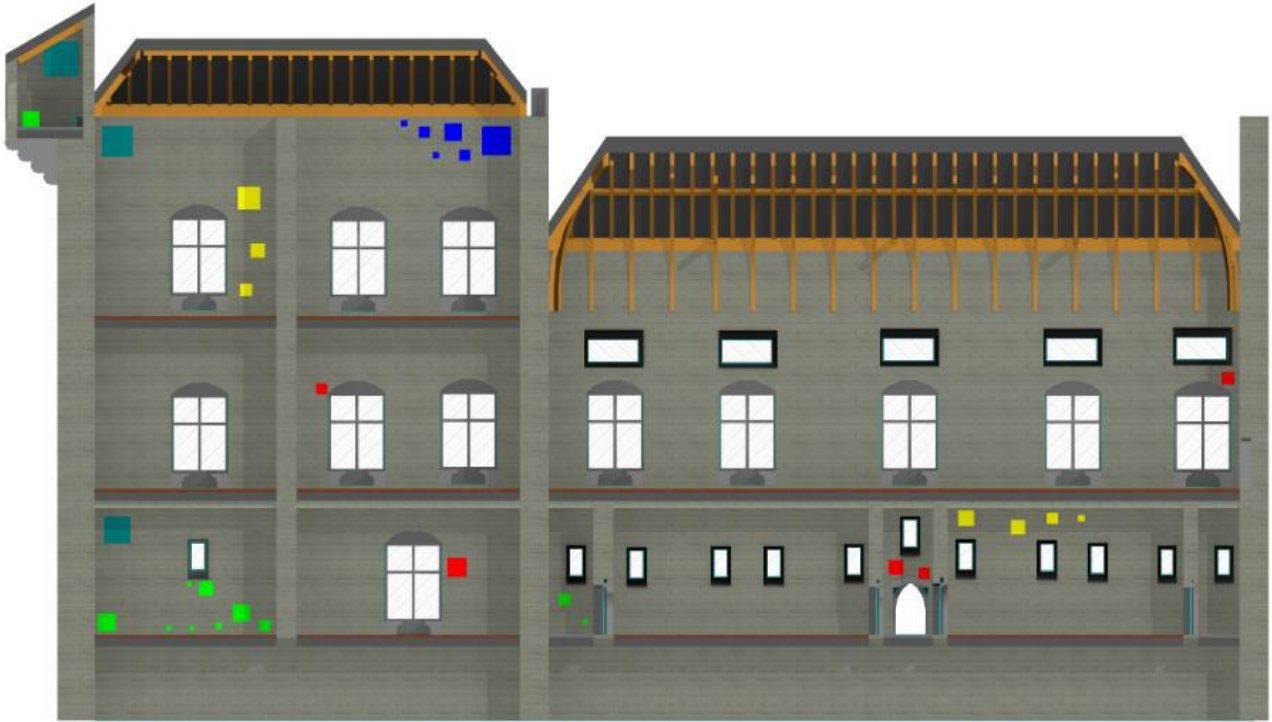
Figure 13: Illustration of a damage survey in the South wing.

during the inspection. Finally, the information was uploaded into the model by processing each form through a plug-in of the proprietary software developed to automatise the data flow. The final aspect of the model with the patch-type elements used to represent the existing anomalies is shown in Figure 13.
