Evaluation of non-destructive techniques for mechanical characterisation of earth-based mortars in masonry joints

In this paper, the use of non-destructive tests for the mechanical characterisation of earth-based mortars in masonry joints is discussed. Four testing methods, namely the penetrometer, Schmidt hammer, pendulum hammer and scratch test, originally developed for other types of mortar, are reviewed. The methods are applied to the earth-based mortars at the Wupatki Pueblo archaeological site, in Arizona, US. The outcomes of the experimental programme allowed to assess the reliability of the methods and to identify their limitations. Finally, the methods are compared in terms of six qualitative indicators, namely easy-of-use, consistency of results, range and granularity of results, respect towards cultural value, depth of investigation under the visible surface and versatility in application. Overall, the penetrometer test is recommended as the preferable method to characterise the mechanical performance of earth-based mortars.

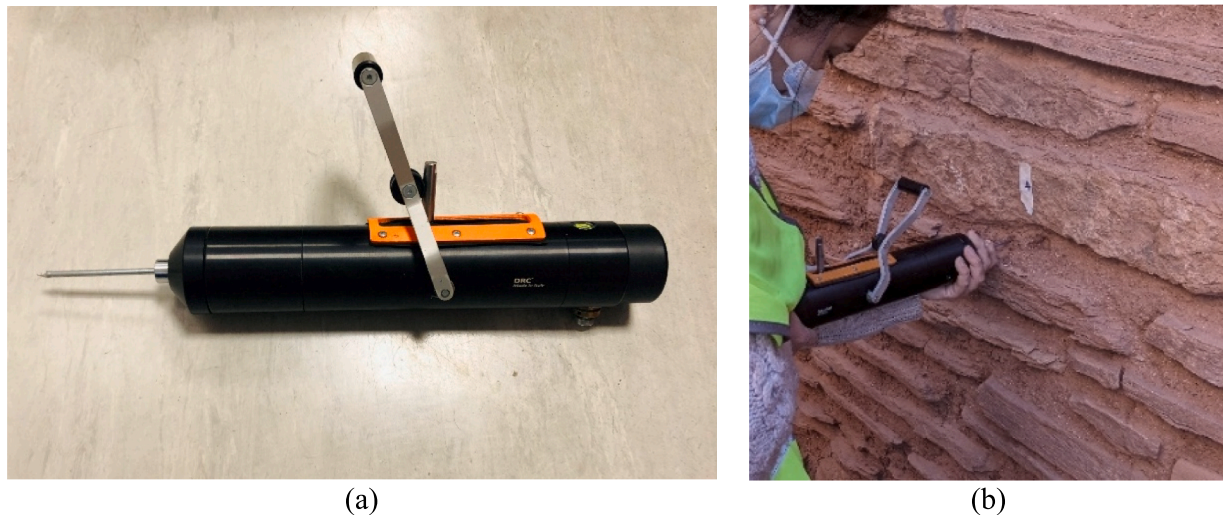
Fig. 1. Penetrometer test: (a) equipment; (b) in operation.

The penetrometer test is carried out by measuring the response of the investigated material to the penetration of a needle and correlating it to the compressive strength. The penetrometer used is the RSM-15 model produced by DRC Srl (Fig. 1a). The device consists of a hammer, connected to a manually-loaded spring, that hits a striker in which a steel needle is located. The tip of the needle penetrates the mortar subjected

to dynamic blows with constant impact energy (Fig. 1b). In accordance with the manufacturer's instructions, the test is carried out by applying ten blows and then measuring the unpenetrated length of the needle L_1 with a comparator. The absolute penetration depth of the needle is finally calculated as the difference between the initial length of the needle L_0 , equal to 80 mm, and L_1 .

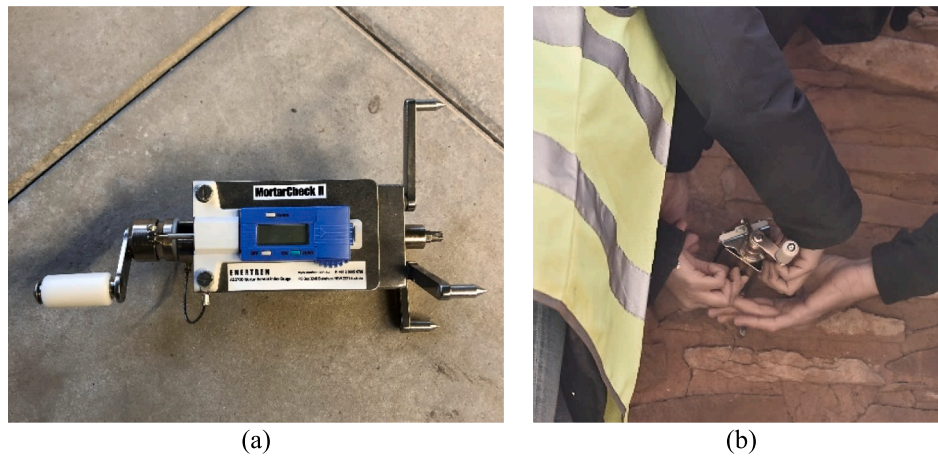
Fig. 6. Scratch test: (a) equipment; (b) in operation.

A mortar scratch test requires using a specific equipment designated as MortarCheck II, manufactured by Enertren Pty Ltd. (Fig. 6a). The test consists in the application, by means of a spring, of a fixed rotational force to a probe with an abrasive tip placed in contact with the surface of the soft material to be investigated (Fig. 6b). The axial force is held constant as, at the commencement of the test, a spacer is removed to allow a 10 mm spring compression of the probe against the joint. After five full turns, the indentation of the probe into the surface is measured. It should be noted that the rotation speed is not specified by the testing protocol, meaning that it depends on the operator. The action of the tip simulates accelerated physical forces that lead to degradation.

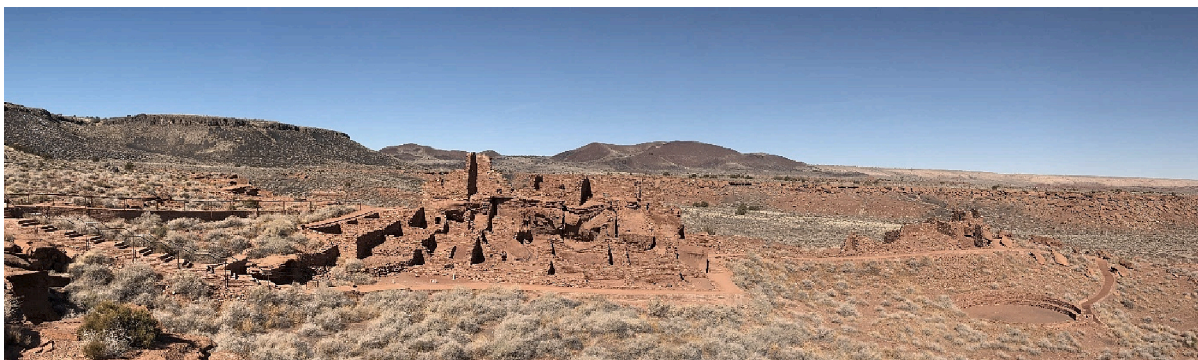
Fig. 7. The Wupatki Pueblo: South Unit at the left and North Unit at the right.

The masonry walls of the rooms are made of Moenkopi sandstone units, which is the main building material, with earth-based mortar joints. The stones are irregular in shape and extremely variable in size. Basalt pebbles, from the nearby volcanic formations, are included in a few places as decorative bands. Although there is a lack of precise information on the cross-section of the walls, based on the inspection of the collapsed areas, it is assumed that they consist of a single leaf, without an inner core, and with a few stones passing through the entire

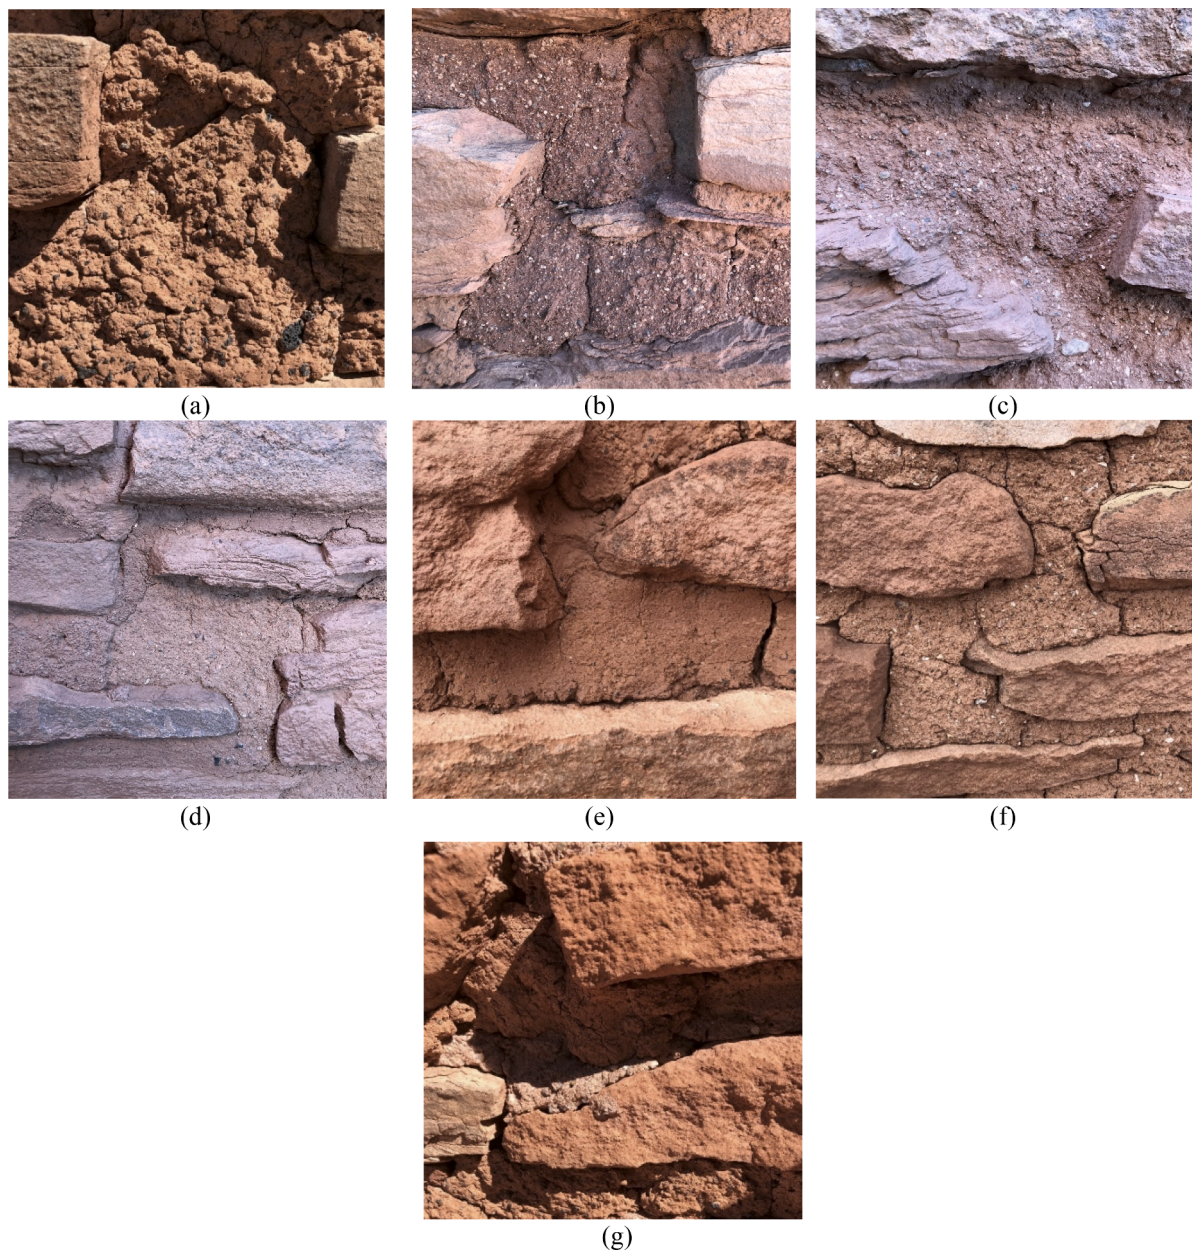
Fig. 9. Types of mortar identified on-site: (a) EM1; (b) EM2; (c) EM3; (d) EM4; (e) EM5; (f) EM6; (g) CM.

The aforementioned degradation of the earth-based mortars, due to the aggressive environmental conditions, motivated the need for a detailed investigation of the performance of the bed-joint mortars of Wupatki Pueblo. On this regard, seven types of mortars were identified by visual inspection, while considering colour, texture, and characteristics of the aggregates. According to the existing documentation, these mortars were likely used in distinct interventions, thus they have

different age and compositions. Among them, six types are earth-based mortars, identified and labelled as EM plus a number (e.g., EM1, EM2, etc.), and one is a cement mortar, labelled as CM (Fig. 9). Their location is shown in Fig. 10. The earth-based mortars were employed during the repointing interventions of the joints, dating from the 1990s to the present day. Although the raw materials and their proportions have changed over time, all these mortars are stabilised with the Rhoplex E-330. These repointing mortars play a key role for the actual and future safety and conservation of the site. Therefore, it is deemed important to examine the evolution of their performance over time to ensure their continued effectiveness. On the other hand, the cement mortar, dating back to the reconstruction years, is extensively present at the site, and it likely constitutes the substrate of many repointed joints. The main purpose of performing cement mortar tests is to provide a benchmark for comparative purposes. Moreover, given its widespread presence, it was deemed appropriate to investigate it to provide a preliminary characterisation of the mortars on site, even though it is no longer in use.

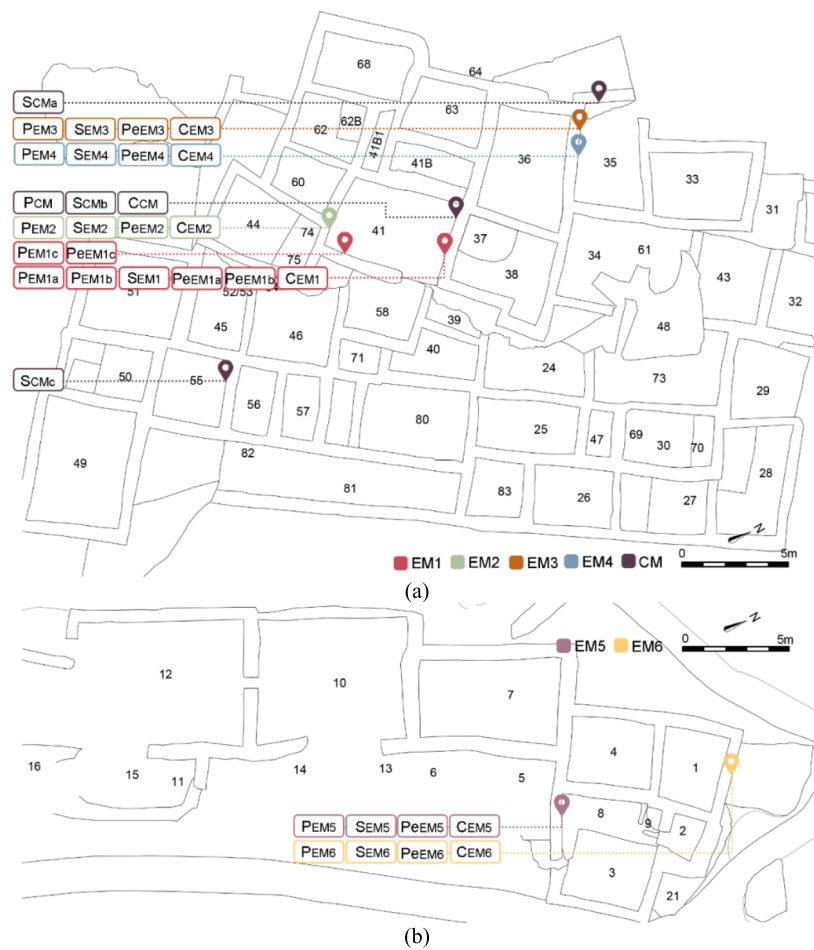
Fig. 10. Room numbering, location of tests and selected mortars: (a) South Unit, (b) North Unit.

The four testing methods were used for each type of mortar, performing one or more acquisitions. The selection of points for testing was primarily based on the regularity of masonry, wherever possible, taking into account joint thickness and alignments. Other selection criteria included the location of the different types of mortars and visible conservation conditions. All measurements are labelled and numbered using a test identification code (Table 1). For the penetrometer test, a total of nine acquisitions, labelled as P plus the type of mortar (e.g. PEM1, PEM2, etc.), were made, namely one measurement for each type of mortar and three repetitions for EM1 in different areas. For the rebound hammer test, ten acquisitions, labelled as S plus the type of mortar (e.g., SEM1, etc.), were made, namely one per each amended mortar and three for the cement one. For the pendulum hammer, eight tests, labelled as Pe plus the type of mortar (e.g., PeEM1, etc.), were performed, namely one measurement for each type of earthen mortar with three repetitions for EM1. The pendulum hammer test was not conducted on cement mortar due to operational limitations of the instrument and morphological characteristics of the site, which made it impossible to obtain the minimum number of required acquisitions in a single tested area. Finally, for the scratch test, seven measurements, labelled as C plus the type of mortar (e.g., CEM1, etc.), were made, namely one for each of the seven mortar types.

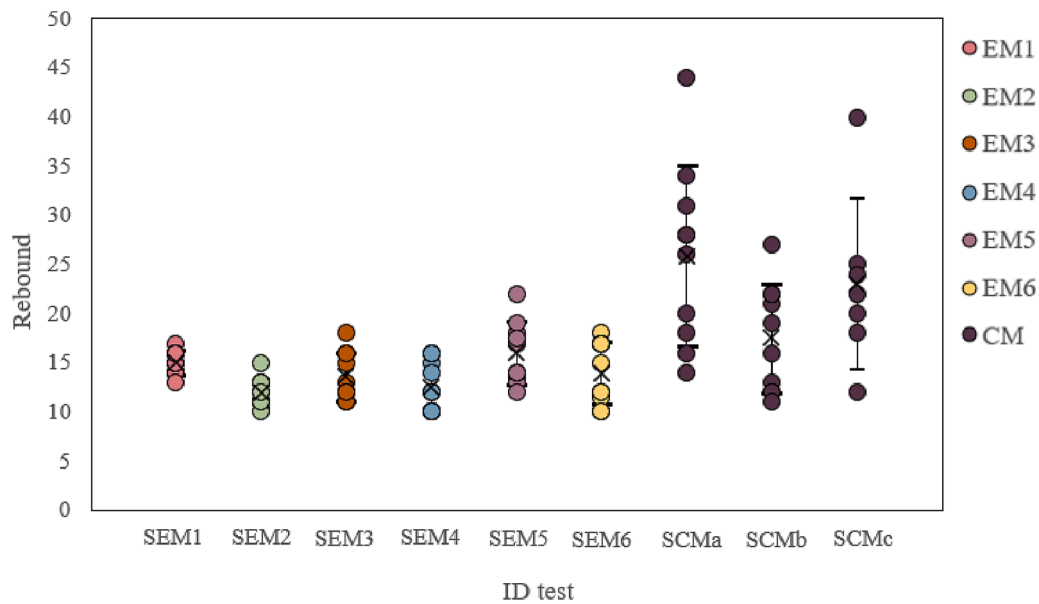
Fig. 12. Results of the Schmidt hammer tests: rebound values, average (x) and standard deviation limits (—).

Fig. 12 shows ten out of the twelve measured rebound values (maximum and minimum were discarded), the average and the standard deviation for each of the nine tests. It is worth noting that the tests performed on earth-based amended mortars are characterised by quite similar rebound values. Values outside the range between the average and more or less the standard deviation are observed but they are located evenly on both tails of the distributions. On the other hand, the tests on the cement mortars (SCMa, SCMb and SCMc) show a greater dispersion of the rebound, affected by values of significantly better performance. Multiple repetitions were conducted to address this dispersion, which could have been caused by factors such as differences in age, curing conditions or inadequate conservation. Furthermore, it is

worth noting that such dispersion resulted in some readings, especially for SCMb, being lower than the results for the earth-based mortars, likely due to poor bonding and/or to the presence of softer layers below the cement one, used for repointing. Nonetheless, as expected, cement mortars present higher average rebound values than the earth-based ones.

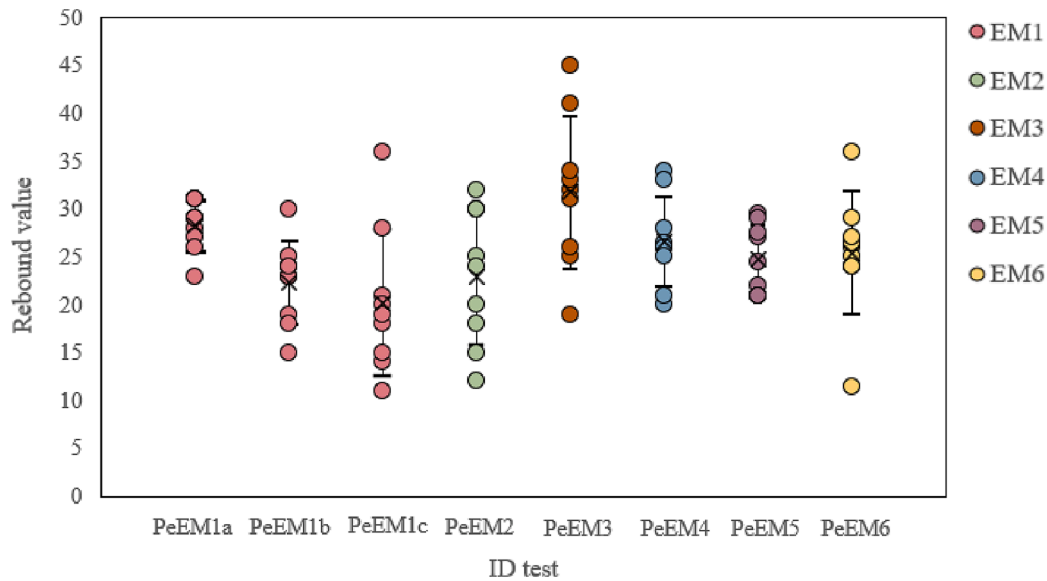
Fig. 13. Results of the pendulum rebound hammer tests: rebound values, average (x) and standard deviation limits (–).

As shown in Fig. 13, the dispersion in pendulum rebound values is large within all the tests, and also produces a scatter between the average values for the different earth-based mortars. The lower scatter in measured values is achieved in tests PeEM1a and PeEM5 for mortars EM1 and EM5, respectively. It is worth noting that the characteristics of the device prevent its correct use when the recess of the mortar joint with respect to the surface of the stone units does not allow the plunger to reach the surface of the mortar. Therefore, the correctness of the operation was verified at each location and the reading was discarded otherwise.

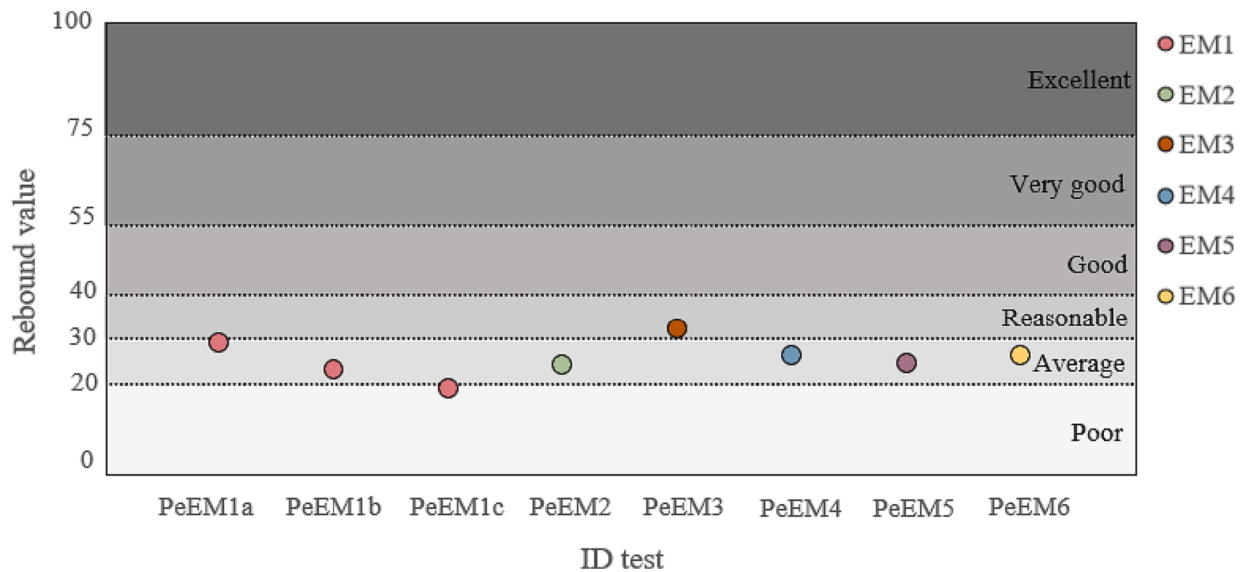
Fig. 14. Classification of the mortars according to the performed pendulum hammer tests.

Based on the correlation provided by the manufacturer, most of the earth-based mortars are classified as “average” (Fig. 14), given the median rebound value between 20 and 30. Nevertheless, mortar EM3 outperforms the other ones, being classified as “reasonable”. Mortar EM1 was tested three times, yet the outcomes were not consistent, as they ranged from “poor” (PeEM1c) to “average” category (PeEM1a and PeEM1b).
