DIAGNOSIS OF AN UNUSUAL STRUCTURAL INSTABILITY: THE CASE STUDY OF THE CATHEDRAL OF SAN LORENZO IN VITERBO

M.CANDELA^{1*}, M.EICHBERG², C.TARANTINO¹

¹Studio di Ingegneria Michele Candela,
via Circumvallazione 76, 83100, Avellino, Italy
e-mail: ing.mcandela@libero.it; arch.cristarantino@gmail.com

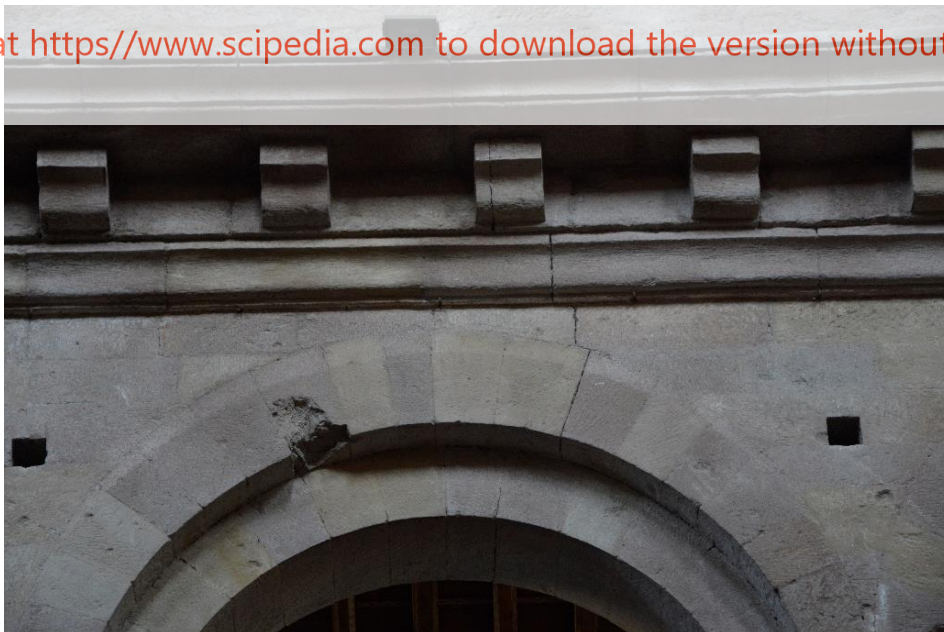
The building exhibits a peculiar crack pattern which exclusively affects the high walls bounding the central nave. The damage occurs at half height of the walls and, specifically, at the level of the arches separating the aisles, where sub-vertical fissures recurrently appear in the proximity of the keystones (fig.3). The cracks start at the intrados of the arches and rise up for few meters, disappearing immediately after the cornice adorning the walls. The damage doesn't involve any fracture of the stones and the cracking path follows the arrangement of the mortar lines.

Figure 3: Lesions on the arches keystones along the nave wall.

To a close observation, the fissures' edges appear coplanar and aligned. This configuration corresponds to a horizontal displacement between the two portions of the wall the crack separates, and it can be possibly caused by a tensile stress, developing into the plane of the wall and acting parallel to its longitudinal axis.

As acknowledged by scientific literature and professional experience, this mechanism is characteristic of some recurrent phenomena: crushing, combined bending and axial loading, foundation settlements with a horizontal component [6].

The first two conditions can be excluded, considering the magnitude of the loads, the stress paths in the walls and the mechanical characteristics of the masonry structures investigated through in-site inspections.

The hypothesis of a foundation settlement is incompatible with the extension of the damage, limited to a confined area of the wall, and with the cracks' constant amplitude. Moreover, it would be inconsistent with the geomorphology of the site and the characteristics of the soil analysed by previous geognostic studies.

A correspondence between the variation of damage's intensity and that of the walls thermal conditions can be observed. The crack pattern shows a symmetry in its localization but is prominent in the south wall with respect to the north wall. The damage concentrates in a border region between two areas characterized by different thermal conditions: the upper clerestory, highly exposed to the solar radiation, and the arcade below, protected by the aisles' roofs.

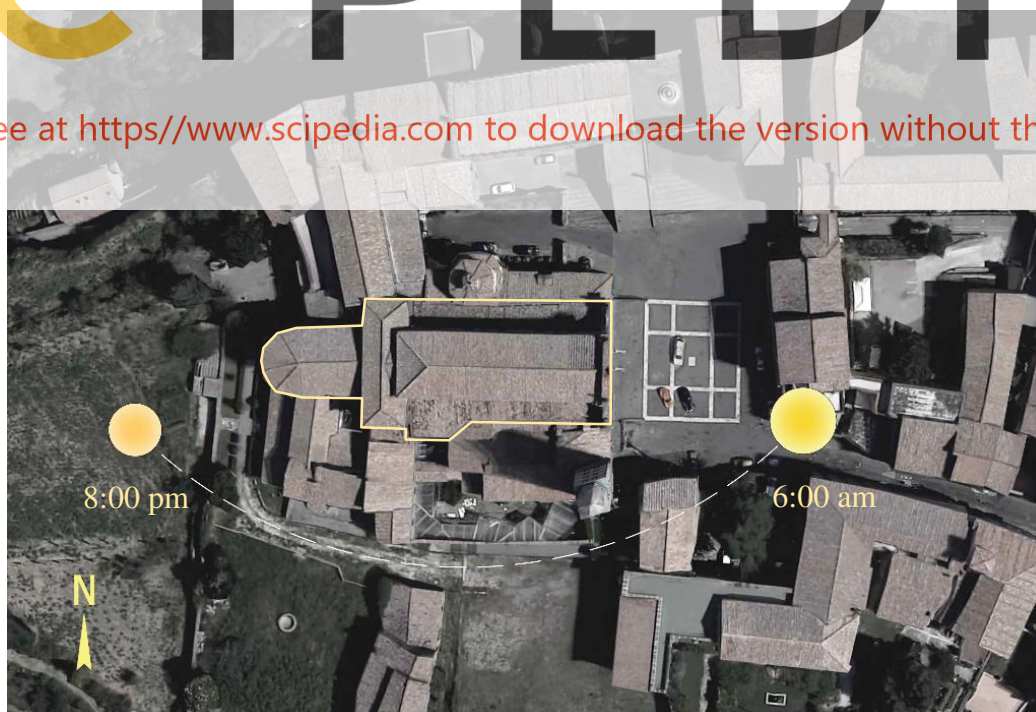
Temperature measurements were carried out to estimate the thermal gradient along the wall's height and between the external and the internal face. The measurements were taken on the south wall, which is the most exposed to solar radiation (fig.5), in the month of August, during the warmer hours. The results are reported in Table 1.

Figure 5: Satellite view of the cathedral and schematization of the sun path.
