SEISMIC VULNERABILITY ASSESSMENT OF A ROMANIAN HISTORICAL BUILDING UNDER NEAR-SOURCE EARTHQUAKE

Keywords: Vertical Ground Motion, Seismic Vulnerability Assessment, Non-Linear Dynamic Analysis, Damage Analysis

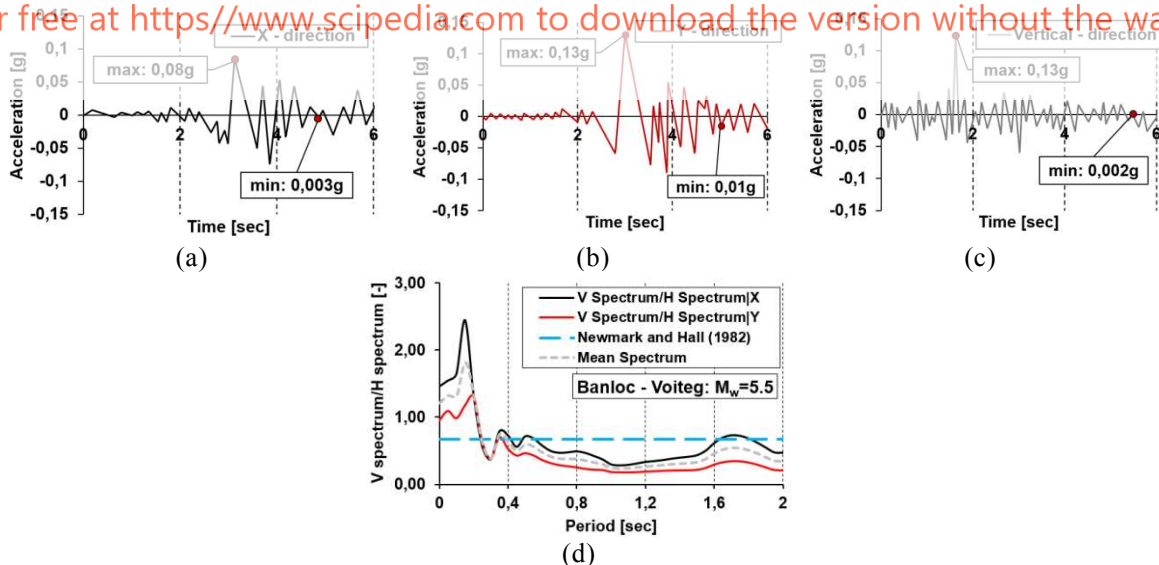
The accelerograms adopted are representative of the event occurred in Banloc in December 1991 considering the BNL1 seismometric station [9]. The accelerations are characterized by maximum components in X direction of 0,08g, in Y direction of 0,13g and in Z direction of 0,13g (Figures 4a and 4c). The seismic phenomenon can be defined of near-source type, since the city of Banloc is located approximately at 7 km from the epicentre.

In addition, the elastic spectra have been derived from the recorded accelerograms and have been processed with the Seismosignal software [11]. Consecutively, the spectral ratios between vertical accelerations, V, and the corresponding horizontal ones, H, in case of near-source ground motions recorded on soil type C, have been depicted in Figure 4d. These results have shown how the vertical component effects are more evident for earthquakes, characterized by small site-source distances, exceeding the V/H limit of 2/3 proposed by [12]. This condition shows that for short periods (around 0,2 seconds), the V/H ratio is greater than 1 [6].

Figure 4: Accelerograms of the Banat-Voiteg seismic event in all directions (a-c) and V/H spectral ratios for near-source records.

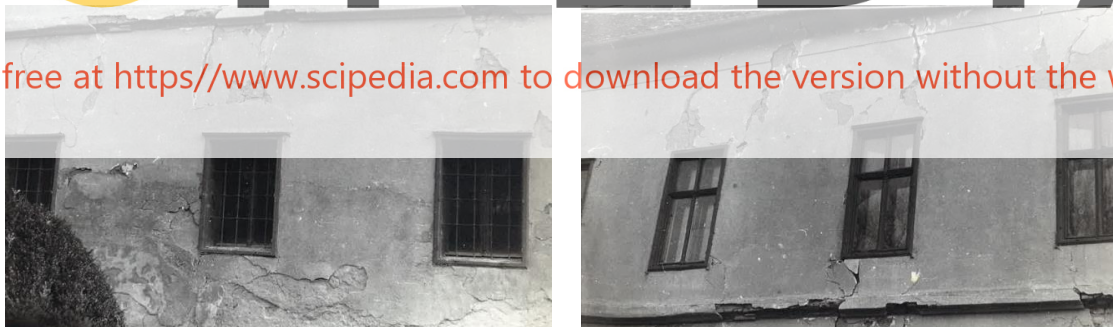
Consecutively, following the impulsive action, the arrival of the horizontal components produced damage to the vertical structures, mainly in the spandrel beams due to the formation of shear failures, as shown in Figure 9 [19].

Figure 9: Vertical and diagonal shear cracks detected in the South façade of the case study building [19].

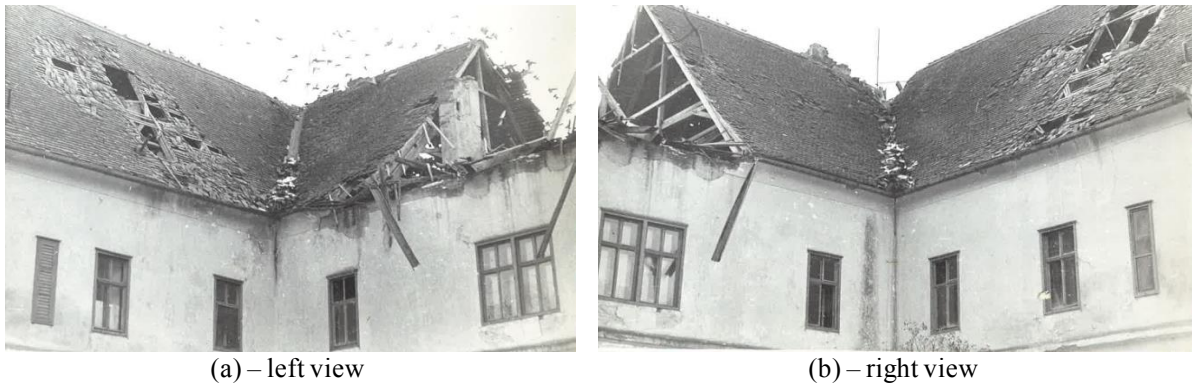
Finally, in the internal court of the building, a partial collapse of the roofing structure was observed. This collapse mechanism was triggered by the impulsive seismic action, as depicted in Figure 10 [19].

Figure 10: Failure mechanisms observed in the internal court of the case study building [19].
