# CULTURAL HERITAGE EXPOSED TO NATURAL HAZARDS: THE CASE STUDY OF THE CONVENT OF SAN DOMENICO IN MAIORI

R. LANDOLFO, C. TARANTINO\*, F. PORTIOLI, L. CASCINI

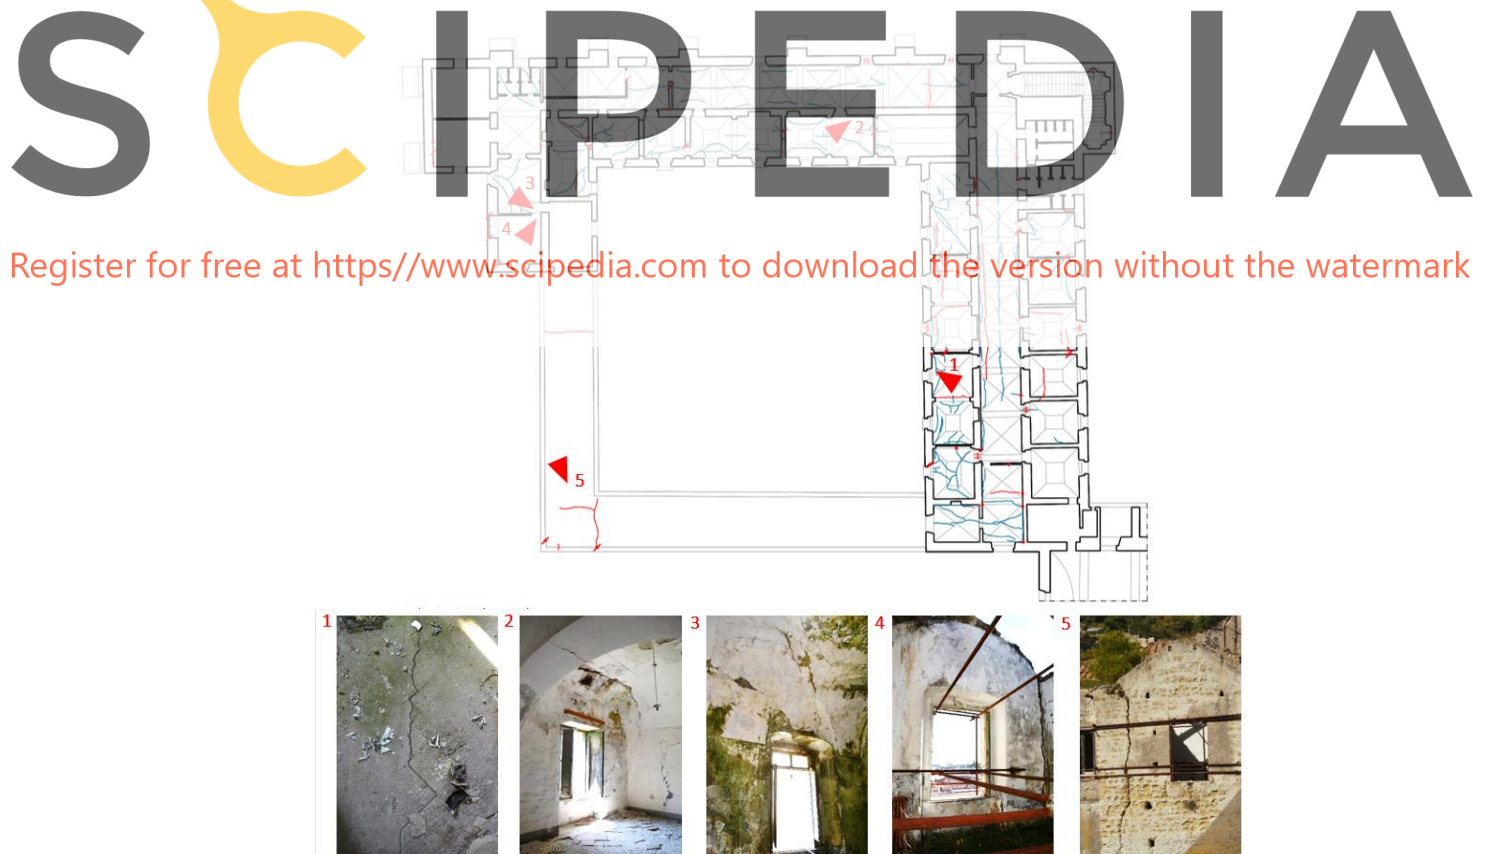
The building currently exhibits an extensive and diffuse crack pattern that, generally speaking, presents recurrent elements and increases in intensity and thickness from the ground upwards (Fig. 3).

Figure 3. Damage pattern at the first floor

The groin vaults of the portico and of the corridor at the first floor show cracks in the centerline and at the attachment to the walls, corresponding to the typical three-hinged mechanism; the trough vaults of the monks' cells exhibit diagonal cracks and multiple dense cracks parallel to the courside wall.

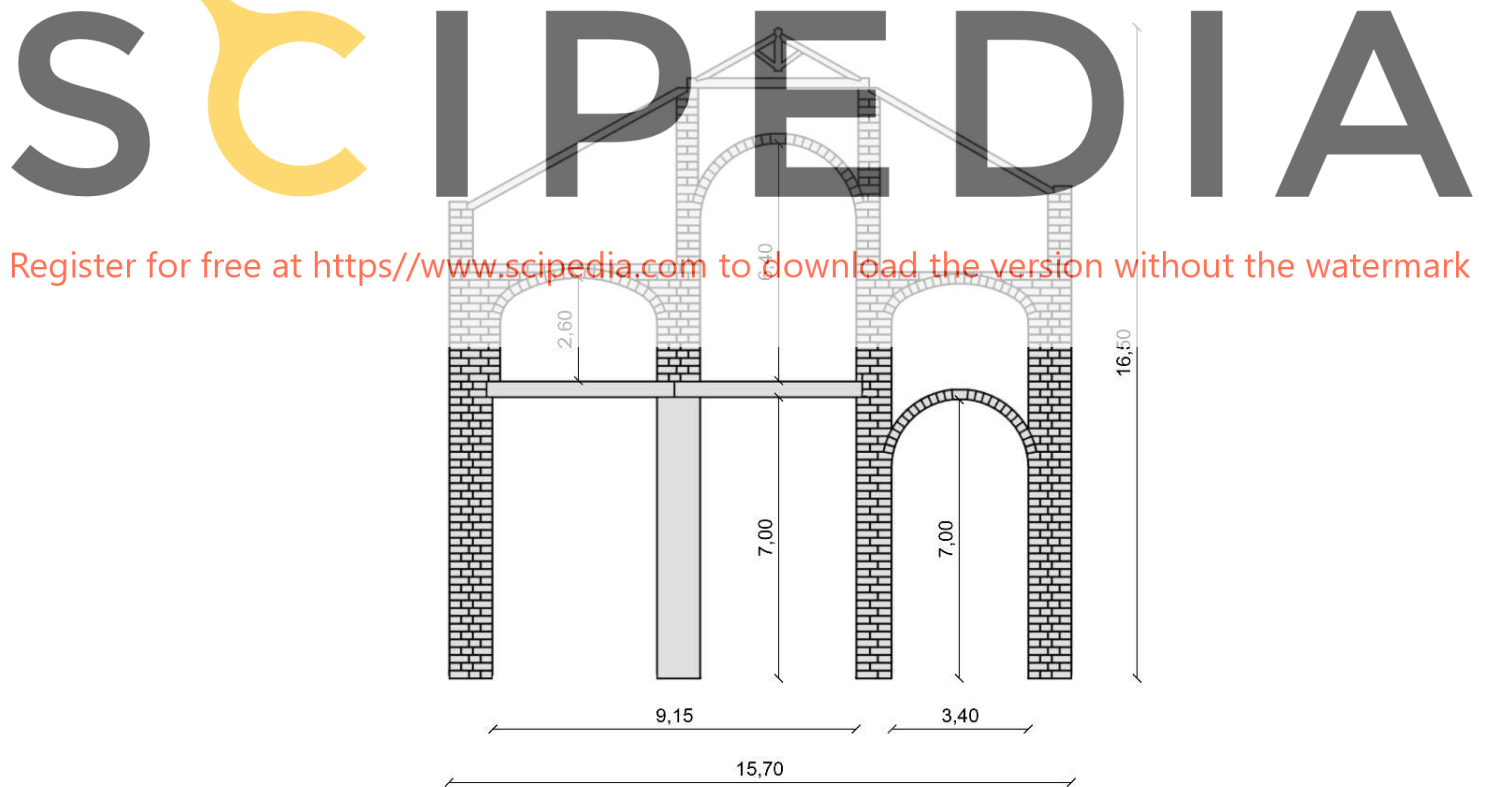
The numerical model of the east wing (Fig. 5) was developed for a characteristic transverse section, which is representative of the whole wing, considering the modularity of this part of the Convent. The section is obtained in correspondence of the symmetry plane between two consecutive spans of the portico and includes the most relevant structural elements of the wing. These are: at the ground floor, the arch separating the crossing vaults of the portico, and the barrel vault of the big hall on the back, in its centerline; at the first floor, the transverse walls between the monks' cells, with their low arch inner openings, and the arch between the crossing vaults of the central corridor. Also the timber roof was included in the model.

**Figure 5.:** The numerical model of the east wing (dimensions in meters)

The numerical model is composed by an assemblage of 685 rigid blocks. discretization of the structure in rigid blocks does not reproduce exactly the real masonry texture but was defined so as reproduce the average size of the real stones. A refined discretization was adopted along the imposts of the arches to enable the freest formation, along the whole structure, of the hinges required by the collapse mechanisms associated to the imposed actions.

The masonry walls and pillars are built with parallelepiped shape blocks. The block maximum dimensions are 50x20x40 cm. Blocks with different shape have been employed in the arches thickness and at the arches springing, to better reproduce the shape of the voussoirs and the interlocking at the attachment sections.

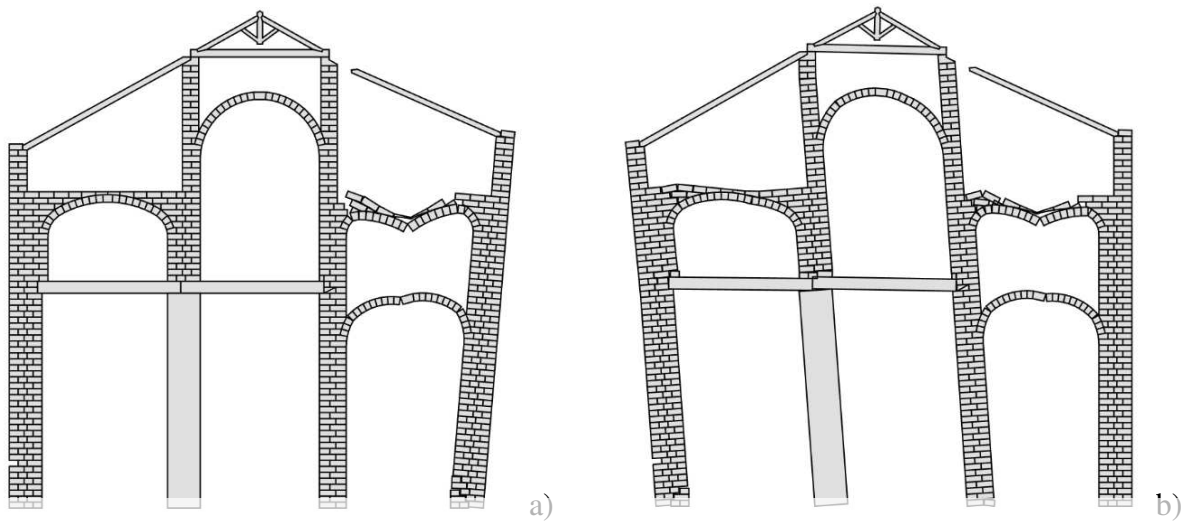
Figures 6a and 6b show the collapse mechanisms corresponding to the non-associative solution of the two in-plane seismic analyses, in the positive and negative x directions respectively. When the load acts in the x positive direction, the collapse condition occurs for a low value of the load factor. The overturning of the courtyard facade is activated and, as a consequence, a typical three hinges mechanism develops in both the round and low arches of the right span of the section. The mechanism also causes the sliding of the timber beam and, thus, the roof collapse. When the load acts in the x negative direction, the load factor needed for the collapse is higher. The left and the middle spans of the section almost behave as a unique block, overturning and causing the serious damage visible in the right span of the section. Here the collapse occurs again with the three hinges mechanism of the arches and the sliding of the roof's beam.

The global damage of the seismic in-plane analysis is partly compatible with the surveyed crack pattern, as it was expected, since no restoration works have been done after the 80's earthquakes. Nevertheless, it contemplates a slight damage of the innermost structures of the section and doesn't detect the floor cracks at the first level.

**Figure 6:** Plots of the collapse mechanisms provided by LiaBlock\_3D for the non associative solutions. Lateral loads acting along the: a) x positive axis; b) x-negative axis
