# Selective demolition of masonry unit walls with a soundless chemical demolition agent

Atteyeh S. Natanzi, Ph.D. <sup>a</sup>, Debra F. Laefer, Ph.D. <sup>b\*</sup>, S.M. Iman Zolanvari, Ph.D. <sup>c</sup>

A Soundless Chemical Demolition Agent was applied for selective demolition to unit masonry [2 full-scale concrete brick walls in Type N mortar and 2 wallettes in lime mortar – 1 historic brick and 1 concrete brick]. Typically, cracking began shortly after 9 hours and ultimately produced an average crack length of 418mm per hole and an average maximum 5.22mm crack width. Samples in Type-N mortar exhibited slower but significantly more cracks and wider cracking. Ninety-three percent of cracking occurred within 4 days. No masonry units were damaged and partial demolition was successful, although selective unit removal was not due to confinement.

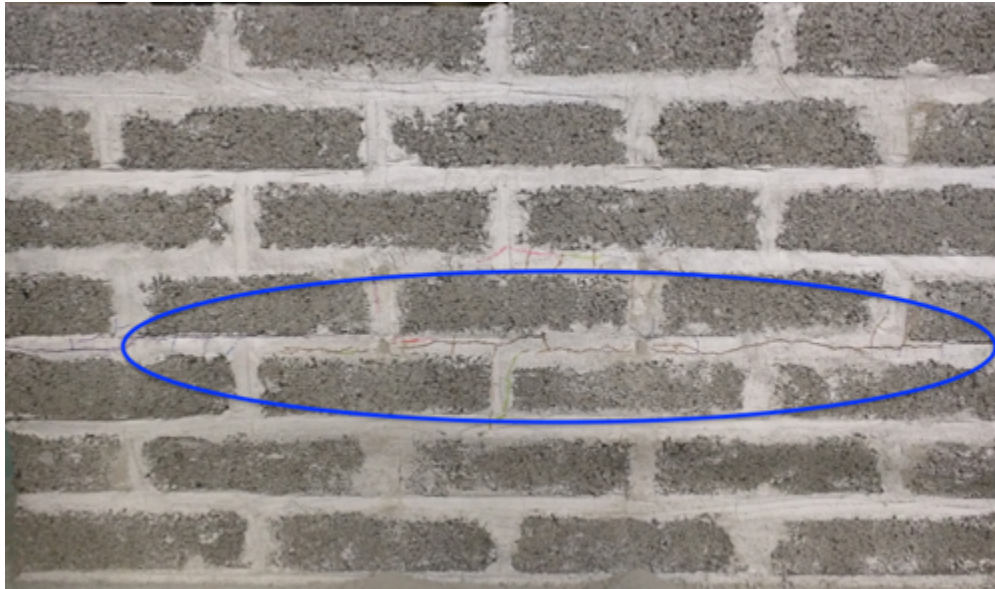
a) Crack propagation photo

b) Crack propagation sketch

**Fig. 7.** Specimen 3 after testing

In Specimen 3, micro-cracks started to appear around all holes 10.2 hours after SCDA injection. At the end of testing, the maximum crack length was 109.6mm, and the cumulative crack length was 1585.8mm (23.2% of the available joints), but the cracks were not sufficiently wide to be measured with Vernier calipers (Fig. 7b). Specimen 3 showed less cracking per hole than the other samples. The removal of the target unit was not possible, because cracking around the target unit was incomplete. Cracking was confined to the mortar joints.
