## **Elektrisk miljø i svinestalde**

Silva, Filipe Miguel Faria da; Bak, Claus Leth

*Publication date:*  
2013

The objective of this project is to find if electricity may be causing an increase in the number of sick pigs at Lars Peter's farm. In order to fulfil the objective, several sets of measurements were prepared, providing data that can be analysed and studied.

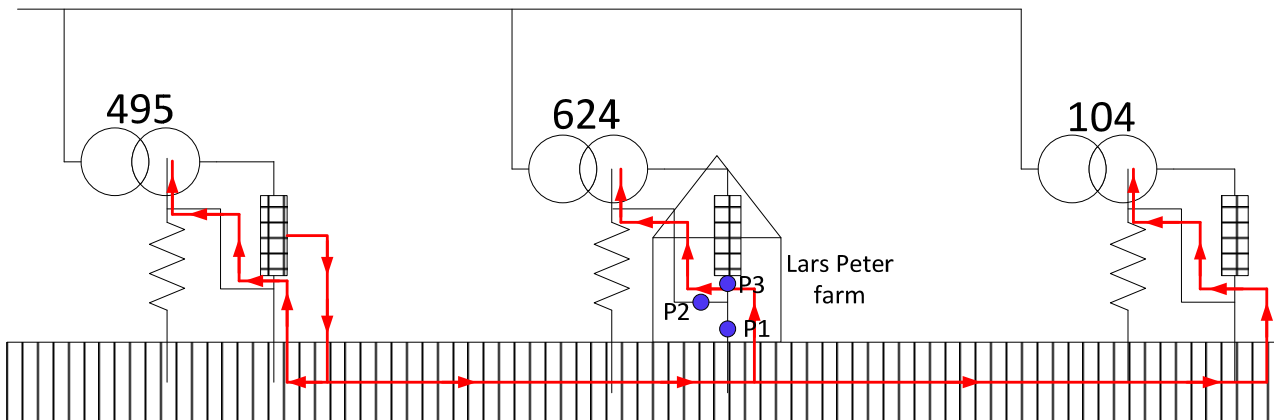
As example, an unbalance at the zone of transformer 495 could result in a distribution of currents as shown in Figure 1, in which for some reason, as a bad connection, the current is flowing to the ground at one point. This current will then flow to the neutrals of the different transformers in the area. The same neutrals that are connected to the ground at the transformer and at the loads though the neutral wire. The path with lower impedance is precisely through the neutral wires, thus, the majority of the current would flow in the ground until the load neutral point, which is also connected to the ground, and then to the transformer neutral in the neutral wire. In this specific example, using a one dimension representation and ground wires of equal length, the only differencing factor would be the ground impedance, resulting in current with a similar magnitude order in all three conductors, being larger in 495 and smaller in 104.

Figure 1 – Current ground return paths

This case can be verified on different ways. The most accurate and easy is most likely to measure the current in three points at Lars Peter house:

- Current in the connection between the neutral point and the ground (P1 in Figure 1)
- Current in the neutral wire (P2 in Figure 1)
- Current just before the neutral point from the house side (P3 in Figure 1) – Not necessary, but helpful for the validation of the results
- Current in the transformer's grounding

If the current at P1 is in phase with the current at P2, for a direction ground-to-neutral, it means that this phenomenon is happening.

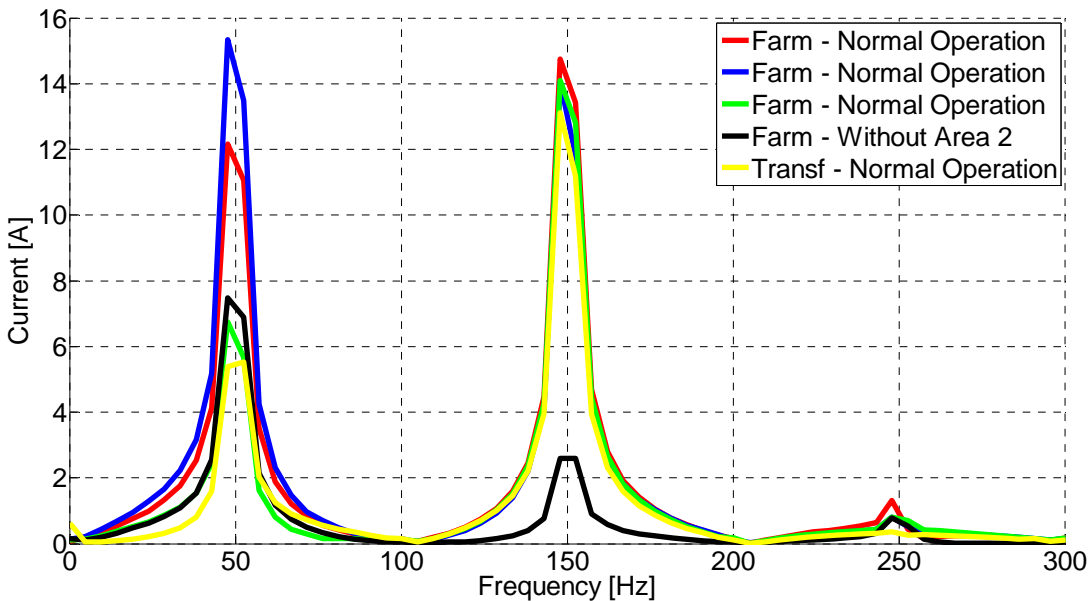
Later it was connected the VLC from the water treatment station located at approximately 8km. These measurements are shown in green curve. This spectrum seems to be rather different from the previous two, but this is because this measurement was made 20 minutes after the previous ones. There were not observed any differences in the oscilloscope while switching on/off the VLC. Thus, we can say it a high degree of certainty that the reduction of the fundamental was not caused by the VLC, but from connections/disconnections on the farm electrical equipment during those 20 minutes. The THD for this case is approximately 200%.

Finally, we tried to temporarily eliminate the harmonic problem and we disconnected the area of the farm that was apparently responsible for most of the harmonics. The frequency spectrum of this case is shown in the black curve, which shows a third harmonic now lower than the fundamental. The THD for this case is approximately 37%. Notice also that the fundamental has magnitude very similar to the previous curves, which may indicate that the loads disconnected for this case are only generating third harmonic.

The current in the neutral of the transformer connected to the farm was also measured and shown in the yellow curve. This result seems similar to the previous measurement made at the farm with all the equipment on (green curve), confirming that most of the current seems to return in the neutral. The THD for this case is approximately 230%.

Figure 2 – Frequency spectrum for the current in the neutral for different times

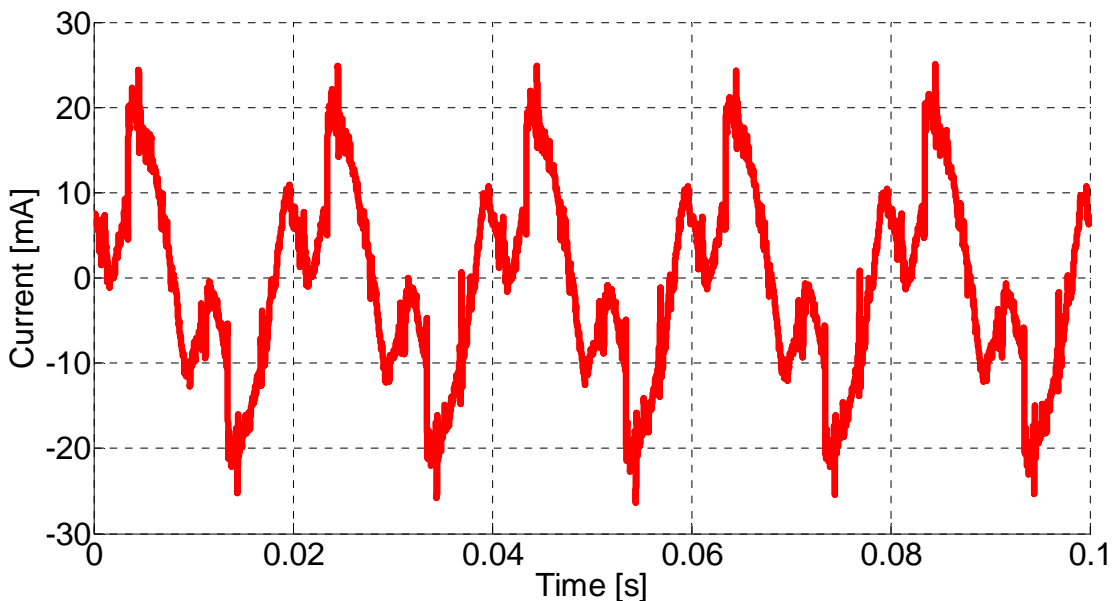
Figure 3 – Current in the farm's ground wire

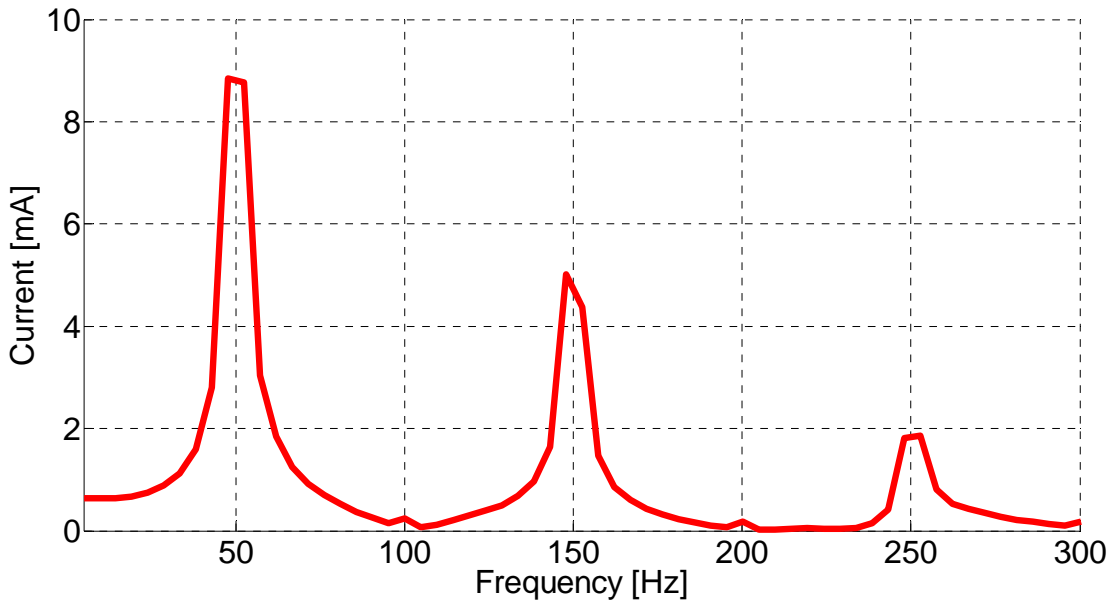
Figure 4 – Frequency spectrum of the current in the ground wire

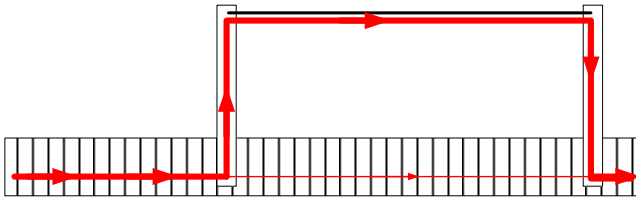
However, this needs to be checked with a further measurement. Two ground rods will be installed in the ground some meters from each other and then short-circuited. The current in the wire connected the two rods will then be measured as shown in Figure 5.

Figure 5 – Measurements of the current flowing in the ground

The current was measured between a grounding stick installed approximately 5m ways from the farm grounding, by short-circuiting both. Only noise was measured.

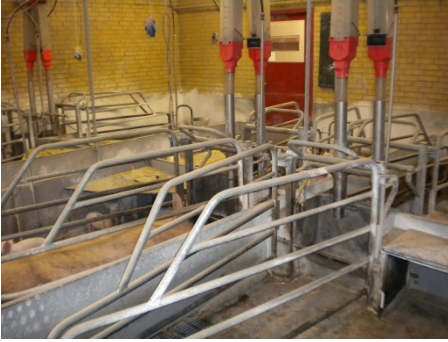
This result can be expected, as all the metal structures in the box were all connected. Therefore, the potential difference between the different points of the box depends only on the impedance of the metal, which is very low, unless if there are rusty parts or loose screws (more on this topic on section IV.6).

Figure 6 – Example of pig boxes

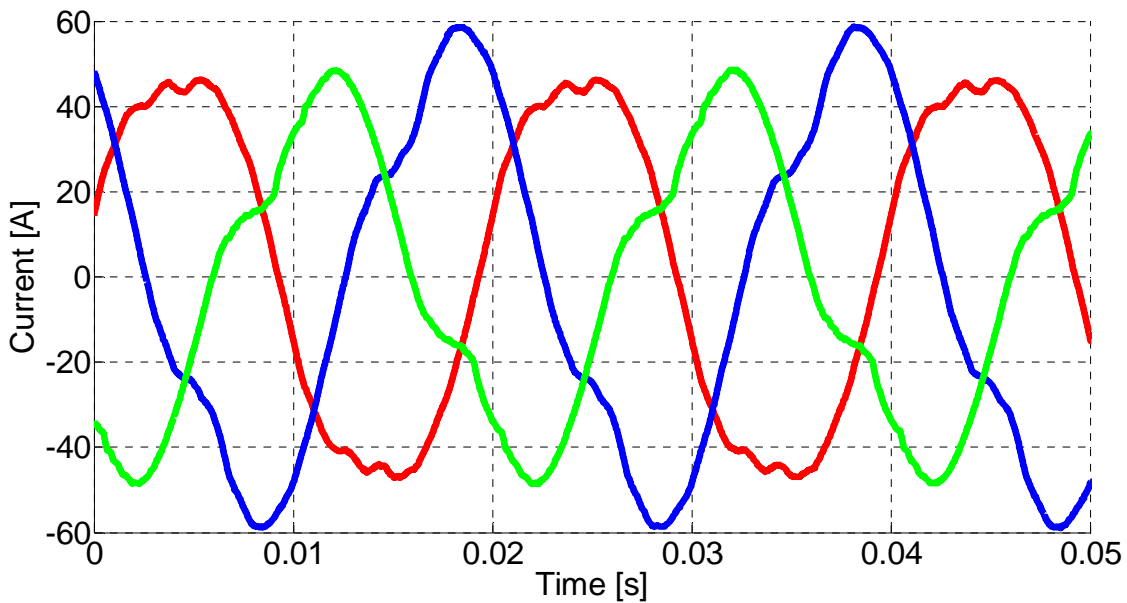
Figure 7 shows the measurements results. It is possible to manipulate the data so that there is  $120^\circ$  phase difference between the phases and then use these results to estimate the neutral current. It is known that there is an error in the estimation as the currents were not measured at exactly the same instant. Yet, the results can still be used to confirm the previous measurements.

Figure 7 – Currents into the farm: Phase A: Red; Phase B: Blue; Phase C: Green

**Current harmonics:** There is a big unbalance between the three phases, as well as strong harmonic content (Figure 7). As the feeder transformer is connected only to the farm, the unbalance is caused by the farm's loads (computers, ventilation, equipment using electronics and power switches, ...).

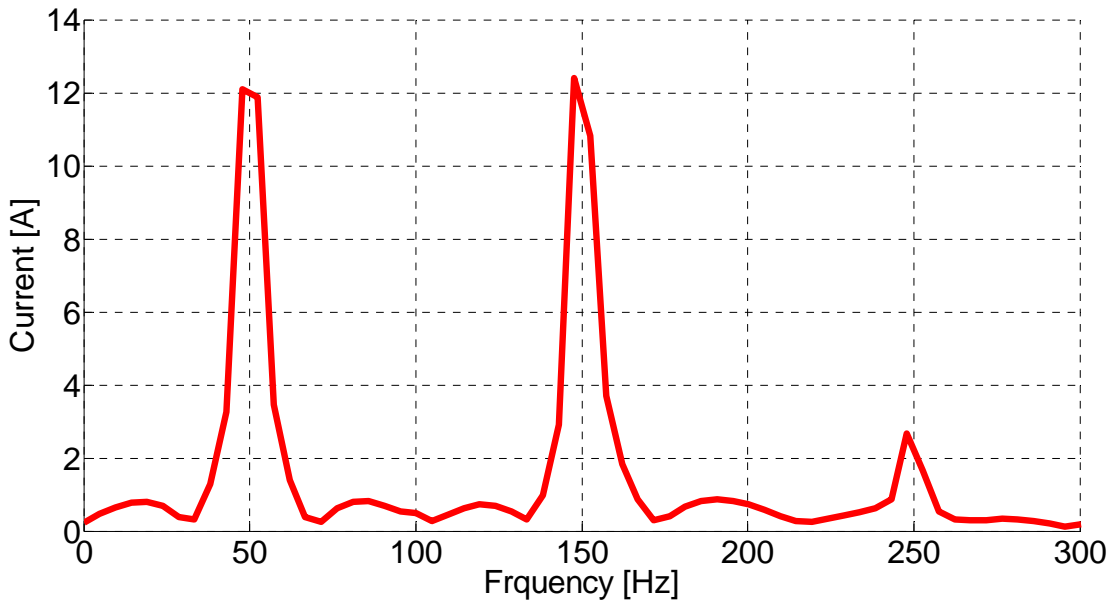
Figure 8 shows the frequency spectrum of the neutral current calculated using the phase currents (by adding the currents in the time domain). The results confirm the measurements previously done in section IV.2.

Figure 8 – Frequency spectrum of the neutral current calculated using the phase currents

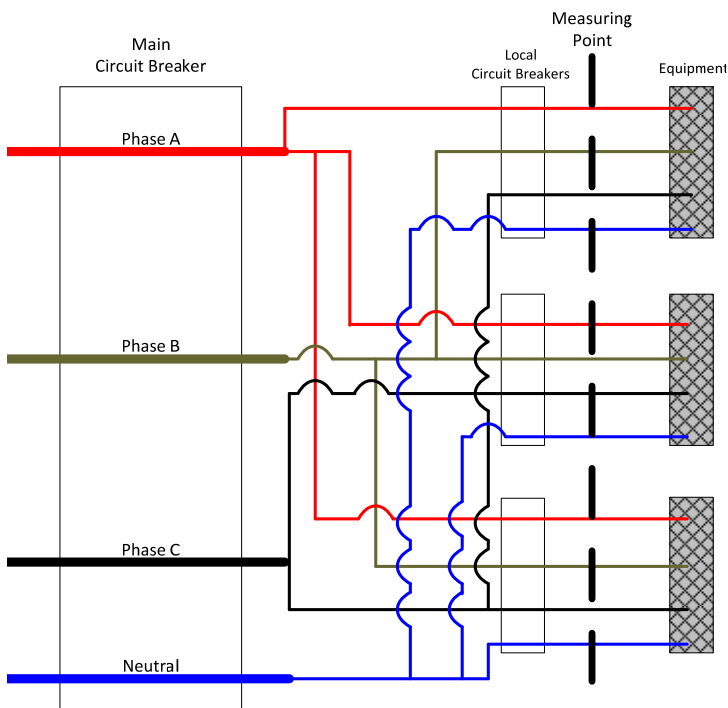
The area 2 is connected to other smaller circuit breakers and it was possible to check in more detail which area/equipment was responsible for this lower impedance. This test showed that the lower impedance was caused by the lights (single-phase line) and three-phase switches (stikkontakter på gang), according to the description that was next to the circuit breakers. When any of these sub-areas was switched off, the impedance between phase-ground raised to high values.

Figure 9 – Setup for the measurement of the impedances

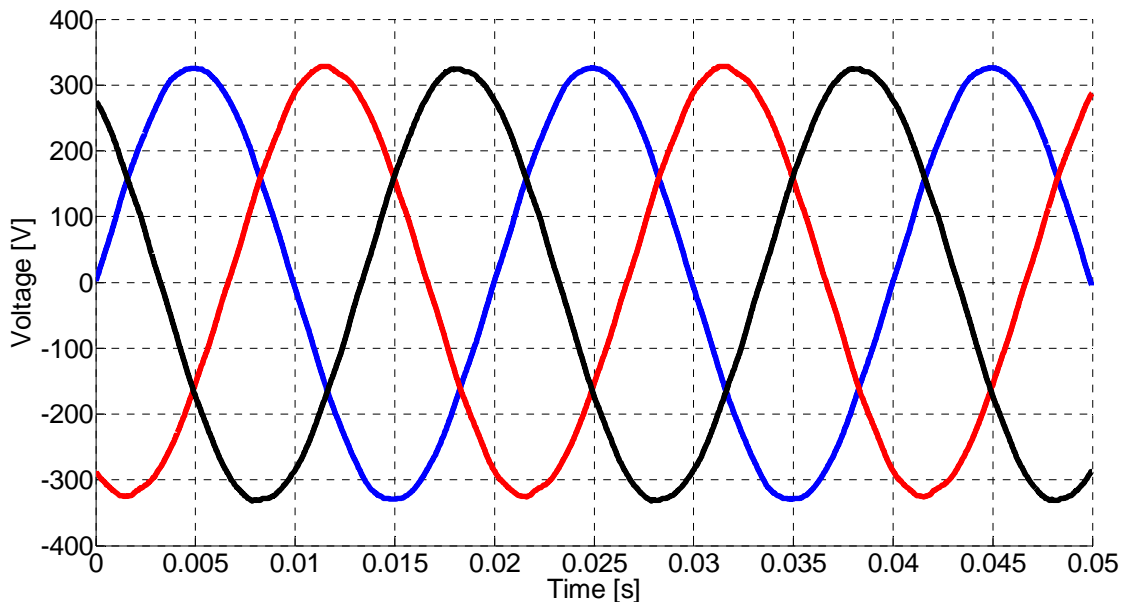
Figure 10 shows the voltage from phase-to-neutral at the entrance of the farm. The voltage is very balance and very small harmonics are present. The waveforms are well inside the standard limits as should not be of concern.

Figure 10 – Voltage from phase-to-neutral
