Mogensen, Jeppe; Jørgensen, Poul-Erik; Thomsen, Trine Rolighed

Published in:
Journal of Industrial Textiles

A microbiological evaluation of SiO₂-coated textiles in hospital interiors: The effect of passive coatings on the cleaning potential of interior textiles

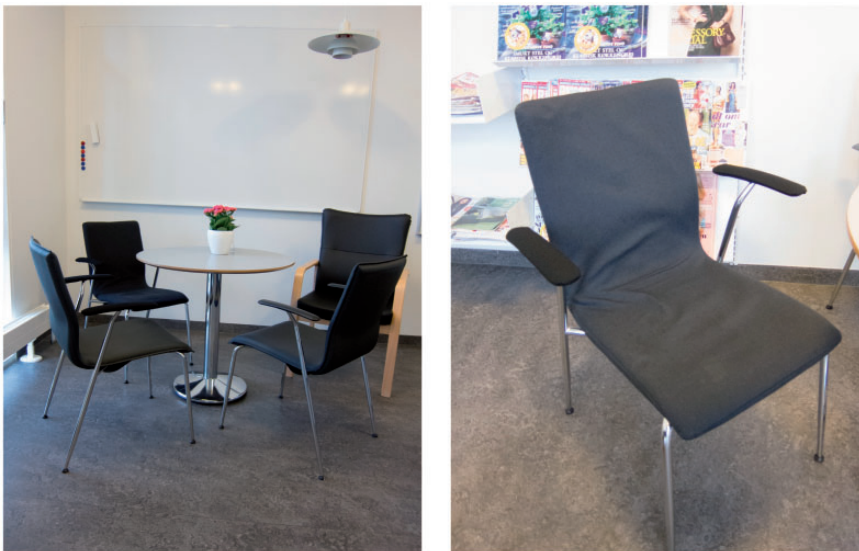
Figure 1. Illustration of the armrest where five different surfaces were installed during the test study.

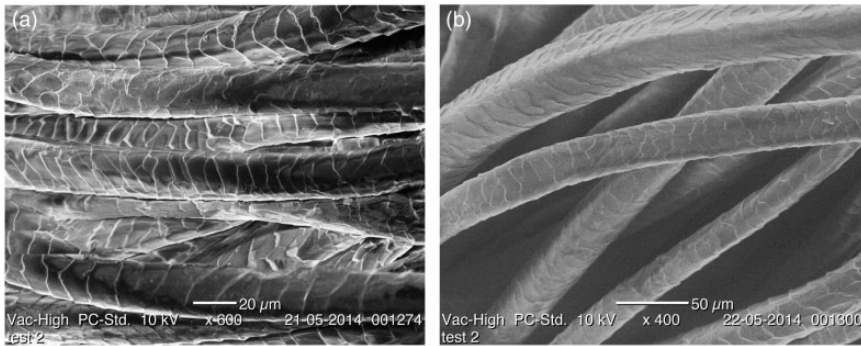
Figure 2. SEM images of WO fibres: (a) noncoated standard WO fibre and (b) WO fibre coated with SiO_2 .

Nobicon A/S, Danish distributor of the NanoPool GmbH “liquid glass coating,” performed the water-based SiO_2 coating that contains SiO_2 molecules as the functional ingredient. The solution is sprayed on the textile surface and is allowed to dry for 24 h at 20°C . As illustrated in the Figure 2, the coating is active at fibre level, and in low concentration (2–10% of SiO_2), the solgel-processed coating forms an 80- to 100-nm thin glass membrane at the surface of the textile fibres. This passive coating of SiO_2 performs hydrophobic and defines an easy-to-clean surface that prevents bacteria growth [23–25]. Contact angles are determined for water droplets as $135 \pm 4^\circ$ for the coated WO fabric, and $128 \pm 4^\circ$ for the coated PES. Despite the hydrophobic properties, the textile handling is maintained in full, and there is no visual or tactile difference in the coated versus noncoated textile surface.
