# Macroseismic analysis of slope movements triggered by the 2011 Lorca Earthquake (Mw 5.1): application of the ESI-07 scale

Geogaceta, 57 (2015), 35-38. ISSN (versión impresa): 0213-683X ISSN (Internet): 2173-6545

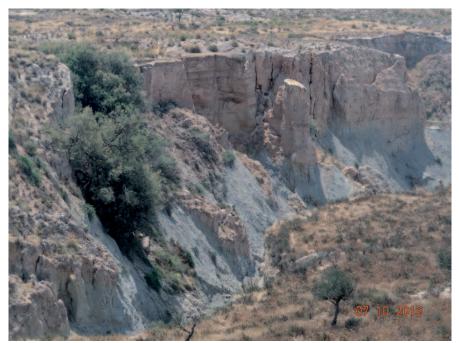
Fig. 2.- Slope movements in the epicentral area. Rambla wall cracking and collapses in the Barranco Hondo.

Fig. 2.- Procesos de ladera en la zona epicentral. Agrietamientos y colapsos en Barranco Hondo.

This category mobilized volumes between 1 and 10 m<sup>3</sup>, and attains the 18% (44 cases) of the mass movements triggered by the earthquake. However in some cases these slope movements occurred assembled (Bco. Hondo; Fig. 2) mobilizing volumes of ca. 500 m<sup>3</sup>. In other cases, small rambla valleys in badlands zones (Bco. El Dorado; Fig. 3) complete slope-valley sections (4x10 m) fully collapsed with estimated mobilized values around 1,500 m<sup>3</sup> (Silva et al., 2013). The widespread occurrence of this kind of rock and soil falls in the zone north of La Serrata, and oversized cases, was confusing from the first reports (Alfaro et al., 2012) since they were relatively far-away (3-4 km West) from the preliminary epicentral location. Now, after the relocation of the earthquake epicenter (López-Comino et al., 2012), it is patent that this zone is in the epicentral area of the Mw 5.1 event, but also of the preceding Mw 4.5 foreshock (Fig. 1).

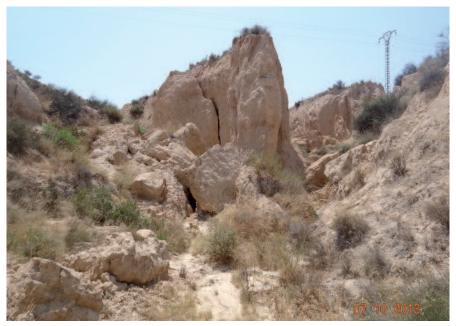
Fig. 3.- Collapse of rambla valleys in the epicentral area (Barranco de El Dorado). Fig. 3.- Colapso de sistemas de ramblas en la zona epicentral (Bco. de El Dorado).
