EVALUATION OF IN-SERVICE SURFACE CRACKING OF ROLLS OF CONTINUOUS CASTING MACHINES

Abstract. The in-service damage in the material for rolls of continuous casting machines is investigated, in particular, the topology of surface cracks is studied, and their statistical analysis is made. Using the results of the microhardness measurements, the structural degradation of the material is evaluated depending on the distance to the roll surface.

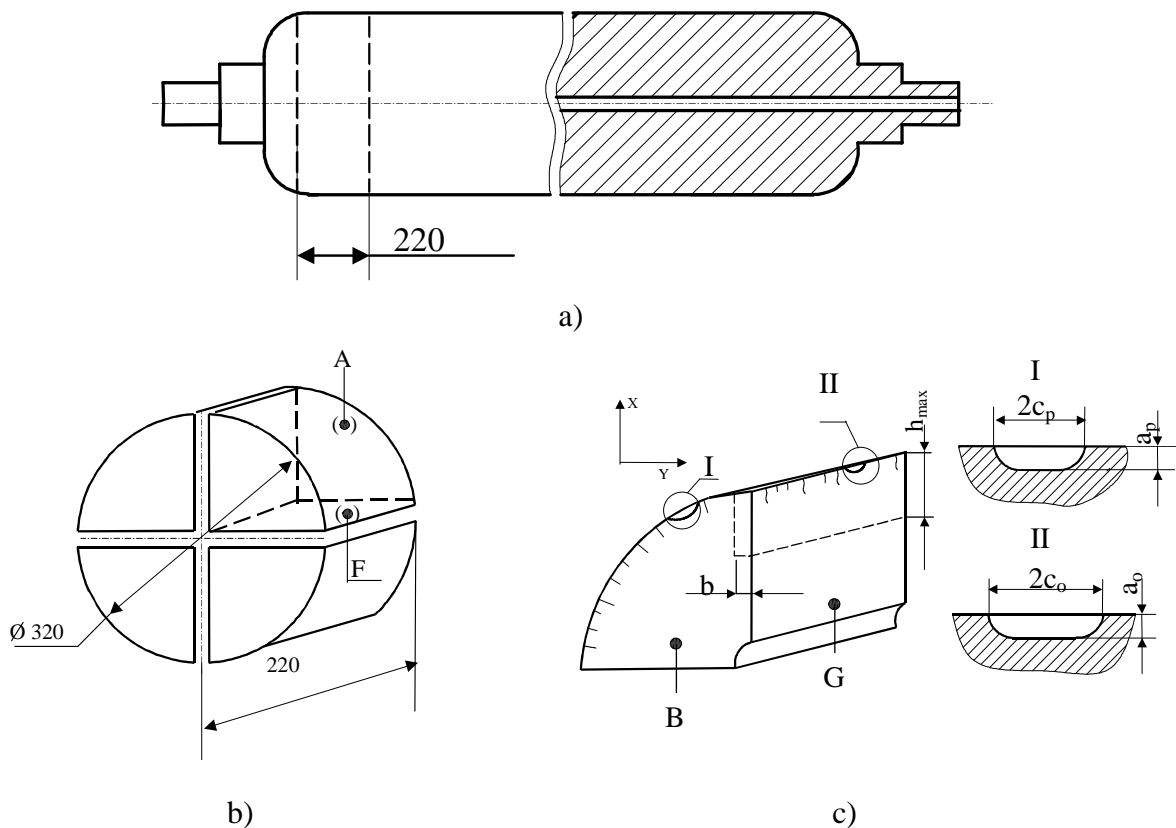
The depth and layer-by-layer distribution of cracks were studied for the roll with the working portion diameter $D=320$ mm that was in service in a horizontal part of the CCM during 4500 melts without refacing, Fig. 1.

The dimensions of the surface cracks were determined on the polished end surfaces (A, B) and lateral ones (F, G) of the templates of length 220 mm, height $h_{max} = 40$ mm and thickness $b = 5$ mm cut-out along the roller axis and in the radial direction (Fig.1).

Fig. 1. Schematic of cutting-out the CCM roll segment of diameter 320 mm (a); cutting-out the template (b); the surfaces and cracks under study (c)

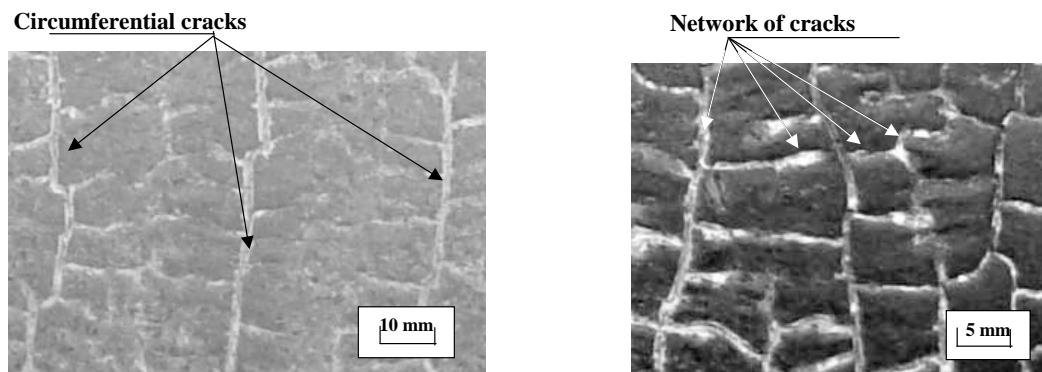
With the use of the methods of macroanalysis of the template surfaces, the main circumferential cracks and network of cracks in rolls were detected on the roll surface (Fig. 2 a, b).

Fig. 2. Photographs of the surface of the CCM roll 320 mm in diameter with typical in-service damages after 4500 melts

The roll surface was coated by an oxide scale layer formed as a result of the action of high temperatures and contact with the slab billet (Fig. 2). It is known that a layer of the oxide scale no more than 0.09 mm in thickness is formed on steel in an air atmosphere after one thousand hours of operation at 600 °C [3].

The cracks in the plane that passes through the specimen axis have the shape of a half circle, which, in our opinion, is due to their location between the networks of radial cracks.

The relaxation of stresses was likely to occur at their edges, which slowed down their propagation along the roll axis.

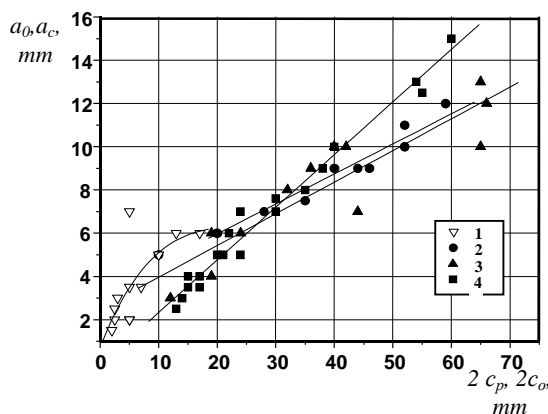
The interrelation between the crack depth and length was studied in the planes that pass through the roll axis and in the planes that are perpendicular to it (Figs 2 and 3).

Fig. 3. Relationship between the crack depth and length on the surface in the axial plane (1) and in the plane perpendicular to the roll axis (2-4) (according to the data of works [1] (2) and [2] (4) and the cracks detected (3))

The cracks detected in the plane perpendicular to the roll axis are deeper by a factor of 1.5 to 1.8 than the axial ones. The crack shape factor (the ratio of crack depth to crack length on a surface) decreases with the increase in the crack depth (Fig. 4). In particular, for cracks that lie in the axial plane, it decreases from $\frac{a_o}{2C_o} = 0.8$ at the depth $a/R = 0.01$ to $\frac{a_o}{2C_o} = 0.35$ at $a/R = 0.36$. The cracks that are in the plane perpendicular the specimen axis have the shape

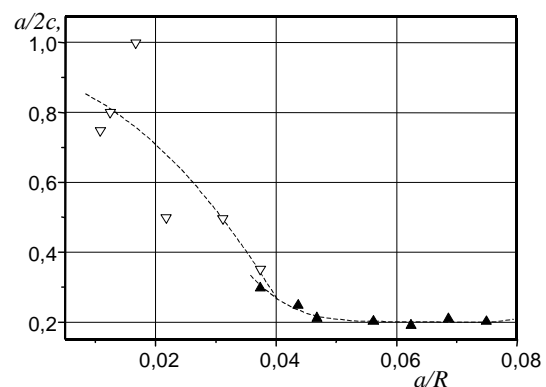
Fig. 4. Relationship between the crack shape factor and relative crack depth (See the notation in Fig.3)

close to a semielliptical one, in particular, at $a/R = 0.037$, the crack shape factor $\frac{a_p}{2C_p} = 0.3$. Note that for $a/R \geq 0.05$, the shape factor for the cracks that are perpendicular to the specimen axis is constant and equal to 0.2 mm.

It has been found that, independent of the crack plane orientation (axial or perpendicular to the roll axis), the crack shape factor (the ratio of crack depth to crack length on a surface) decreases with the increase in the crack depth.

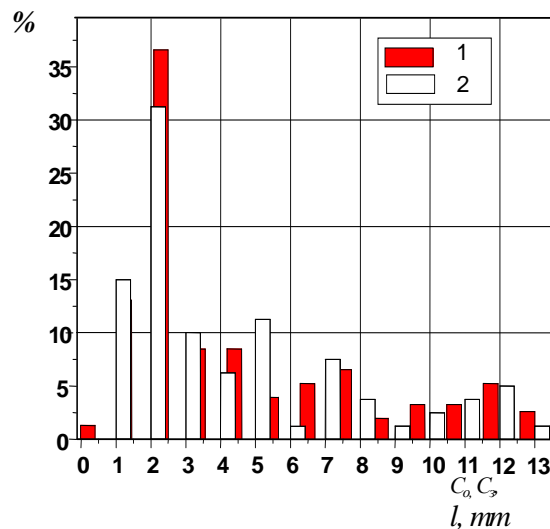
The specific distribution of cracks of different lengths in the radial and axial directions is given in Fig. 5. The cracks within the network of cracks constitute about 57% of the total number of the cracks under study. With their formation, the roll surface stresses decrease due to the increase of a free surface. However, they contribute to the intensification of the process of the corrosive oxidation and the subsequent wear of the working surface.

Fig. 5. Distribution diagram for cracks of different depths (%) detected on the template surface in the axial plane 1-F, G (a) and in the plane perpendicular to the roll axis 2-A, B (b) (See the notations in Fig. 1 b, c)

“Deep” cracks more than 10 mm in length constitute about 10% of the total number of the detected cracks. The depth of the longest crack among them is 13 mm. These cracks propagating in the roll body form a network of cracks which, by unloading the adjacent areas, creates the so-called “shadow zone” for the cracks of lower depths. This enables their adjacent areas to be expanded freely in heating and reduced in cooling.

However, on the other hand, such cracks are the most dangerous since these, propagating and merging, form circumferential cracks that can result in the complete failure of the roll.

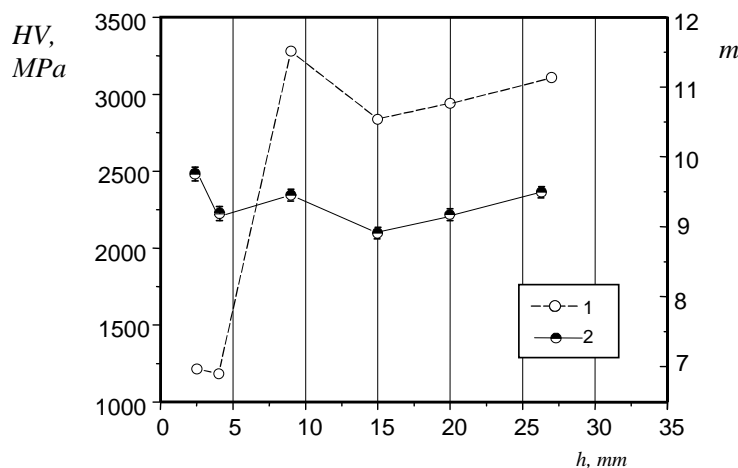
The maximum microhardness of 2500 MPa was found on the roll surface (Fig.6).

Fig. 6 Dependence of the homogeneity factor (1) and microhardness (2) on the distance in the plane perpendicular to the roll axis.

The microhardness decreases down to 2200...2350 MPa with increasing distance from the surface. A slight increase in the microhardness of the surface layers is likely to be caused by the process of the roll manufacture on the one hand, and the influence of operational conditions, in particular, the elastoplastic deformation of the surface layers and variation in the steel structure consisting in the pearlite decomposition, redistribution of carbides along the ferrite grains, on the other hand.

The use of the Weibull homogeneity factor makes it possible to detect the material degradation. In particular, a decrease in the value of the homogeneity factor to $m = 6.9$ indicates that the process of damage accumulation occurred considerably more intensively in the surface layers. At the final stage of heat treatment, tempering is likely not to result in the formation of the equilibrium structure, therefore in the process of thermal fatigue, the redistribution of the alloying elements and carbon in solid solution with dissolution of the existing carbide phases and precipitation of new ones is possible.

At a distance of $h = 9$ to 25 mm from the surface, $m = 9.5 \dots 11.5$, which is higher by 60 to 72 % than that in the near-surface zone, and this is indicative of the lower scatter in the microhardness and lower damage of the metal.
