## Socio-Economic Problems and the State

# Safety of visually impaired and partially sighted people on rail platforms in Poland – existing state and mistakes committed

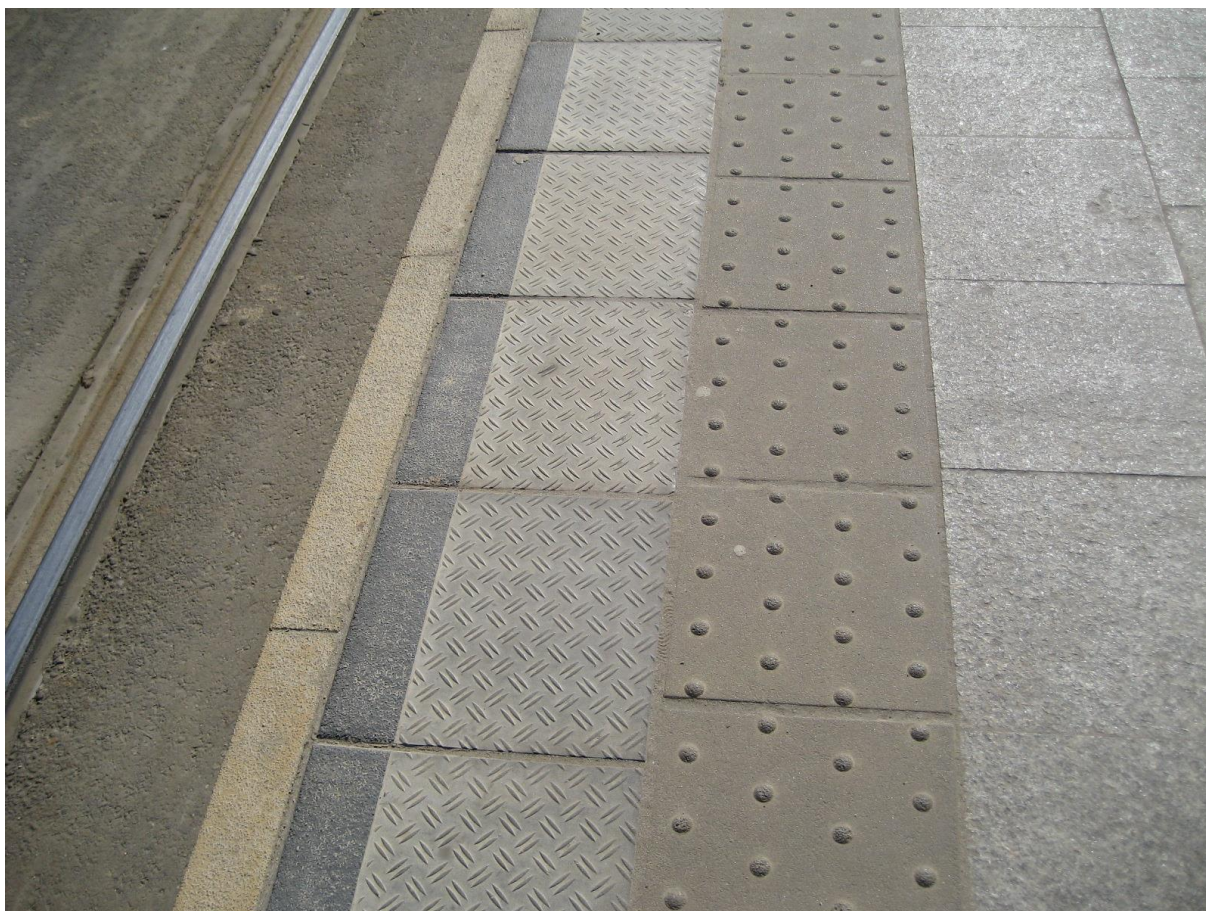
**Figure 1. Examples of markings the edge of the tram platform in Warsaw taking into account the guidelines of the Polish Association of the Blind**

Fig. 1 shows that correct markings of the platform edge is made using colored, small paving elements. In contrast, in Grudziądz there has been used a monolithic plates of non-slip textured surface with warning strips. Coatings have been applied on the plates according to the recommendations of Polish Association of the Blind. It is worth noting that in current regulation (Regulation 1999), in the § 120, which provides guidance for the tram platforms, recommendations have not been included for platform surface and its adaptation to the need of visually impaired and partially sighted people.

Examples of solutions are shown in fig. 1, taking into account the recommendations of Polish Association of the Blind.

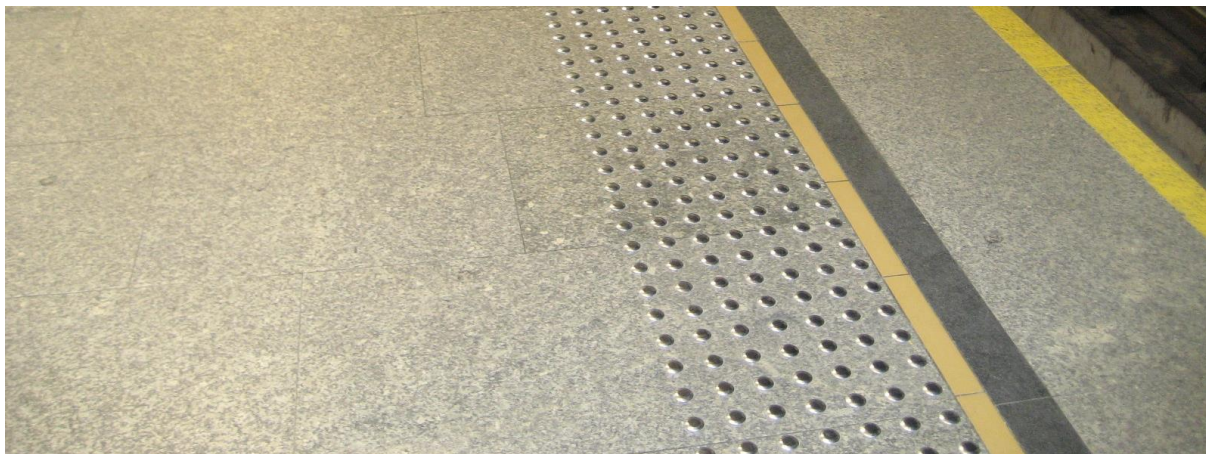
**Figure 3. Markings of the platform edge at Warsaw Underground**

It is worth noting that on the new platform stations - now finishing the central section of Underground Line II - there are applied tactile warning signs for visually impaired and partially sighted people according to the above mentioned Regulation. The view of the platform edges of Warsaw underground is shown on the fig. 3.

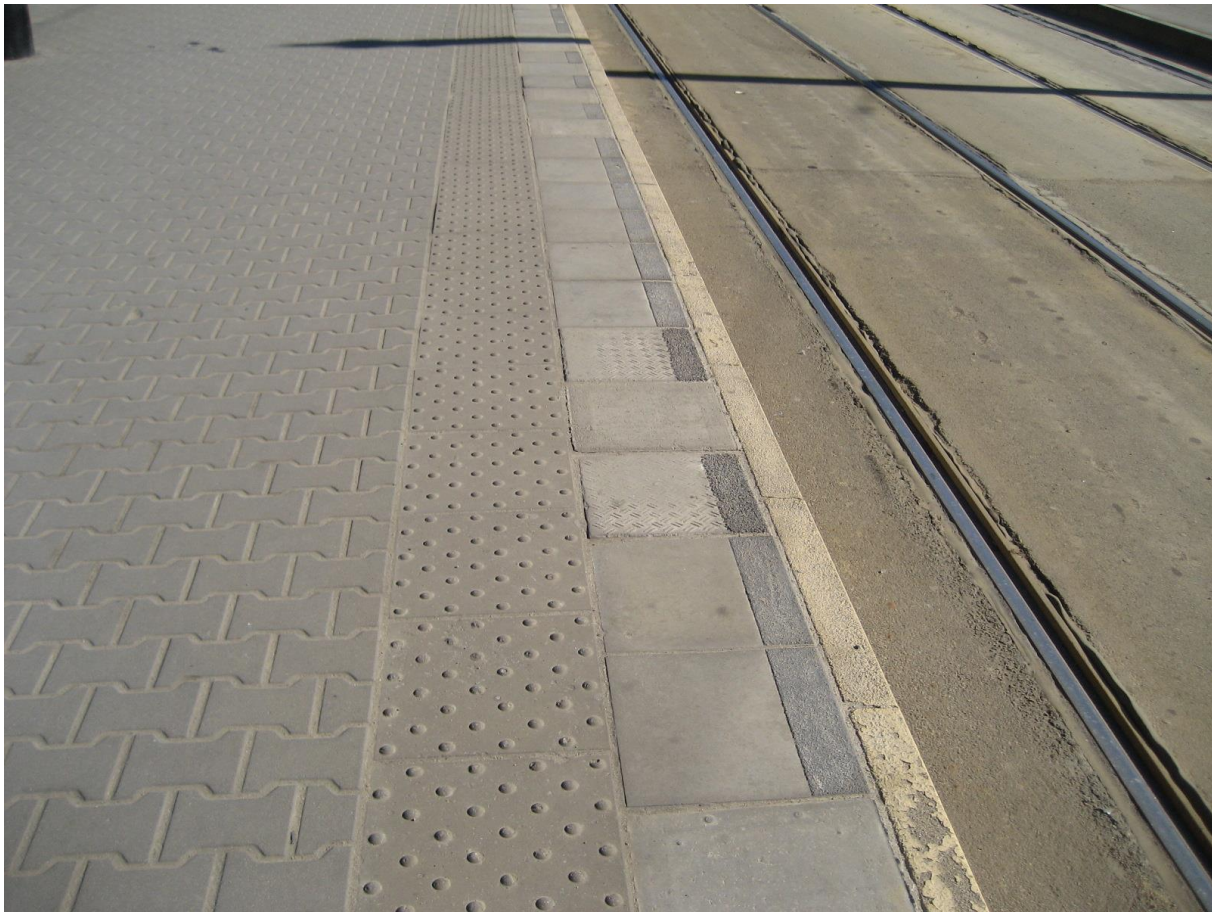
**Figure 6. Example of improper maintenance of tram platform**

In many cases of tram platforms, the defective elements are not reconstructed, which introduces large difficulties to the blind. The causes of visual markings damage are an extended operation of the tram platform surface at high passenger flows, as well as the changing weather conditions. Defects and damages of such markings for visually impaired and partially sighted people pose a risk and may cause an accident. Improperly maintained tram platform surface is shown on figure 6, where the damaged plates are replaced by others. However, yellow-black strip meaning the platform edge, was not reconstructed.
