Prepared in cooperation with the U.S. Army Corps of Engineers, Omaha District

Hydrographic Surveys at Seven Chutes and Three Backwaters on the Missouri River in Nebraska, Iowa, and Missouri, 2011–13

Data Series 909

By Justin R. Krahulik, Brenda K. Densmore, Kayla J. Anderson, and Cory L. Kavan

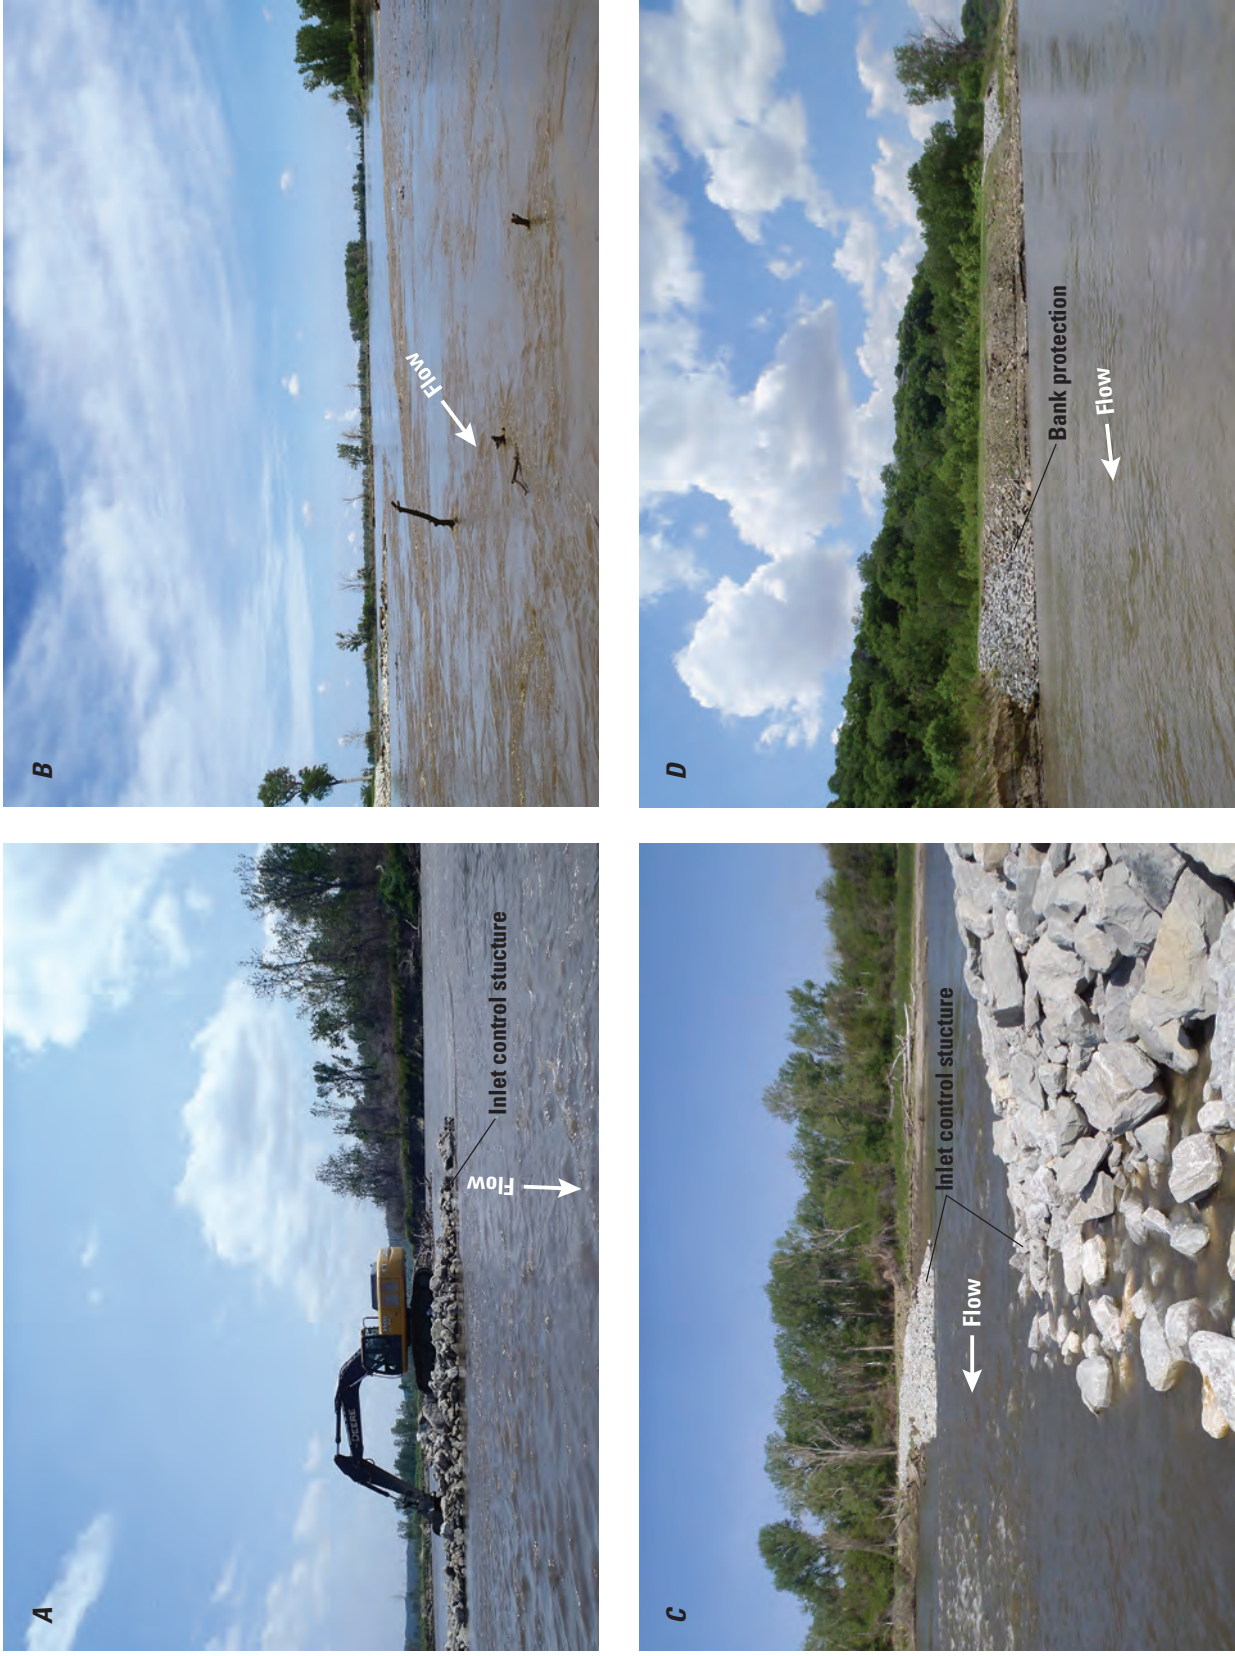
Figure 2. Control structures at Missouri River chutes, 2011–13. *A*, Construction of a new inlet control structure at Deroin chute, 2013. *B*, Turbulent water around the inlet control structure and snags at Lower Hamburg chute, 2014. *C*, New control structure within Lower Hamburg chute, 2014. *D*, Limited bank protection on an eroded bank at Tobacco chute, 2014.

The split of total discharge between the Missouri River main channel and the chutes was consistent with observed effects of the 2011 Missouri River flood (deposition, erosion, degradation of entrance control structures, flanking of internal control structures, chute widening) at most chutes as noted by the U.S. Army Corps of Engineers and U.S. Fish and Wildlife Service (2013). Many chute entrances and control structures were damaged by floodwater in 2011, allowing a larger percent of the Missouri River total discharge to flow through the chute than originally intended in the chute design. The designed flow split varies by chute, but is typically 10–12 percent of the total discharge (U.S. Army Corps of Engineers and U.S. Fish and Wildlife Service, 2013). The USACE repaired many of these chutes in 2012 and 2013, and effects of these repairs as well as changes in total discharge can be seen in the discharge split between the Missouri River main channel and the chute in data collected for this study. It is likely that the repairs affected the water depths and riverbed elevations not only at the construction site, but throughout the chutes and backwaters—however, there is no way to distinguish the changes contributed specifically to the repairs from general post-flood geomorphic changes. Also, survey data could not be

collected over newly built and repaired structures because of safety concerns (rough water flowing over the new structures, heavy machinery still working on structures, and difficulty walking on new structures because the rip-rap was still settling into place). In addition to total discharge and discharge splits, the mean velocity of the cross section collected during each discharge measurement is reported. Cross sections selected for discharge measurements typically were uniform, narrow areas of the chute, and are not necessarily representative of the entire chute, but represented the best locations to accurately measure discharge. Therefore, even when mean velocities of discharge measurement cross sections were greater than 0.6 m/s, there were likely areas along the cross section and many areas throughout the chute that did have flow velocities less than 0.6 m/s.

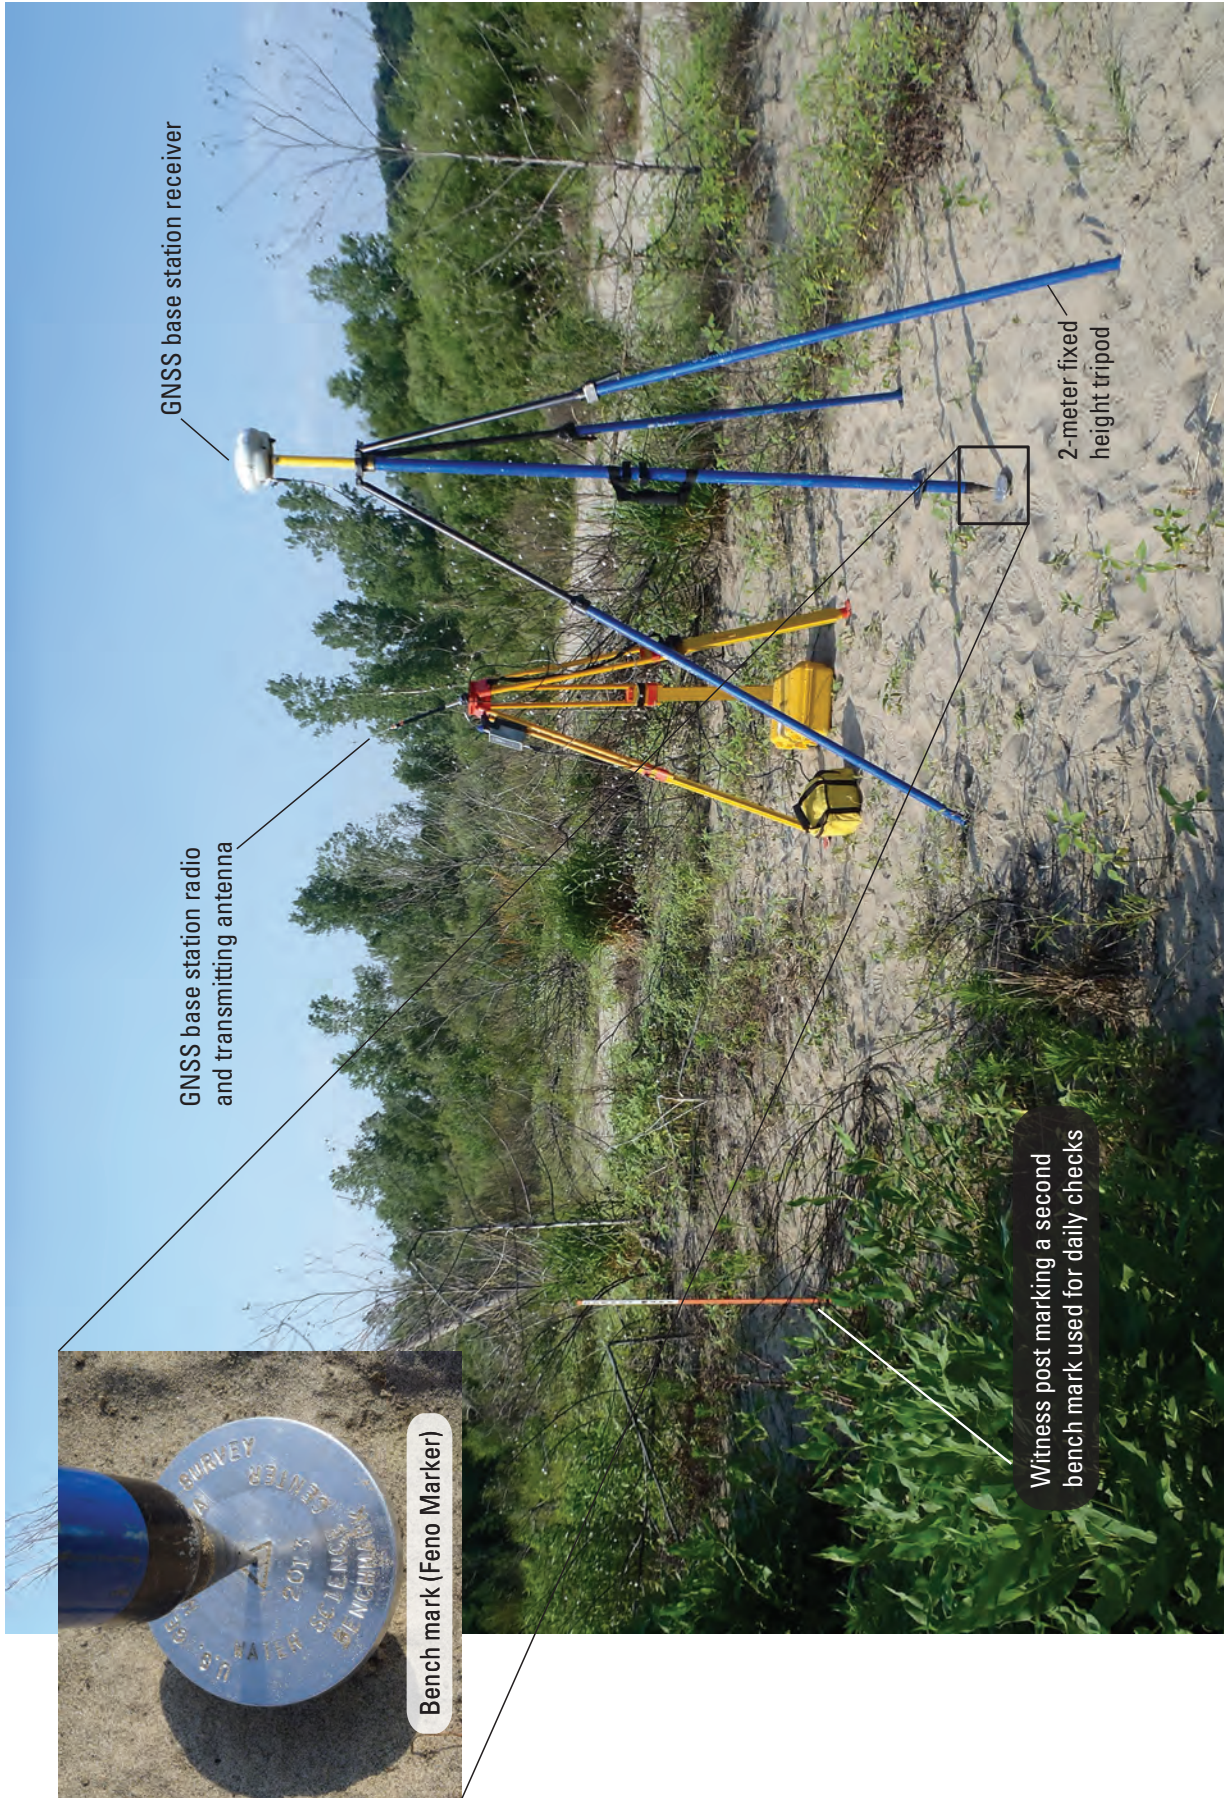
Figure 3. Real-Time Kinematic (RTK) Global Navigation Satellite System (GNSS) base station and bench mark at Deroin chute, Missouri, 2013.

The RTK GNSS surveying required USGS surveyors to walk along the banks with an RTK GNSS rover with an antenna mounted on a 2-m adjustable-height pole. The surveyors located each transect and collected elevation measurements by setting the foot of the pole flat on the riverbed or riverbank, leveling the pole, and taking a measurement. The RTK GNSS surveys included main-objective points to be surveyed at three positions on each transect, whenever possible: top of bank (left and right), toe of bank (left and right), and edge of water (left and right, denoted in the data file as “we”). Additional data points were collected between these main-objective points and into the channel to ensure a point spacing less than 15 m. The RTK GNSS surveys extended into the channel as far as water depths and substrates allowed for safe wading conditions. Water-surface elevations (denoted in the data file as “ws”) were surveyed at the same point at the beginning of the day and at the end of the day, and these locations extended upstream and downstream from the bathymetric survey data collected during that day. Similarly, water-surface elevations were collected at the upstream and downstream cross section of backwaters. This water-surface elevation collection method allowed the hydrographic surveying software to account for water-surface slope as well as changing river stage when converting the bathymetric survey depth to elevation.
