Gates, P, Ibell, T, Darby, A & Evernden, M 2018, 'GFRP durability appraisal: mechanical testing of naturally aged composite panels', *Proceedings of the Institution of Civil Engineers: Construction Materials*, vol. 171, no. 6, 1700023, pp. 267-283. <https://doi.org/10.1680/jcoma.17.00023>

GFRP Durability appraisal: mechanical testing of panels from the Severn Crossing Visitors' Centre

ABSTRACT

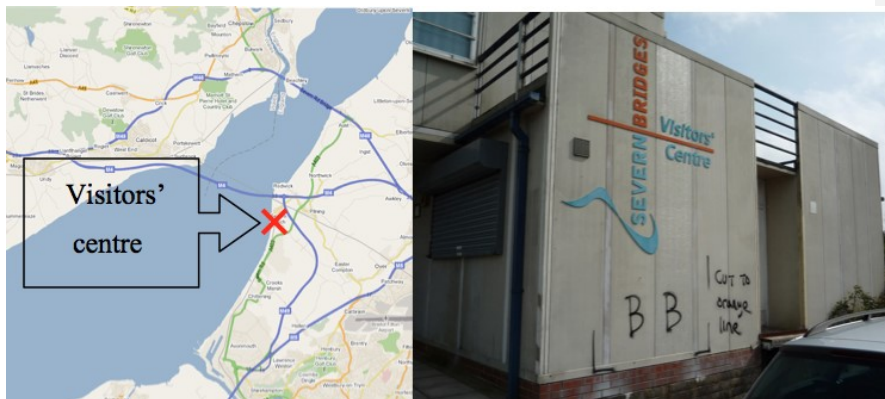
Figure 1 Left: Location of the four 'panel pairs' from the Visitors' Centre at the Severn crossing estuary. Right:

Photo of the southerly elevation

Environmental factors that can cause degradation of the composite include UV irradiation, moisture absorption and thermal fatigue from both diurnal and annual cyclic variations (Karbhari et al. 2003; Compston et al. 2008). South facing panels (see Figure

1) will have experienced the greatest solar irradiation, whilst panels on the north facing façade are expected to have endured the dampest conditions. Panels were missing surface veils (a component present in new panels, responsible for creating a resin rich surface layer during the pultrusion process, to improve aesthetics and durability) on the external face, thus decreasing the expected long-term mechanical performance of this material. This concurs with reports that these panels were earmarked as factory seconds and not used for the primary design purpose in bridge enclosure. A comparative study using internal, external, and web material from each of the façade elevations has been carried out to establish the influence of environmental exposure on the mechanical performance of GFRP pultrusions.

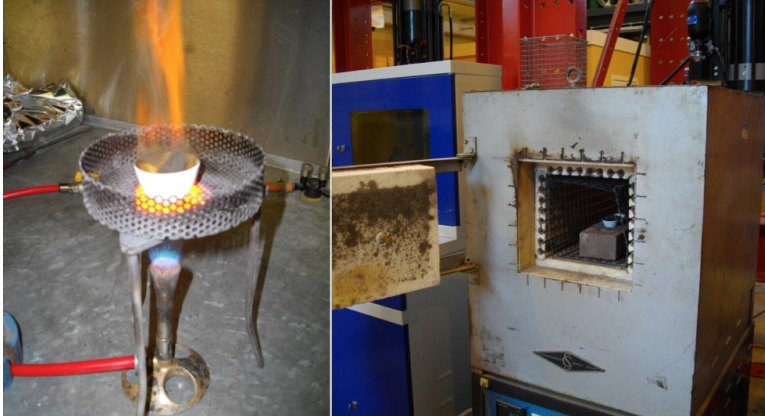
Figure 5 The sample was ignited using a Bunsen Burner (left), and then later placed into a muffle furnace (right)

For both the aged and new material, resin burn-off to establish fibre weight fraction has been conducted according to ASTM code D 2584-02. After weighing to find the initial mass of each of the 25 mm square samples, each sample was ignited by heating in a crucible over a Bunsen flame and left until the volatiles had cleared (once the smoke had stopped) and only the fibres, ash and carbon remained. Each sample, in its own crucible, was then placed in a muffle furnace at 565°C until all the carbonaceous material had disappeared (see Figure 5). Six hours was sufficient for this. Re-weighing of the remaining fibres yielded the fibre weight fraction, and using values for the fibre and matrix density, (2570 and 1200 kg/m³ respectively (Bank, 2006)), the volume fractions could then be determined.

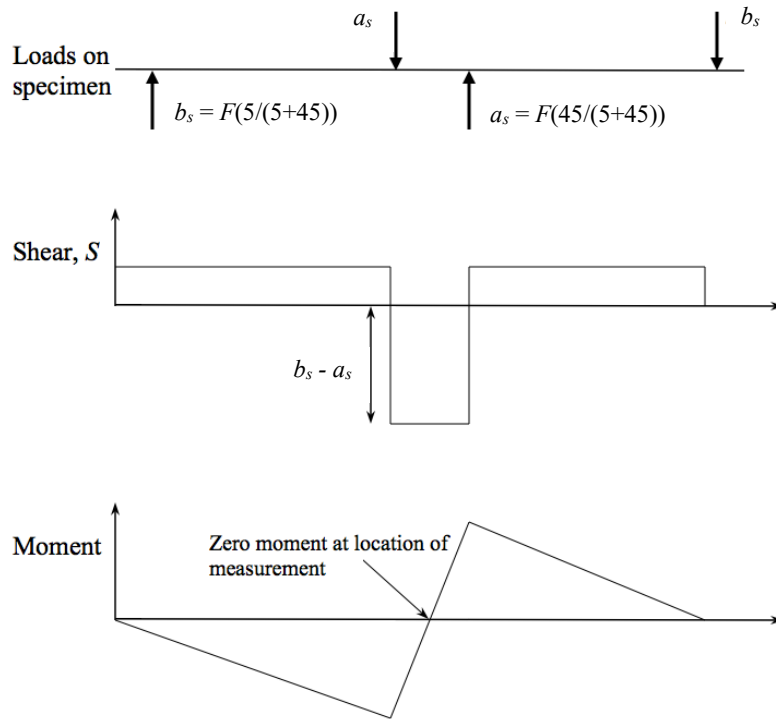
Figure 9 Iosipescu shear rig set-up (all dimensions in mm). Schematic showing how loads on specimen are achieved and shear is derived at zero moment location

(perpendicular to the load direction). Two steel plates provided out of plane stability to the test specimen. The specimens were 20 mm wide \times 100 mm long. Top and bottom steel loading bars, together with a pin arrangement, enabled loading to be applied to produce maximum shear and zero moment at the centre point of the test coupon. An observation window cut-out allowed strain gauges to be located effectively. The pins were located within long slotted holes to guide them, avoiding the need to notch the sample at the pin locations, which could otherwise have caused unwanted stress concentrations due to the notch inhibiting lateral movement of the pin across the surface under flexure. The specimen was loaded by means of a mass hanger and weights, with the load applied through the top pin of the rig. Loading was limited to 80 kg by the strength of the loading system, and it was found that this could be applied accurately without damaging the rig. The geometry of the loading arrangement results in a shear force, in the measured region, of 80% of the applied load, as shown by Equation 2 and illustrated in Figure 9.

Where ε_1 and ε_2 are strains from the two perpendicular gauges inclined at 45° to the horizontal, and τ_{xy} is the shear stress at mid depth of the section found from the section dimensions, and the shear force as per Figure 9. Equation 4 is taken from a technical note for use of strain rosettes in performing Iosipescu tests (Vishay, 2008), and accounts for the influence of the vertical compressive strain when using gauges inclined at 45° to determine shear strain, γ_{xy} , where α is the inclination angle of the gauge, thus explaining why γ_{xy} is represented as $(\varepsilon_1 - \varepsilon_2)$ in Equation 3.

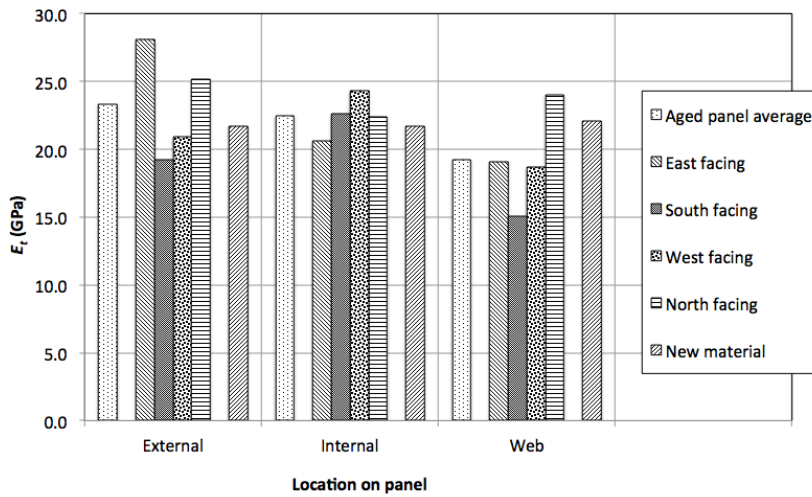
Figure 12 Tensile elastic modulus as a function of coupon origin

Figure 12 shows the results of coupons taken from the panels and tested in tension. The web material of the aged panels appears to have a lower tensile modulus compared to flanges, though this difference is not evident in the new material. This is as predicted by resin burn off and hand calculation. The lowest value of tensile elastic modulus established during testing was 15 GPa (for the south facing panel web coupons). This correlates well to the established reduction in fibre content of these elements as illustrated in Table 2. Coupons of internal material out-perform those of external material from both south and west facing panels, subjected to the prevailing estuary wind. Coupons from north and east facing panels do not exhibit this trend. A large variance across tests is observed, particularly for the webs (as already discussed) and external material, prompting further investigation. Each result represents an average from three coupon tests.

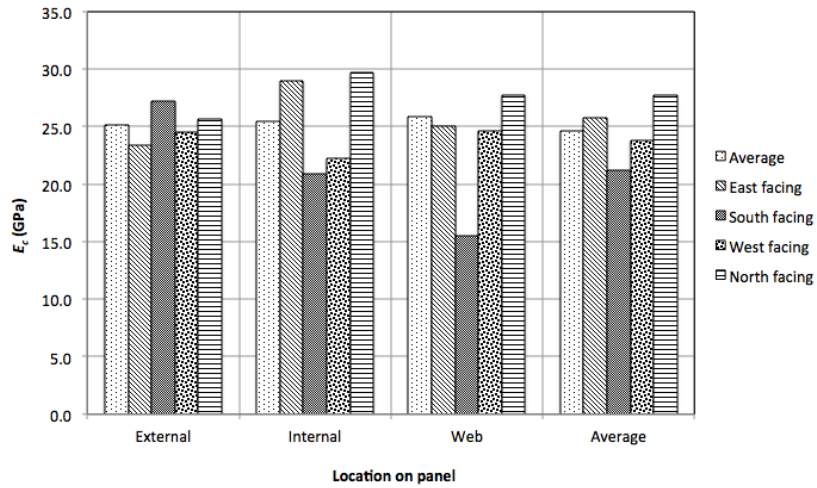
Figure 15 Compressive modulus, E_c as a function of coupon origin

The overall average compressive elastic modulus of 26.8 GPa was 17.5% higher than the tensile modulus determined in Subsection 3.3. It is more usual that compressive modulus is lower than tensile modulus for FRP materials (Bank, 2006), so this suggests that, in this case, the resin is playing an important part in the behaviour. The resin component, which would not contribute much to the measured modulus in the new material, could be contributing to compressive stiffness to a greater extent than tensile stiffness, owing to physical change with age. A hypothesis explaining this outcome is presented and tested in Section 4.

No new material was available by the stage of compression testing for comparison. A standard deviation of 2.1 GPa was found for average results relating to panels on different facades, in both tensile and compressive testing for elastic modulus. In tension, however, the panel webs displayed a lower average stiffness compared to the panel flanges, which is not evident in results for compressive testing. This suggests that the resin is of greater influence on the compressive modulus measured than the tensile modulus. The compressive strength was not measured due to test limitations resulting in premature buckling of the specimens.
