# The influence of the physical environment on self-recovery after disasters in Nepal and the Philippines

S. Sargeant<sup>1</sup>, A. Finlayson, T. Dijkstra, B. Flinn, H. Schofield, L. Miranda Morel, J. Twigg, E. Lovell, V. Stephenson and B. R. Adhikari

## Abstract

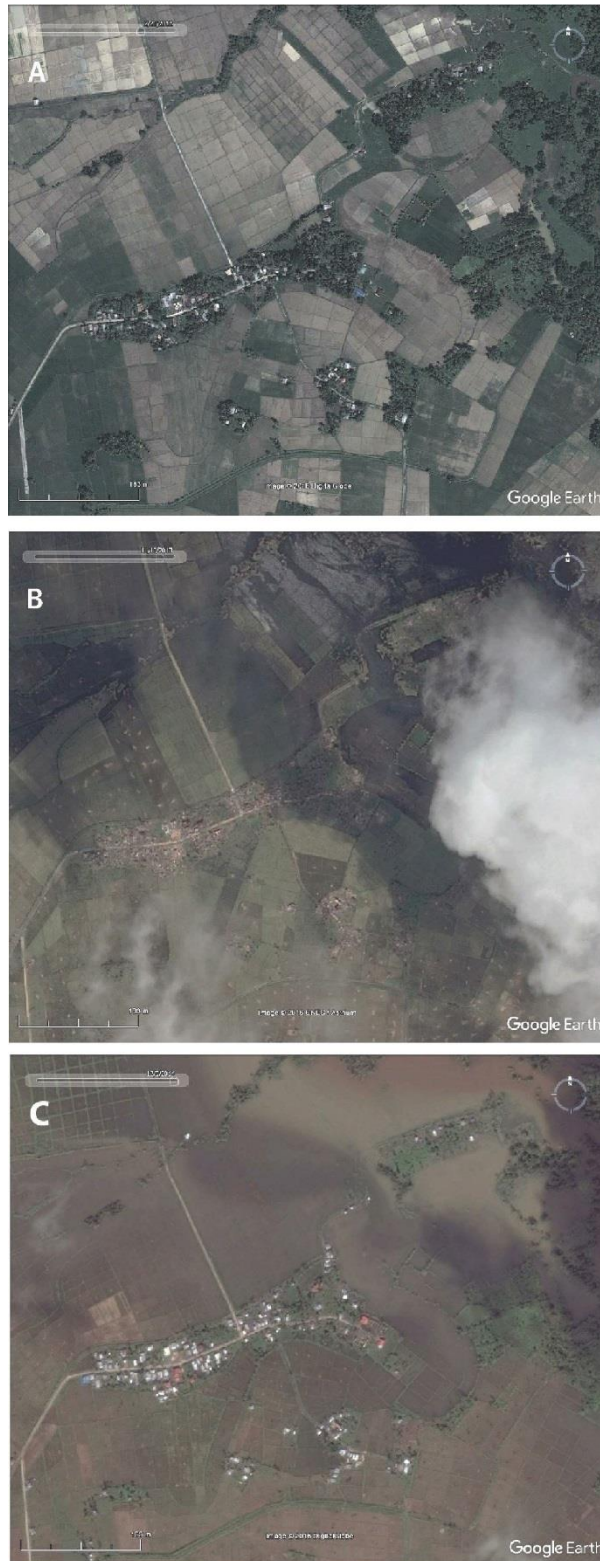
Figure 2. (A) DigitalGlobe image (23 February 2012) courtesy of Google Earth showing the community of Badiangay prior to Typhoon Haiyan. (B) CNES/Airbus image (13 November 2013) courtesy of Google Earth showing the severe wind damage to the community five days after Typhoon Haiyan passed through. (C) DigitalGlobe image (9 December 2014) courtesy of Google Earth, showing the extent of flooding around reconstructed houses following heavy rainfall associated with Typhoon Hagupit. British Geological Survey (c) UKRI 2020.

The primary cause of damage in this community during Typhoon Haiyan was the intense wind speeds that destroyed 125 out of 128 houses (Fig. 2A, B). Flooding also impacted the community, with residents reporting that water levels reached *“knee to waist depth”*. Flooding was a common theme in the focus group discussion about recovery, as might be expected in a community located within the floodplain landsystem: *“we experience flooding every year... water can stay high for several days”*. The extent of flooding during Typhoon Hagupit (associated with lower wind speeds than Typhoon Haiyan, but high total rainfall), which occurred one year after Typhoon Haiyan, illustrates this kind of impact on the community (Fig. 2C). Repeated flooding causes rot and termite infestation, both of which increase the vulnerability of wooden housing.

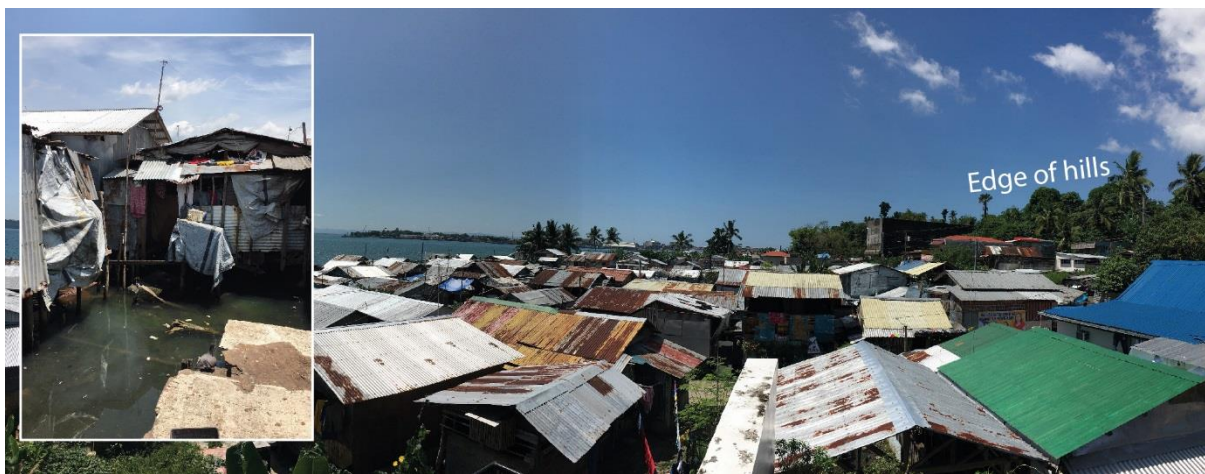
Figure 3. Photograph illustrating context for the community of Anibong, Tacloban. Closely spaced houses are located between the sea and a group of outlying hills. Inset: Shelters encroaching into the sea and are vulnerable to frequent low severity tidal flooding. British Geological Survey (c) UKRI 2020.

outlying hills with slopes up to 30° (composed of weathered sedimentary rocks) all occur in very close proximity (Fig. 3). As a result, a number of shelters encroach out into the sea. At the opposite, south-eastern side of Tacloban City, the barangay of San Juan (Brgy 88) is located on a coastal sand spit where the ground surface rarely rises above a few meters above sea level, and everywhere is within 500 m of the coastline. Both Anibong and San Juan are located in areas where published maps indicate a high storm surge hazard level – and are now classified as no-dwelling zones (Ong et al., 2016; NOAA, 2018). Anibong also includes areas exposed to flood hazard from the Mangonbangon River and a landslide hazard from the hills that the community backs onto. Barangay 83-C is located along the banks and close to the mouth of the Burayan River, and is also exposed to river flooding.

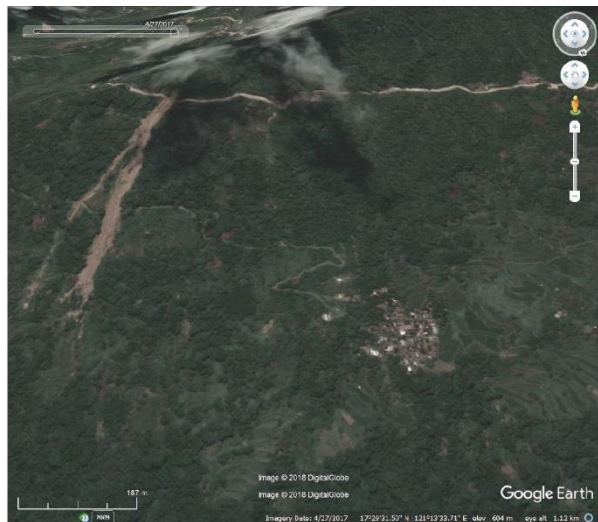
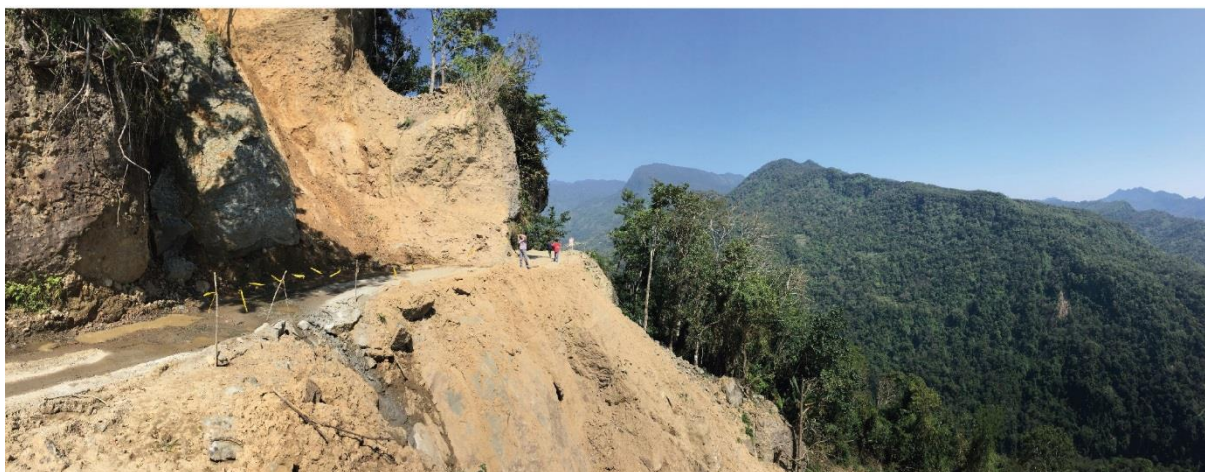
Figure 4. (A) Digital Globe Image (25<sup>th</sup> February, 2009) courtesy of Google Earth illustrating the context for the community at Sitio Bolo. (B) Digital Globe Image (5<sup>th</sup> February 2017) courtesy of Google Earth showing the extent of a debris flow adjacent to the community, that was triggered by heavy rainfall during Typhoon Haima. (C) Photograph illustrating conditions on the only access road in March 2017, 6 months after the typhoon. A large landslide scar is clearly evident and unstable blocks remain above the road. Local people spoke of concerns about the continued threat of landslides here. British Geological Survey (c) UKRI 2020.

In the mountain slope community some building damage was caused by high winds, but this was generally limited to roof damage. Numerous landslides blocked the access road (e.g. Fig. 4B) and affected the community's irrigation system, and one house in a neighbouring community was buried. River bank erosion at the valley base also destroyed a bridge preventing access to fields on the opposite side of the valley.

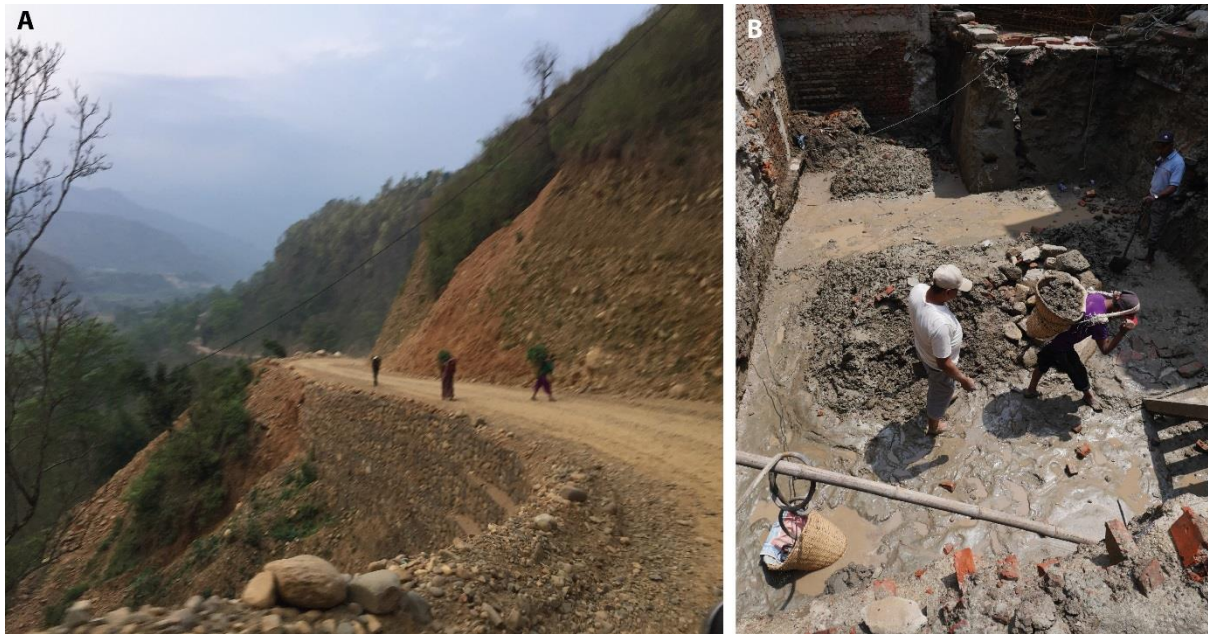
Figure 7. (A) The road that accesses communities on the Salyantar terrace is cut into a steep escarpment that is vulnerable to instability during monsoon rains. (B) Excavation in silts and fine sands with a sump pump, for building foundations in Bhaktapur in April 2018. Evidence for liquefaction below the feet of the construction workers. Local people reported that this stage of reconstruction is not possible during the monsoon.

The clayey and silty nature of the sediments under Bhaktapur make foundation excavation particularly challenging in wet conditions (Fig 7B). Another interviewee in Bhaktapur also described how the occurrence of dry spells can have an impact on rebuilding when mixing mortar: *“Water is scarce here but it is important for the building”* and people had to buy water from tankers to use in housing reconstruction, which increased the cost of rebuilding. The limited weather-controlled ‘windows’ for different building stages compounded delays caused by blocked roads and access difficulties, further slowing down peoples’ recovery.

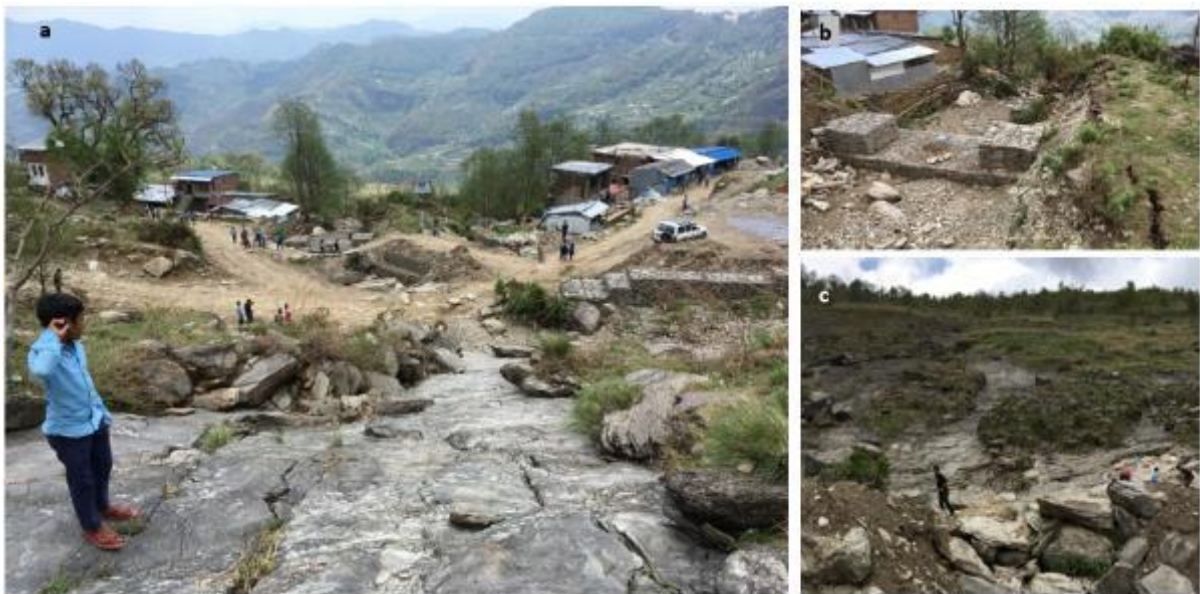
Figure 8. The community of Phulkarka is at risk from high stream flow, overland flow and landsliding. (A) The slopes above the community are widely stripped of their soil cover and this results in very rapid and destructive floods during the monsoon. A system of gabions is being constructed to direct flows and reduce their erosion potential. (B) A close-up of a gabion structure intended to control flow in a stream channel. Bank stability is still very poor (large cracks are visible) and housing is in very close proximity to the stream channel. (C) an view of the slopes above the community highlights the absence of suitable slope and vegetation cover. It is reported that the treeline visible to the left were planted by the community in an attempt to stabilise a landslide.

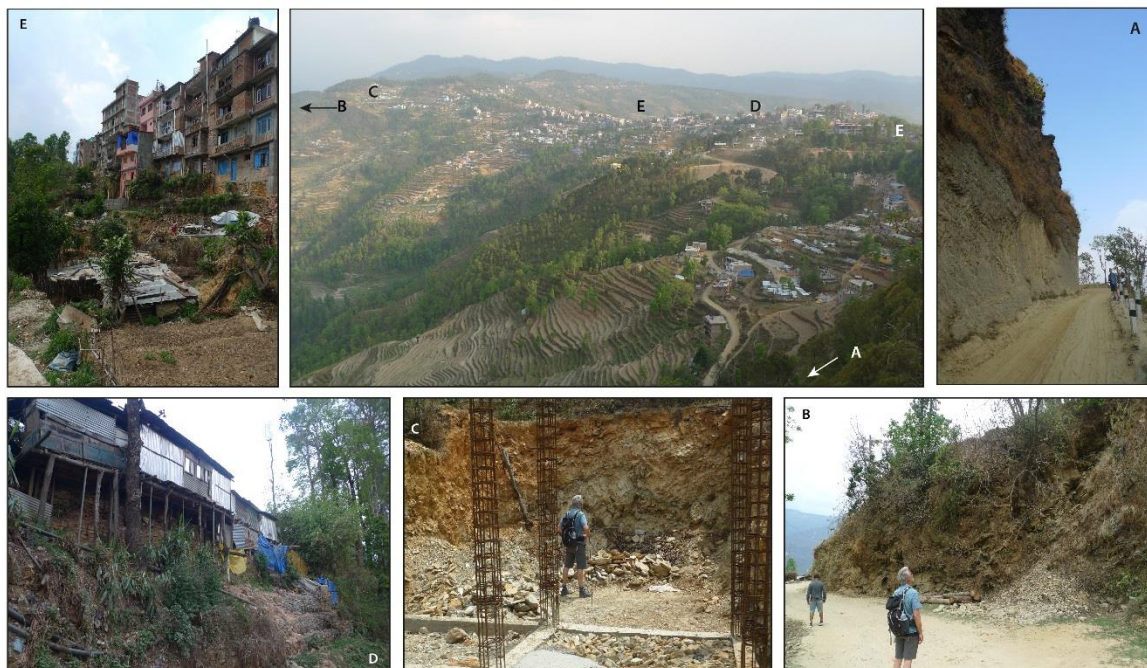
Figure 9. Central image provides a context for the ridge-top urbanised community of Chautara. (A) Vulnerable and exposed access road beneath a steep rock wall to the north of the town. (B) An active landslide at the southern edge of the town. Local people reported that the large block moves every monsoon and impacts the road. (C) Conditions for excavating foundations are challenging. The surface material comprises weathered and fractured bedrock, and has been affected by slope movement. (D) Informal housing at a slope edge, illustrating the challenges of building where flat space is limited. (E) There is a lack of flat building space at the town edge and buildings are constructed several storeys high at the slope edge. British Geological Survey (c) UKRI 2020.

The urban context of Chautara has also led to a shortage of space for building, so that people are increasingly having to build on or close to steeper slopes (Fig. 9D, E). The highly fractured and, in places, weathered nature of the bedrock in Chautara (Fig. 9C) was also reported to be challenge for people digging foundations for their reconstructed homes:
