## *Analysis of historic rammed earth construction*

# Analysis of Historic Rammed Earth Construction

## Volume III

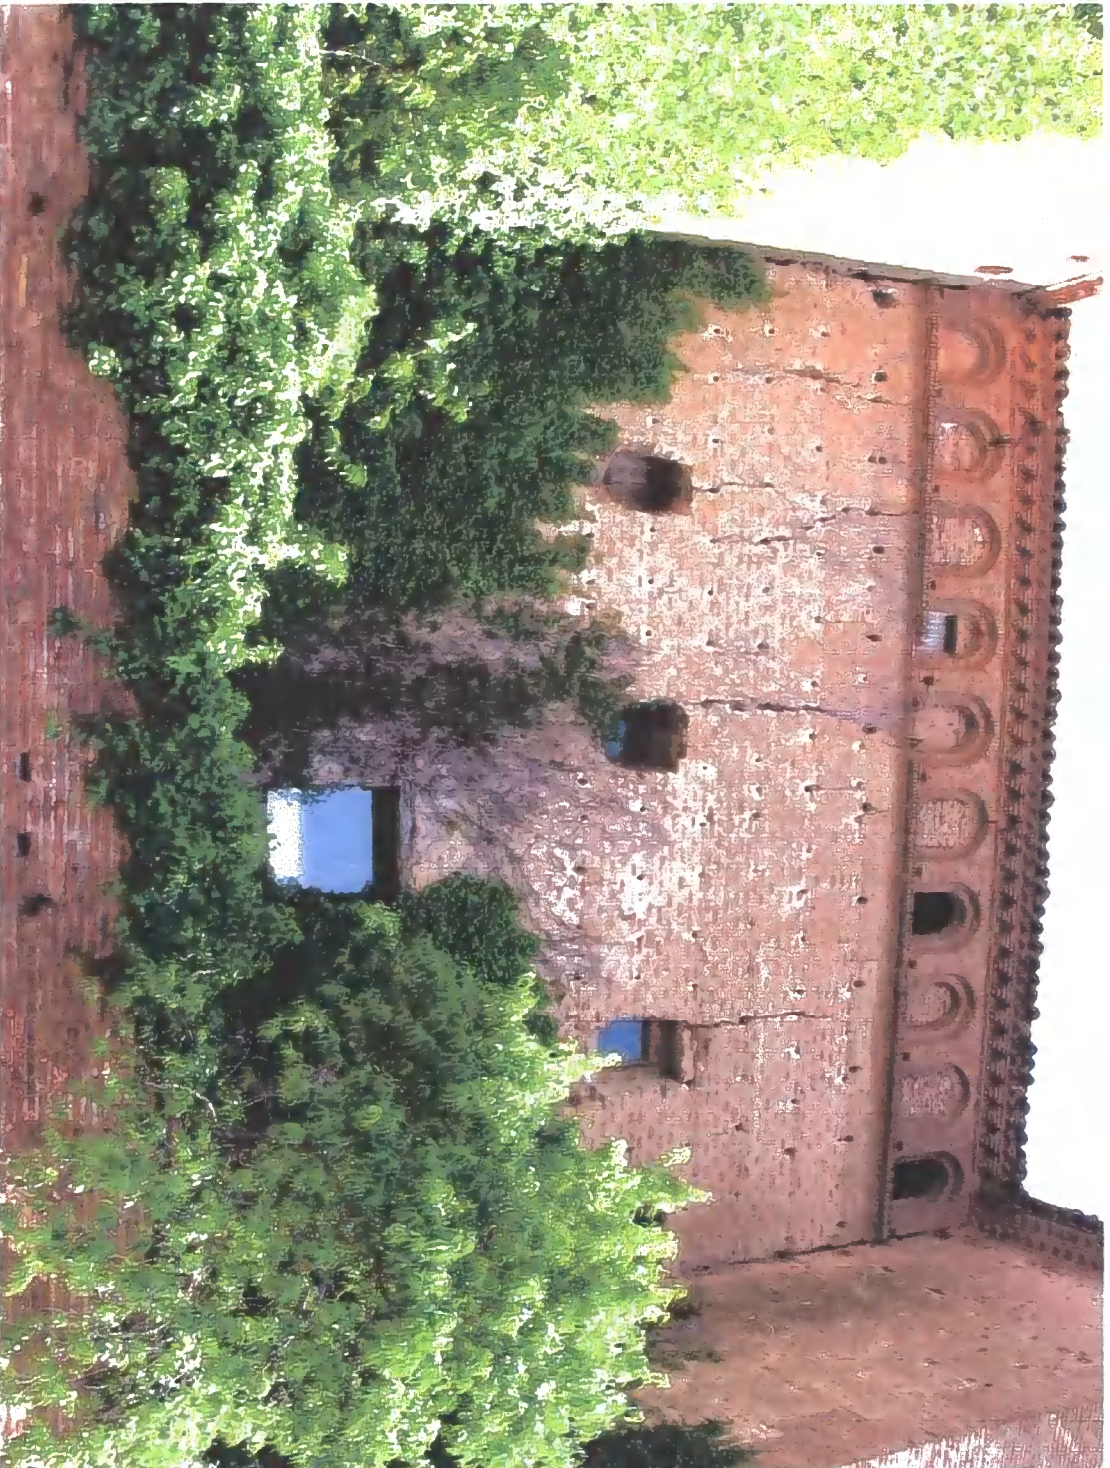
**Figure B.11** Central section of Ambel preceptory. Cracks suggest settlement of north east tower (left)

In Chapter 5 it is argued that the north east corner of the structure is settling with respect to the rest, as evidenced by the cracking pattern on the north east tower (described in Chapter 5, and the cracking pattern on the central section of the building (Figure B.11).

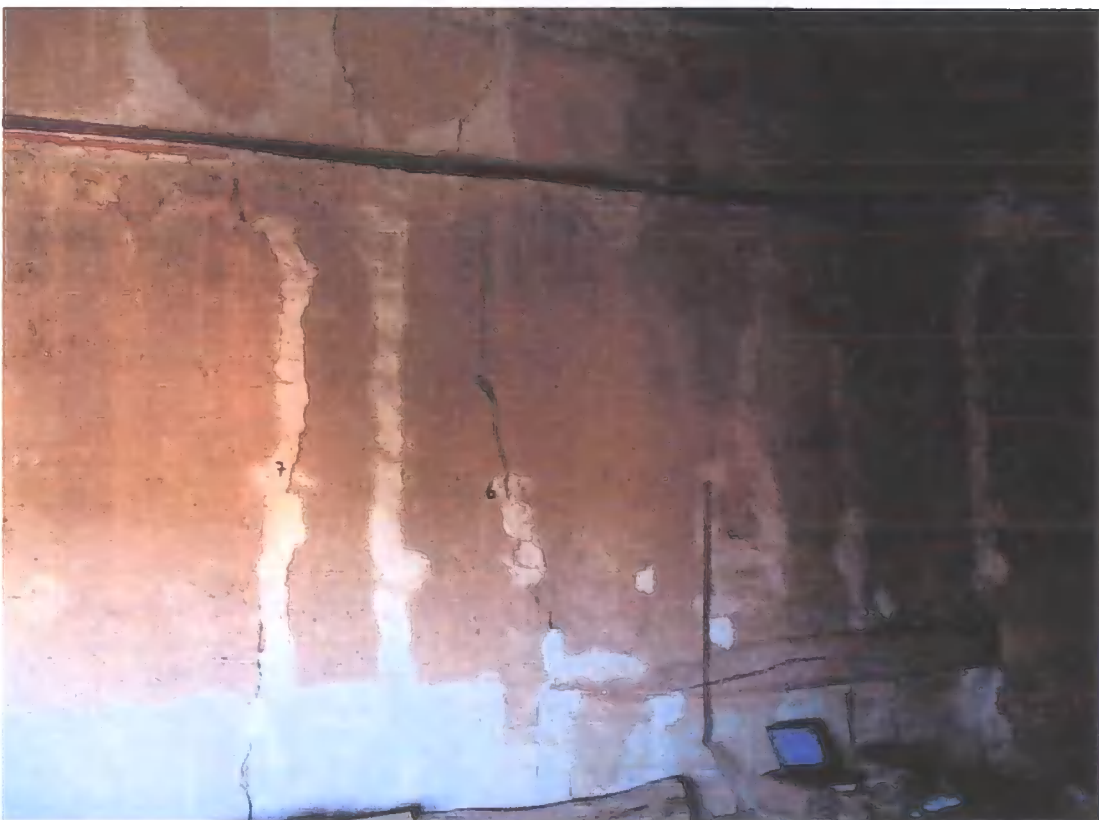
**Figure B.14 Cracks 5 to 7 and timber repair. West wall internal. Roof level of north east tower**

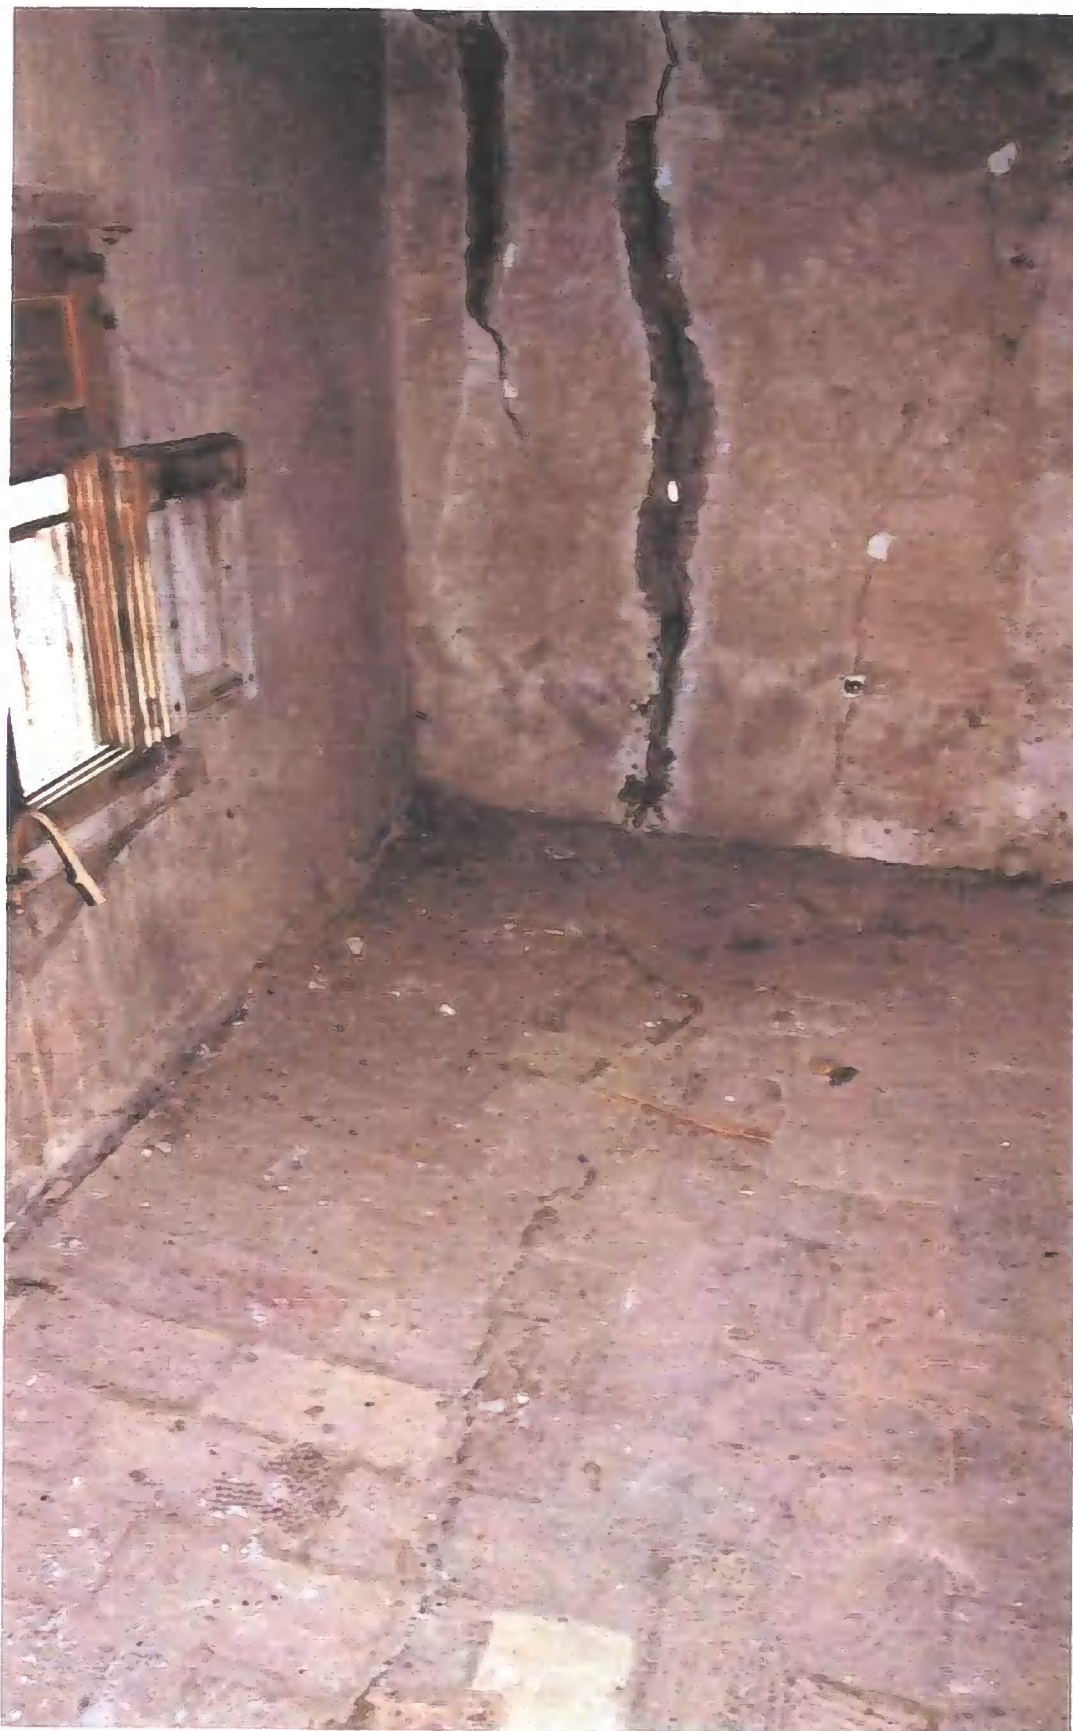
**Figure B.15 Cracks 9 (left) and 10 (right), and gap between floor and wall. First floor. East wall of north east tower**

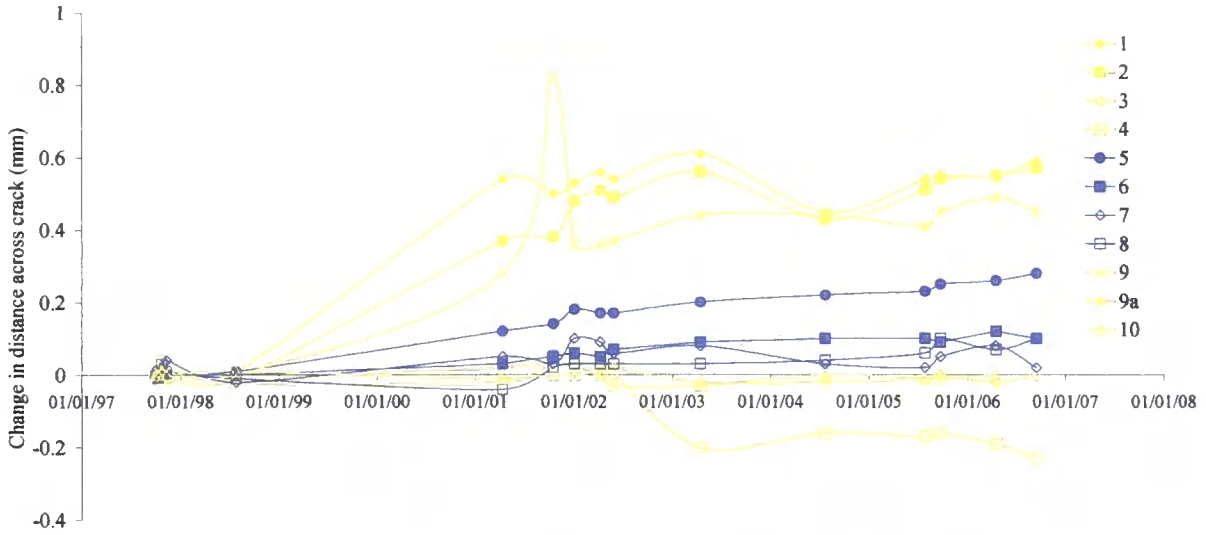
Figure B.16 Crack monitoring data in Ambel north east tower

In the 1960s two families were occupying the site, the building passed to its current owners in the 1980s when crack monitoring was initiated in the north east tower. The crack data is reproduced in Figure B.12 and the location of the monitoring points is shown in Figure B.16. This monitoring showed continued movement of the north wall, and in 2000 tie bars were placed at ceiling level at the ground, first and roof levels, fixed internally by being bolted to the ceiling beams and externally to H bars at the face.

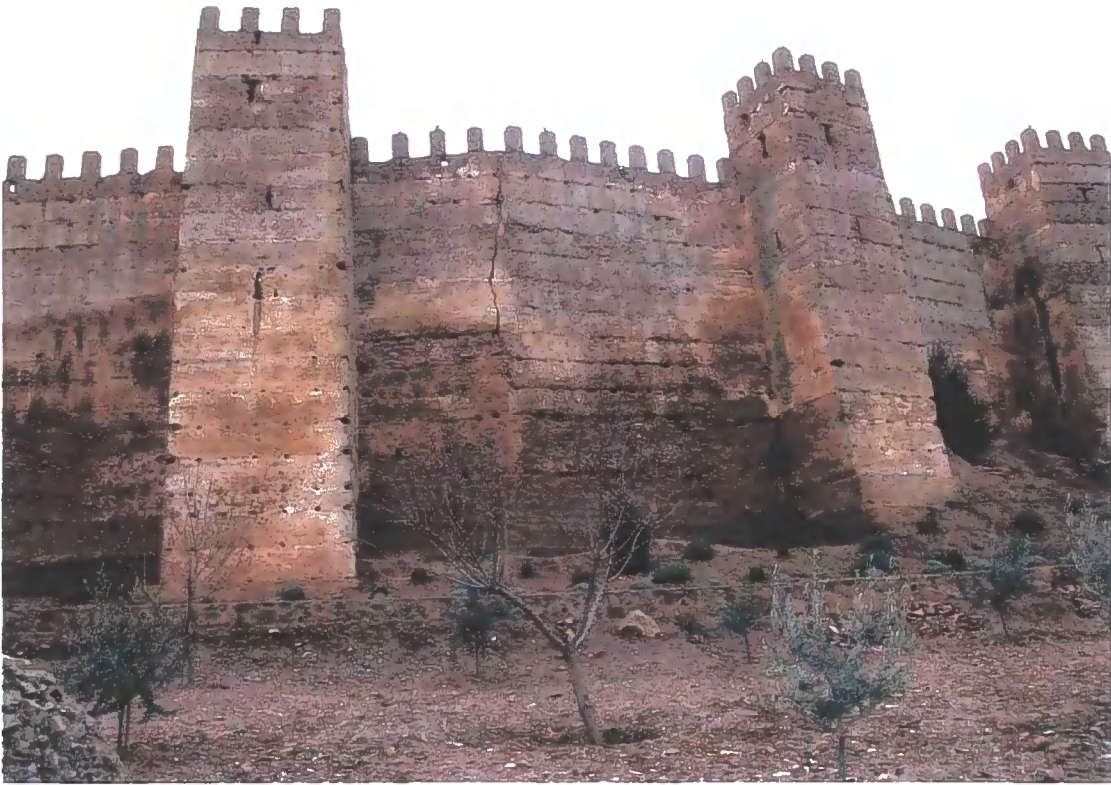
**Figure C.18 Bale Crack between towers 2 and 3, note cement repair at base**

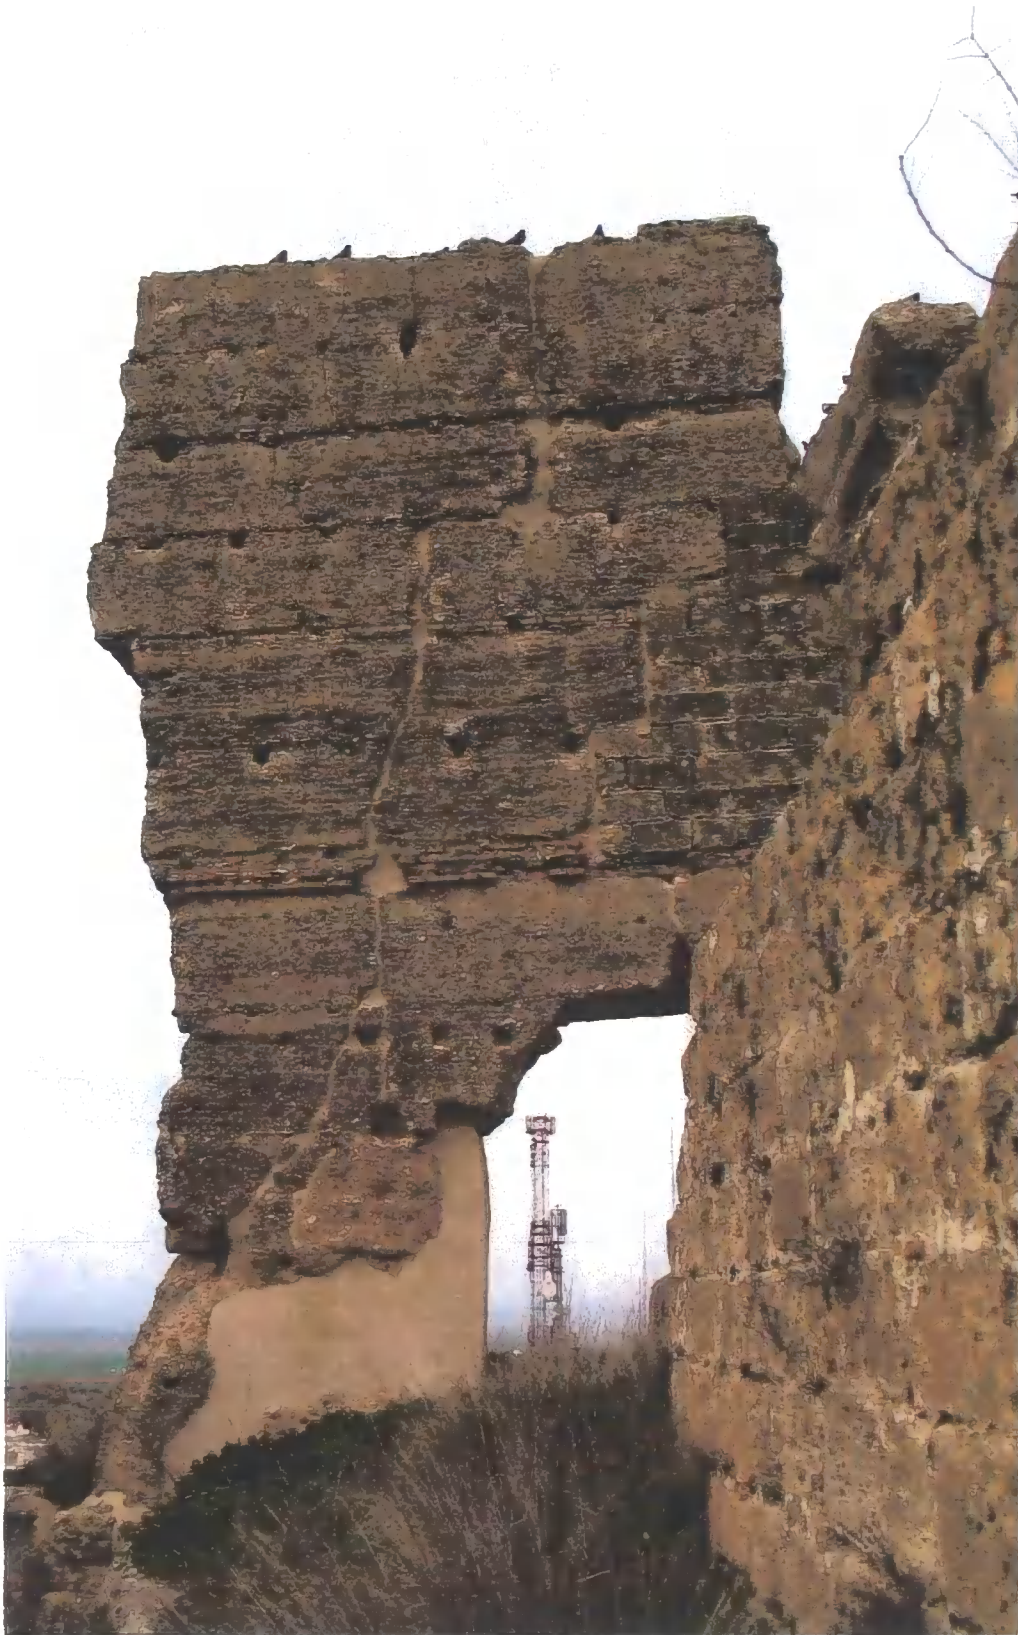
**Figure C.24 Ca1a Earthquake damaged tower, Carmona. Constructed 1502**

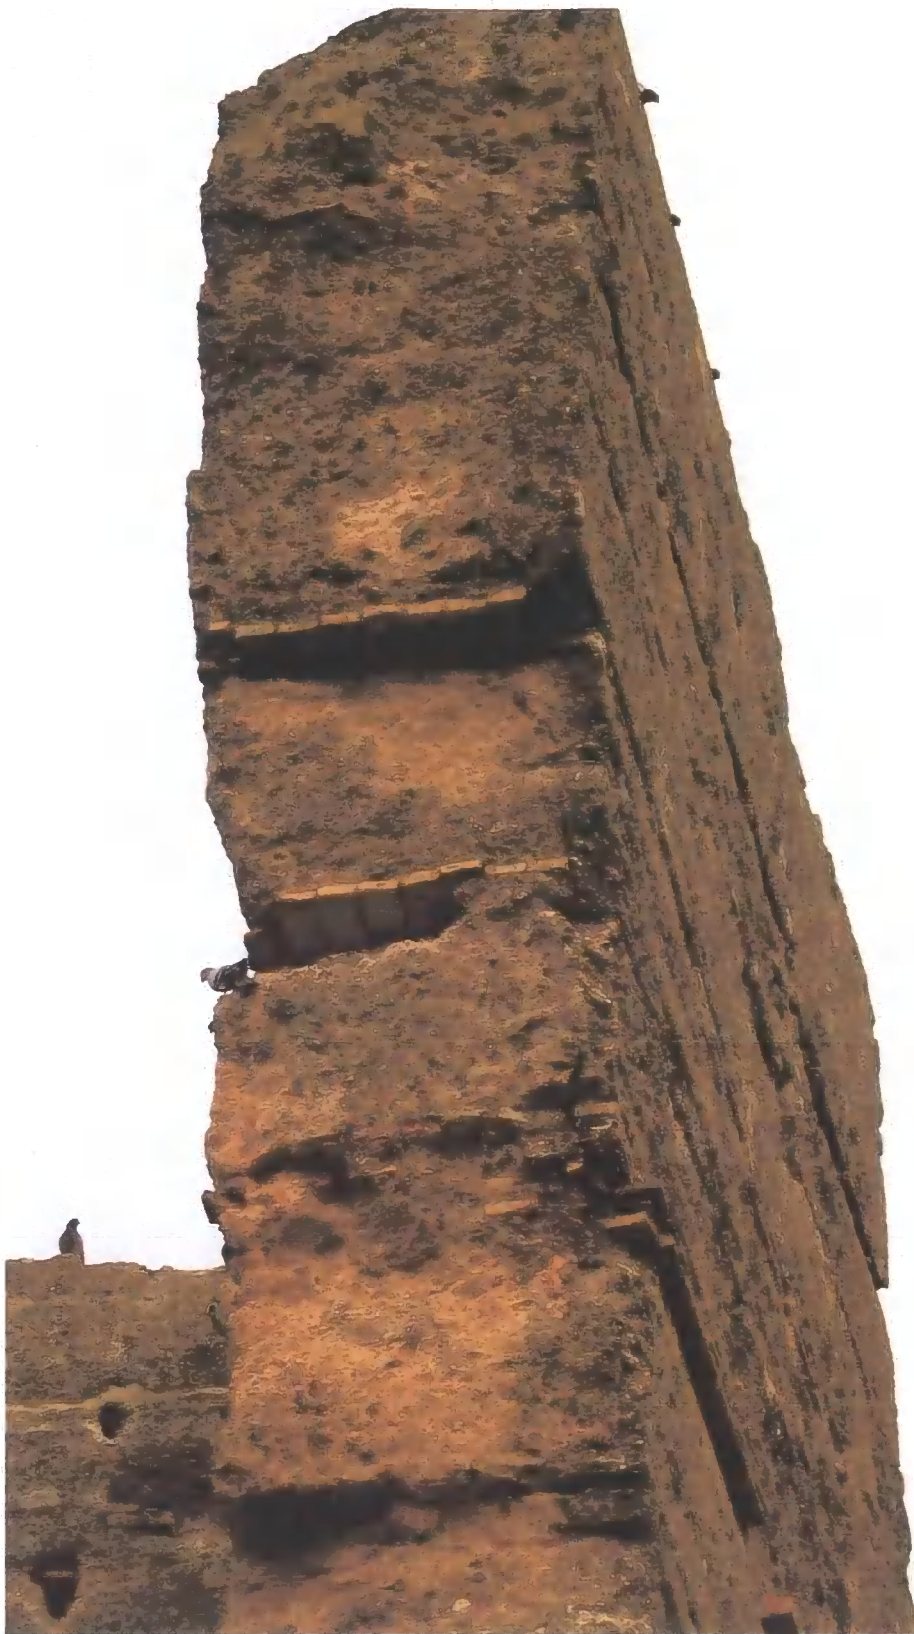
**Figure C.25 Ca1b Bricks over putlog hole**

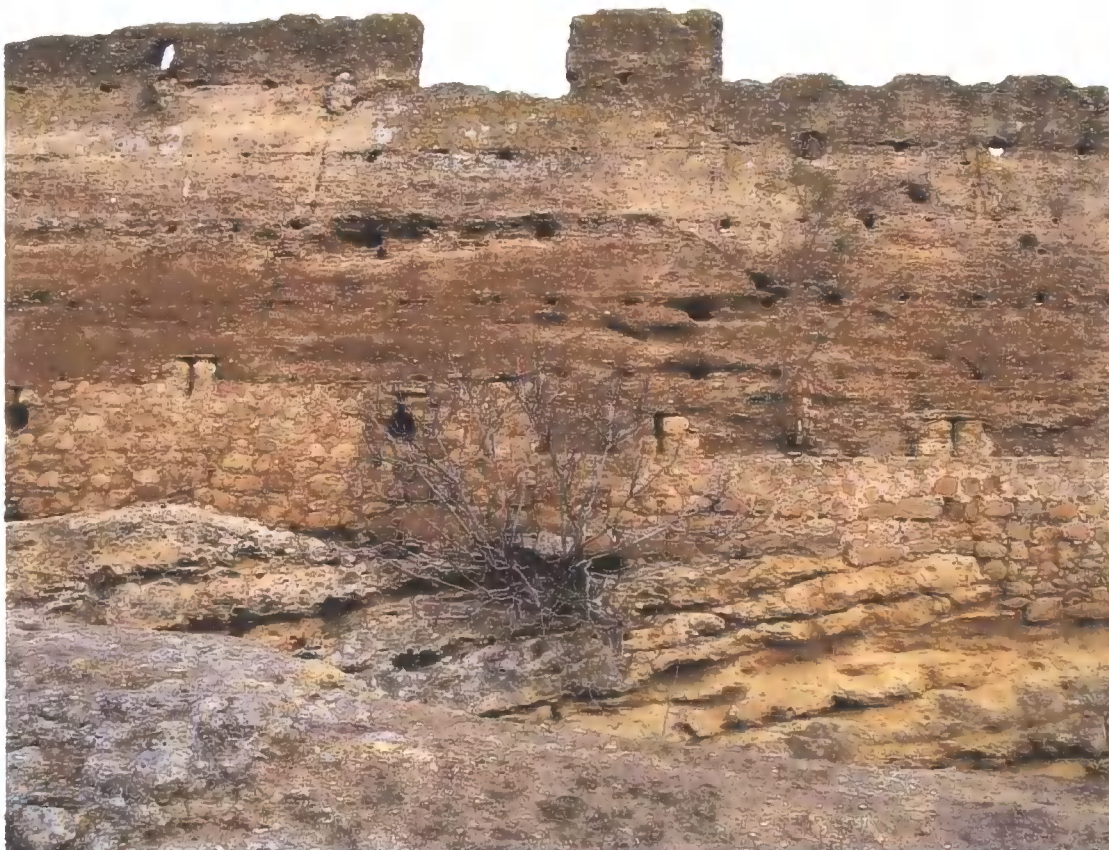
**Figure C.27 Ca3 Exterior wall. Rock foundation with masonry levelling course.**

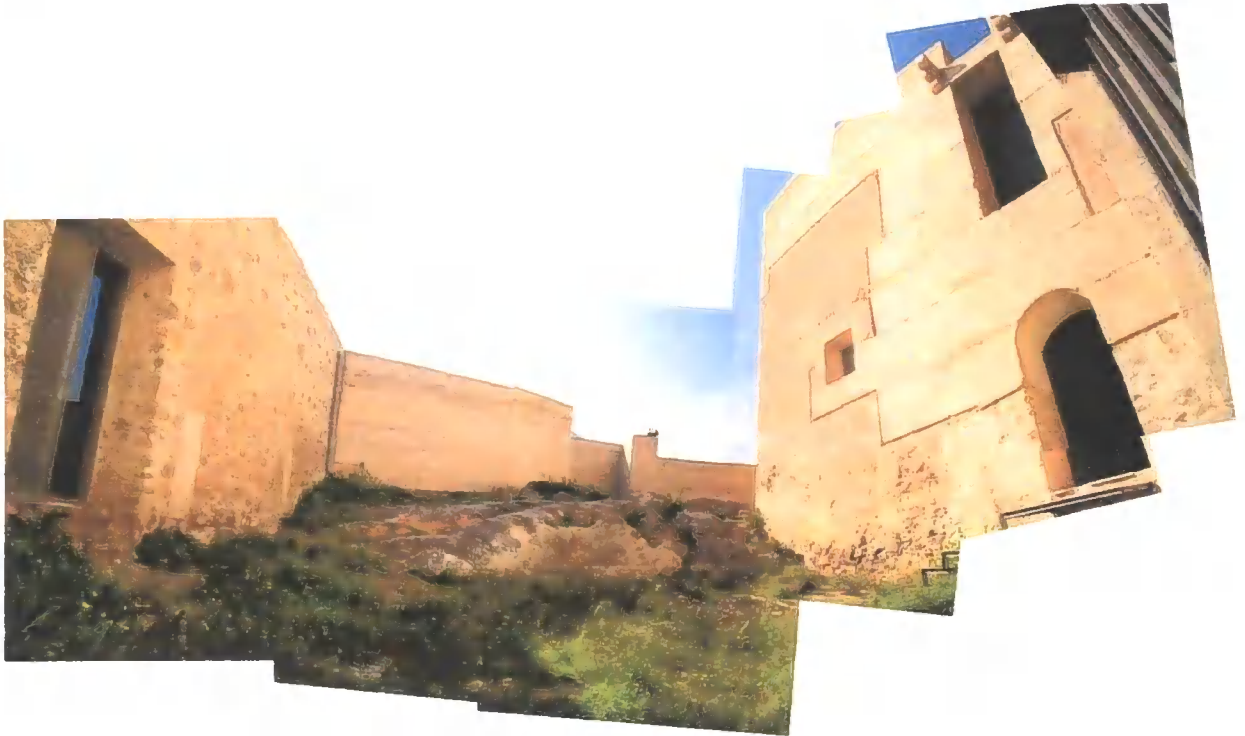
**Figure C.38 Cx1b Internal with concrete repairs**

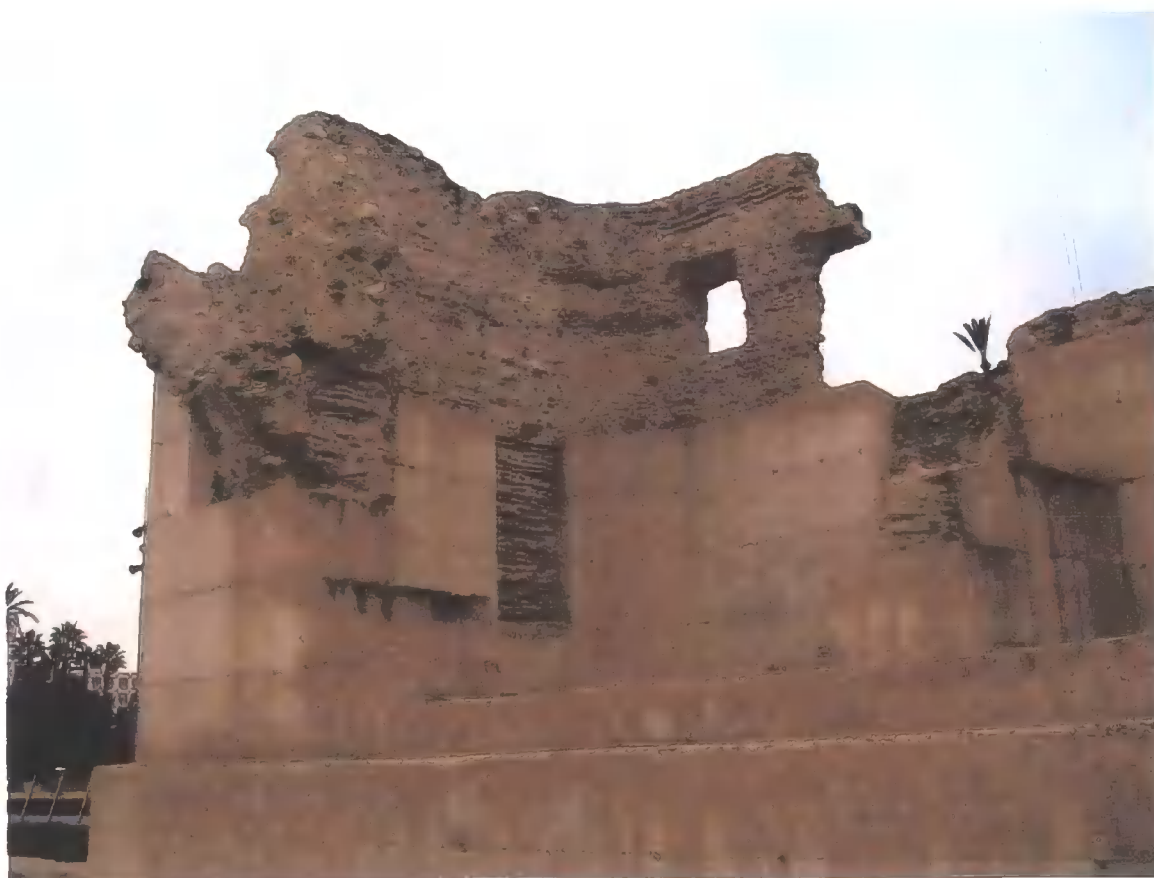
**Figure C.41 E13 Elche consolidated ruins, note concrete repairs**

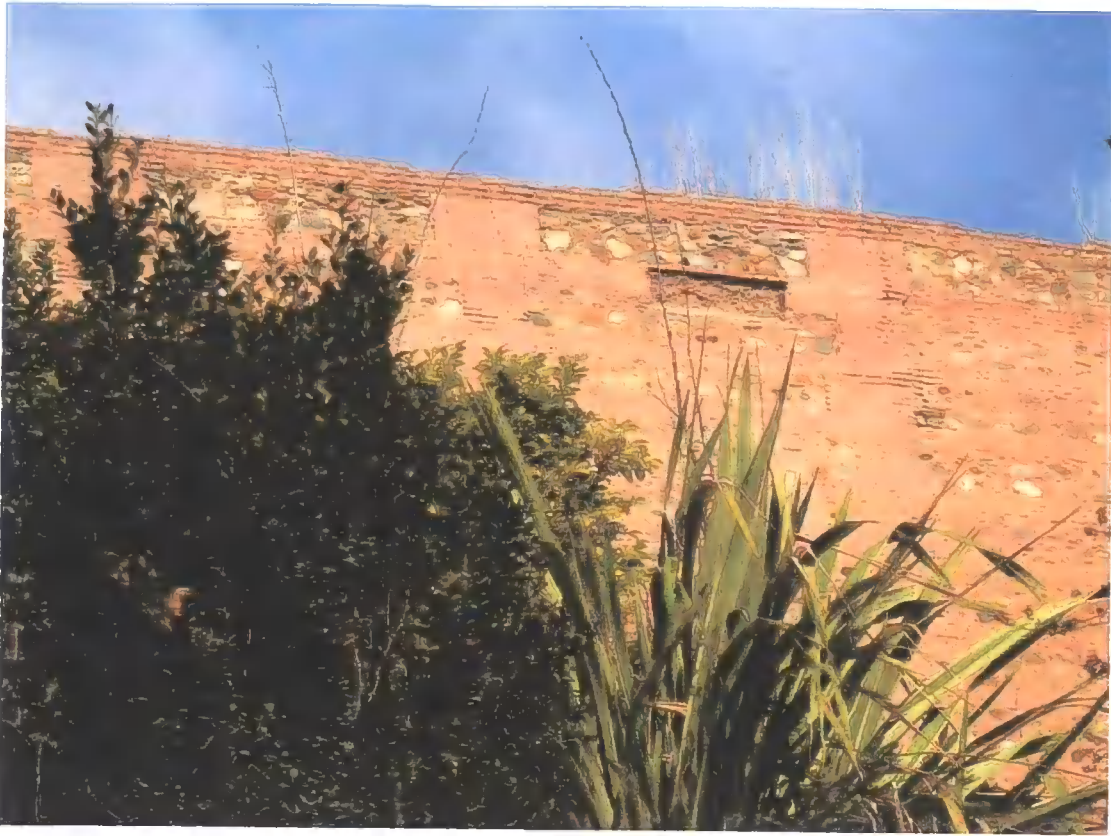
**Figure C.51 Gr4b Nasrid wall repaired**

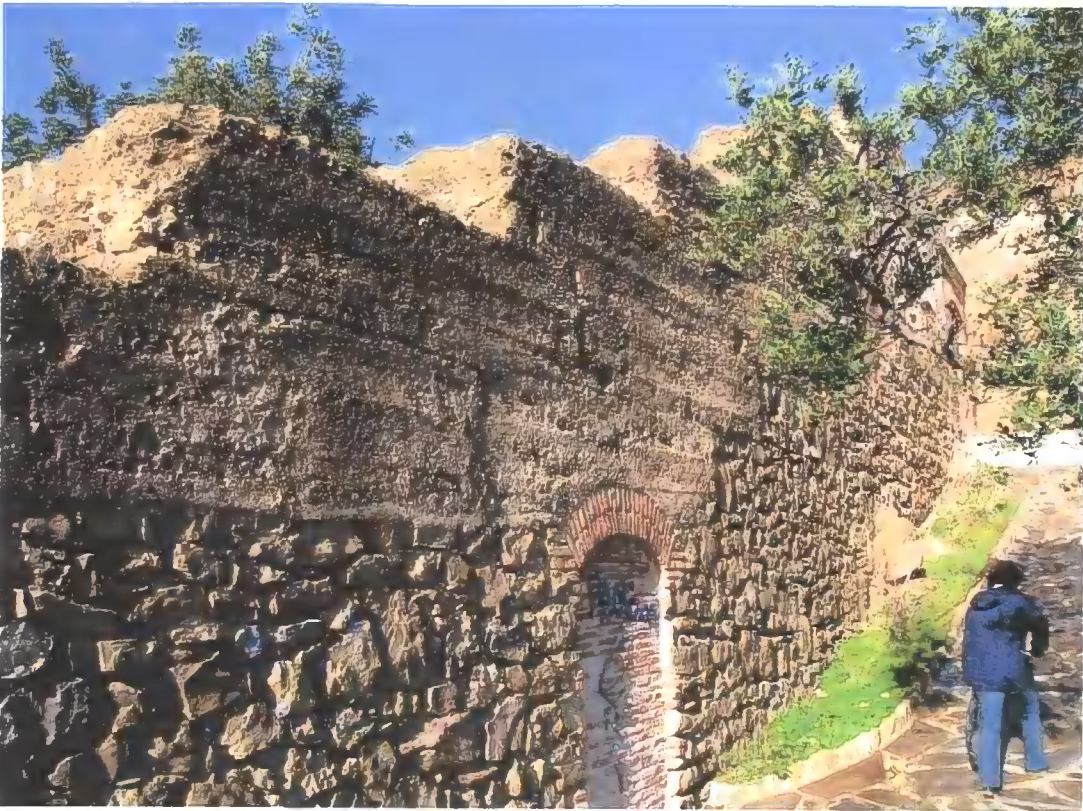
**Figure C.68 Ma1 Rammed earth wall above masonry base**

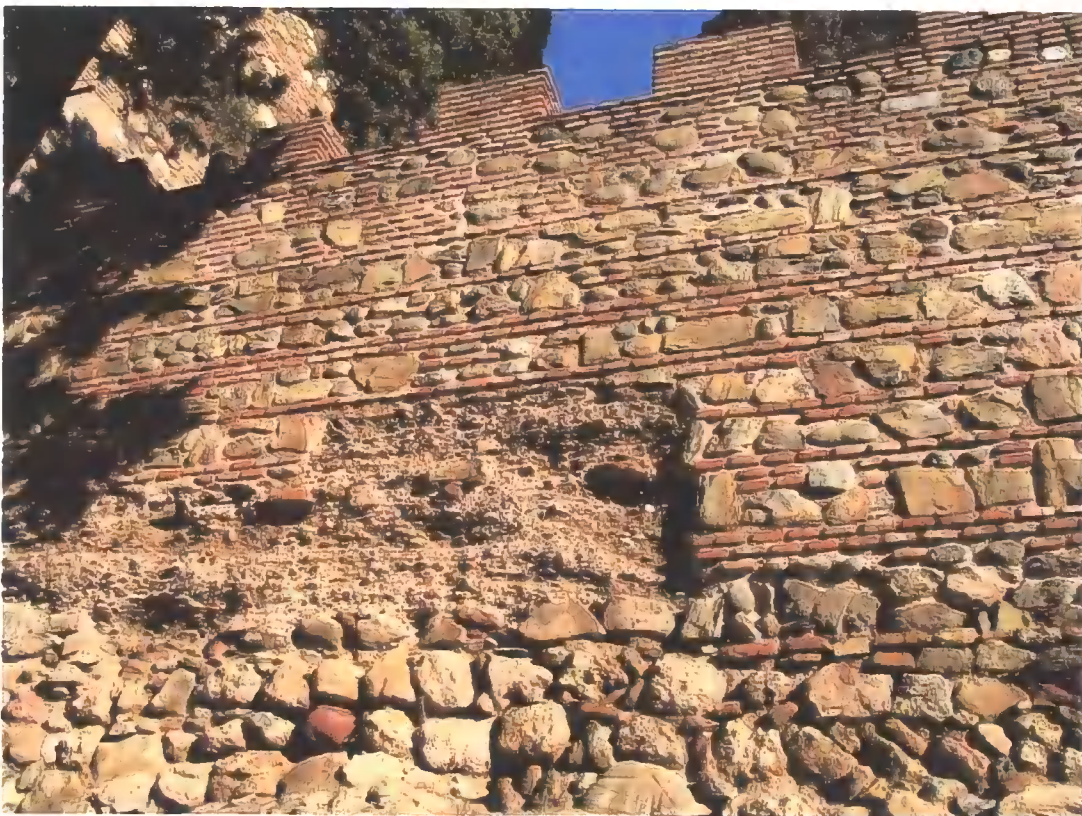
**Figure C.69 Ma2 Brick and stone repair to rammed earth wall**

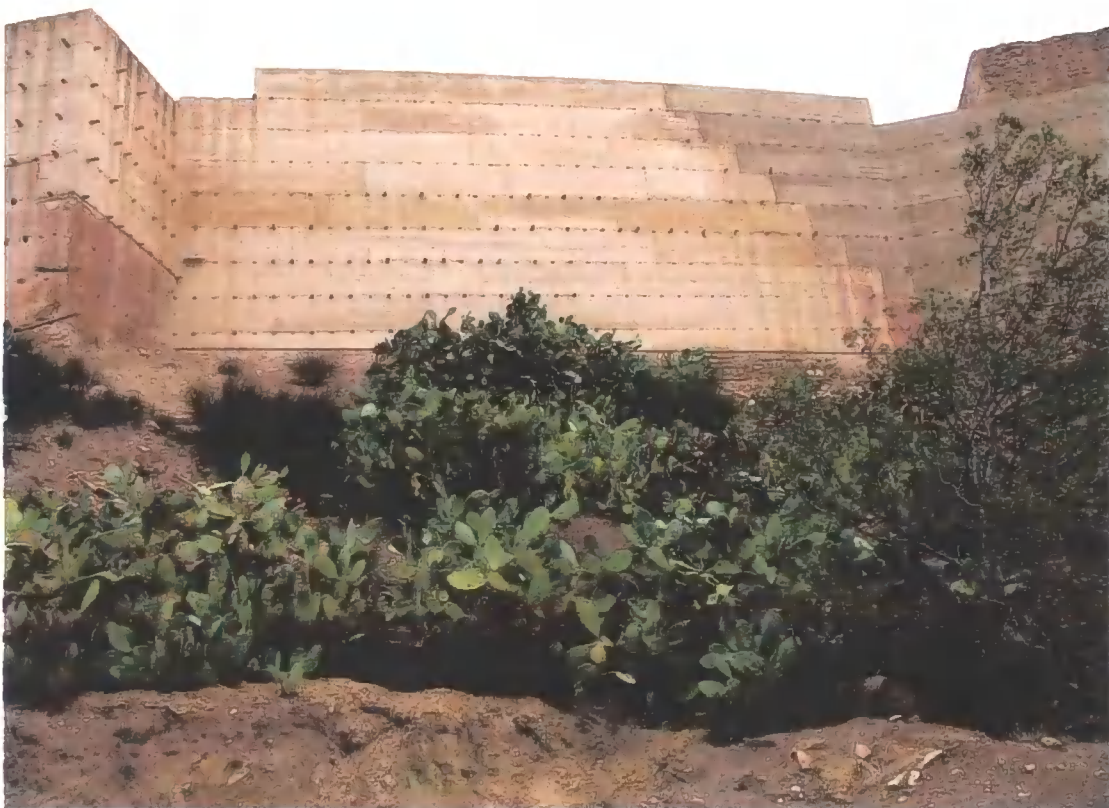
**Figure C.74 No4 Concrete repair to south face of curtain wall**

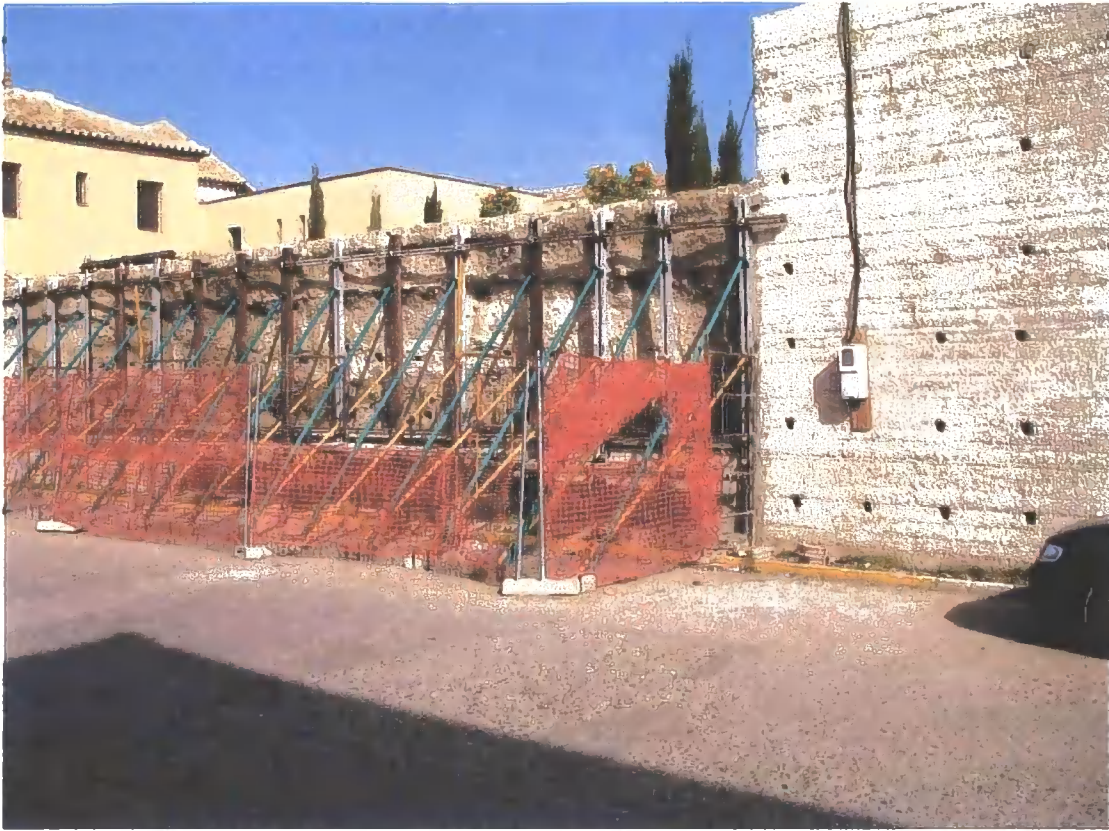
**Figure C.78 Pa3 Concrete facing repair to eroded rammed earth wall.**

The town of Palma del Rio (literally Bend in the River) has a large, ruined *Almohad* castle, which is now used as municipal parking. A rammed earth wall extends from the castle into the present town, and is of original height (Figure C.75). The castle (Pa1, Figure C.76) was constructed during the *Almohad* period (after 1121) but was conquered by Christians in 1231, who repaired part of the curtain wall (Pa2, Figure C.77, Pa5, Figure C.80). An octagonal tower, (Pa4, Figure C.79) now part of a private residence, is built in rammed earth and brick. Concrete repairs to the rammed earth town wall were observed (Pa3, Figure C.78).

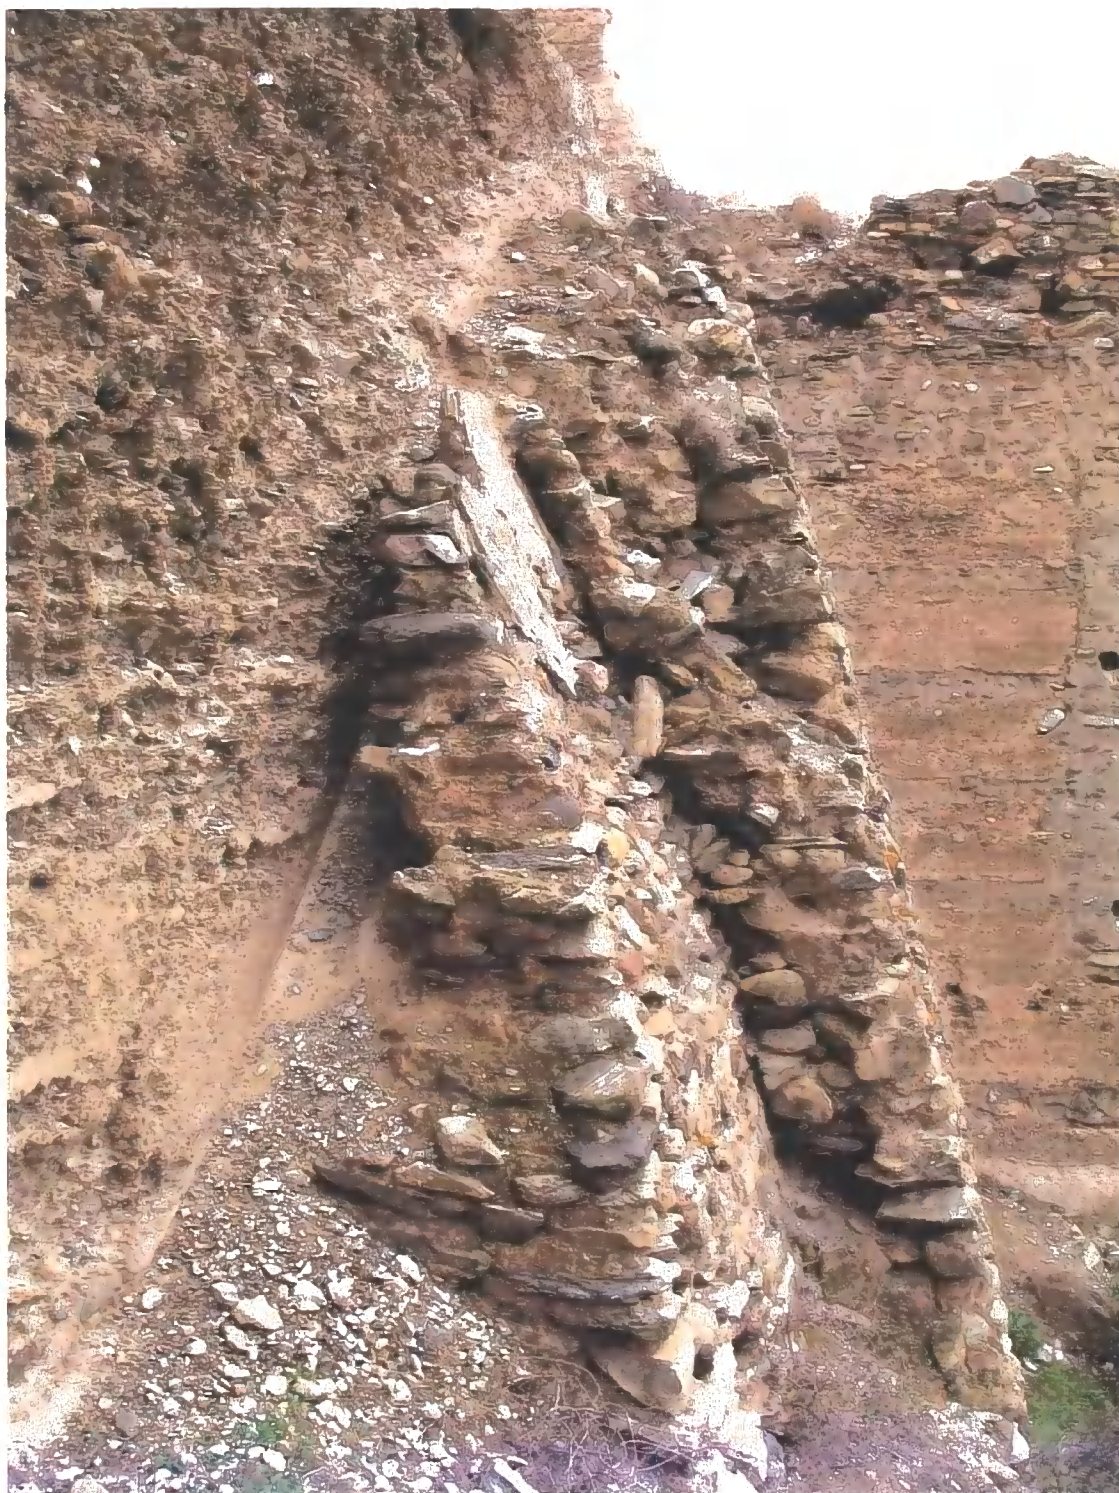
**Figure C.88 Ta1 Rubble facing to rammed earth**

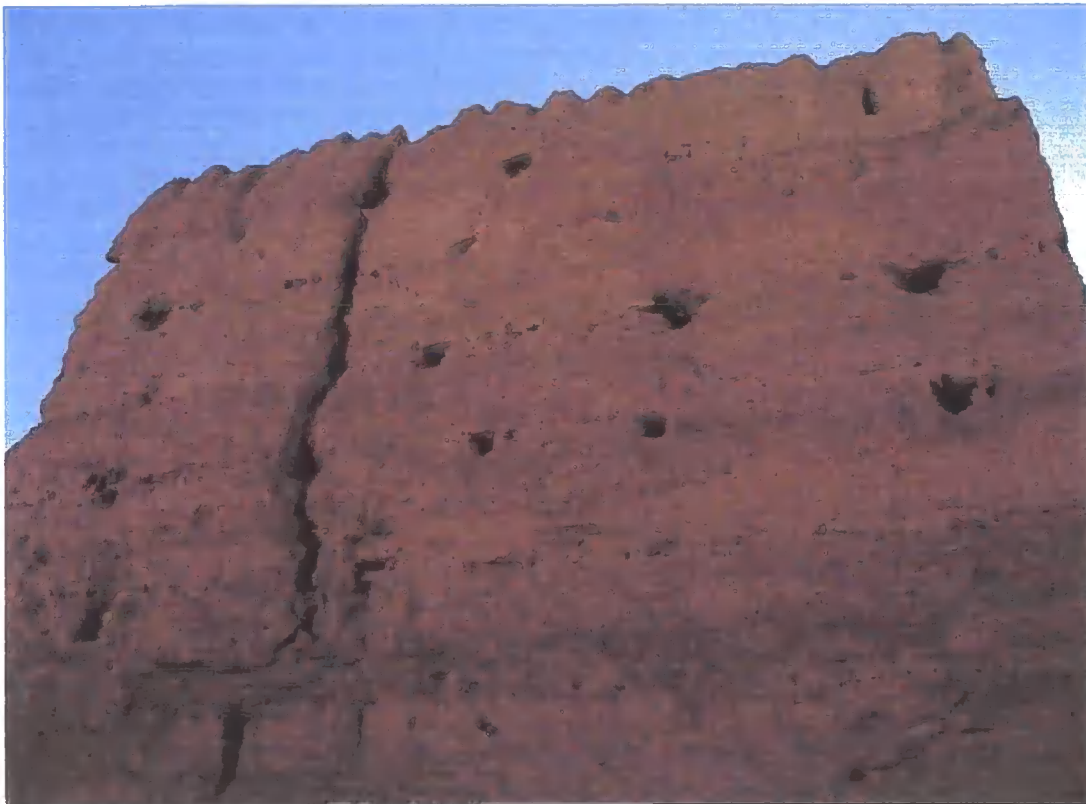
**Figure D.20 Bg1b Basgo crack stitch photograph**

The rammed earth section stands in the centre of the site (Figure D.19), and consist of a mainly ruined set of walls, with no roof structure. A large crack is visible in the face of one of the walls (Figure D.20 and Figure D.21) which was repaired by in 2000 using the methods shown in Figure D.22.
