Assessing the importance of river bank erosion for fine sediment delivery to Bassenthwaite Lake

Assessing the importance of river bank
erosion for fine sediment delivery to
Bassenthwaite Lake

Thesis for M. Sc. (by research)

Durham University, Department of Geography

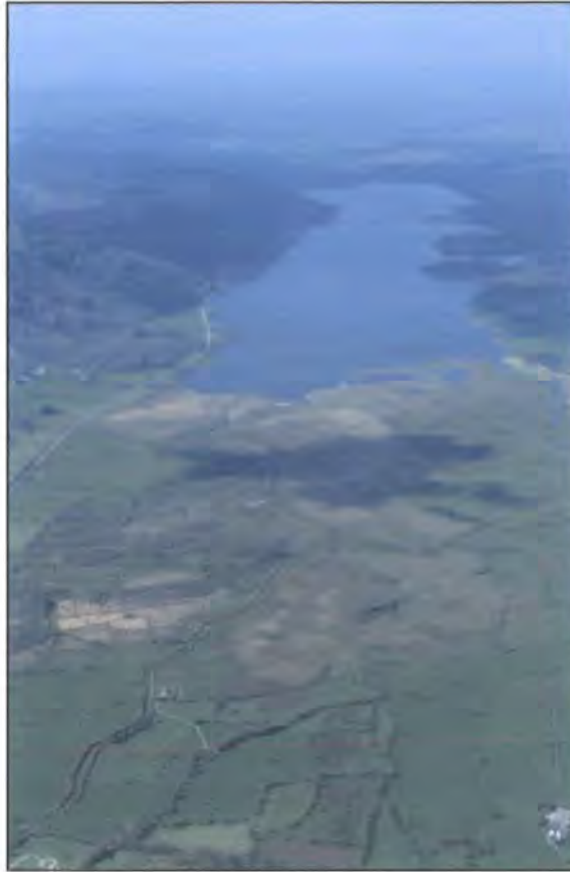
Figure 1.2: Aerial photograph of Bassenthwaite Lake, looking north-west along the lake from above Portinscale. The A66 road is visible on the west (left) side of the lake. The two main watercourses flowing into the lake are visible flowing across the wide floodplain. The River Derwent is visible on the far right of the photograph, flowing into the lake to the east of its former delta. Newlands Beck is visible flowing in an enclosed channel through the large area of marshes in the centre of the floodplain.

Bassenthwaite Lake (Figure 1.2) is located in the Lake District, Cumbria, and is the most northerly of its major lakes, situated c. 5km to the north-west of the town of Keswick. The lake's importance as an ecological habitat, especially to the rare vendace (*Coregonus albula*), is discussed below, and provides the main justification for this project.

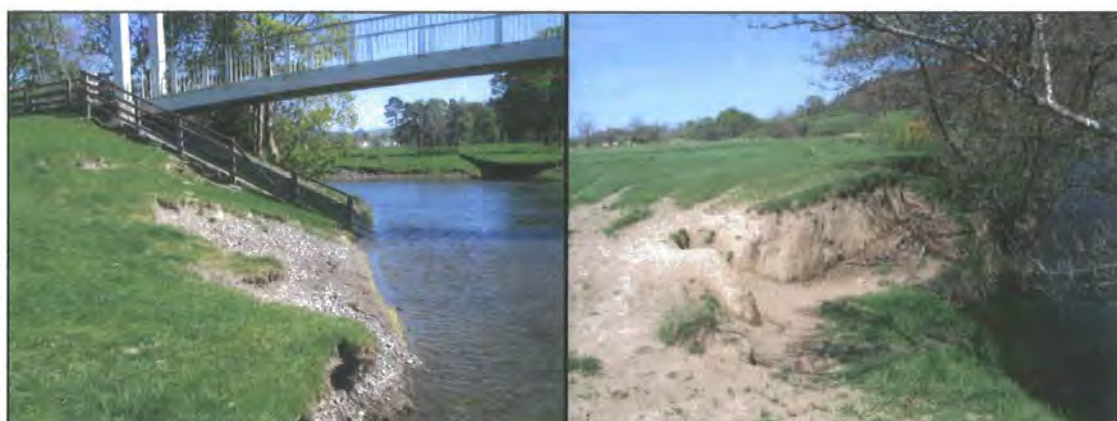
Figure 2.3: Poaching scars at Portinscale (left) and Low Stock Bridge on the River Derwent, Cumbria (right) showing trampled, disturbed fine sediment in areas of grazing.

and Radford 1994). Such scars frequently form on river banks where agricultural land borders the channel (Figure 2.3), and loosened material can be easily entrained by high flows. In some upland grazing areas, including the northern slopes of Skiddaw (Figure 1.3), the installation of networks of drainage channels known as grips has taken place (Figure 2.4) in order to increase the area of grazing land. The erosion of such grips has the potential to contribute fine sediment to the lowland catchment, with additional increases in peak flows following the installation of upland drainage networks (e.g. Conway and Millar 1960, Knighton 1973).

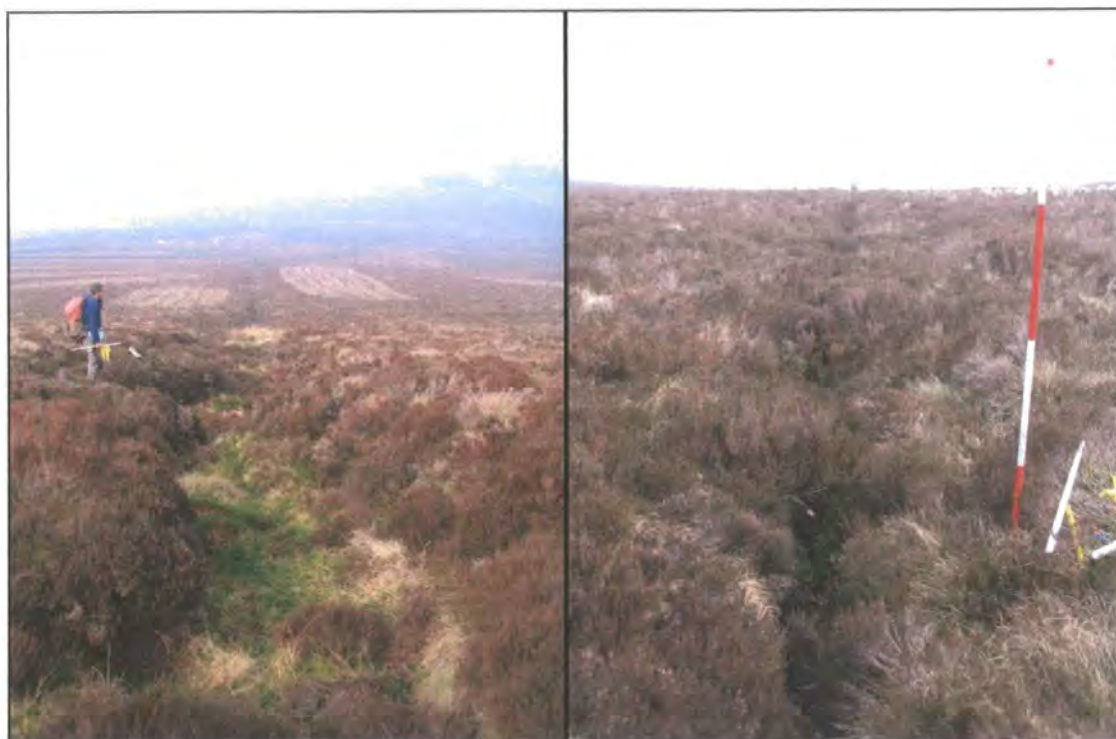
Figure 2.4: Grips at Candleseaves Bog (NY 277 304) near Skiddaw House, showing parts of the network of narrow and deep (maximum depth c. 1m) drainage channels cut into the peat bogs on heather moorland close to the Derwent/Eden watershed.

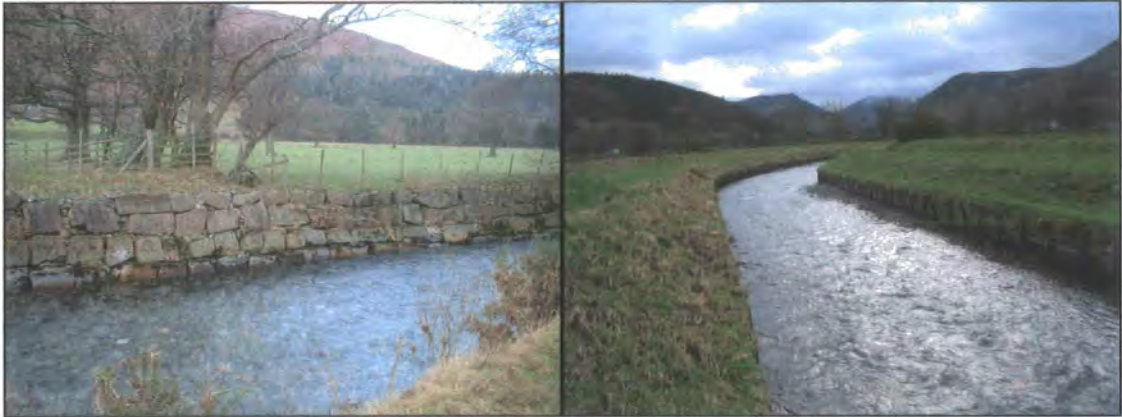
Figure 2.5: Channel regulation on Newlands Beck, showing channel straightening and bank heightening and reinforcement using (left) boulder revetments (NY 238 221) and (right) wooden revetments at Newlands Bridge (NY 240 263).

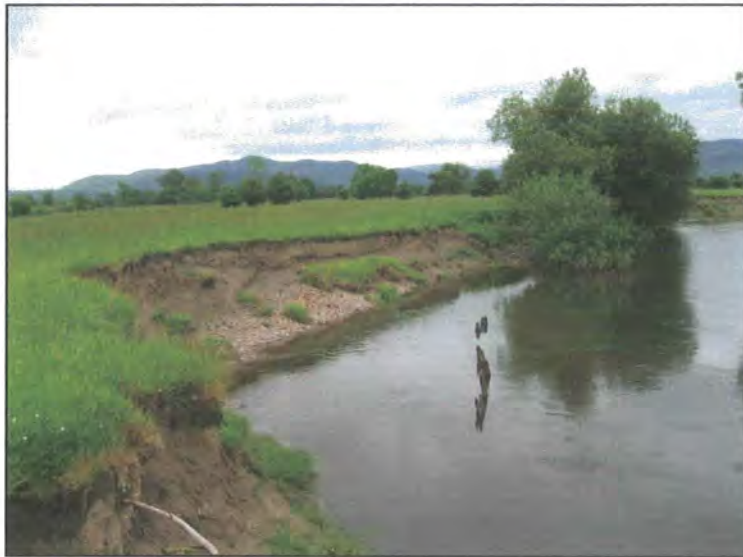
Figure 2.6: A line of ruinous wooden revetments in the River Derwent's channel at erosion study bank 2 near Low Stock Bridge (NY 237 266), showing obvious retreat and erosion of the bank back from the revetments.

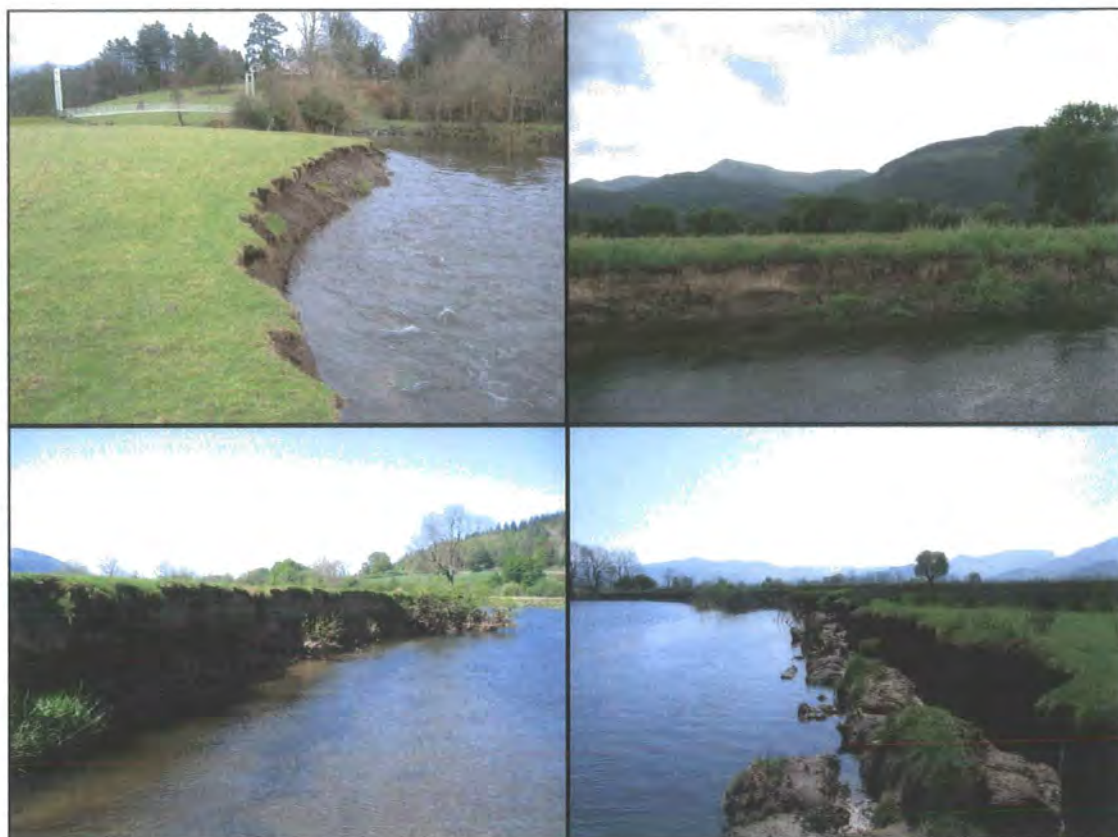
Figure 2.7: Examples of eroded banks on the River Derwent. Top row: at Portinscale (left), upstream of Low Stock Bridge (right). Bottom row: eroded river banks downstream of Low Stock Bridge.

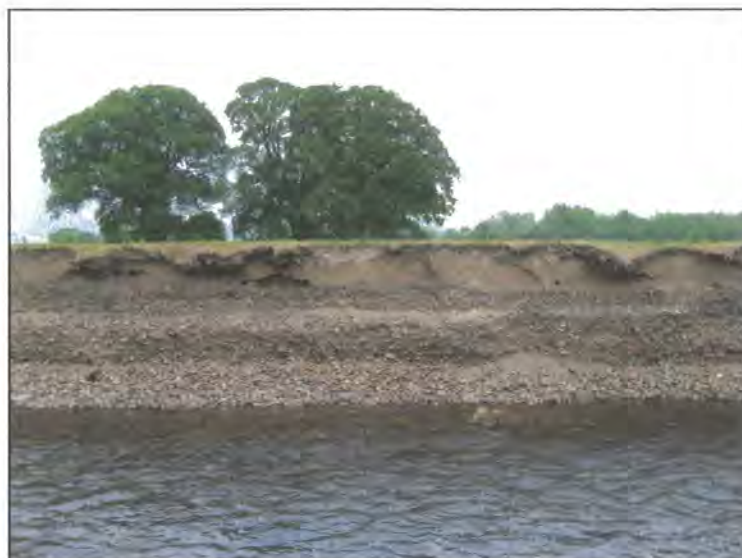
Figure 2.14: A well-developed, eroding composite river bank near Portinscale Bridge (height c. 2.5 m). Note the cohesive upper layer of fine-grained sandy material overlaying a non-cohesive lower layer of coarse pebbles and gravel. The turf slippage and slight overhang development at the bank top, and the steepened profile of the lower bank suggest recent active erosion of this bank.

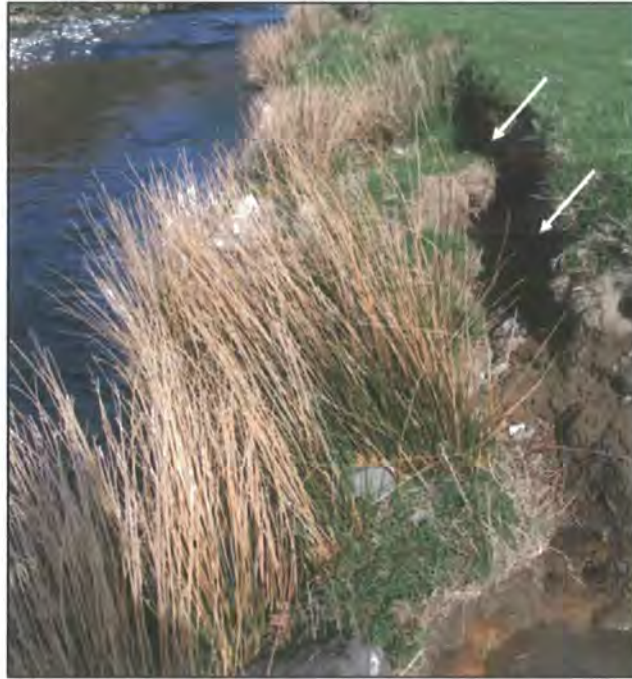
Figure 2.16: Shallow slip failure on the river bank of St. John's Beck, St. John's-in-the-Vale, Cumbria. The failed block has not been further eroded and it remains well vegetated. An obvious tension crack (indicated by the white arrows) is situated between the failed block and the retreated bank face.

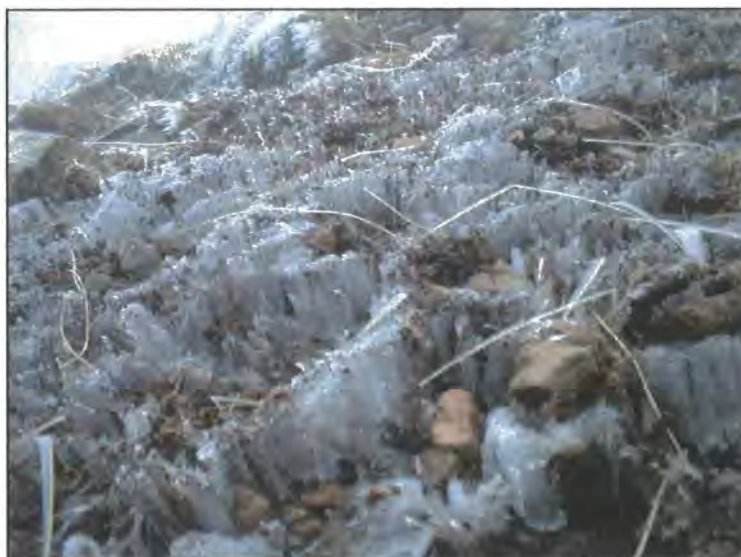
Figure 2.18: Needle ice observed on bare in the upland Bassenthwaite catchment on 26th December 2006. The crystals in the photograph were around 50 mm in length.

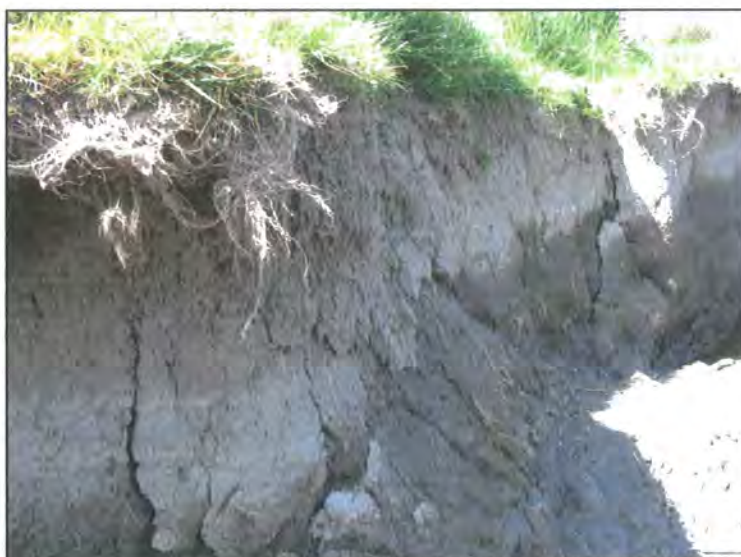
Figure 2.19: A desiccated river bank on the River Derwent near Bassenthwaite Lake, showing a dry and crumbly upper bank with deep cracks in the upper bank surface.

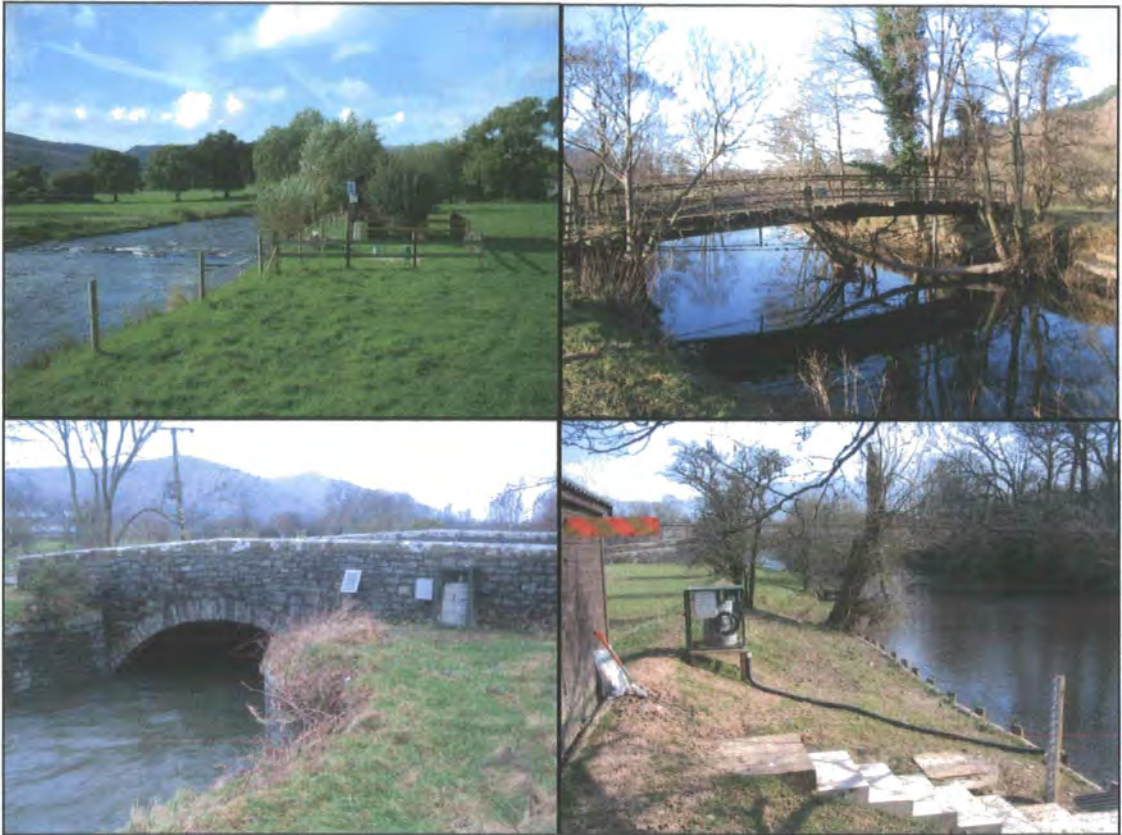
Figure 3.3: Monitoring stations used to collect turbidity data and river water samples:

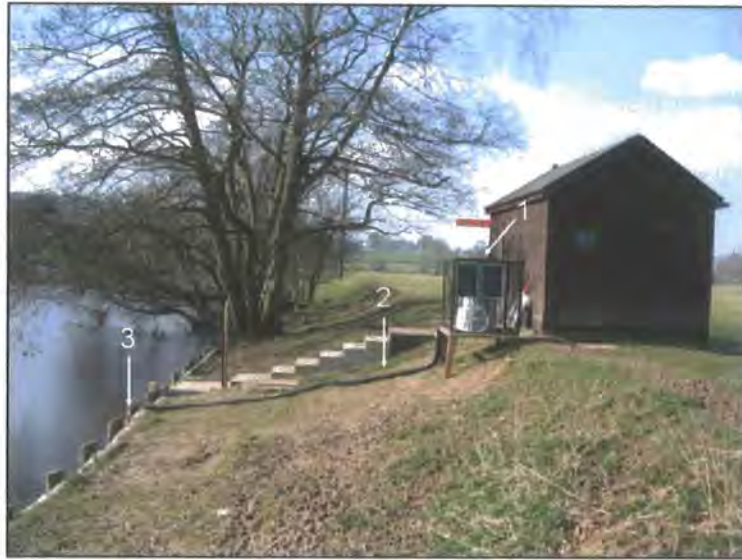
Figure 3.4: Field monitoring station at Ouse Bridge. The elevated cage (1) contains the automatic water sampler and datalogger (not visible). The black pipe (2) leading down the bank contains the turbidity probe wire, water sampler tube, sampler float switch and pressure transducer. The turbidity probe and water sampler tube are attached to the bank face at the stilling well (3). The two solar panels on the cage supply power to the datalogger battery. The hut close to the cage is an Environment Agency river level and flow gauging site, which collects river stage and discharge data.

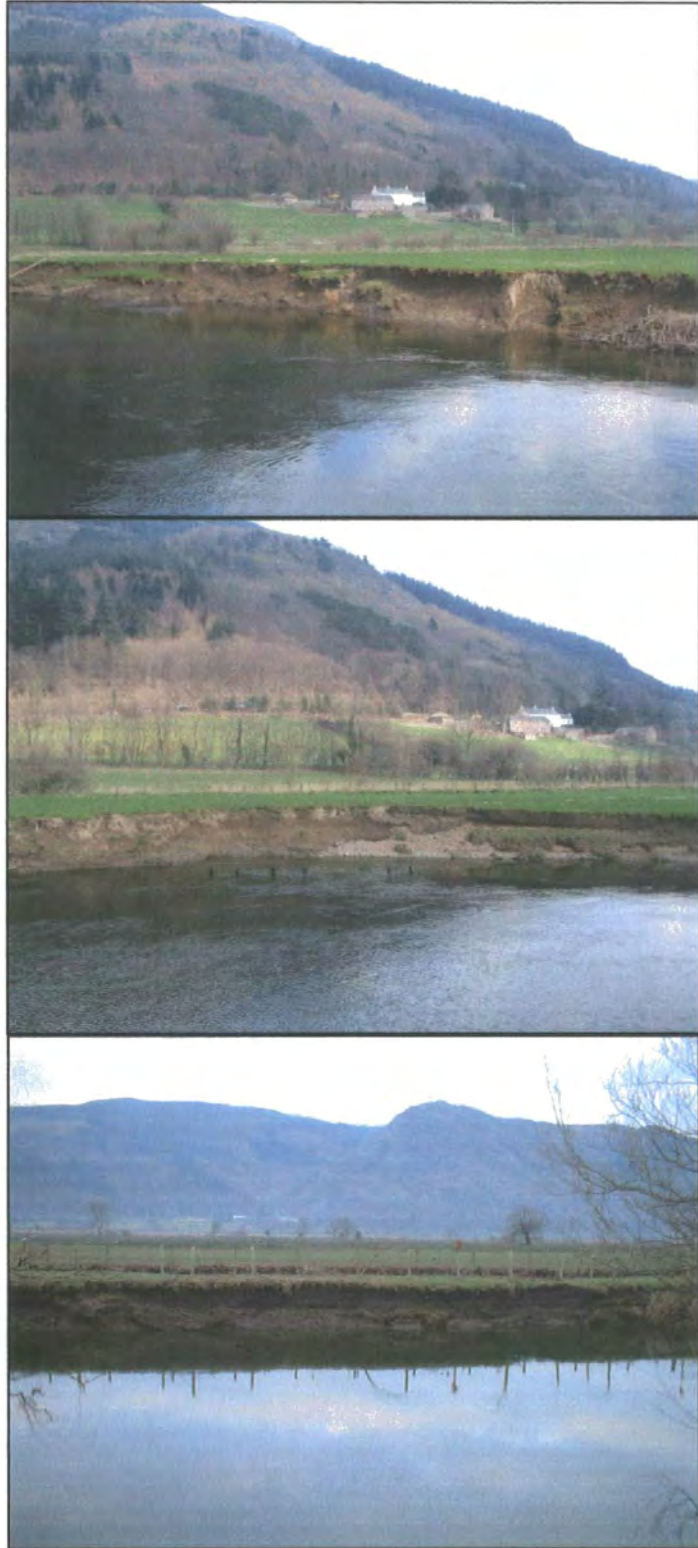
Figure 3.7: The three river bank sections analysed in the river bank erosion study in this project, showing bank 1 (top), bank 2 (middle) and bank 3 (bottom).

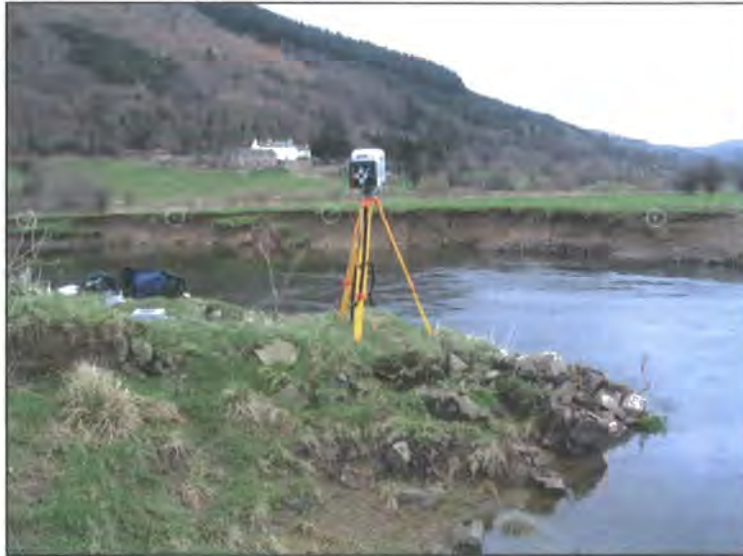
Figure 3.8: The laser scanner taking the first base scan of river bank 1, 13th March 2007. The laser scanner is mounted on the yellow tripod. The scan targets used for referencing the scans are indicated (circled).

Before the erosion study began, reference points for scan comparisons were installed at the erosion sites. Threaded rods (c. 1 m length, 20 mm diameter) were inserted into the river bank faces, onto which reference targets (200 mm x 200 mm) were mounted during scanning (Figure 3.8). Twelve reference points are used at the sites, with five used at the longest bank reach (bank 1), four used at bank 2 and three used at bank 3. The scanner was set at a resolution of 30 mm at a distance of approximately 20 m from the surface being scanned.

The base scans for the bank erosion study were carried out on the 13th March 2007 (Figure 3.8). To carry out a bank scan, the scanner was set up on the opposite river bank, which enables the clearest view of the surface to be scanned (Figures 3.8). The laser scanner firstly scans the reference points at each bank section, before carrying out a detailed scan of the whole section. One

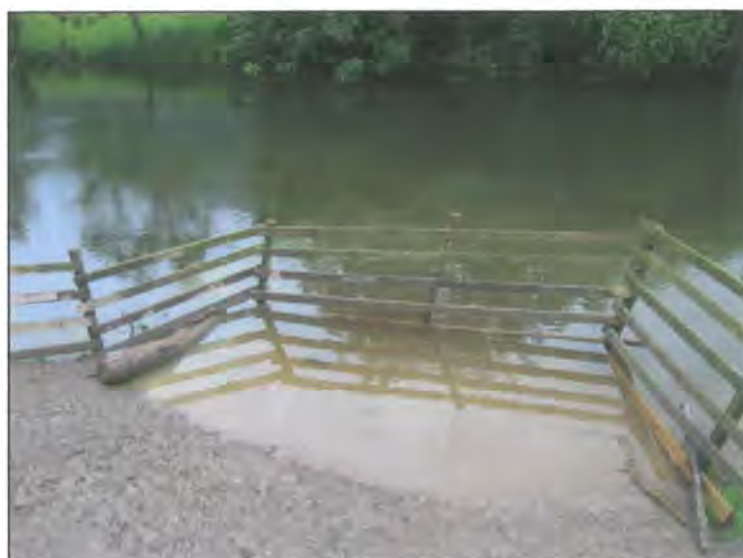
Figure 4.11: Suspended sediment addition to the River Derwent from an area of bare soil in the large poaching scar c. 150 m upstream of Low Stock Bridge (NY 244 257) following heavy rain, 22nd June 2007.

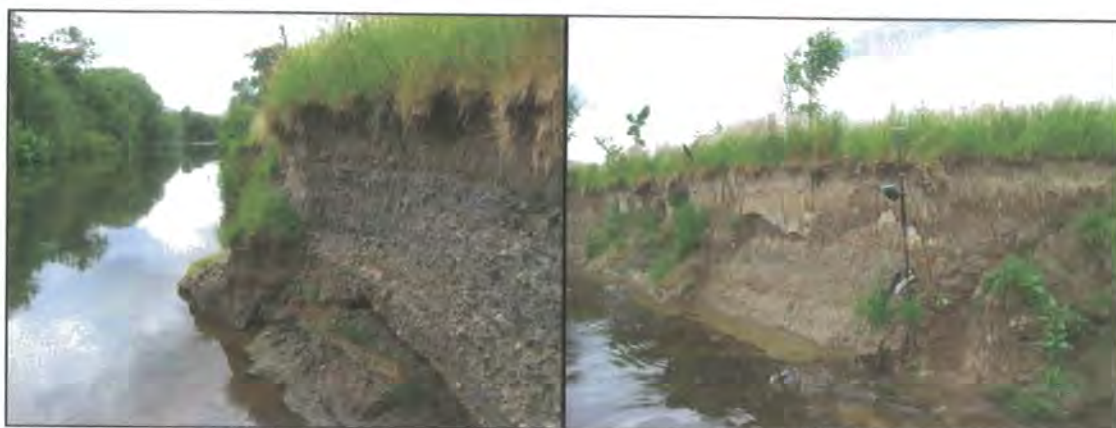
Figure 4.15: Comparison of river bank composition between High and Low Stock Bridges: a composite bank with a thick non-cohesive layer (left), and an almost completely cohesive bank (right).

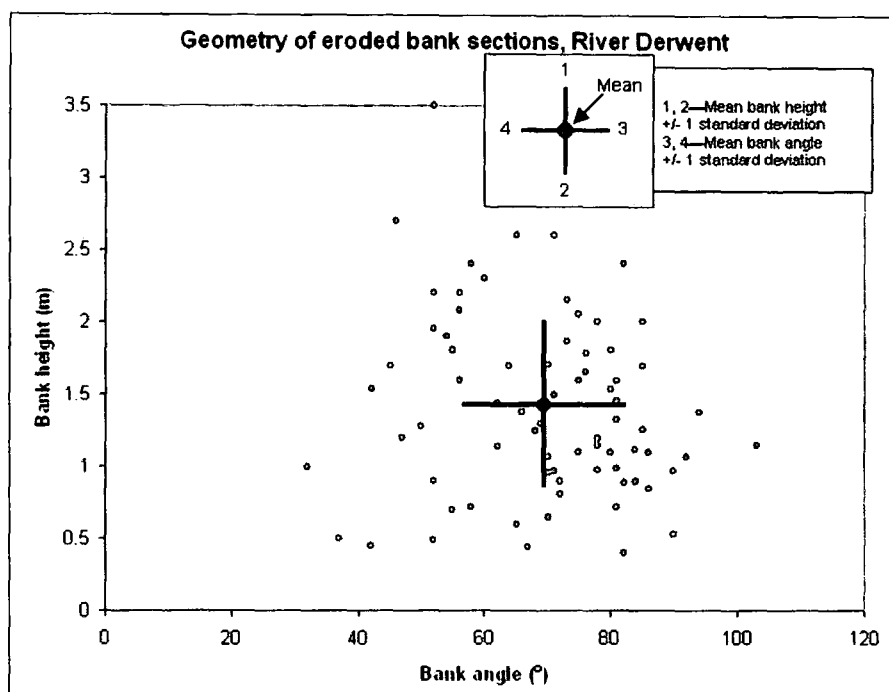
Figure 4.16: The geometry of eroded bank sections measured on the River Derwent, showing average geometry and centroids.

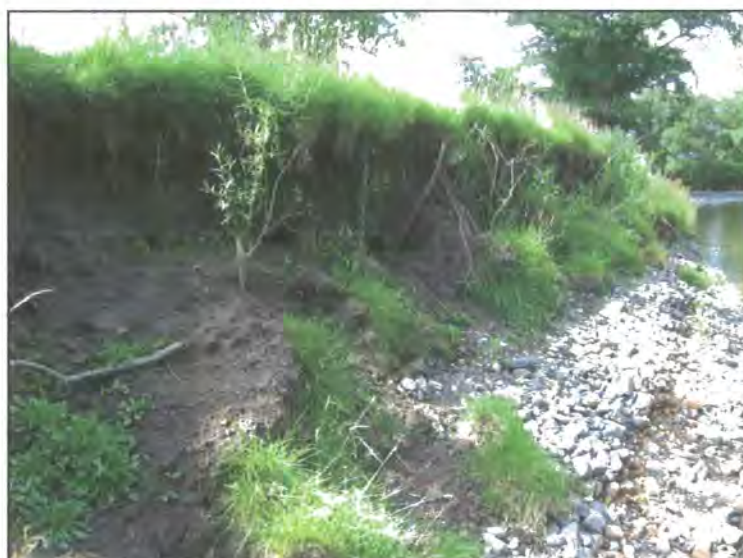
Figure 4.20: Bank 2 (West bank, NY 255 237, looking downstream).

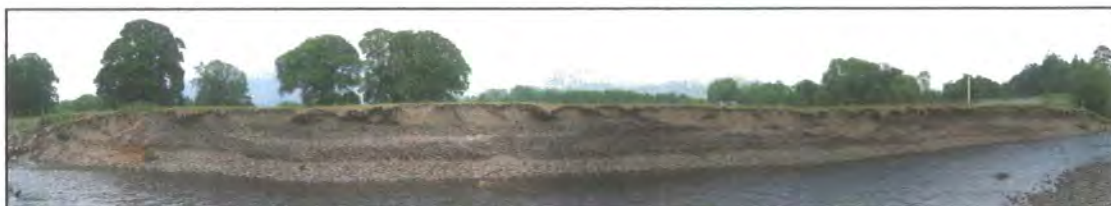
Approximately 80 m downstream of Portinscale suspension bridge is a 49 m eroded bank section (bank 3, NY 252 238) (Figure 4.21). The river bank is a classic high (maximum height = 2.08 m) composite river bank, with an upper layer composed of fine-grained silt and a lower layer of gravels. The river bank face has undergone several changes in form, as high river flows have eroded the talus slope at the bank foot and caused retreat of the lower bank, causing oversteepening (Figure 4.22). Active block failures have been observed on the bank throughout the course of the fieldwork, with the frequent delivery of cohesive material from the upper bank to the bank foot (Figure 4.23). Much of the upper bank is therefore considerably undermined, with extensive overhang development and turf slippage. The maximum undercut depth is 700 mm, suggesting considerable instability of the upper bank. Therefore, significant undermining of the upper bank is the key destabilising influence on this bank.

Figure 4.21: Bank 3 (East bank, NY 252 238, river flow right-left).

The composite river bank structure, which favours high erosion rates on the lower bank (Section 2.6.2.2), is also a contributing factor towards bank failures.

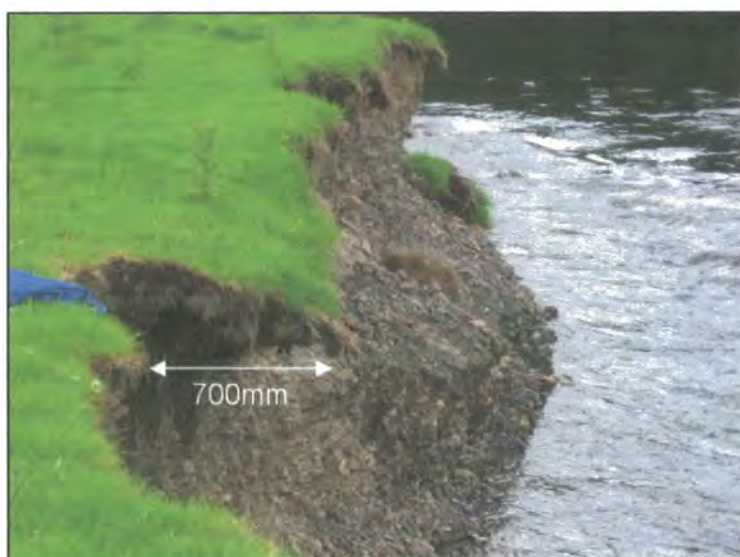
Figure 4.22: Considerable undercutting (indicated) at bank 3 following a rise in river levels, also note the oversteepened profile of the lower bank.

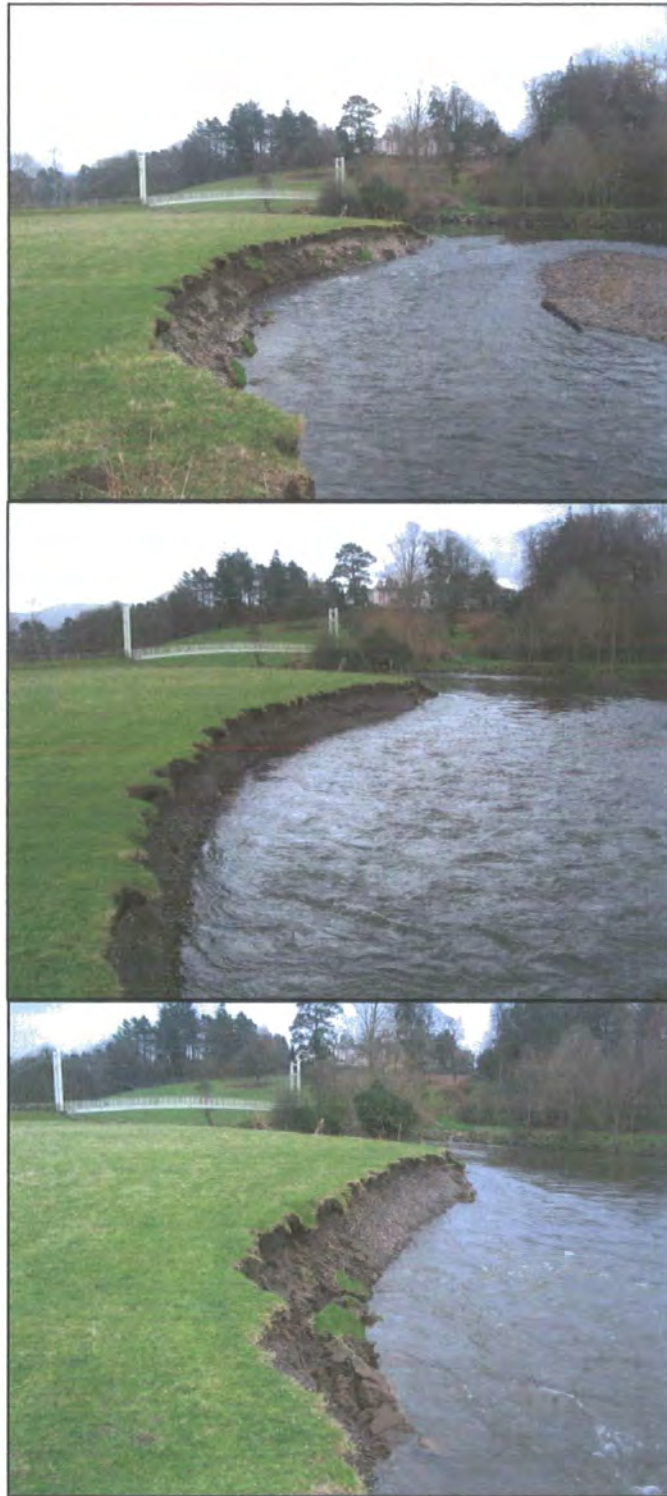
Figure 4.23: Block failure events and material removal from bank 3 near Portinscale suspension footbridge (looking upstream). Photograph dates: Top - 19th February 2007, middle – 5th March 2007, bottom – 11th March 2007.

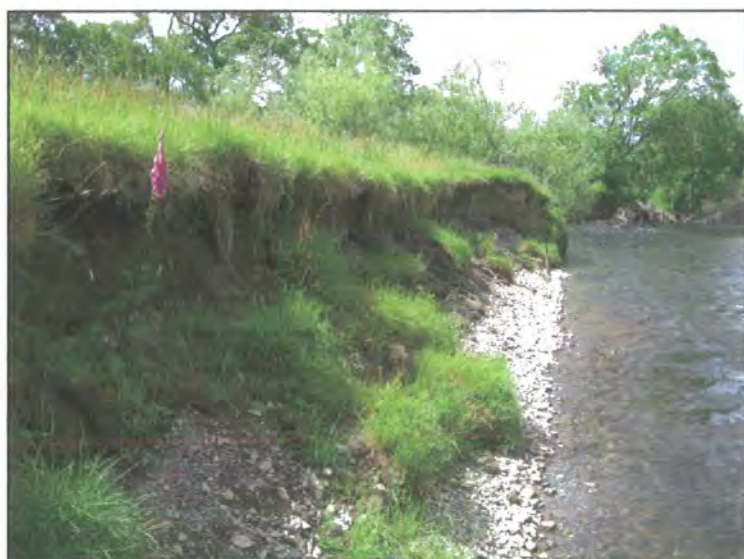
Figure 4.25: Bank 5 (West bank, NY 243 259, looking downstream).

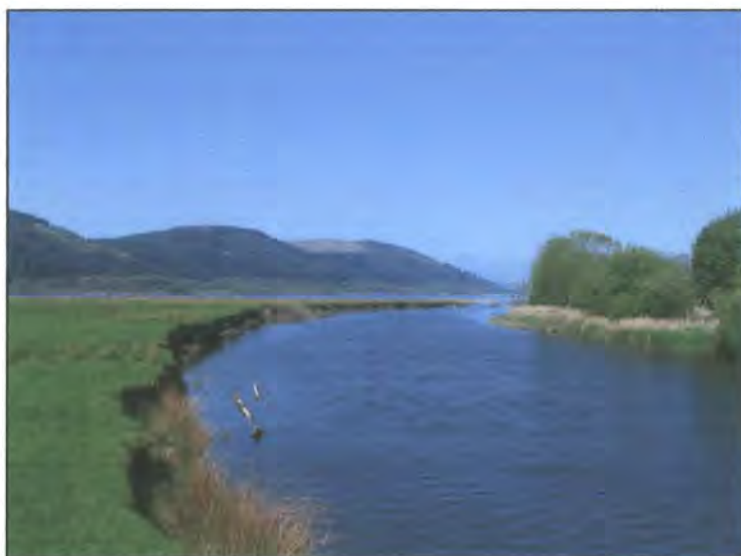
The most extensive reach of active block failures occurred downstream of Low Stock Bridge, on the west bank of the River Derwent. This bank section includes over half (54%) of all actively eroding river bank lengths on the River Derwent between Derwent Water and Bassenthwaite Lake. A large proportion of the west bank of the river is actively eroding, and an area of spectacular block failures (Figures 4.26, 4.27) is found on the outside of the final meander before the lake inflow at Derwent Foot (bank 6). Three bank profiles were measured on the 235 m eroding reach, and were relatively low, between 0.9 m and 1.15 m in height. However, the bank was consistently steep throughout its length, and two

profiles were undermined from the bank foot with overall gradients in excess of 90° . Maximum undercut depths were also considerable (240 mm, 280 mm, 450 mm). Several large, vegetated blocks of material were resting at the base of the river bank at Derwent Foot (Figures 4.27, 4.28). Most blocks were rectangular in shape and were up to 1 m in length. A large proportion of blocks were resting sub-parallel to the river bank line with their grassy top facing the channel, suggesting that they had rotated forwards during collapse. This suggests active beam failures (Section 2.4.2.1, Figure 2.15), which are likely to remain active as the upper bank remains undercut, with tension cracking present at the bank top in some areas of the bank.

Figure 4.26: Bank 6 (West bank, NY 232 272, looking downstream to Bassenthwaite Lake).

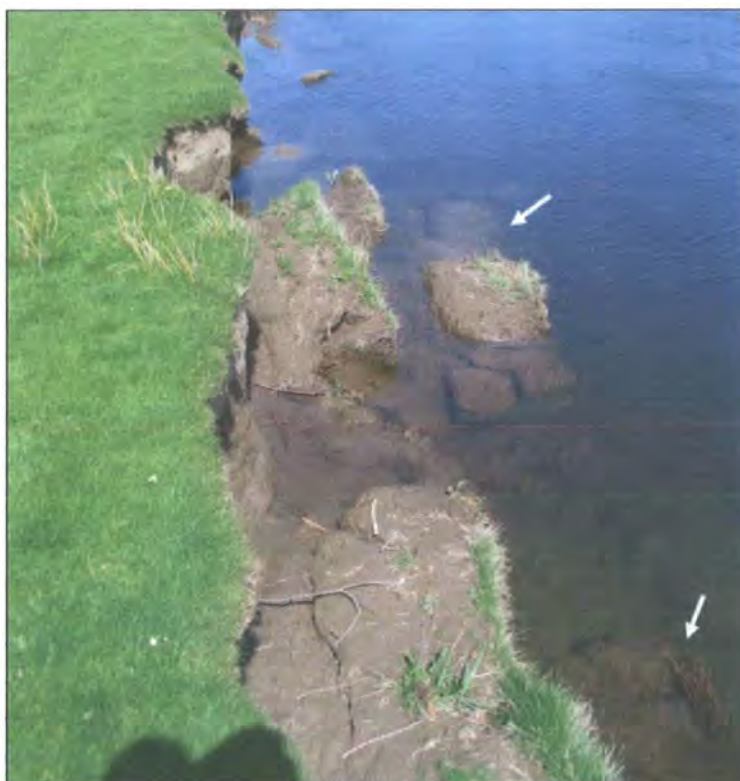
Figure 4.28: Unvegetated, intact blocks (indicated by white arrows) lying in the river channel below more recent failures at bank 6 (flow direction: away from photograph).

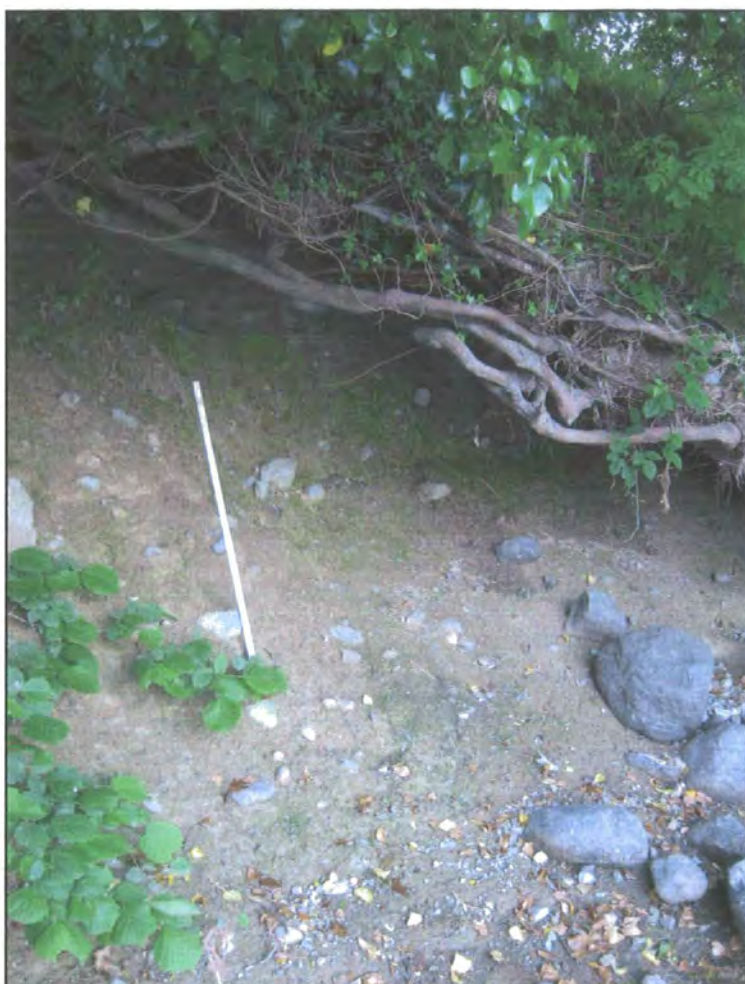
Figure 4.29: High (3.5 m) but presently stable river bank near Portinscale (NY 252 238), with metre ruler for scale. The dense vegetation roots at the overhang and the highly cohesive till on the lower, exposed bank face have prevented active erosion of this bank.

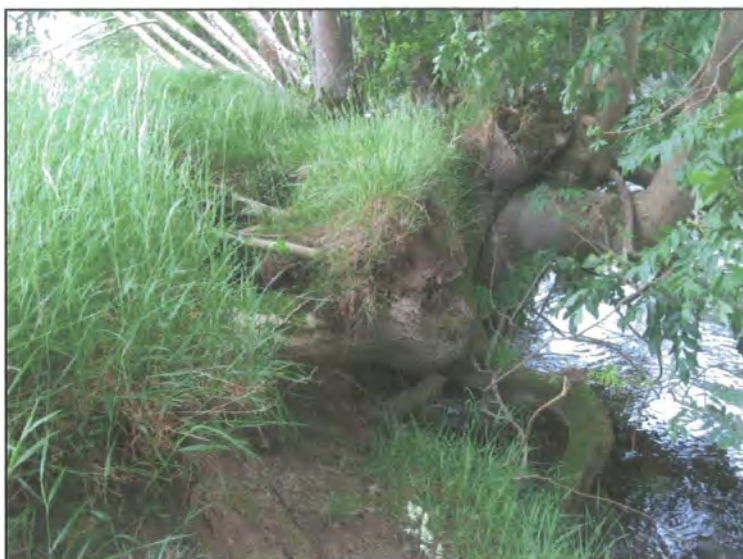
Figure 4.30: Semi-active exposed bank face between Portinscale and High Stock Bridge at NY 248 250, showing the influence of tree roots on river bank form and upper bank stability. The tree is however extremely undermined.

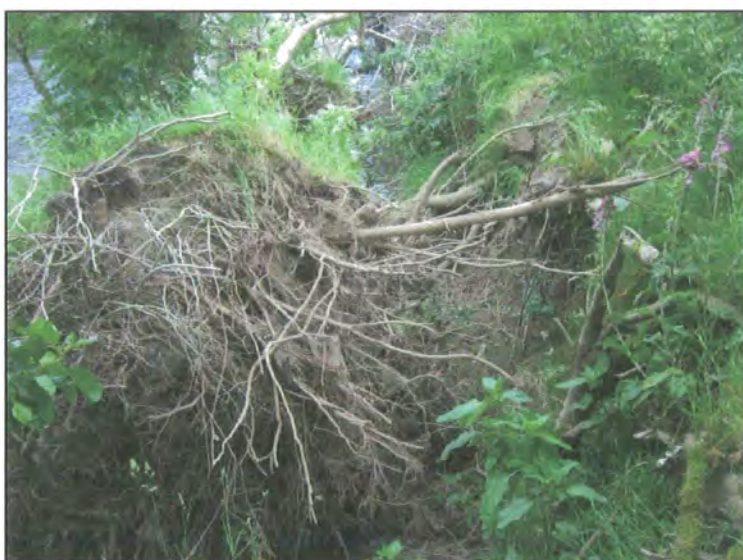
Figure 4.31: Collapsed bank-top tree at NY 247 251, showing a considerable amount of material removed from the bank attached to the roots, and a steep bank face left exposed by the removal of the material.

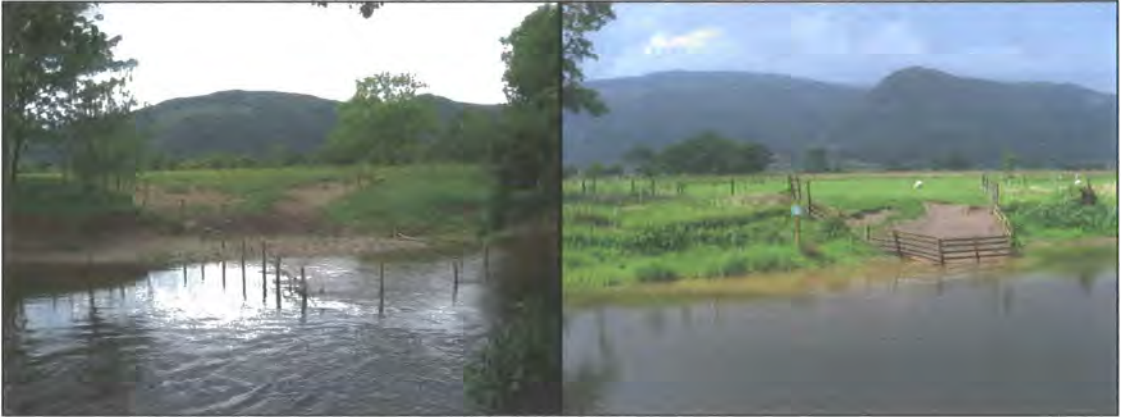
Figure 4.32: Large poaching scars: (left) near High Stock Bridge (NY 244 257), (right) near Low Stock Bridge (NY 244 257). Note the diversion of fencing into the river channel to allow grazing animals access to the water.

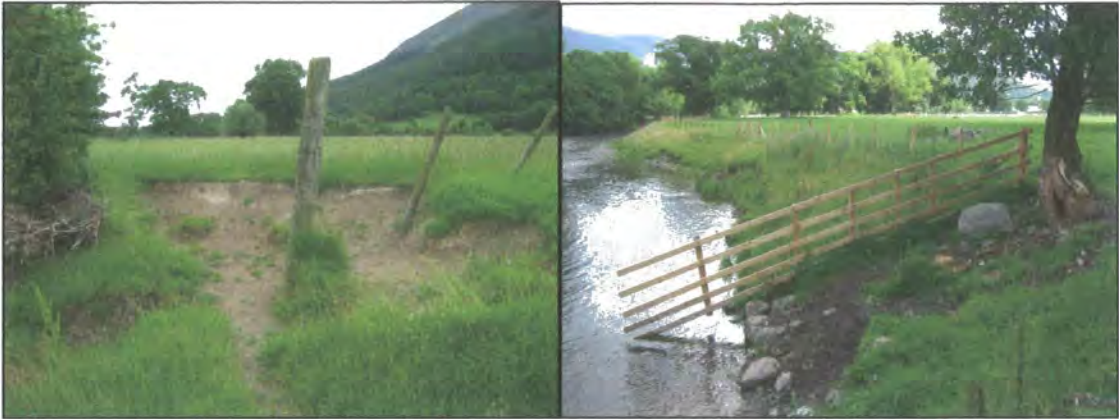
Figure 4.33: Examples of poaching scars formed near to fences in areas of channelled grazing: upstream of Low Stock Bridge (NY 237 264) (left) and near Portinscale (NY 253 237) (right).

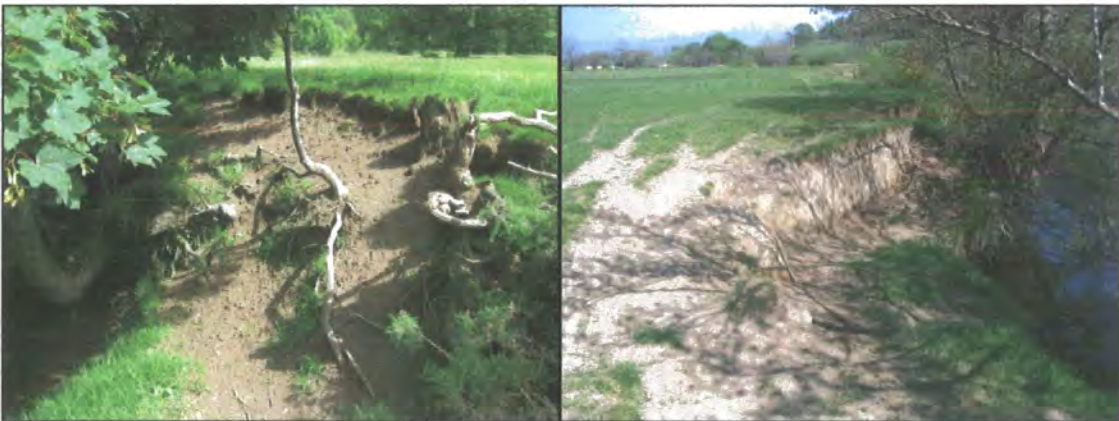
Figure 4.34: Examples of poaching scars that have formed in sheltered areas of river bank: under trees near Portinscale (NY 251 240) (left), and below a steep bank face downstream of Low Stock Bridge (NY 236 268) (right).

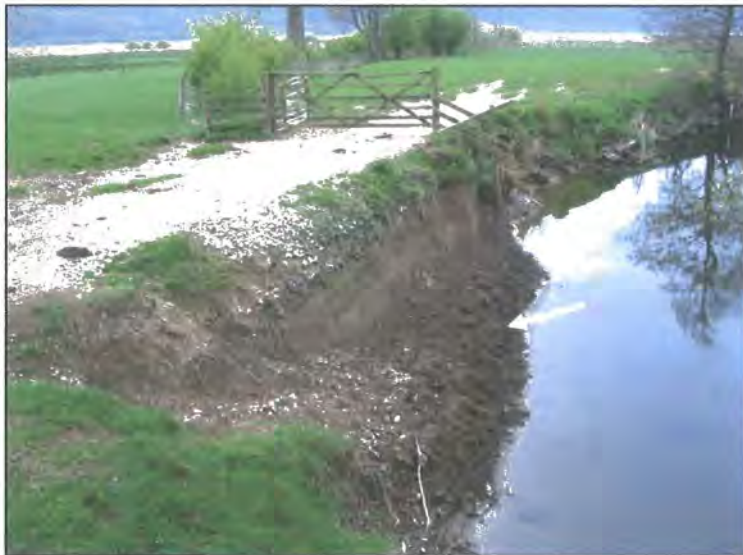
Figure 4.35: Poaching scar at Low Stock Bridge (NY 236 268) showing hoofmarks and loosened soil at the lower part of the scar (indicated by arrow). Photograph looking downstream.

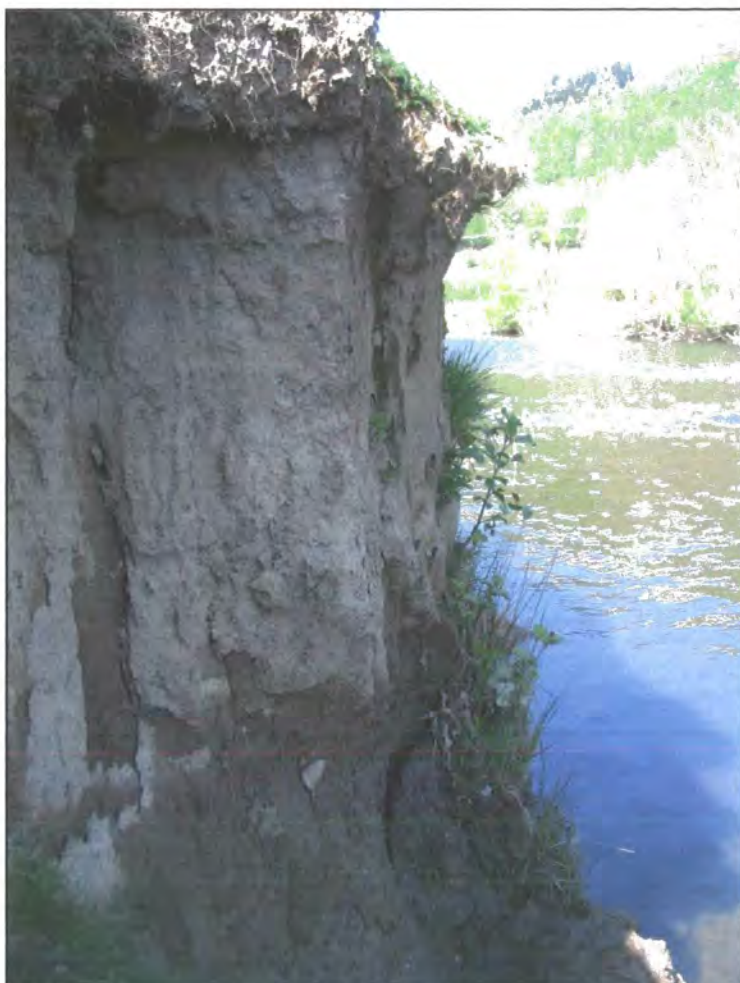
Figure 4.36: Desiccated river bank face downstream of Low Stock Bridge at NY 235 269, showing the moisture contrast between the (dry) upper and lower bank.

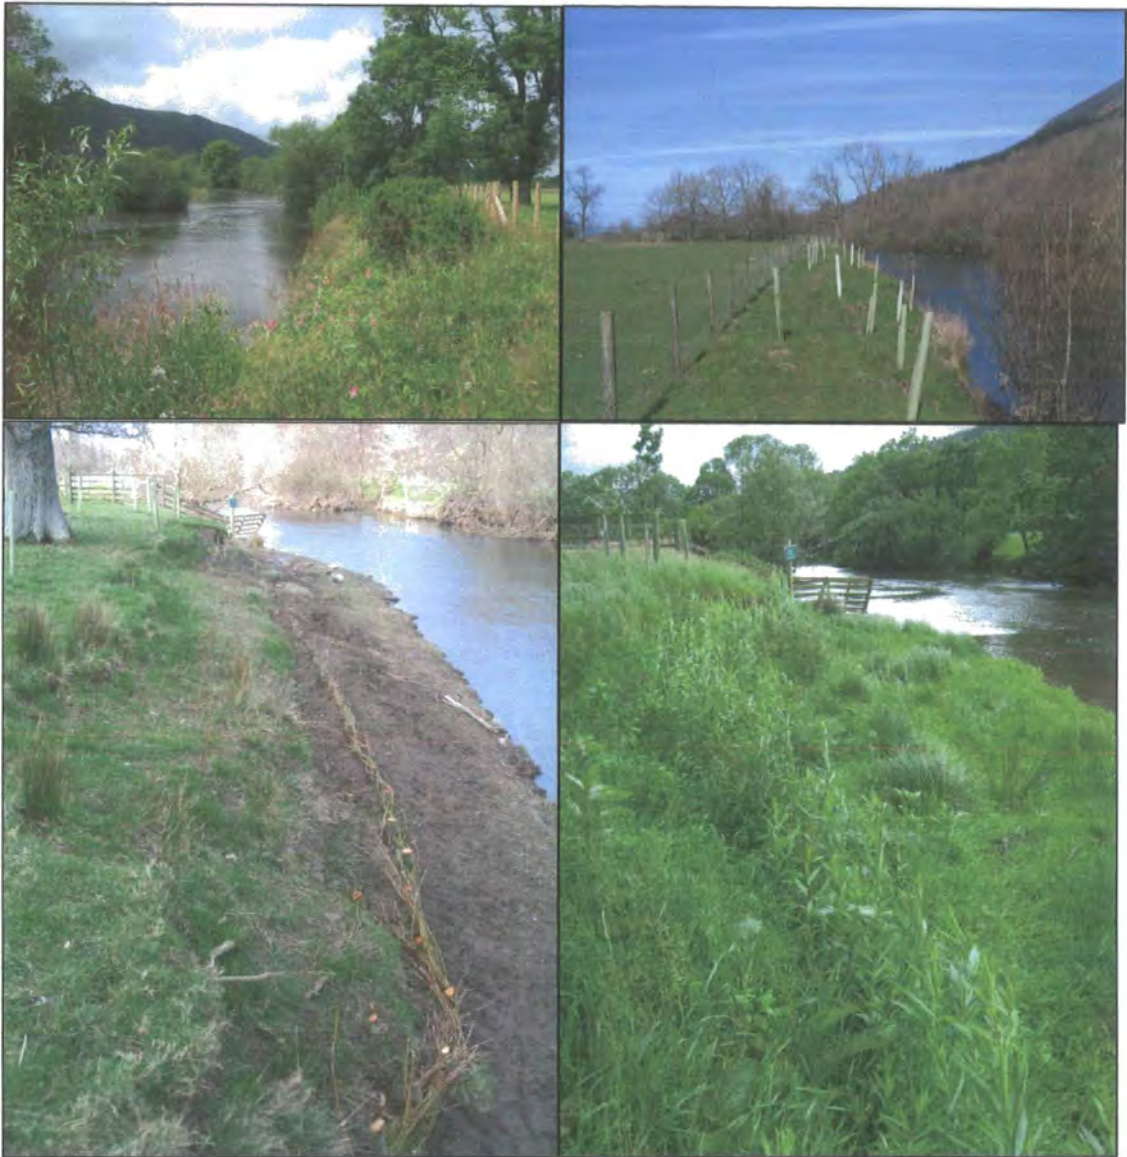
Figure 4.41: Field management techniques on the River Derwent (all photographs looking downstream). Top right: dense vegetation on a fenced bank downstream of High Stock Bridge (NY 243 260). Top left: Tree plantation and bank top fence installation upstream of Low Stock Bridge (NY 236 267). Bottom: Willow bank spiling installed on a c. 40 m reach of riverbank upstream of Low Stock Bridge (NY 236 266), showing (left) newly planted spiling in March 2007 and (right) willow growth by June 2007.

There is evidence that the plantation of vegetation has taken place on some areas of river bank in order to increase river bank protection from erosion.

These include some small plantations of young trees on the west bank upstream of Low Stock Bridge (Figure 4.41). Additionally, willow spiling has been installed on a c. 20 m section of the west bank of the Derwent upstream of Low Stock Bridge at NY 237 266. The willow was planted during March 2007, and by the spring the vegetation cover on the bank had increased considerably (Figure 4.41). An older area of spiling is situated upstream of Portinscale on the west bank between NY 255 238 and NY 256 237. The increased root density and increased vegetation cover will increase bank protection from erosion, reducing the risk of bank failure and sediment delivery in these areas.

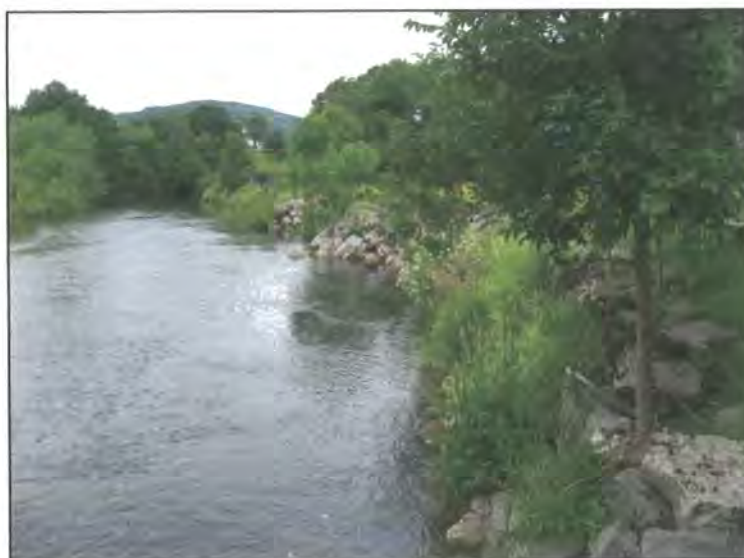
Figure 4.42: Large stone revetment in the form of a raised embankment on the east bank of the River Derwent to the north of the A66 bridge (NY 250 241, looking downstream).

Revetments are commonly used to straighten the river channel, act as flood defences and to protect river banks. Compared with other rivers in the Bassenthwaite catchment (in particular the River Greta and Newlands Beck), the River Derwent's channel between Derwent Water and Bassenthwaite Lake has not been extensively modified (Section 2.1.2). During this field survey, the overall length of stone revetments on the Derwent was measured at 760 m, or 5.4% of the total length of the river channel. There are however large areas of engineered river banks near Portinscale. The largest revetment of this type is a 170 m long raised embankment situated on the east bank of the Derwent between the A66 road bridge (NY 251 241) and the environs of the old railway bridge (NY 249 241) (Figure 4.42). This bank is in the form of a mound of boulders (maximum height c. 4 m) at the channel edge. Furthermore, an 85 m stone revetment is found
