Assessing the importance of river bank erosion for fine sediment delivery to Bassenthwaite Lake

Assessing the importance of river bank
erosion for fine sediment delivery to
Bassenthwaite Lake

Thesis for M. Sc. (by research)

Durham University, Department of Geography

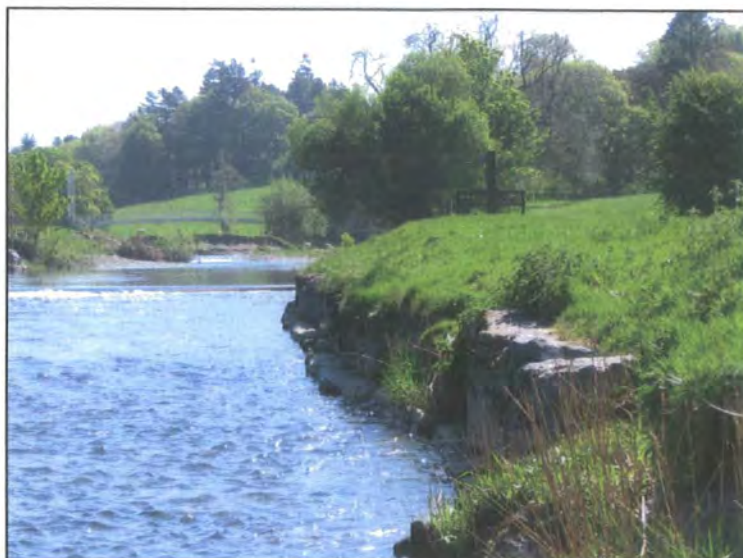
Figure 4.43: Boulder revetment wall at Portinscale (NY 251 238, looking upstream).

opposite Portinscale gauging station to the north of NY 251 238 (Figure 4.43), with similar revetments on the east bank near the gauging station. These revetments are placed to stabilise the weir at the gauging station. Aside from these large revetments and some shorter sections close to Portinscale, including the banks at the recreational area close to Portinscale suspension footbridge (NY 253 237), the largely agricultural reaches to the north of Portinscale do not feature extensive stone revetments. Some sections of boulders are found near Low Stock Bridge, including a 40 m section to the north of a reinforced promontory at NY 236 265. Gabions, constructed as five walls built perpendicular to the bank line (maximum height c. 2-3 m) were found on the east bank of the Derwent at NY 247 251 (Figure 4.44). Such features are not widespread on the River Derwent, but prevent erosion in areas where they do exist.

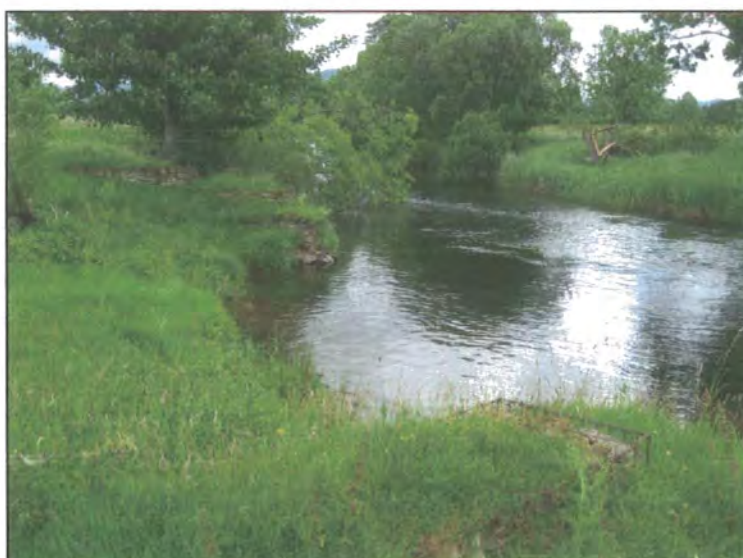
Figure 4.44: Gabion cages between Portinscale and High Stock Bridge (NY 247 251, looking upstream).
