Survey and preliminary assessment of a baroque vault for refurbishment planning

Keywords: baroque vault, non-destructive survey, mechanical response, load carrying capacity estimate

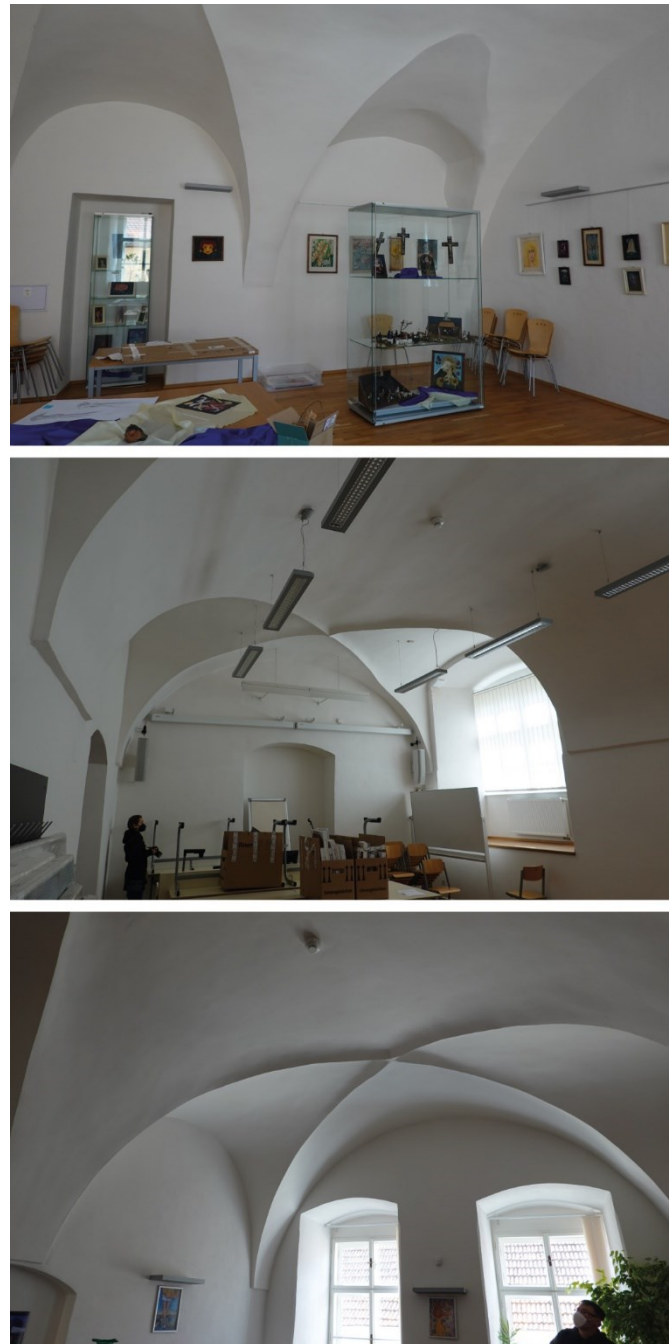
Fig. 1. Barrel vaults with lunettes under room 1.11 (top), cross vaults under room 1.11 and room 1.12 (middle), barrel and cross vaults under rooms 1.17 and 1.18 (bottom). (Photo: Válek, 2021)

The geometry of the lower surfaces of the vaults was measured by an authorized surveyor and the measured vaults are shown in Fig. 1. Figure 2 shows the measured values of the vertical coordinates of the shape of the edges of the passage of individual vaults from rooms 1.17 and 1.18 and their ground plan. During the local investigation for radar measurements, it was revealed that the thicknesses of the perimeter walls on individual floors are not the same; the division of rooms by transverse walls is not identical either. For the calculation, the vaults were spatially modelled according to their undivided shape on the floor below the vaults.

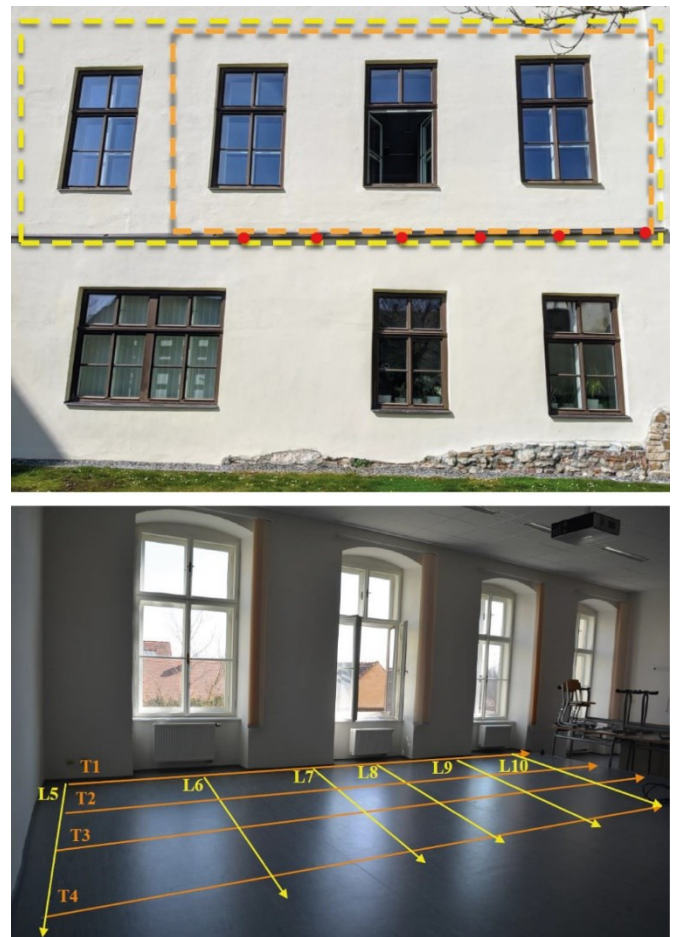
Fig. 3. Room 1.18 (yellow) and measurement area (orange). The red dots show the initial positions of the longitudinal (L) profiles, which were positioned according to the central axis of the windows. (top) Orientation marking of the square network of longitudinal (L) and transverse profiles (T) in room 1.18. (Author: Válek, 2021)

For the radar measurements the space of room 1.18 was divided into 6 longitudinal and 4 transversal mutually perpendicular straight line profiles, which formed a rectangular grid. The longitudinal profile guidance was adapted to the position of the windows in the room (Fig. 3). The starting point was located in the northeast corner of the room at a distance of 300 mm from the walls. The IDS type ground radar was used for the task. With regard to the resolution and the expected depth range, a 900 MHz and a 2 GHz antenna was used. The linear distance when the antenna was moved along the profile was measured by a wheel. After initial authentication, the following system settings were selected: A depth resolution of 1,024 samples/scan was chosen for radar scans, the time limit was 60 ns for the 900 MHz antenna and 20 ns for the 2GHz antenna, the signal velocity was estimated at 140 mm/ns and the signal was read by 10 mm in the direction of the antenna movement.

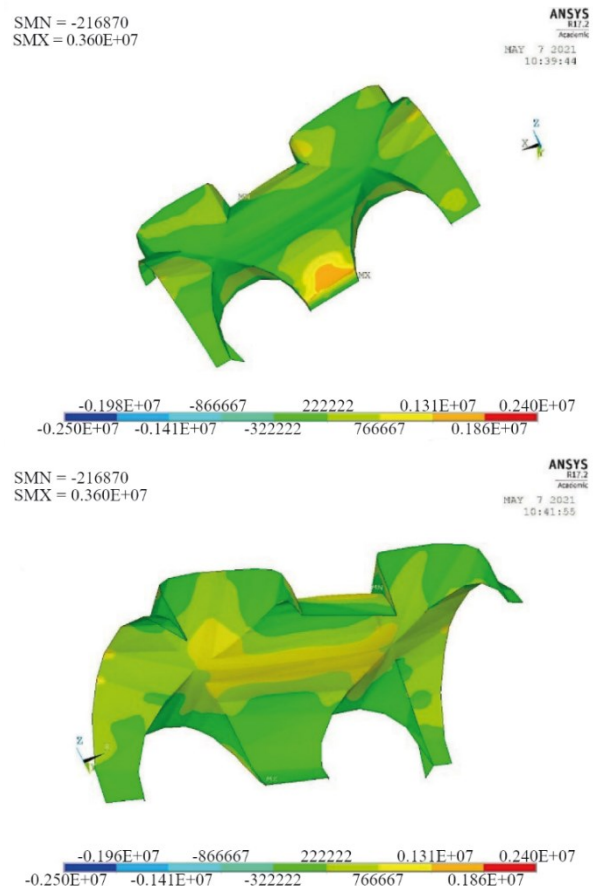
The maximum compressive stress on the model, taking into account the 25 cm thickness of the vault, is approximately 5.2 MPa (see Fig. 8) and the most stressed point is the contact edge between the longitudinal and transverse vaults at the lower surface. In the middle of the barrel vault belt above the place of fixing, maximum tensions of up to 1.8 MPa occur at the upper surface, which in fact cannot be completely transmitted through the masonry and will lead to a redistribution of stress, which will increase at this point the theoretically calculated compressive stresses at the lower surface. With the lower surface in the same place, the compressive stress in one direction is approximately

Fig. 8. The first main stress on the upper surface, (top), and the lower surface (bottom). Vault thickness 25 cm, + 5.5 KN/m² live load. (Author: Bayer, 2021)
