Implications of the 2023 Flood on the Lower Diamond Fork River, UT

WATS Capstone Senior Undergraduate Research Thesis

Christian J Stewart, Principal Investigator

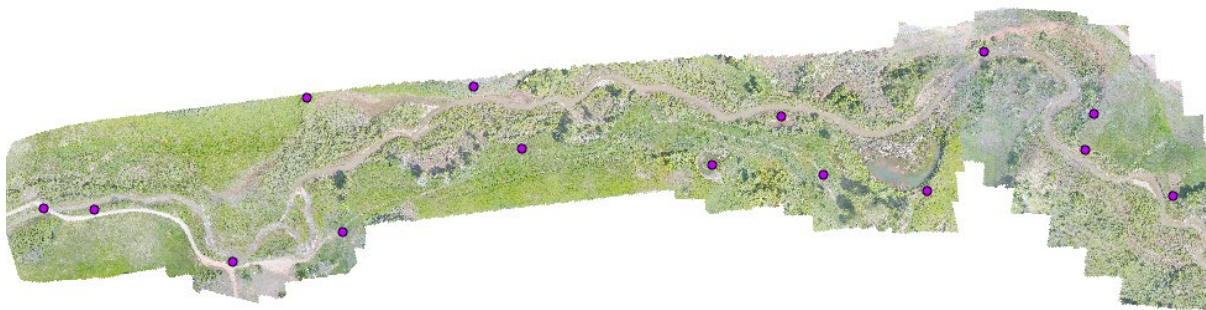
Figure 3: Control Points (pink) Overlaying the 06/09 Drone Imagery on the Lower Diamond Fork River.

Using ArcGIS Pro, the drone imagery sets were georeferenced to the ArcGIS pro basemap, composed of the following imagery: Maxar (Vivid) imagery captured on Jul 1, 2022 and Maxar (Vivid) imagery Nov 3, 2021. Georeferencing was completed by identifying 56 control points on the basemap imagery (Figure 3; Figure 4).

At these 56 control points, a “spline” transformation was used to calibrate the imagery to the points. At the control points, spatial error is zero, whereas error increases further from control points due to distortion naturally present in the original imagery. At 10 test points on features in the stream channel (not the 56 control points), original imagery spatial error ranged from 2-5m. After the georeferencing process, spatial error at the test points decreased to 0.1-2m.

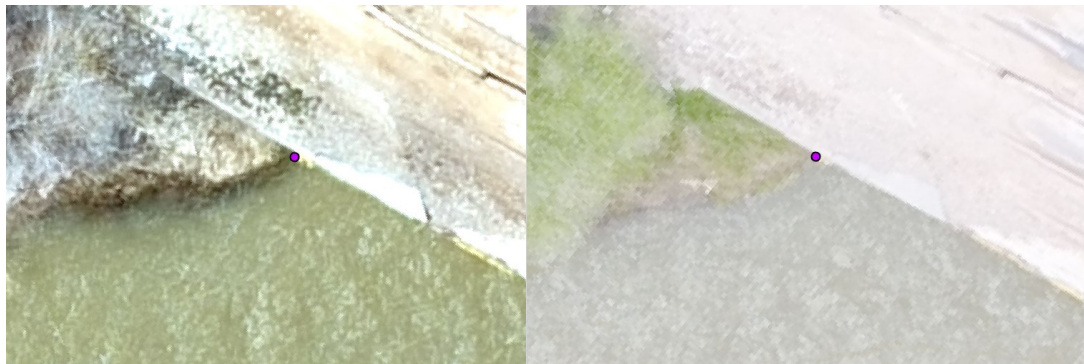
Figure 4: A Control Point (pink) Located at Child's Bridge, 04/23 (left) and 06/09 (right)

- features that cannot not move due to time, geomorphic change, or flooding (rocks, notable shrubs, concrete corners, culvert edges)
- features as close as possible to the water surface, but not the water surface/channel edge
- relatively equal amounts of control points on each side of the stream
- relatively equal spacing between control points

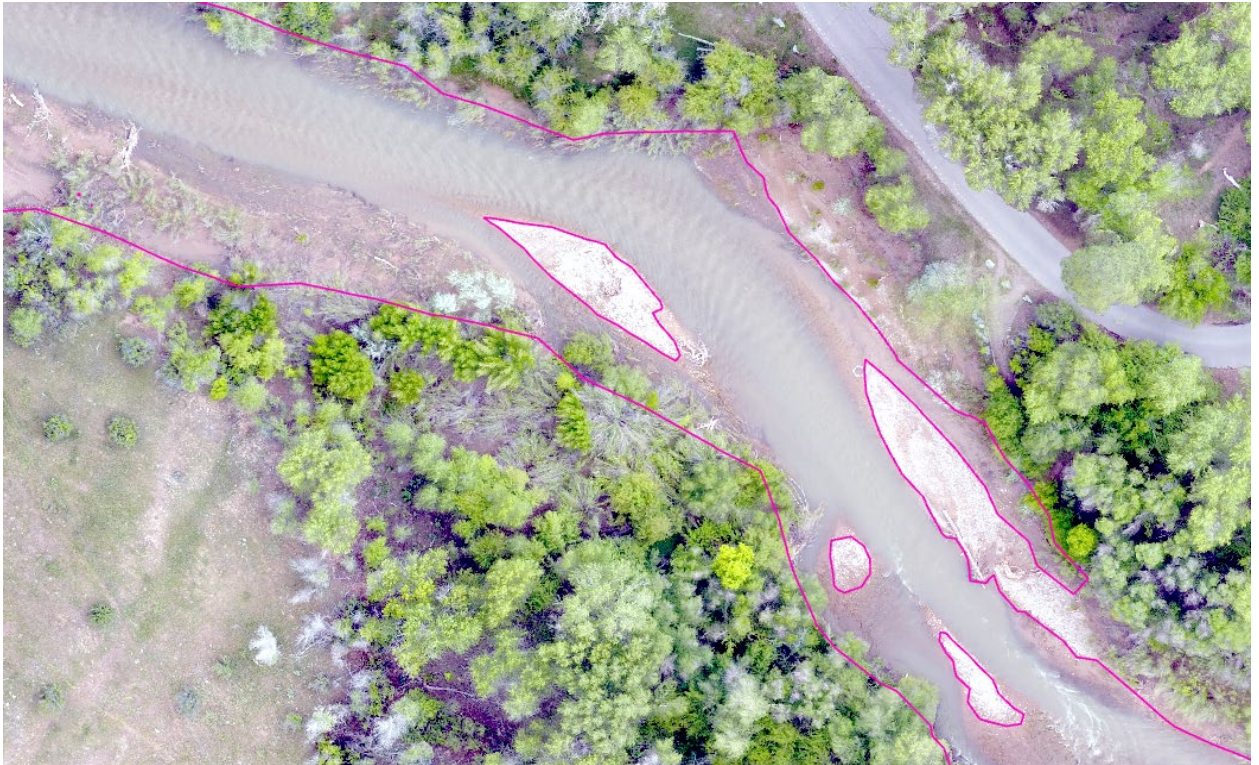
Figure 5: An Example Polygon/Polyline from the Manual Water Surface Delineation Overlaying USU Imagery, Diamond Fork River 06/09/23.

The manual channel delineation has points at a resolution of approximately 1 point per meter of water surface. The maximum pixel dimension in the imagery is .06m, so each click spans an average of 17 pixels. This is a high density of points generated and is a high resolution manual delineation of the water surface (Table 1; Figure 5).

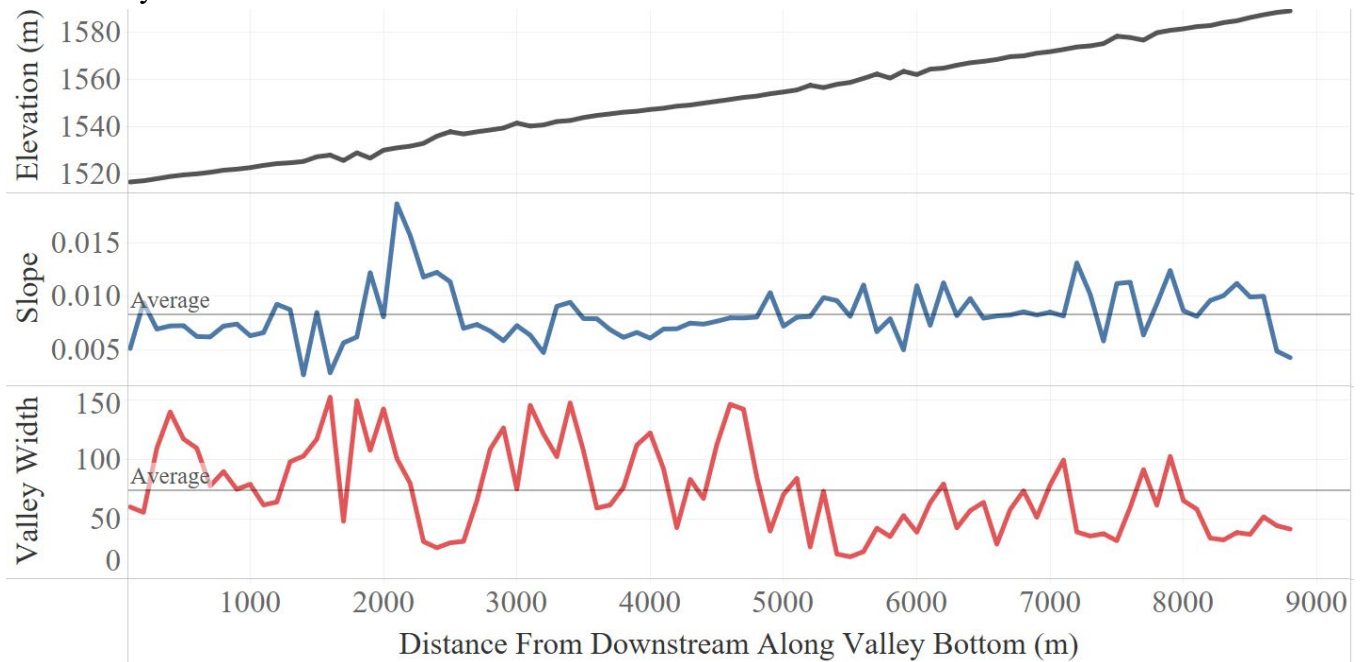
Figure 9: Valley Bottom Characteristics, Lower Diamond Fork River.

A valley bottom longitudinal profile shows elevation, stream slope and valley width along 100m transect measurements along the valley bottom centerline. Distance from downstream was calculated along the valley-bottom centerline from Child’s Bridge.

The study reach has a higher average slope close to the Diamond Fork Campground at the upstream to the culvert, and experiences a lower slope near the motherlode and oxbow reaches (Figure 9). The valley bottom generally increases in width going from upstream to downstream in the study site.

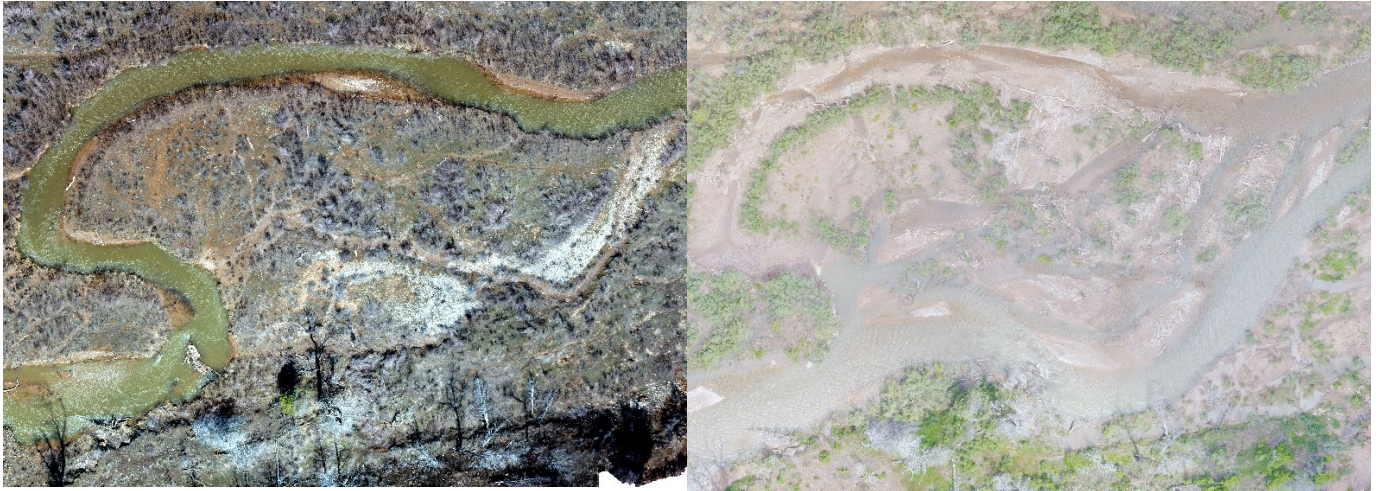
Figure 10, Channel Centerline Migration through New Channel Avulsion. Pre flood imagery (left) and post-flood imagery (right) located at the same site, ~5500 meters upstream of Childs bridge along the post-flood stream centerline.

Drivers of centerline migration were primarily meander-expansion and new-channel-avulsion (Figure 10). Meander cutoffs also led to centerline migration through channel straightening (Figure 11).

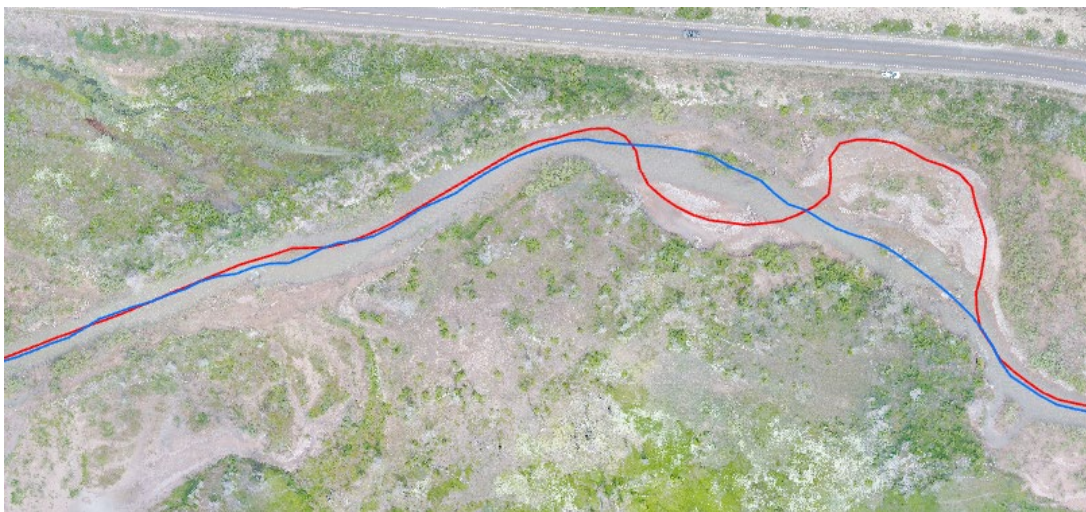
Figure 11. Two Meander Cutoffs, **Pre-flood** (red) and **post-flood**(blue) centerlines

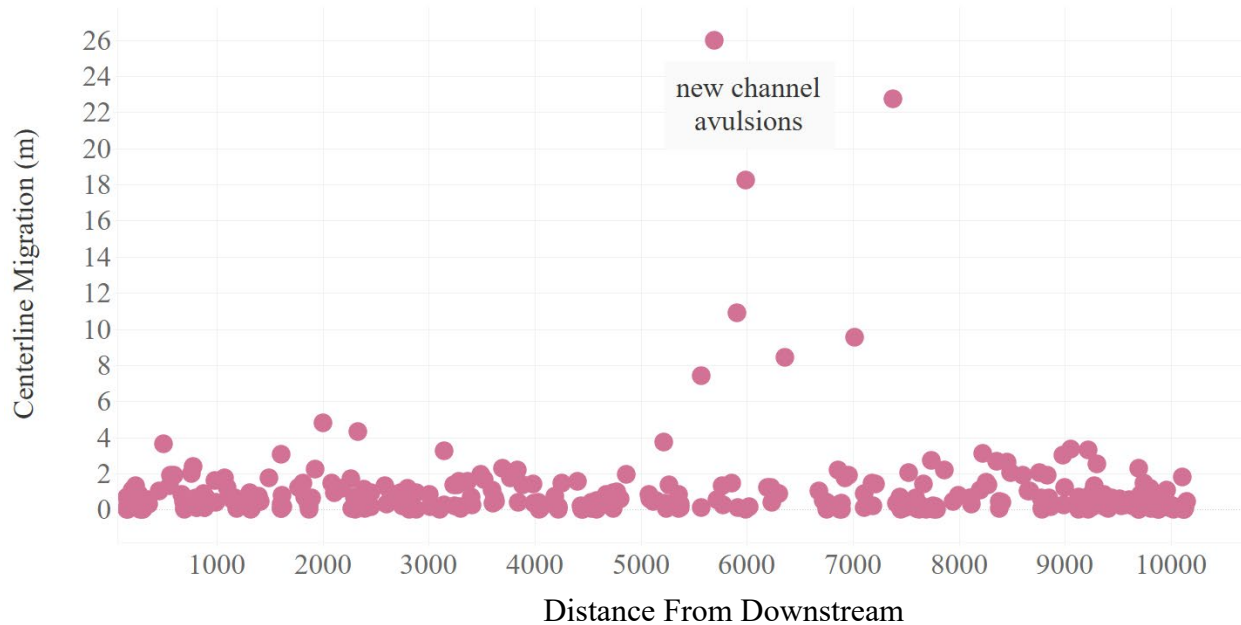
Figure 12: Channel Centerline Migration, Lower Diamond Fork River.

Distance from downstream was calculated along the post flood stream centerline from Child’s Bridge.

Because there was inevitable georeferencing error averaging about .5 meters, centerline migration values less than 1m are likely just attributable to imperfect georeferencing, while values larger than 1 meters represent a significant channel migration (Figure 12).

10% of the 5m transects surveyed had an average channel centerline migration of 1.9 meters or higher (Table 3). 1% of the transects surveyed migrated by 14.9 meters or more. The 99th percentile for centerline migration is 14.9m. This is likely attributable solely to new channel avulsion.

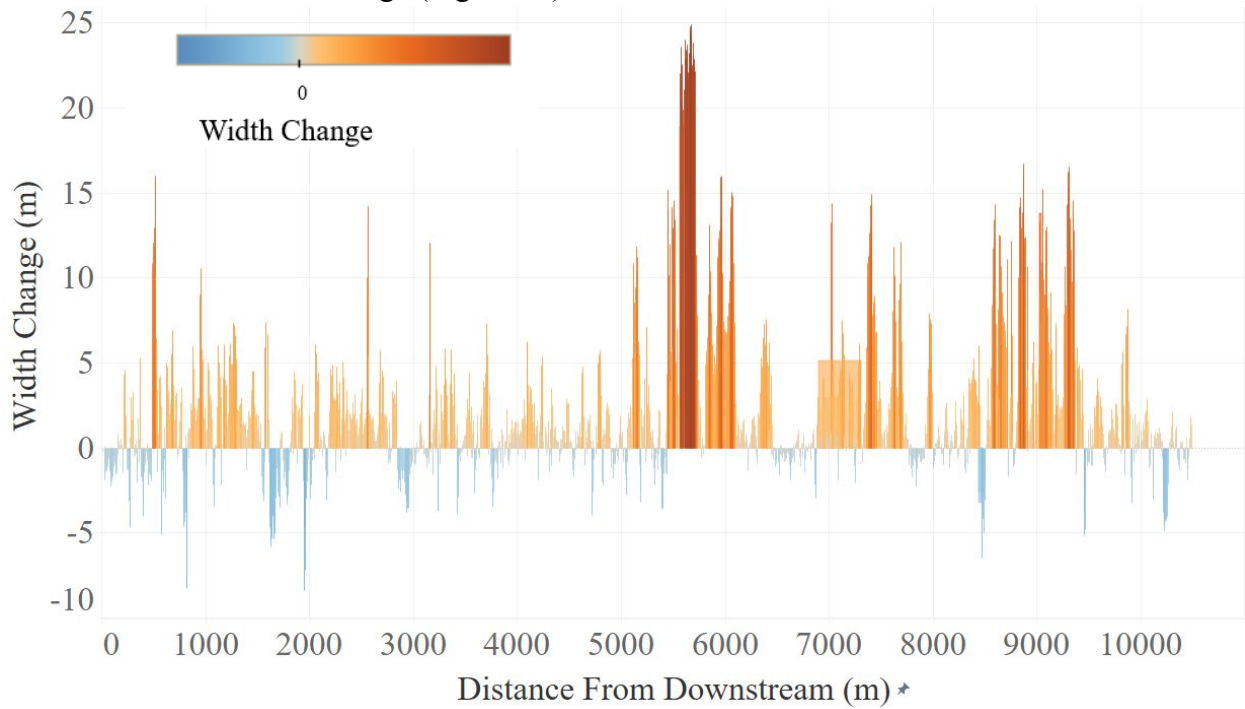
Figure 13: Change in Channel Width, Lower Diamond Fork River. Orange reflects increases in width, blue reflects decreases in channel width. Distance from downstream was calculated along the post-flood stream centerline from Child’s Bridge.

Braid plain and gravel bar formation was responsible for most of the significant increases in channel width, shown in orange (Figure 13).

Narrowing occurred in 25% of the transects sampled, while the median transect increased in width by 1m (Table 4). 10% of transects increased in width by 7.4 meters or more, which can be explained by gravel bar braid plain development.

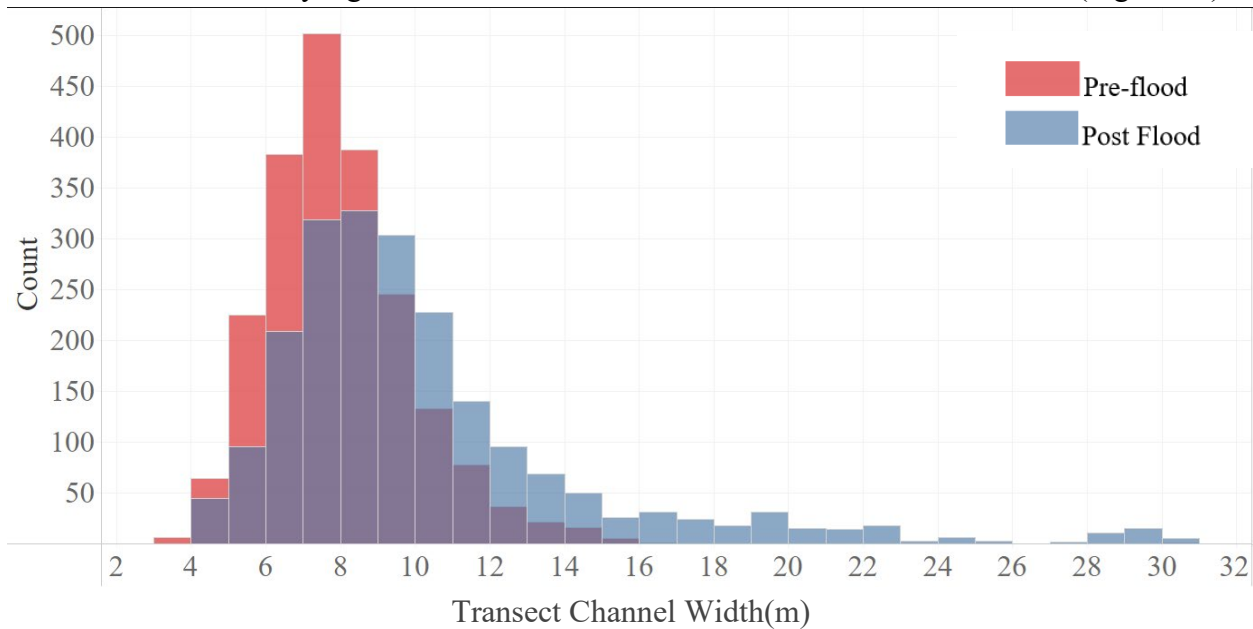
Figure 14: 5m Transects Width Distribution, Pre/Post Flood

While post-flood width standard deviation is much higher than pre-flood (43% to 24%), most of this is driven by significant width increases above 16m total channel width (Figure 14).

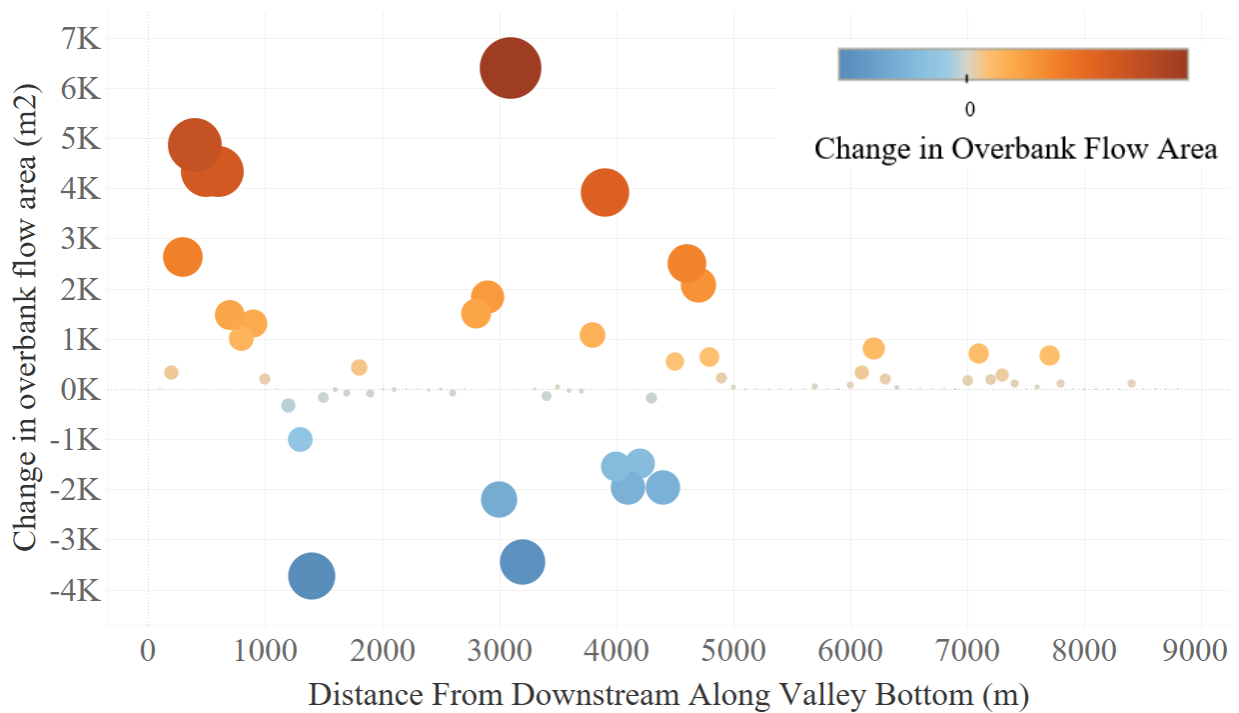
Figure 16: Change in Overbank Flow Area, Lower Diamond Fork River. Distance from downstream was calculated along the valley-bottom centerline from Child's Bridge.

The lower half of the river (<5000m) had a significantly more dynamic change in overbank flow area and a net increase in overbank flow area, displayed by the red bubbles (Figure 16). It is important to note that some 100m transects experienced a decrease in overbank flow area however, noted by the blue bubbles. The upper half of the stream did not experience significant changes in overbank flow area.

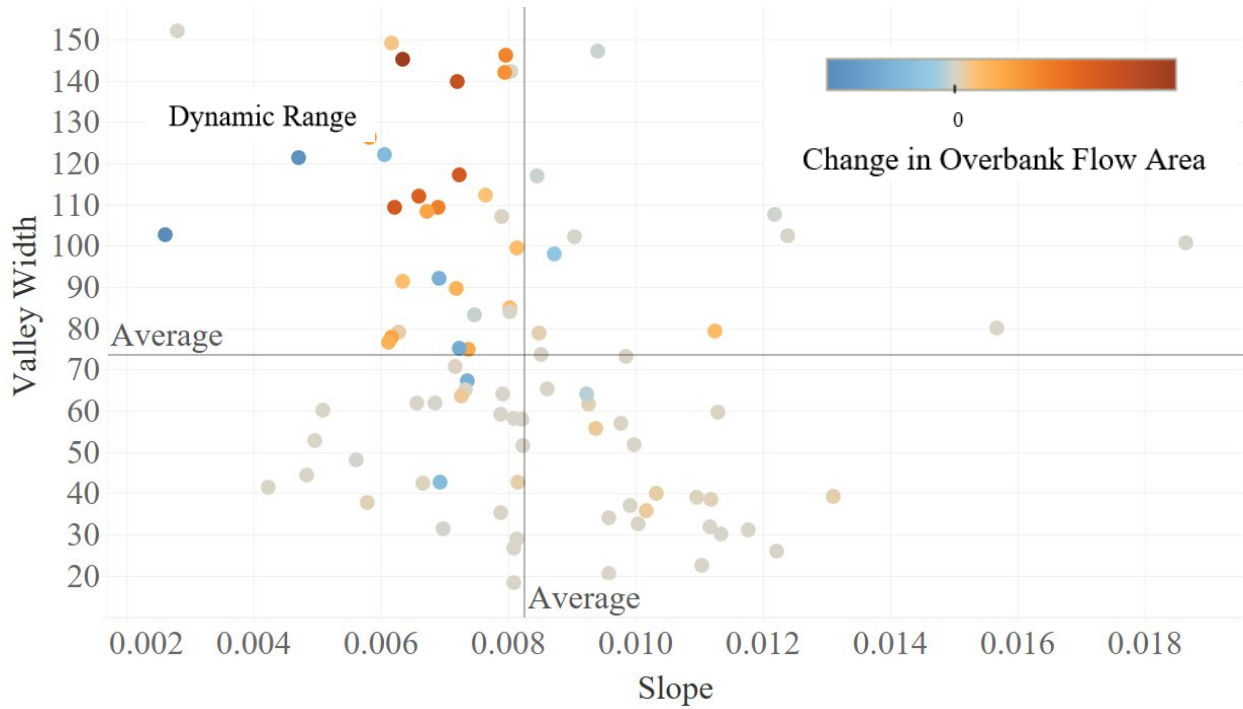
Figure 17: “Dynamic Range” of Slope and Valley Bottom Width, Lower Diamond Fork River. The colored upper-left quadrant represents where changes in overbank flow were most dynamic during the 2023 flood.

Almost all changes in overbank flow area occurred in areas with below-average slopes with above-average valley width (Figure 17). It seems both of these are necessary for the development of extensive overbank flow on the Lower Diamond Fork, as neither slope nor valley bottom width alone predicted increases or decreases in overbank flow during the 2023 flood.

- Imagery suggests some overbank flow areas are stagnant water, but most of the overbank flow is concentrated enough to flow through vegetation and reenter the river after traveling across the floodplain.
- Areas inundated by overbank flow naturally in the 2023 flood provide an opportunity for restoration actions to develop channel complexity. Actions to maintain these concentrated overbank flow channels are suggested to improve fish habitat
- Areas with valley bottom width and slope conditions approaching the “dynamic range” (Figure 17) might be prime targets for actions targeted at increasing channel diversity
