Multi-temporal analysis to support the management of torrent control structures

DOI:10.1016/j.catena.2023.107599

## Multi-temporal analysis to support the management of torrent control structures

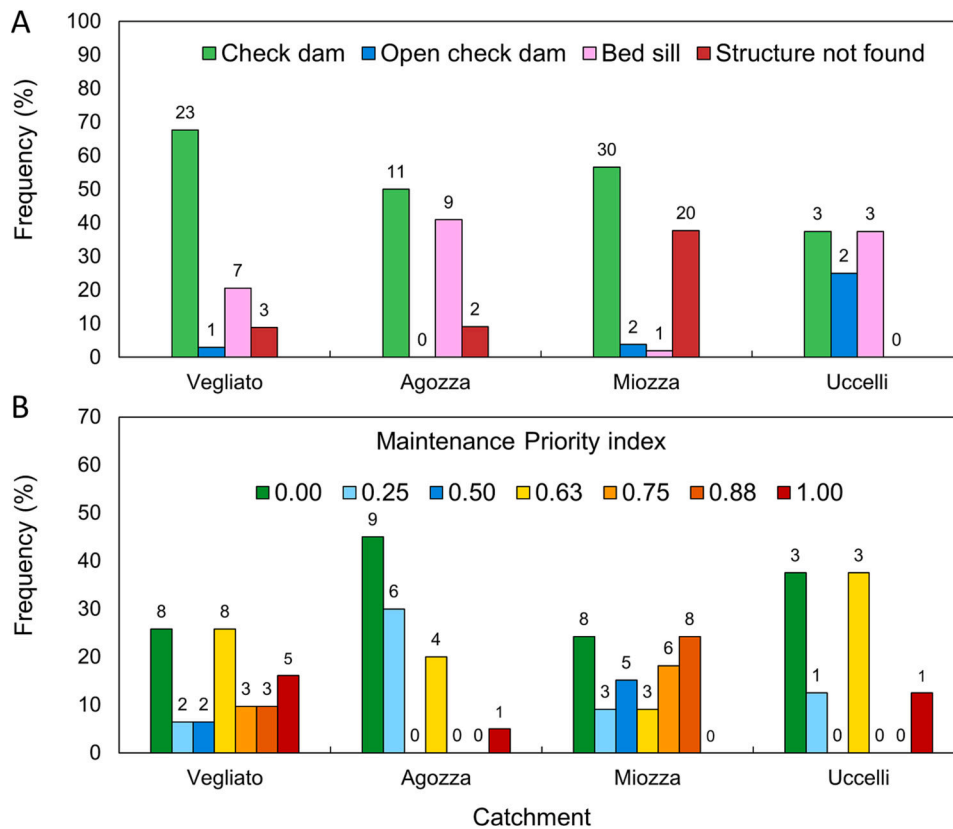
**Fig. 4.** (A) Relative frequency and number (at the top of each bar) of the type of torrent control structures. (B) Relative frequency and number (at the top of each bar) of the structures with a specific value of the Maintenance Priority Index (MPI), for each study catchment.

Comparing the  $MPI$  among the study catchments, as visible in Fig. 4B, the Vegliato catchment presents the highest percentage of red-ranked torrent control structures, the Agozza has the highest number of green and blue-ranked works, while the Miozza shows the highest percentage of orange-ranked structures. Furthermore, the Miozza and Agozza catchments also present the lowest number of green-ranked and red-ranked structures, respectively. It is useful to point out that in the Uccelli catchment, 37 % of the structures are both operative and in good condition (i.e., green-rank), but the same number of structures are also damaged (i.e., orange-rank).

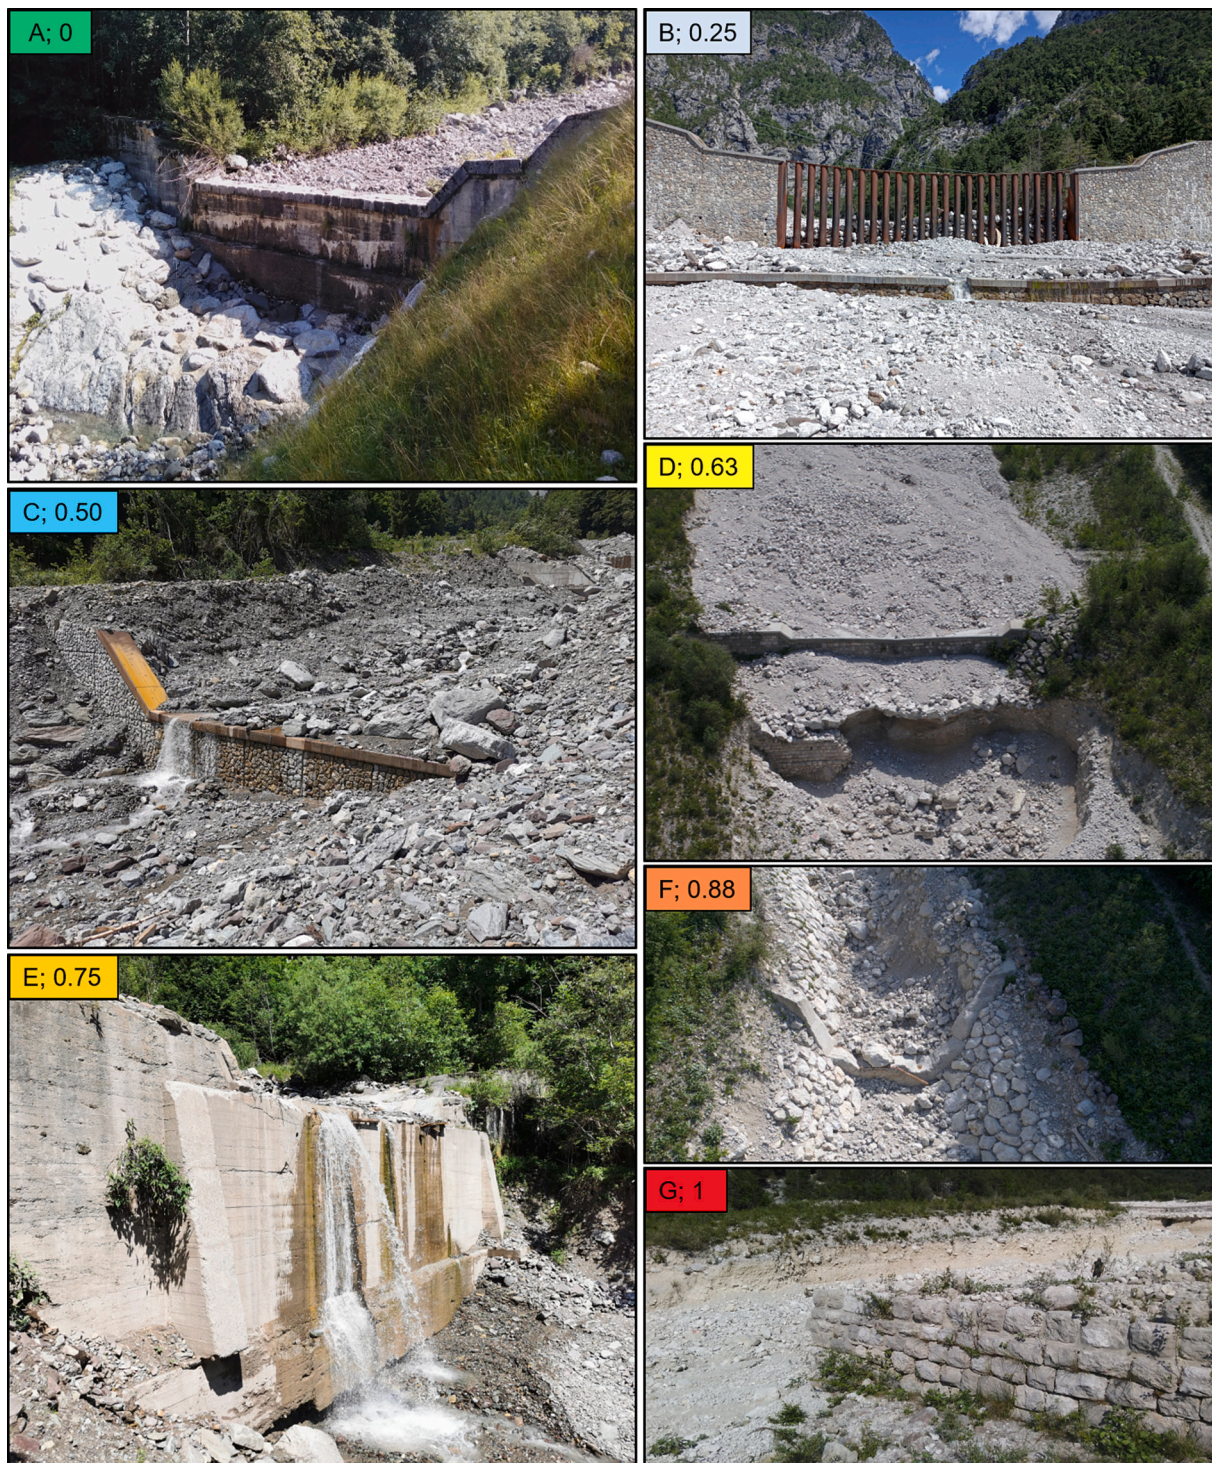
**Fig. 6.** Examples of check dams with different MPI values associated. (A) Check dam A120 in the Agozza Torrent was assigned 0 of the MPI and green-rank. (B) Open check dam U060 in the Uccelli Torrent was assigned 0.25 of the MPI and blue-rank. (C) Check dam M130S in the Miozza Torrent was assigned 0.5 of the MPI and blue-rank. (D) Check dam V060 in the Vegliato Torrent was assigned 0.63 of the MPI and orange-rank. (E) Check dam M100S in the Miozza Torrent was assigned 0.75 of the MPI and red orange-rank. (F) Bed sill V190 in the Vegliato Torrent was assigned 0.88 of the MPI and orange-rank. (G) Check dam V050 in the Vegliato Torrent was assigned 1 of the MPI and red-rank. Photos taken in summer 2022. (For interpretation of the references to colour in this figure legend, the reader is referred to the web version of this article.)

Relevant examples of the seven  $MPI$  values are found within each catchment's study reach. An example of a green-ranked structure is visible in Fig. 6A, where the check dam A120 in the Agozza catchment is characterized by an  $MPI$  value of 0 due to operative functionality and good status. In the Uccelli basin, Fig. 6B presents a case of a blue-ranked ( $MPI = 0.25$ ) check dam. Even though the open check dam shows good status, a reduced functionality was observed, as the sediment is clogging almost 50 % of the filters, impeding correct sediment sorting and retention during intense floods. Fig. 6C shows a check dam (M130S in the Miozza Torrent) with low functionality in terms of channel stabilization but good structural status, leading to a blue rank ( $MPI = 0.5$ ). Fig. 6D shows check dam V060 along the Vegliato Torrent, whose  $MPI$  corresponds to 0.63, hence ranked orange. Even though it still can exert its primary function of sediment regulation, the physical condition is in a precarious state. A deep scour visible in the downstream part already caused the collapse of the counter dam and is now affecting the main check dam's foundation as well. The check dam M100S in Fig. 6E is characterized by reduced functionality in terms of sediment retention due to upstream massive sediment overfilling. In addition, there was evidence of important siphoning at the base of the check dam, which affects both the functionality (potential fluxes passing underneath) and the future stability of the structure itself. Indeed, the degree of siphoning in this structure is bound to widen considerably over time, because, from field inspections and as seen in Fig. 6E, there is the presence of runoff under the check dam body along the entire spillway even in areas not directly affected by crest flow. For these reasons, an  $MPI$  value of 0.75 and the orange-rank were assigned. Fig. 6F, in the Vegliato torrent, presents an example of an orange-ranked ( $MPI = 0.88$ ) bed sill (V190) due to low functionality of bed stabilization, showing important signs of lateral and downstream erosion. Finally, Fig. 6G displays the completely destroyed V050 check dam (only the left wing is visible) that is unable to perform its function of stabilizing the channel, therefore the  $MPI$  is 1 (i.e., red-rank).
