On monitoring fretting fatigue damage in solid railway axles by acoustic emission with unsupervised machine learning and comparison to non-destructive testing techniques

Michele CARBONI, Marta ZAMORANO

This is a post-peer-review, pre-copyedit version of an article published in Proc IMechE Part F: J Rail and Rapid Transit 2024, Vol. 238(2) 256–267. The final authenticated version is available online at: <https://doi.org/10.1177/09544097231193186>

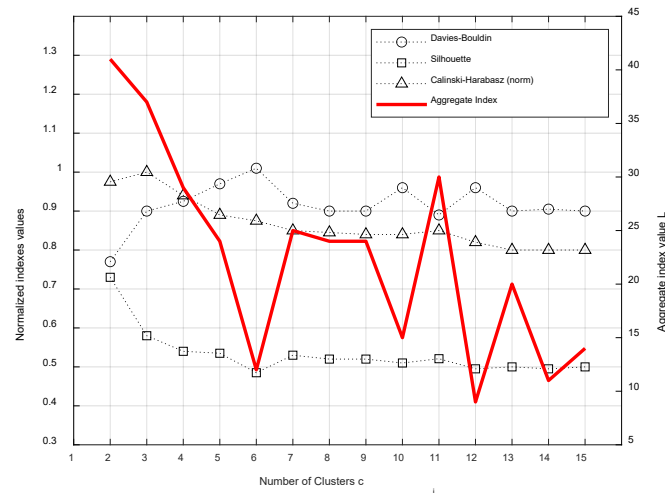
Figure 7. Estimation of the optimal number of clusters for AE raw data.

For the application of the k-SOM algorithm to the present AE raw data, all the time domain features, shown in Figure 1, and some frequency domain features (frequency peak amplitude, frequency centroid) of the recorded AE waveforms were inputted to the algorithm. The optimal number of clusters was estimated (Figure 7) to be equal to 2 and the clustering process defined Cluster 1 containing 104,338 AE hits (15.6% of the total), and Cluster 2 containing the remaining 565,858 ones (84.4% of the total). It seems reasonable to assume that one cluster is related to fretting fatigue damage, while the other one to background noise.
