Structural health monitoring of an onshore steel wind turbine

Abstract

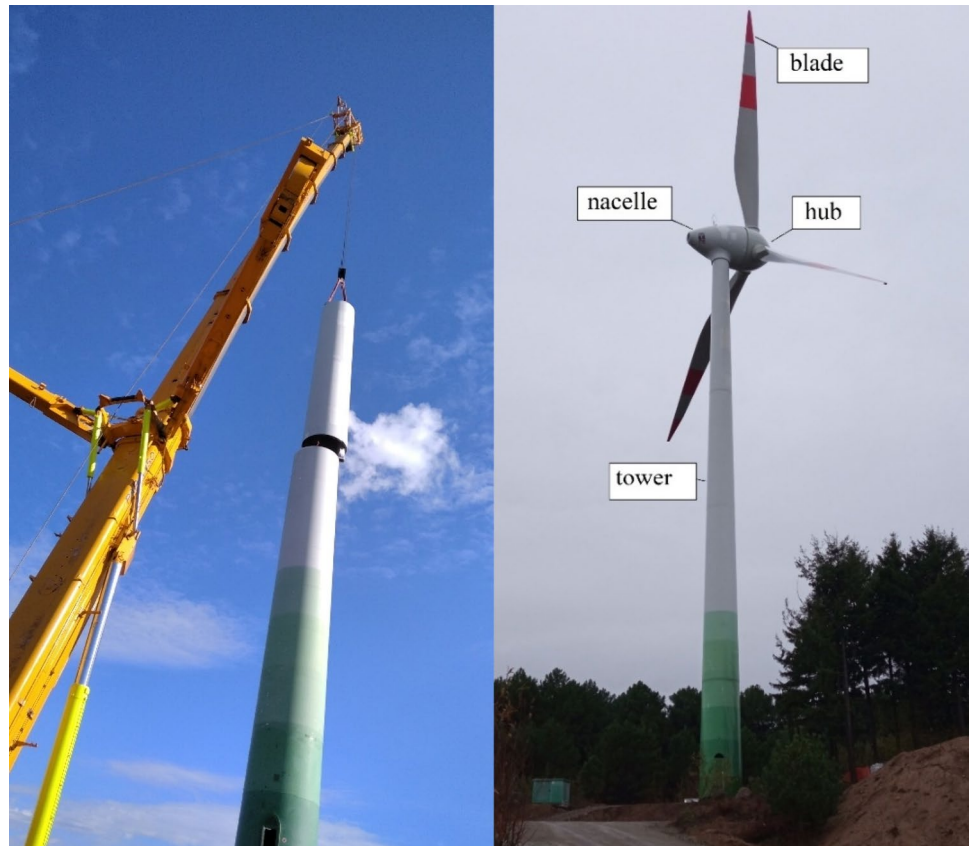
Fig. 2 A tubular steel tower and its main components

Different types of wind towers are marketed, which can be placed on land (onshore) or in the open sea (offshore); onshore steel turbines are generally realised using a tubular steel column with different diameters along the height (Fig. 2), whereas, in the case of offshore structures, a lattice

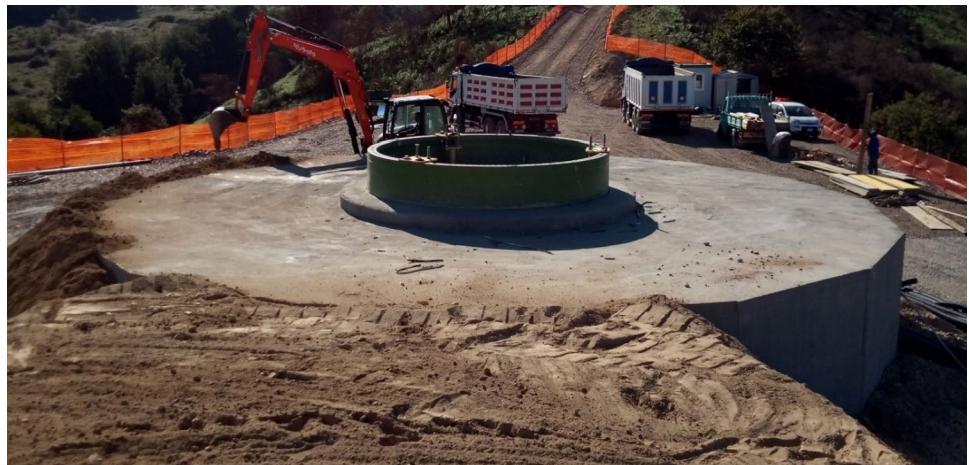
Fig. 3 Typical wind turbine foundation in reinforced concrete

In general, steel turbines are designed to have a 20-year service life before being dismantled, producing enormous environmental issues. Some authors proposed very clever and interesting solutions to reuse the waste steel coming from dismantled turbines [20]; however, these do not consider the reuse of foundations, which are huge reinforced concrete blocks that cannot be easily removed from the ground (Fig. 3).

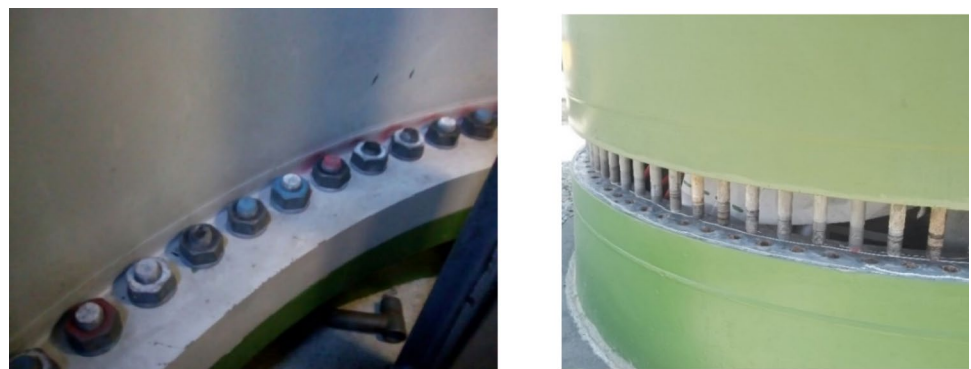
Fig. 4 Typical flange-to-flange connection with high-strength preloaded bolts

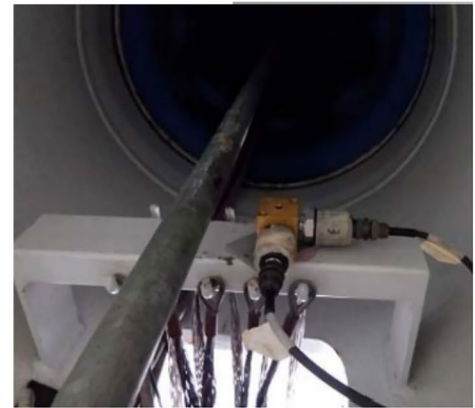
Accelerometers Pos.6

Strain gauges (Area 1)

Fig. 6 The monitored tower with the position of the instruments

fixing the strain gauges in position with the proper adhesive. Afterwards, the sensors were cabled and the protective coating was finally applied to protect both the sensors from dust and humidity and the tower steel from corrosion (Fig. 6).

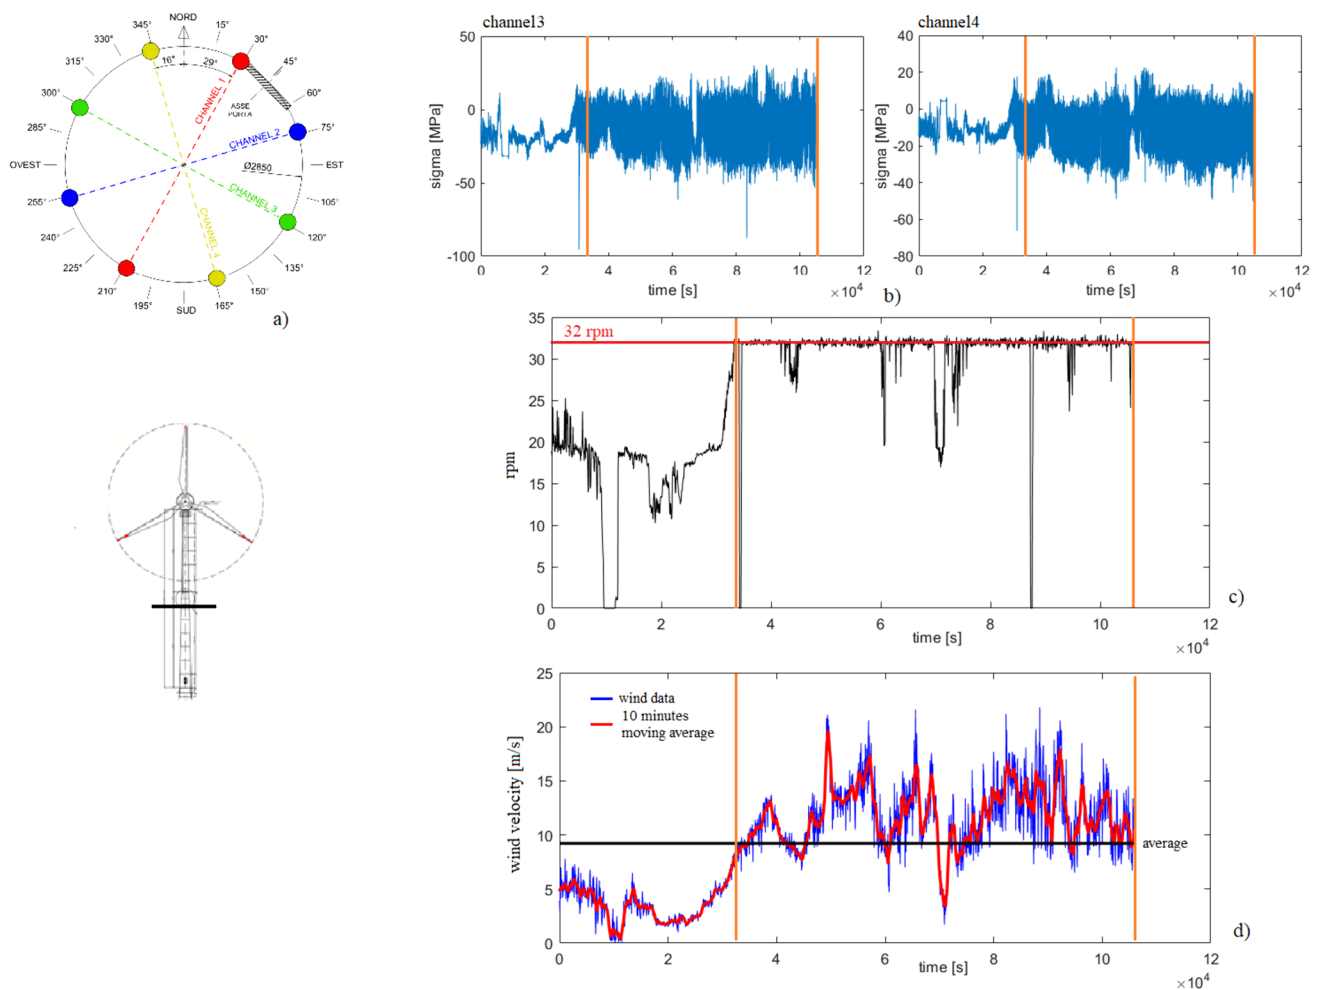
Fig. 12 Output associated with the tower in resonance for about 20 h: **a** position of the channels, **b** stresses vs time, for ch3 and ch4, **c** rpm vs time (red line represents 32 rpm value), and **d** wind velocity.

The part between vertical lines corresponds to the area in which the 32 rpm value was reached (colour figure online)

To further explore the resonance problem, during a windy day (30th April 2022) the tower was made to work at its limit for 20 h. In Fig. 12 the output in terms of maximum stresses and rpm is shown. A great increase in the monitored stresses can be observed with respect to the initial part of the registration for which the stress level is comparable to the ones displayed in the previous figures. The phenomenon is directly linked to the initiation of the structural resonance, which results in a dangerous state of stress for the tower. A typical resonance effect is an unconditional increase in the displacements in time with limited effect by the structural damping. The limit of 32 rpm is hence necessary to guarantee the tower's safety and cannot be overpassed, not only with respect to the fatigue life but also regarding the maximum admissible stresses themselves.
