Flume tests on fluvial erosion mechanisms in till-bed channels

Leila Pike,¹ Susan Gaskin^{1*}

Earth Surface Processes and Landforms

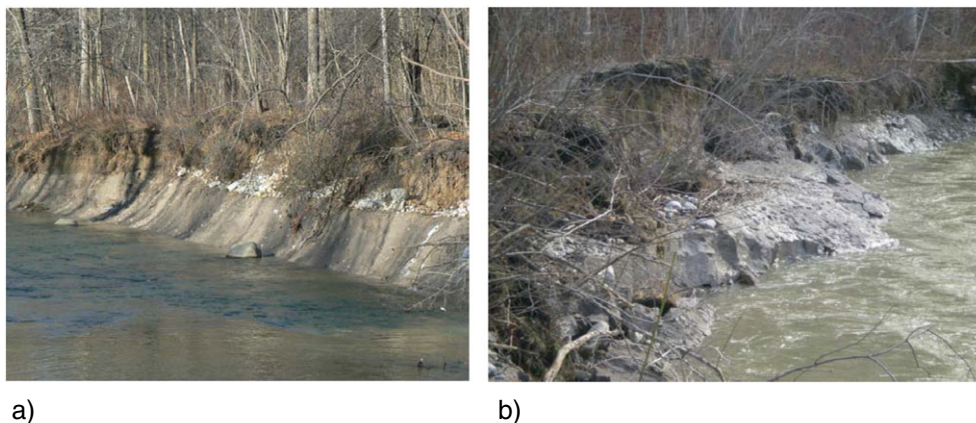
Figure 2. (a) Medway Creek bank showing till in lower bank with overlying sand and gravel. (b) Till at base of bank extending across the bed below the water. [Colour figure can be viewed at wileyonlinelibrary.com]

Medway River has a catchment area of approximately 200 km². Water Survey of Canada has operated a gauging station near the sampling site since 1947 at which the mean annual discharge is 2.8 m³/s, and maximum daily and instantaneous discharges are 117 and 146 m³/s, respectively. Annual maximum daily mean discharge with 2.3 and 5 year recurrence intervals are approximately 60 and 80 m³/s. Till is exposed in the bed and banks along the sampled reach (slope of 0.0042) and in places is covered by a layer of alluvial gravel–cobble up to 0.3 m thick (Hrytsak, 2012) (Figure 2).

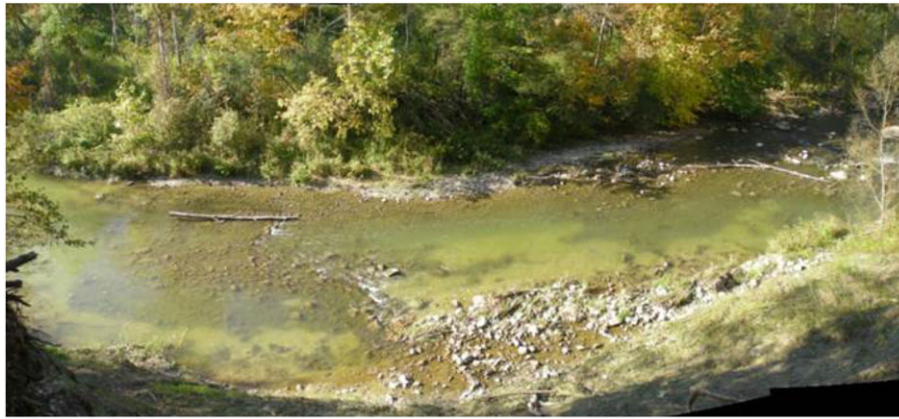
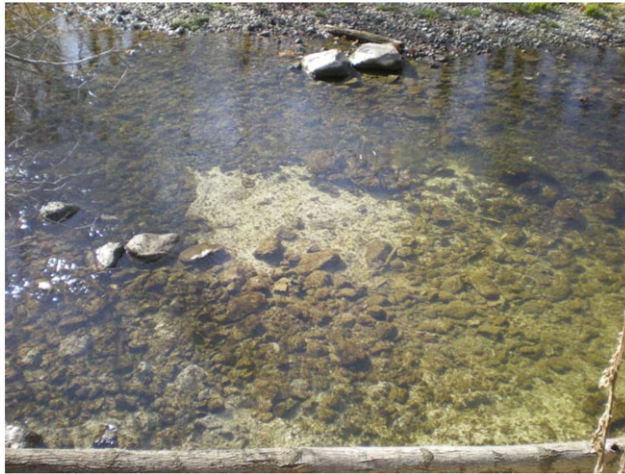
Figure 5. (a) Overview of channel showing exposed till (light patches) and thin gravel cover layer. (b) Close up view of till patch exposed beneath gravel cover. [Colour figure can be viewed at wileyonlinelibrary.com]

Gravel and cobbles could be seen embedded in the till, and pockets were visible where embedded particles had been removed. The till may therefore be a source of the gravel–cobble cover on the bed, as are the thin gravel layers in the eroding banks. Loose gravel mantles some areas of the bank toe and a discontinuous gravel–cobble alluvium with occasional boulders covers the river bed (Figure 5). Previous sampling in the reach (Hrytsak, 2012) showed that 50–70% of the bed area has some cover. In some areas the cover is only one grain thick, but thicker (and finer-grained) bar deposits also occur. Averaged over the reach, gravel cover thickness is 0.24 m (Hrytsak, 2012).

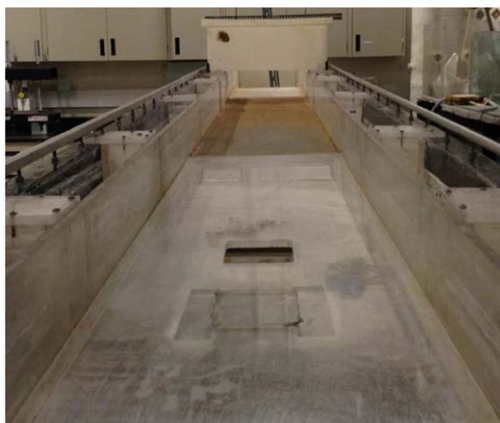
Figure 6. (a) Plan view of flume and sample location. (b) Photo of flume photo showing block placement. [Colour figure can be viewed at wileyonlinelibrary.com]

fluvial stresses equivalent to those at the bed of the channel. The shear stress is the parameter causing erosion and the size of the sample selected (10 cm × 10 cm) was large enough to study the mass erosion due to the till's structure. A 4 m long by 0.4 m wide by 0.15 m deep recirculating hydraulic flume was used to test the samples (Figure 6).

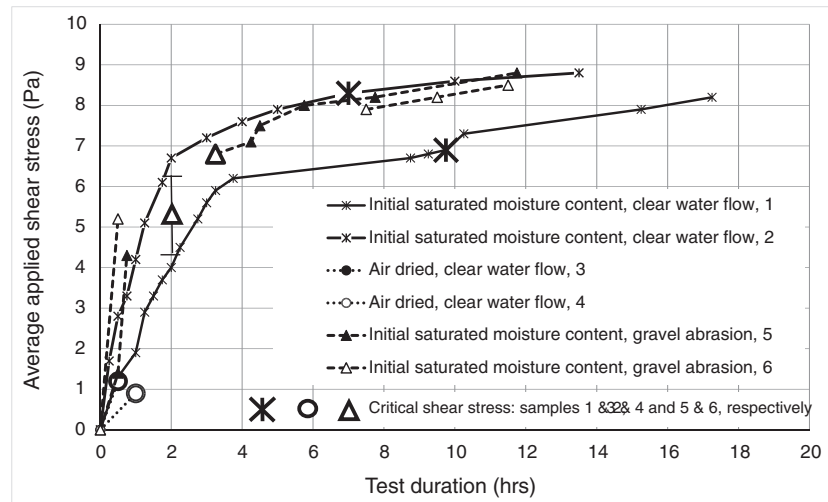
Figure 7. Flume erosion test results of the applied shear stress versus time (—, ---, ···) and the critical shear stress (x, O, Δ) for each sample type: initial saturated moisture content, air dried and initial saturated moisture content with gravel abrasion.

The critical shear stress values for the six samples obtained from the hydraulic flume studies are summarized in Figure 7. Critical shear stress ranged from 0.9–8.3 Pa. (Table II). Critical shear stress was almost an order of magnitude lower for the two air-dried samples (3 and 4) compared with the samples at the initial saturated moisture content, and the presence of loose gravel moving over the till reduced critical shear stress slightly compared with the absence of gravel. The plot of applied stress over time for samples 5 and 6 reflects the fact that at times the samples were completely covered by gravel and it was assumed that stress on the till surface was effectively zero under those conditions.

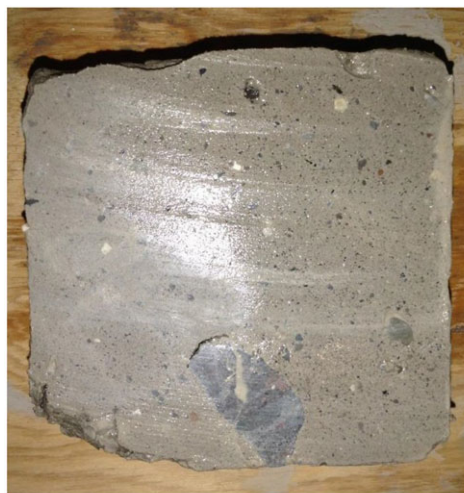
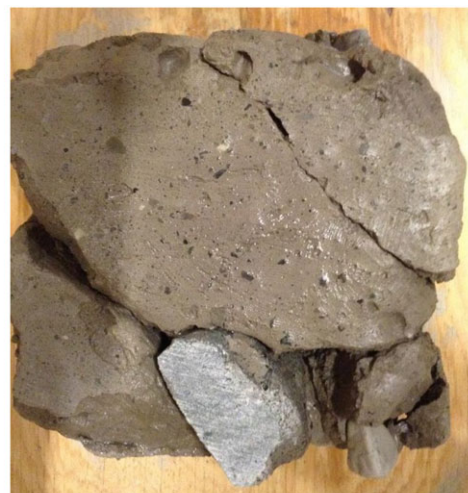
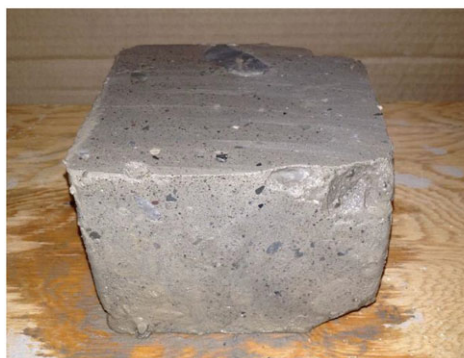
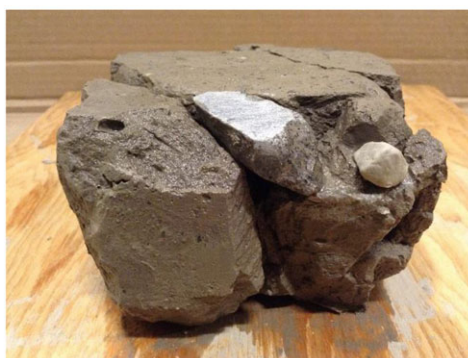
Figure 8. Sample 2, initial saturated moisture content clear water flow, (a) before and (b) after erosion test top view, (c) before and (d) after erosion test side view. [Colour figure can be viewed at wileyonlinelibrary.com]

Samples 1 and 2 showed similar erosion behaviour (Figure 8, sample 2 shown) to mass erosion defined as block separation and detachment and fluvial scour or surface erosion. Sample 1 eroded by a mass erosion process in which spontaneous fracturing delineated small blocks of till, which eventually detached from the sample. The first sign of weakening of the till sample was a crack developing down the middle of the sample at an applied shear stress of 6.7 Pa, appearing to split the entire sample in half. With a further increase in the applied shear stress to 7.9 Pa, a block of till adjacent to the crack became detached and eroded – this point was assumed to be the critical shear stress of the sample. Further increase in the shear stress did not yield more mass erosion (block separation and detachment), however, embedded gravel pieces within the surface of the sample were slowly revealed as fluvial scour (surface erosion) of the clay matrix occurred. In Sample 2, very small gravel pieces were eroded from the surface of the sample by first becoming more exposed by surface erosion of the matrix and then being plucked from the surface at a shear stress of 6.7 Pa. With a further increase to 7.6 Pa, cracks began forming at the surface, including a large crack originating from a large gravel piece and extending to the edge of the sample. At 8.3 Pa, blocks of till began detaching from the cracked areas, and this was taken to be the critical shear stress of the sample. As the applied shear stress increased to 8.8 Pa, more large cracks formed along the surface and the sample continued to undergo mass erosion (block separation and detachment).

Erosion of the air-dried samples (3 and 4) occurred by fluvial scour/surface erosion as soon as the sample was subjected to flow at the minimum shear stress of 1.2 and 0.9 Pa for both samples. Surface erosion began immediately at the edges of the sample and around large gravel particles embedded in the sample. Gravel particles detached from the sample when they became fully exposed. On sample 4, erosion also occurred by removal of very small pieces of the fine-grained matrix. Within 30 min both samples had lost a large proportion of their initial mass (Figure 9). Erosion of the air-dried samples was effectively by disintegration of the sample into sub-millimeter particles delineated by the microfissures, the larger-scale mass failure and cracking seen in the initial moisture content samples did not occur. The observed moisture content of the air-dried sample after testing (a mass of very small particles) had increased to 23–24% (compared with 10–11% of the initial water content sample) due to the microfissures resulting in a higher surface area and allowing for increased absorption of water. These observations show that wetting and drying has a substantial effect on the erosional resistance, as seen in a comparison of Figures 8 and 9.
