## Ukrainian Journal of Nephrology and Dialysis

Desai A, Bennikal M, Bangari G, Janaky M, Manjunath R

### Malpositioned dialysis catheters: A case series

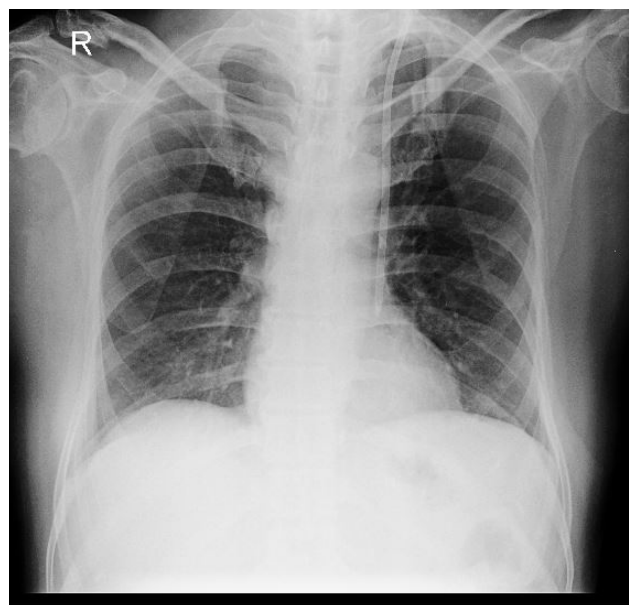
had a straight course rather than a curved course of the brachiocephalic vein. Chest X-RAY (Fig. 1a) showed the catheter to be malpositioned.

Fig. 1a. Chest radiograph of the patient showing the straight course of the catheter through persistent SVC.

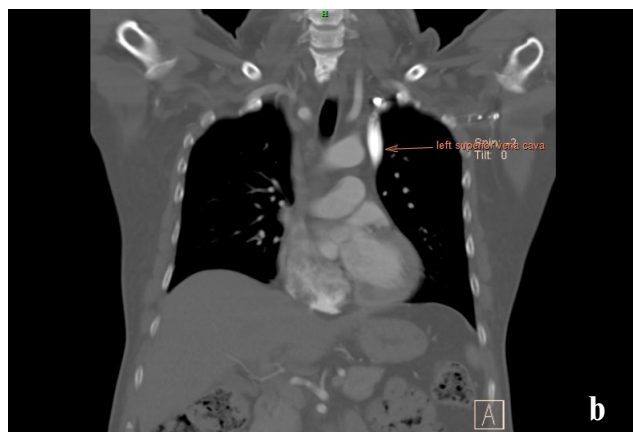
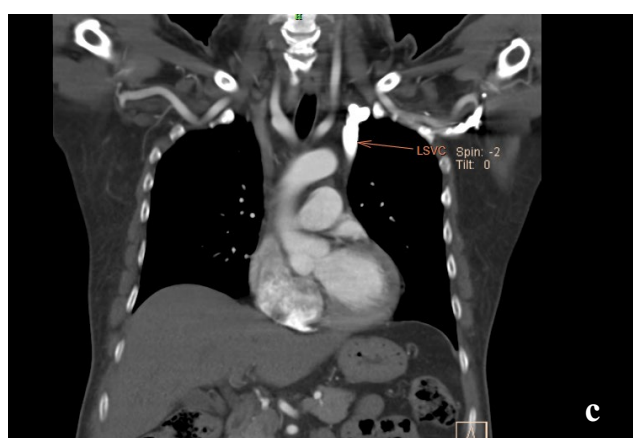
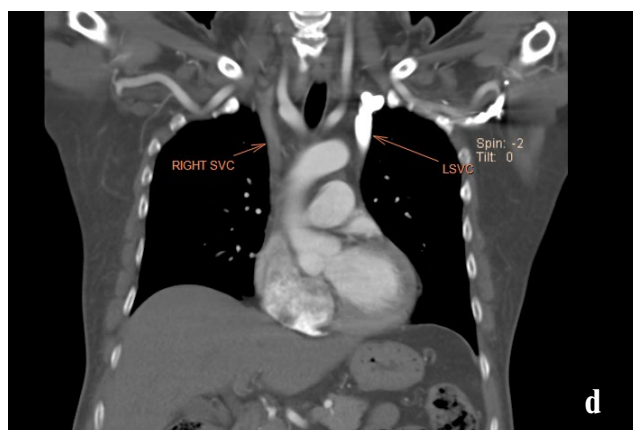
Possible catheter locations may be in the mediastinum, superior intercostal vein, or a hemizygous vein. However, the patient remained asymptomatic. A computed tomography (CT) scan was done, which showed the catheter to be in the persistent left superior vena cava (SVC) (Fig. 1b, 1c, 1d).

Fig. 1b-d. CT chest images reveal persistent left SVC and Right SVC.

Cardiac echocardiography did not reveal any other congenital heart defects. Blood flow of 350 ml per minute and adequate clearance were noted during hemodialysis using the catheter placed in the left SVC. Hence, the patient continued dialysis from the catheter and transitioned to right brachiocephalic AVF over the next five months.

Persistent left superior vena cava is the most common abnormality of systemic venous circulation, with an incidence of 0.3% in the general population. This congenital anomaly is not usually associated with other cardiac defects [5]. In one of the patients, the left IJV catheter was found entering the persistent left SVC. Since the flow was good, the patient continued dialysis via the same catheter.

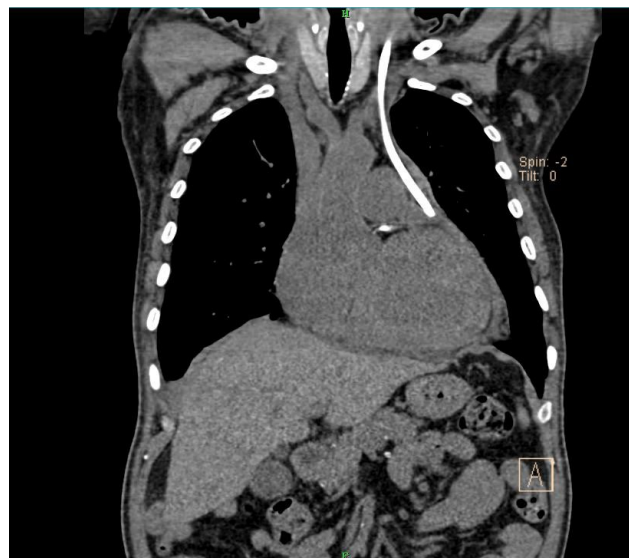
**Case 2.** An elderly male with a history of diabetes mellitus, hypertension, and CKD-5D had multiple failed vascular accesses and presented features suggestive of catheter-related bloodstream infection. His right IJV tunneled catheter was removed. He underwent left IJV non-tunneled catheter insertion under ultrasound guidance. The patient complained of retrosternal chest pain after the procedure, and the post-procedure Chest radiograph was inconclusive. A CT scan of the chest revealed that the left IJV catheter was in the pericardial space, following which it was removed (Fig. 2).

Fig. 2. CT chest revealing the left IJV catheter in the pericardial space

The time to remove it from insertion was 50 minutes. A suitable femoral catheter was secured, and the patient underwent heparin-free dialysis uneventfully. The patient remained hemodynamically stable with stable hemoglobin levels, assessed every sixth hour. A repeat CT and cardiac echo scan after 12 hours and 24 hours later did not show any mediastinal or pericardial collection. Later after one week, the patient underwent a Left Tunnelled catheter under fluoroscopy and continued dialysis via the same

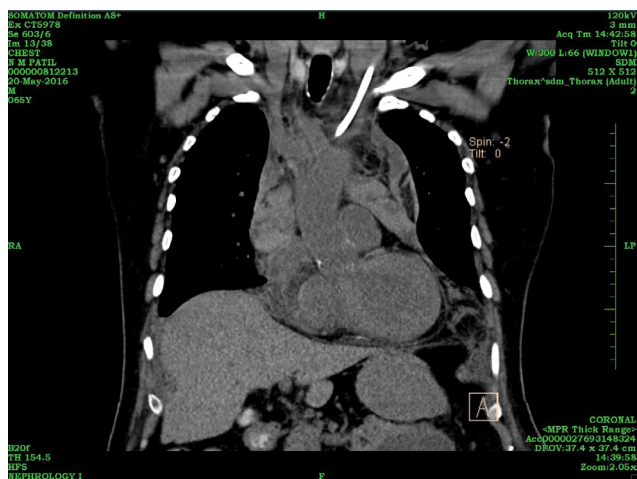
**Case 3.** An elderly male with a known history of HTN, CKD-5 not on dialysis, with primary failure of left brachiocephalic AVF, presented with uremic complaints and volume overload. As he was scheduled for a right brachiocephalic AVF, a dialysis catheter was inserted into the left IJV (MAHURKAR™\* 12 Fr High-Pressure Triple Lumen Acute Dialysis Catheter, 13 cm). The patient complained of retrosternal chest pain during insertion. As the X-ray chest was not conclusive, a CT chest was done. CT chest revealed that the catheter had punctured the brachiocephalic vein (BCV). There was also a mediastinal hematoma (Fig. 3a, 3b, and 3c). The catheter was immediately removed, and a femoral dialysis catheter was inserted.

Fig. 3a. The left IJV catheter crossing over to the right.

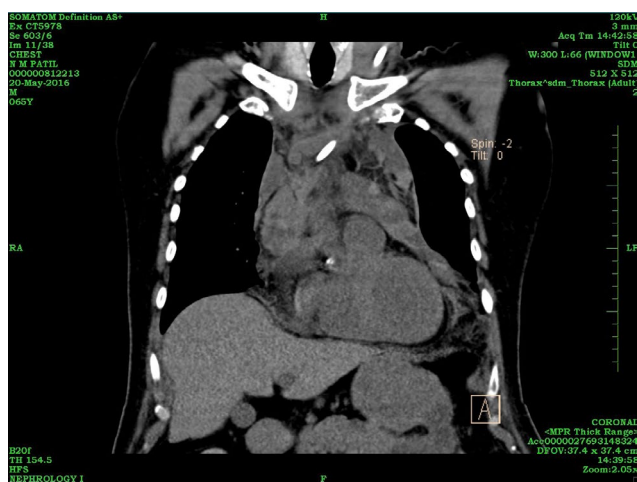
Fig. 3b. The left IJV catheter piercing the brachiocephalic vein.

Bleeding and hematoma formation associated with CVCs are usually resolved by placing icepacks and compressions, but an invasive surgical procedure to close the bleed site might sometimes be needed. The left IJV pierced the innominate vein causing mediastinal hematoma in one of our cases. The catheter was removed, and the right IJV was secured. Previous studies have reported favorable fatal outcomes after the malpositioning of the HDC into the mediastinum [8-10]. Treatment options for complications are primarily based on the position of the injured vessels, the stability of the patient, and available expertise. While ballooning and surgical repair were advocated for injured more prominent veins, treatment for smaller superficial veins included close observation and manual compression [9, 10]. Under close surveillance, stable patients with left BCV puncture and even with an anterior mediastinal hematoma up to 5 cm in size may be managed conservatively.

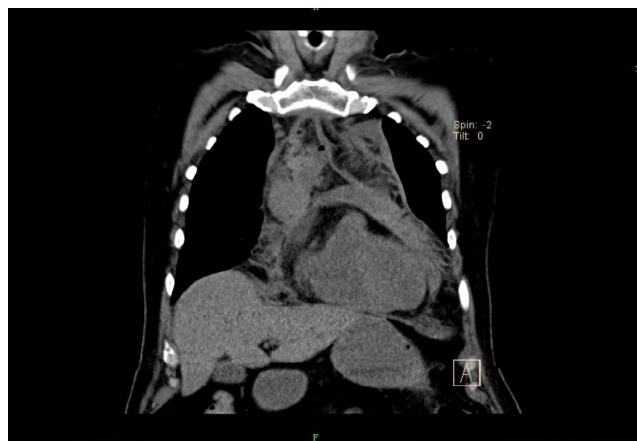
Fig. 3c. A mediastinal hematoma formed after the piercing of the brachiocephalic vein by the left IJV dialysis catheter.

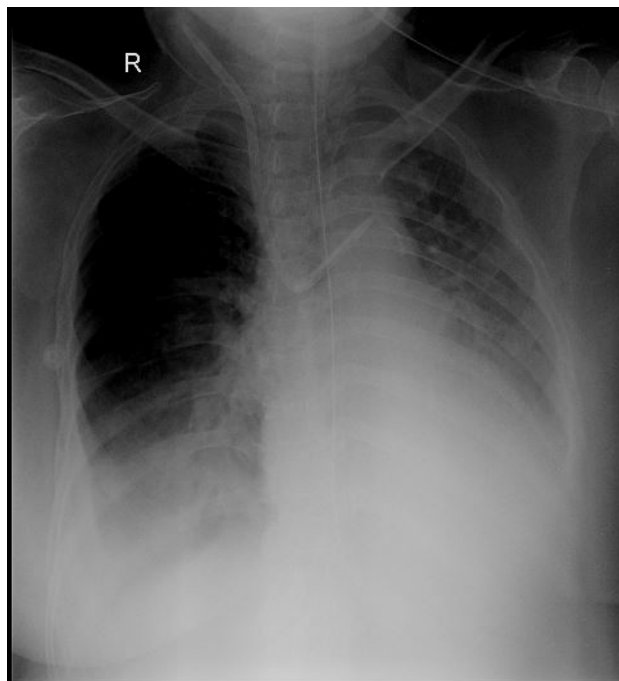
**Case 4.** An elderly female with no past medical illness was admitted for sepsis and septic shock. Hemodialysis was planned as the patient was diagnosed with acute kidney injury stage III. Right IJV double-lumen HDC(MAHURKAR™\* 11.5 Fr Dual Lumen Acute Dialysis Catheter) was inserted under ultrasound guidance. The right IJV HDC had traversed into the right

subclavian vein, as evidenced by the post-procedure radiograph (Fig. 4). The patient received hemodialysis via the same access without blood flow issues.

Fig. 4. The right IJV dialysis catheter traversing into the right subclavian vein.

The incidence of pneumothorax is higher with the insertion of CVC into the subclavian vein than the IJV, and the treatment includes inserting a chest drain. The published incidence of pneumothorax ranges from 0-3.3% with the radiological placement of tunneled CVC [1]. The suitable IJV catheter for one patient in our study went into the right subclavian vein. The patient succumbed to the disease.
