Management measures for ancient settlements threatened by coastal hazards at Boca do Rio, Algarve, Portugal

Ana R. Carrasco
Óscar Ferreira
A. Matias
João Alveirinho Dias
Universidade do Algarve

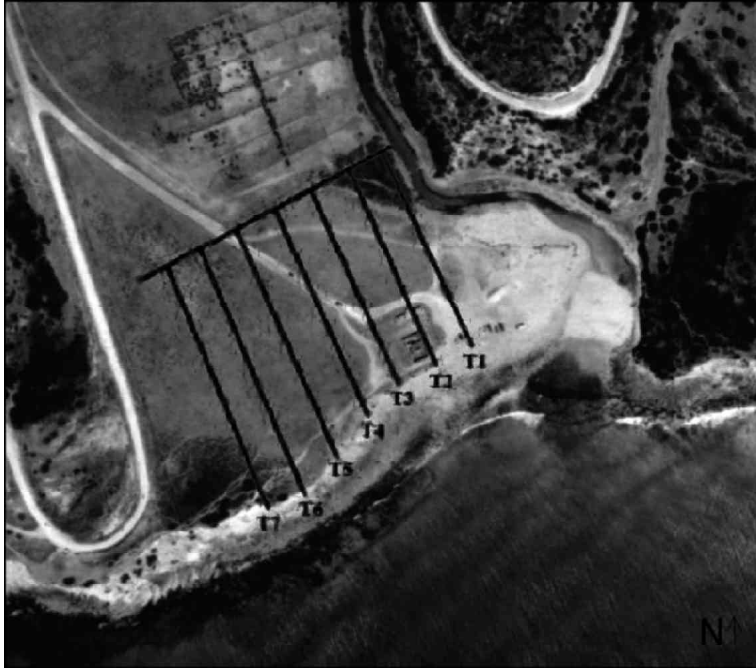
FIGURE 4. Aerial photo from 2001 showing the seven control lines normal to the coast and the imaginary shore-parallel line used to measure changes in the bluff position at Boca do Rio beach.

In order to quantify coastal retreat in the area during the last 50 years, vertical aerial photographs from 1945, 1976, 1988, and 2001 were analyzed. Coastal retreat at Boca do Rio beach was quantified by measuring the distance between the shoreline and an imaginary line parallel to it (Figure 4). Seven transects (T1 to T7) normal to the shoreline were defined to constrain longshore variability. The area of the Roman ruins extends between T4 and T6. For the purposes of this study, the shoreline along the beach section was defined as the contact between the toe of the bluff and the beach. Taking into account the scales of the aerial photographs, spatial measurement accuracies of between 4.2 and 13.9 m were determined.

In general, shoreline retreat was more pronounced in the central and western parts of the beach area (T3 to T7), probably due to spatial variation in exposure to waves. The eastern part is relatively re-entrant, while the western limit is more prominent (Figure 4). As a consequence, differences in the incident wave have led to different shoreline evolutions. In addition, the eastern area is under the direct influence of the stream mouth, being nourished by the discharged sediment. If coastal dynamic forcing mechanisms continue unaltered, and protective measurements are not implemented, this trend is expected to continue into the future. At medium to long-term it is expected to the Roman ruins sector a general shoreline retreat of about 0.25 m / year, and in special periods, a shoreline retreat up to 1 m / year.

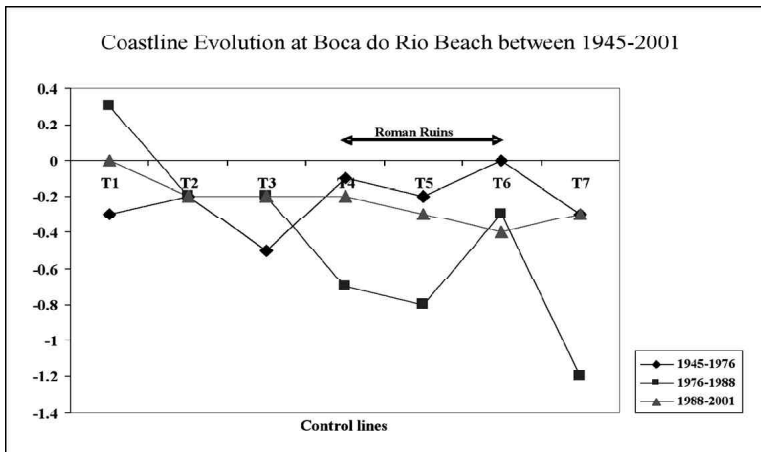
FIGURE 5. Shoreline evolution at Boca do Rio between 1945 and 2001. Negative values represent bluff or dune retreat and positive values dune recovery.

Aerial photo analysis shows a general tendency of coastal retreat at Boca do Rio beach (Figure 5). Shoreline retreat clearly dominates at all observed periods and for all considered transects (with exception to T1). Seaward shoreline displacement was observed only at T1 and only for the period 1976-2001. This was due to dune recovery next to the river mouth. Maximum shoreline retreats were observed during the 1976-1988 period. The coastline in front of the Roman ruins, which are located between T4 and T6, faced an

average shoreline retreat between 0.15 and 0.33 m / year, between 1945 and 2001, and a maximum retreat of 0.8 m / year between 1976 and 1988.

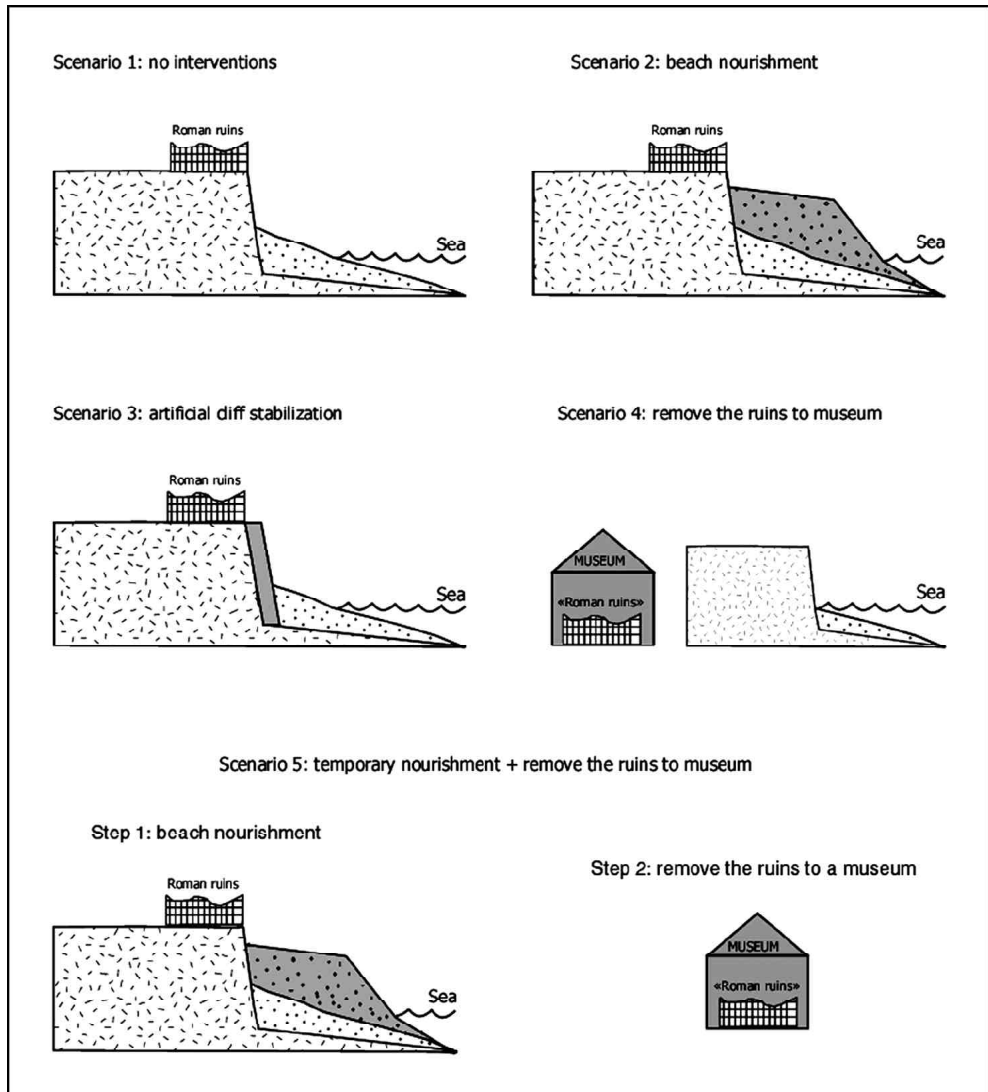
FIGURE 6. Management scenarios proposed to the Roman ruins of Boca do Rio.

For the Roman ruins at Boca do Rio beach, five management scenarios were defined (Figure 6) and scores for the factors assigned to each of them. The first scenario is a type 1 strategy, the second and the third scenarios are strategies from type 2, and the fourth and fifth scenarios are a type 3 strategy. No intervention along the beach (first scenario) is characterized as being of low cost (since there is no investment in coastal defences/management) and as allowing the destruction of the ruins in the short or medium term by coastal erosion (patrimonial degradation).
