Pakrashi, V., O'Connor, A., Schoefs, F., 2007. An Image Analysis Based Damage Classification Methodology. In: Kanda, J., Takada, T., Furuta, H. (eds) *Applications of Statistics and Probability in Civil Engineering: Proceedings of the 10th International Conference, ICASP10*. Tokyo, Japan, 31 July - 3 August 2007. London: Taylor & Francis. pp.147-148 ISBN: 9780415452113

# An Image Analysis Based Damage Classification Methodology

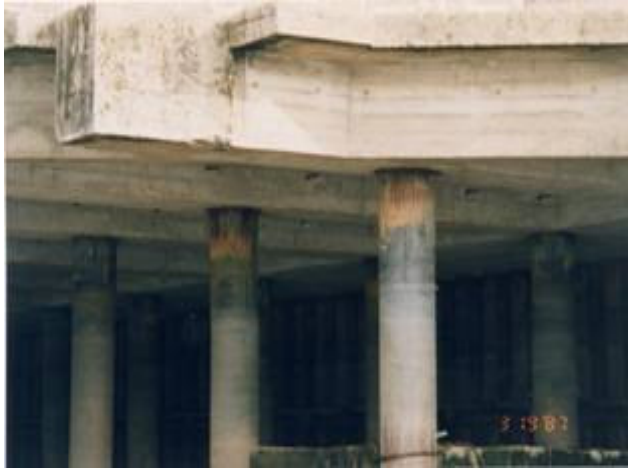
Figure 1. Steel piles with Corrosion.

The benchmark structure is a wharf located at St. Nazaire, France and the general arrangement of the wharf is provided in Figure 1. This wharf belongs to the category of on piles wharfs. It is located in the

Being in the marine environment, the steel piles are susceptible to corrosion and hence the assessment of the structural health of such a structure is considered to be of great practical importance. In fact steel piles play two major roles - the first being a mechanical function and the second being a protection of reinforced concrete inside against corrosion, which is generally uniform. Submarine inspections and investigations of localized corrosion have been observed by divers in this regard. These damage conditions have been recorded on video tapes and reported as pictures on inspection report. The damages look like pitting in white metals, which is usually why the corrosion is referred to as 'pitting corrosion'. This type of corrosion is often a consequence of the defects in the metals that the structure is comprised of. In fact, these piles come sometimes from the rebus of the pipe-lines (non-conforming pieces).

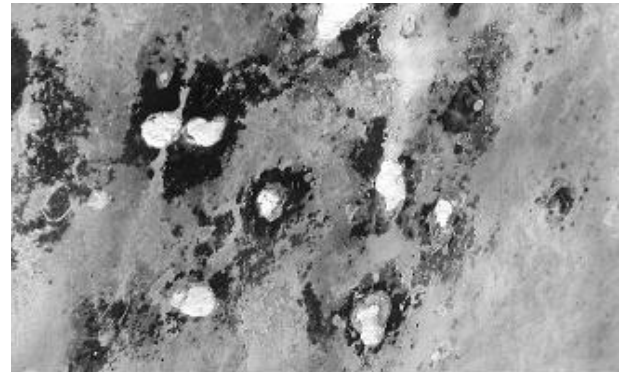
Figure 2. A Treated Specimen with Corrosion.

An example of a successful image processing based damage region detection as proposed in the paper is given in Figure 3, where Figure 2 has been successfully analyzed to isolate eight major closed damaged areas of irregular geometry with precision. Some spurious features are also identified due to the environmental noise but are insignificant with respect to the damaged regions. Sometimes, a visual idea about the spurious features can be helpful to preprocess the picture to make the computational effort of the pattern recognition scheme easier and the scanning region comparatively smaller.

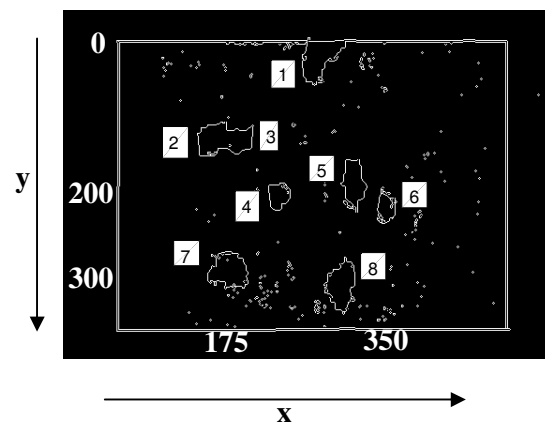
Figure 3. Detected Damage Regions in a Specimen.

It is also important to note that the objects labeled 2 and 3 in Figure 3 are considered to be a single object while processing and hence the combined geometric property of the system has been rendered instead of their individual statistics. This is due to the fact that in the real specimen the damages are in fact physically connected. However, by a proper control on preprocessing, lighting and camera resolution these two geometric regions can be separate incorporating some additional effort.

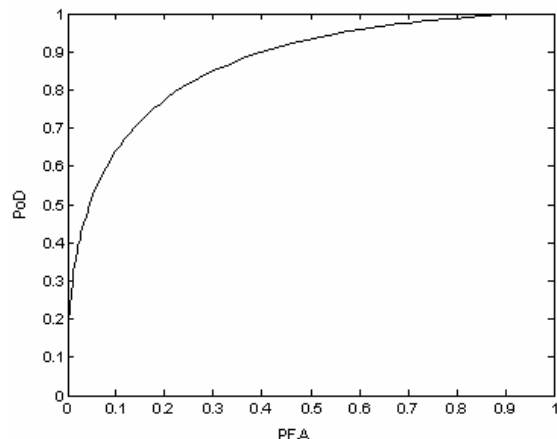
Figure 4. Receiver Operating Characteristic curve.

where  $A$  is the measured area.  $A_d$  is a deterministic parameter or a random variable. This definition implies that PoD is a monotonic increasing function. To complete this concept, the probability of false alarm has been introduced. It is the probability to defect a non-existing defect. For a given range of defects  $A_i$ , the curve that joints the points of coordinates (PFA,  $PoD(A_i)$ ) is called Receiver Operating Characteristic (ROC) curves (Arques (1982), Fücsök et al. (2000)). Such a curve is plotted on figure 4.

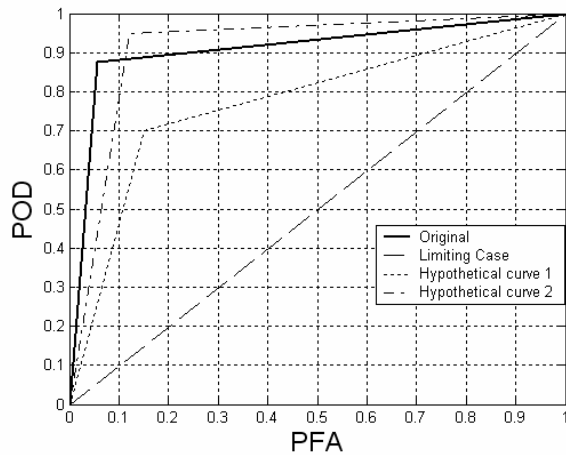
Figure 5 ROC Curves for the Current Problem.

An application of such a case is provided in the current problem and the results are provided in Figure 5. The ROC of the current detection condition is constructed. With the increase of resolution, the PoD detection increases, but so does the PFA. On the other hand with poor resolution characteristics within the image, both PoD and PFA are considerably low. It is only at some intermediate level of resolution is the optimized value obtained where a high PoD corresponds to a minimum of PFA. The effects of high and low resolutions are earmarked within the figure. Two alternative hypothetical curves in dotted lines are employed to emphasize the effects of the presence of other factors within the same methodology like lighting, nature of damage, etc.

The hypothetical ROC curves illustrate the uncertainties associated with the measuring conditions (which are variable) like luminosity, contrast, noise etc. and emphasize the shift of the efficiency achieved using the proposed NDT tool due to such uncertainties. It can be observed from Figure 5 that there may be possible cases where the ROC can be unsatisfactory due to the quality of the measured data itself and such situations can be identified by considering an envelope of ROC due to various conditions through existing data or simulations close to the chief governing conditions due to the change of the major affecting parameters. The efficiency and the robustness of the methodology are thus illustrated within the structural health monitoring framework in this regard.
