Physical Sulphate Attack on Concrete

Graduate Program in Civil and Environmental Engineering
A thesis submitted in partial fulfillment of the requirements for the degree in Master of
Engineering Science
© Ahmed Ramadan Suleiman 2014

PHYSICAL SULPHATE ATTACK ON CONCRETE

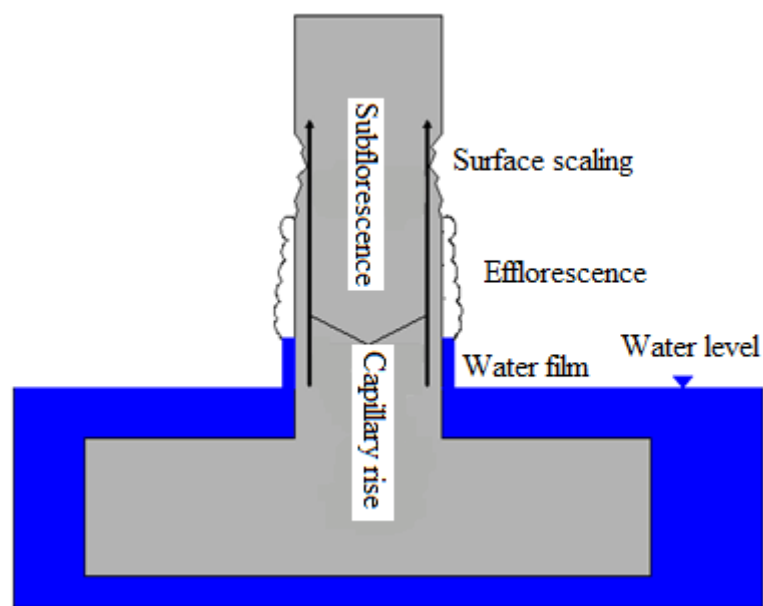
Figure 2.1: Schematic of capillary rise and concrete degradation in a foundation in contact with ground water that contains sodium sulphate.

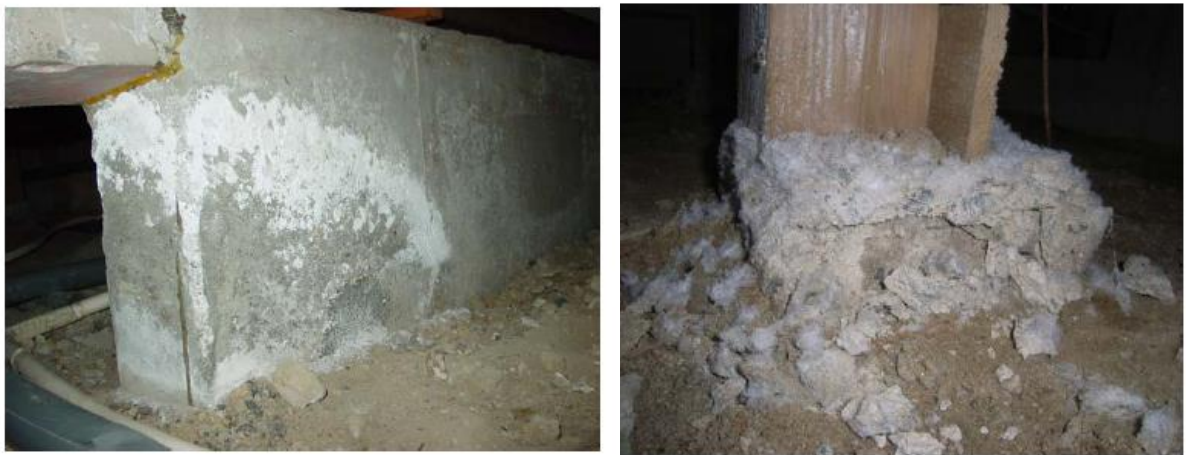
Figure 2.2: Concrete damage in field exposure to salt crystallization (Yoshida *et al.*, 2010).

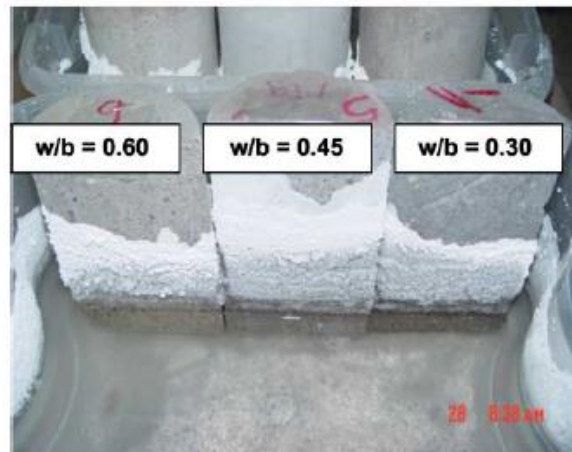
Figure 2.3: Salt efflorescence of concrete cylinders partially immersed in a sodium sulphate solution (Nehdi and Hayek, 2005).

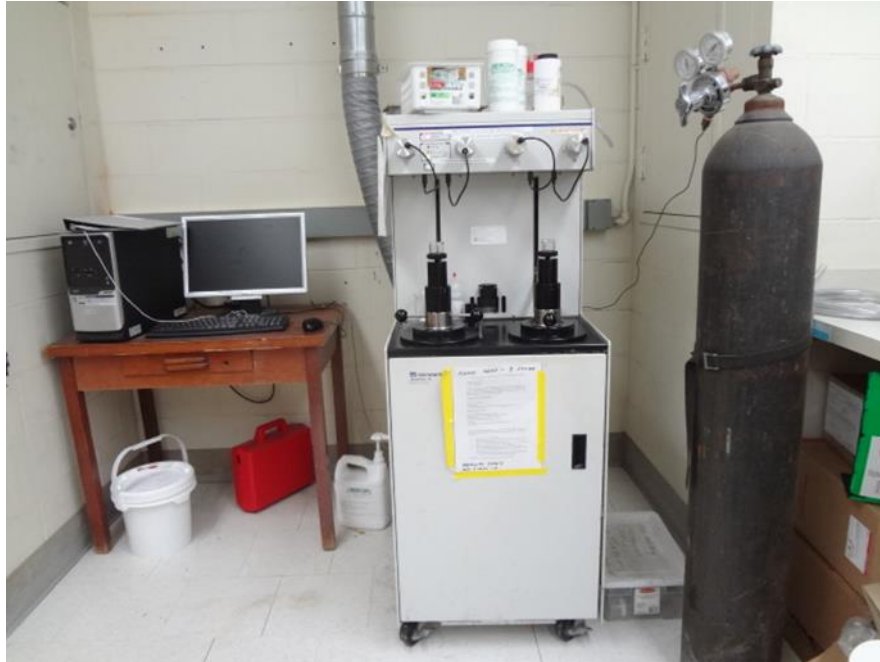
Figure 3.1: Illustration of MIP test apparatus.

mercury was 0.484 N/m [2.76x10⁻³ lb/in] at 25°C [77°F] according to ASTM D 4404 (Standard Test Method for Determination of Pore Volume and Pore Volume Distribution of Soil and Rock by Mercury Intrusion Porosimetry).

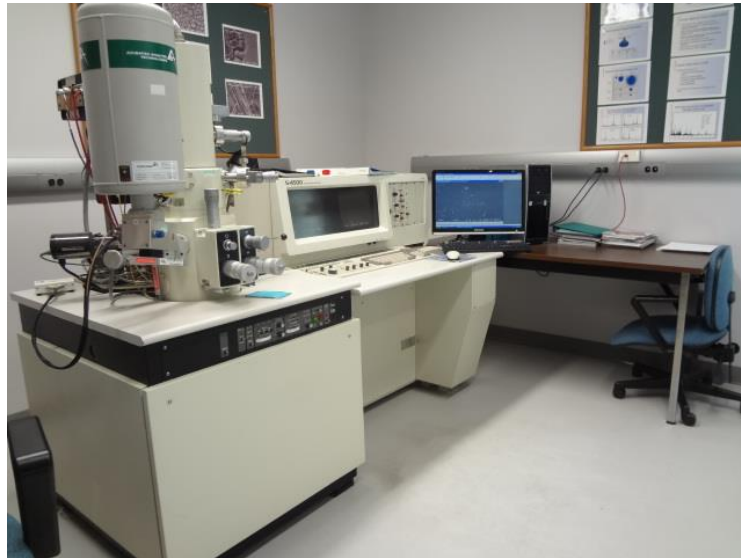
Figure 3.2: Illustration of SEM test apparatus.

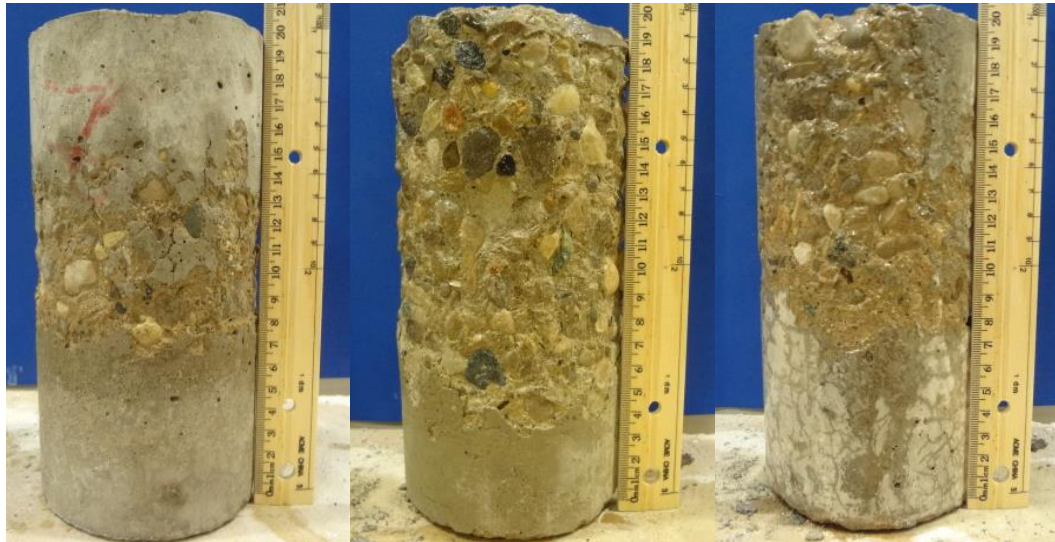
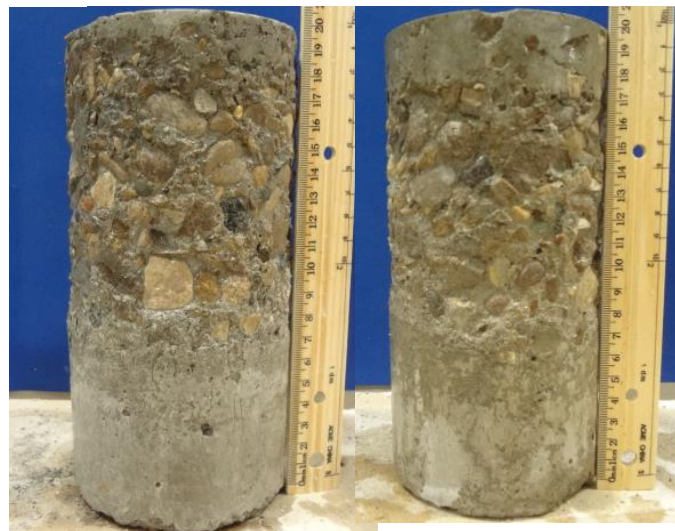
After one month of sulphate exposure (4 cycles of wetting and drying) scaling of concrete surfaces appeared above the sulphate solution level. The exposure was continued for up to six months (24 cycles of wetting and drying) and all concrete cylinders were inspected to diagnose the level of damage. **Figure 3.3** shows typical surface scaling above the solution level for the concrete cylinders. For all tested

cylinders, the portion of concrete immersed in the solution was found in intact condition compared with the damaged above solution part. Higher surface scaling above the solution level was found in the concrete specimens incorporating pozzolanic minerals compared to that of the specimens made with 100% OPC or 100% HS.

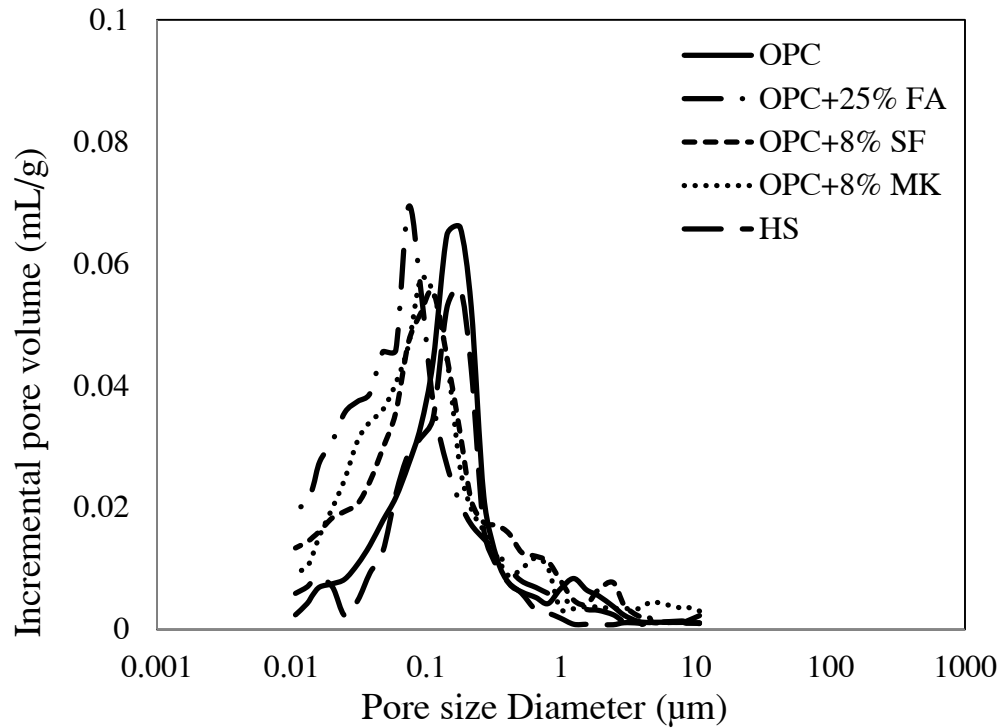
Figure 3.4: MIP results for different concrete mixtures before exposure to physical sulphate attack.

Figure 3.4 shows MIP test results for specimens from the various concrete mixtures before exposure to physical sulphate attack. Results indicate that concrete made either with pure OPC or HS cement incorporate pores with relatively larger diameter. Partially replacing the cement with pozzolanic minerals led to a decrease in the pore size diameter due to the pore refinement effect of pozzolanic minerals.

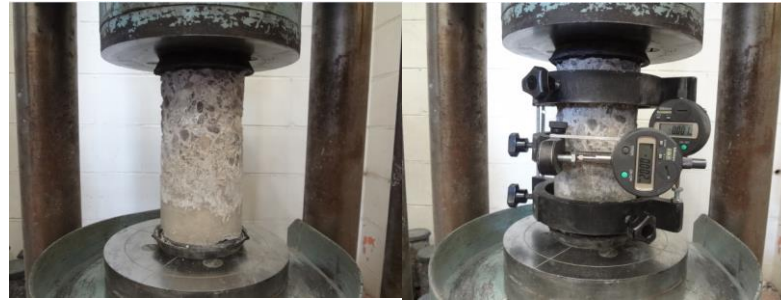
The compressive strength and static modulus of elasticity were measured for all the concrete cylinders partially immersed in the sulphate solution. Appendix B shows the results of the compressive strength and static modulus of elasticity tests. In addition, control specimens were reserved in the laboratory condition at temperature = 23°C [73.4 °F] and RH = 70% for 180 days. **Figure 3.5** shows the testing procedure. **Figures 3.6** and **3.7** show the compressive strength and static modulus of elasticity for concrete cylinders before sulphate exposure at 28 days and partially immersed in 5% sulphate solution at 90 and 180 days.

For all the concrete cylinders, the compressive strength and modulus of elasticity increased regardless of their surface damage. This indicates that the concrete core was in intact condition and the concrete surface scaling did not significantly affect the mechanical properties of the concrete. According to Boyd and Mindess (2004), applying a compressive stress on deteriorated concrete tends to close up internal cracks. Hence, compressive strength may not be a sensitive indicator for internal cracks. However, at six months, a decrease by 12.5 % occurred in the modulus of elasticity of the 100% OPC concrete cylinders in comparison with the control specimen. This suggests that the decrease in modulus of elasticity may be due to the chemical sulphate attack on the submerged portion of specimen. Concrete made with 100% OPC exhibited less surface degradation above the solution level than that of the other concrete cylinders incorporating binders that can resist the chemical sulphate attack.

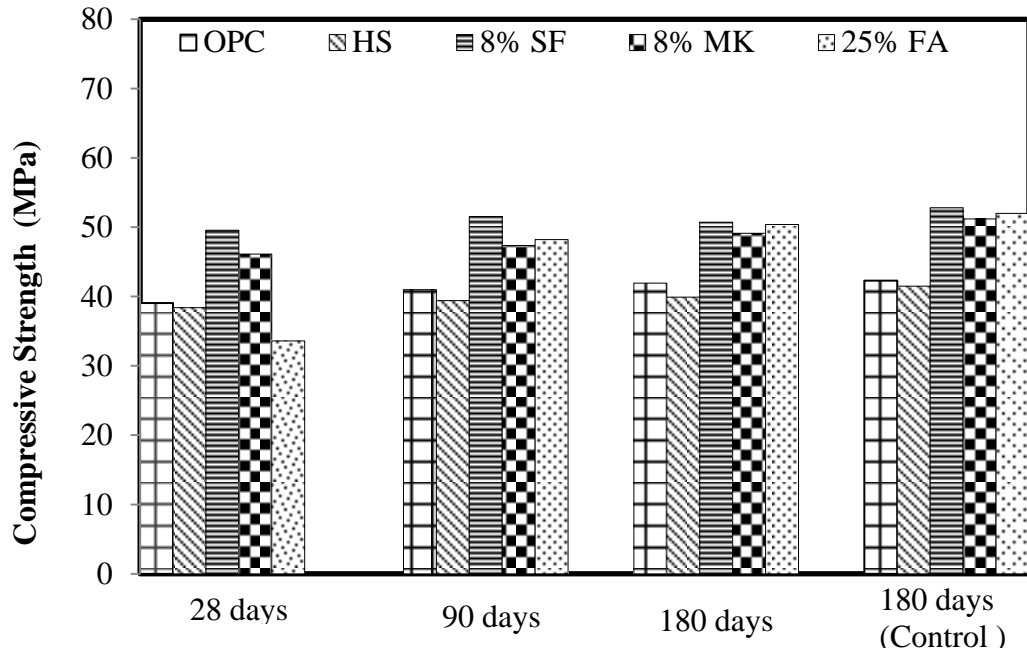
Figure 3.6: Compressive strength for concrete mixtures made with $w/b = 0.60$.

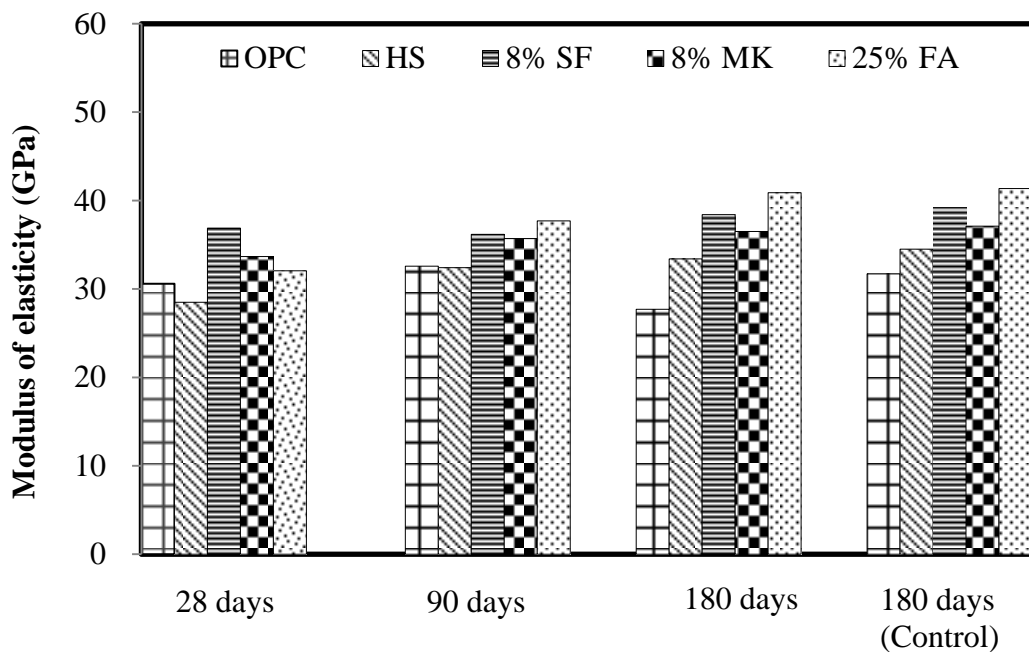
Figure 3.7: Modulus of elasticity for concrete mixtures made with $w/b = 0.60$.

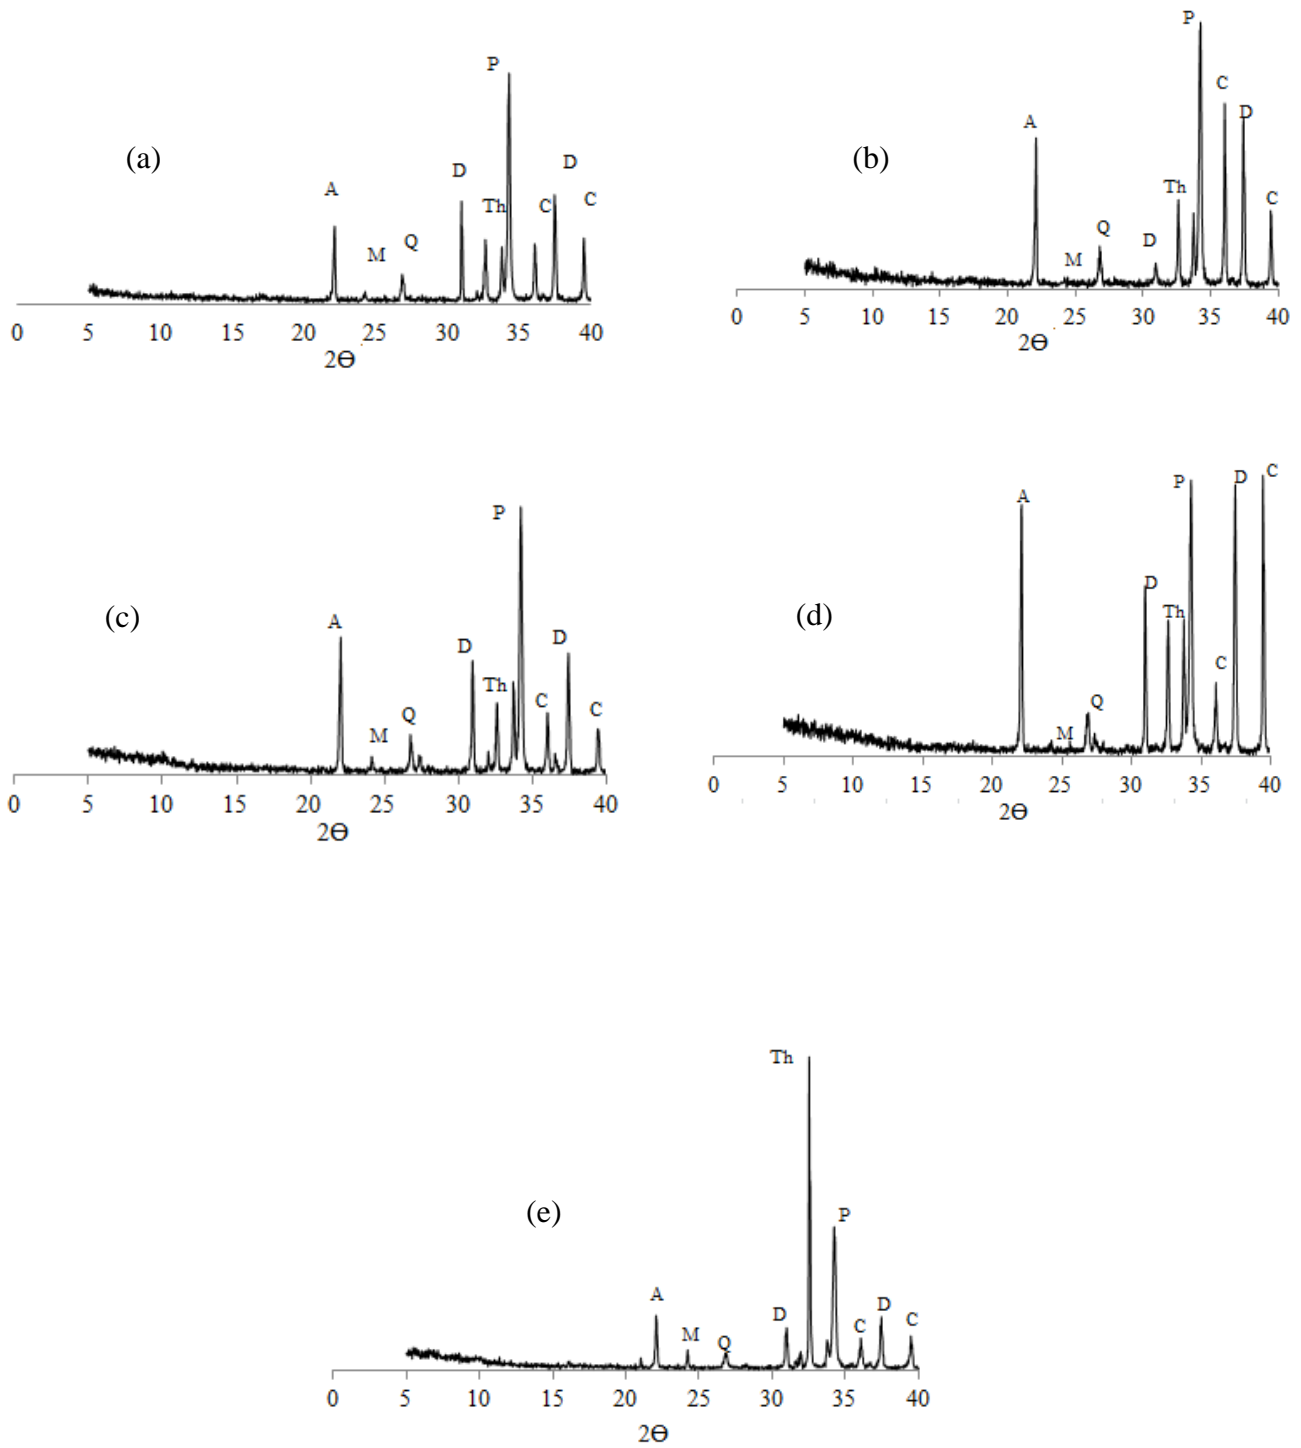
Figure 3.8: XRD results of concrete above the solution level: (a) concrete with OPC; (b) OPC + 25% fly ash; (c) OPC + 8% silica fume; (d) OPC + 8% metakaolin; and (e) concrete with HS. [A: Albite, D: Dolomite, Q: Quartz, P: Portlandite, M: Monosulfate, C: Calcite, Th: Thenardite].

Previous study by Liu *et al.*, (2012) suggested that the damage above the solution level is more likely caused by the chemical sulphate attack due to formation of high sulphate concentration in the upper part. Thus, extensive chemical sulphate attack can occur according to the theory of the chemical reaction. However, their study only relied on measuring the sulphate concentration above the solution level and did not show damage or formation of gypsum or ettringite above the solution level. Damage due to the chemical sulphate attack mainly results from expansion of the concrete due to formation of gypsum or ettringite. In the current study, surface scaling was occurred instead of concrete expansion. Thus, damage due to the physical sulphate attack above the solution level is the more likely the predominant mechanism.

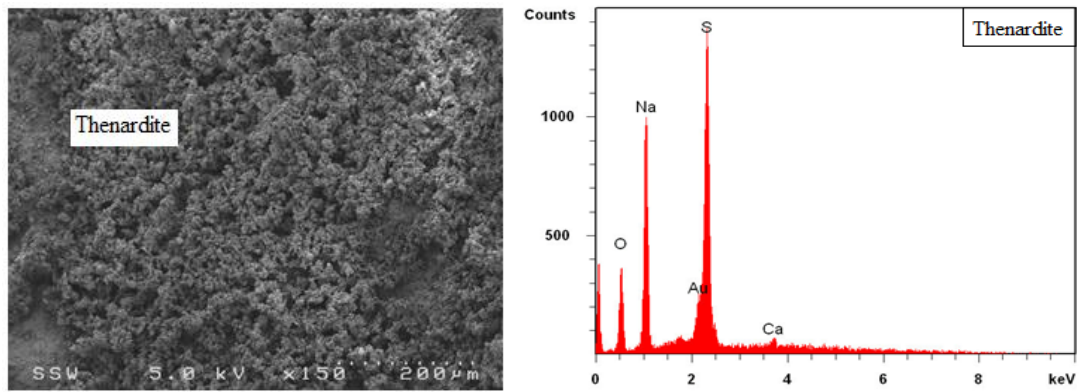
Figure 3.9: SEM and XRD analysis showing thenardite above the solution level.

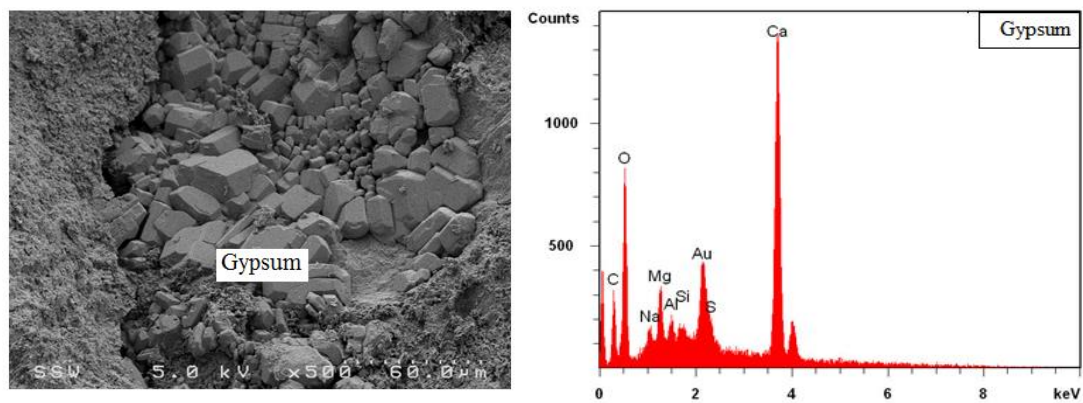
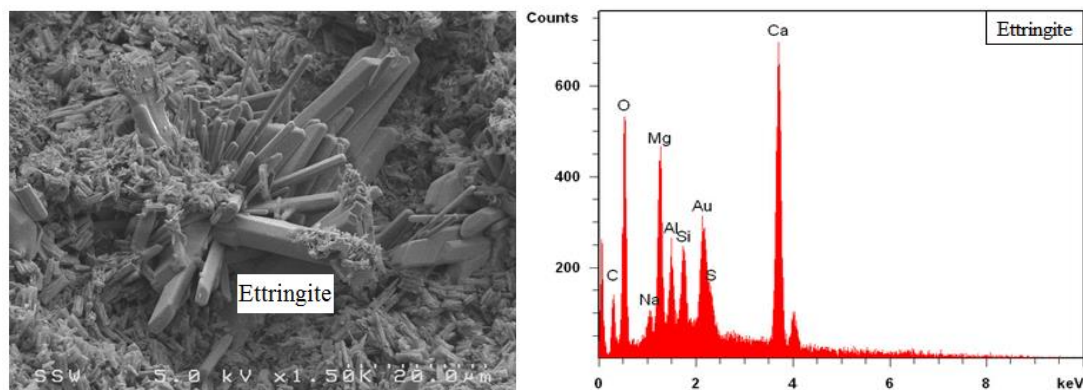
Figure 3.10: SEM and XRD analysis showing formation of gypsum and ettringite in the portion of concrete immersed in the sulphate solution.

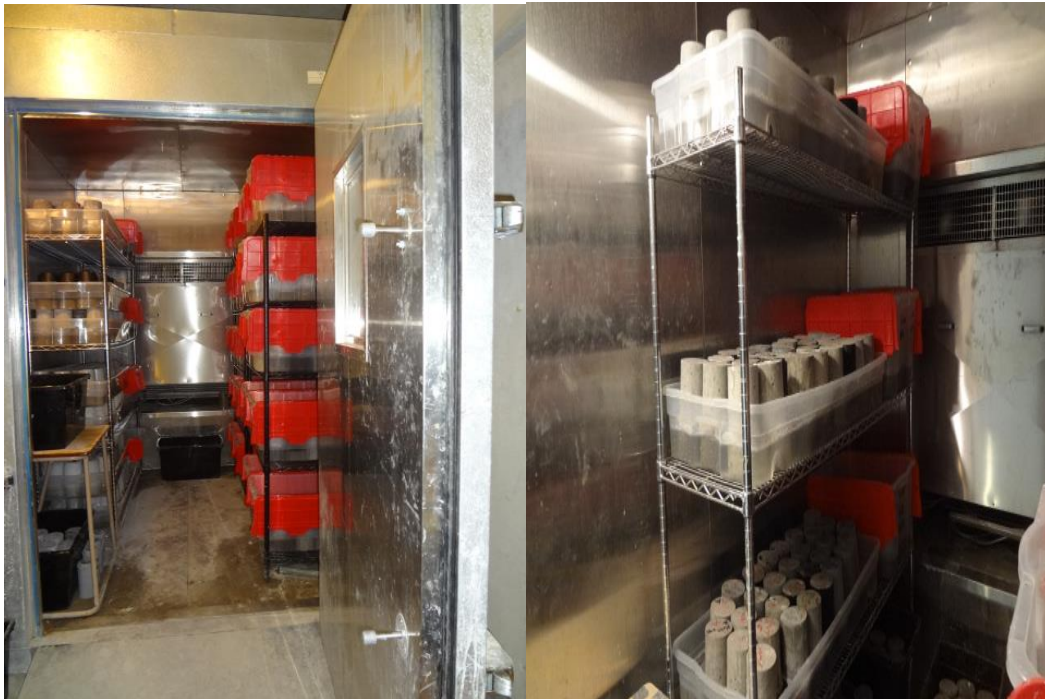
Figure 4.1: Tested specimens in the environmental chamber.

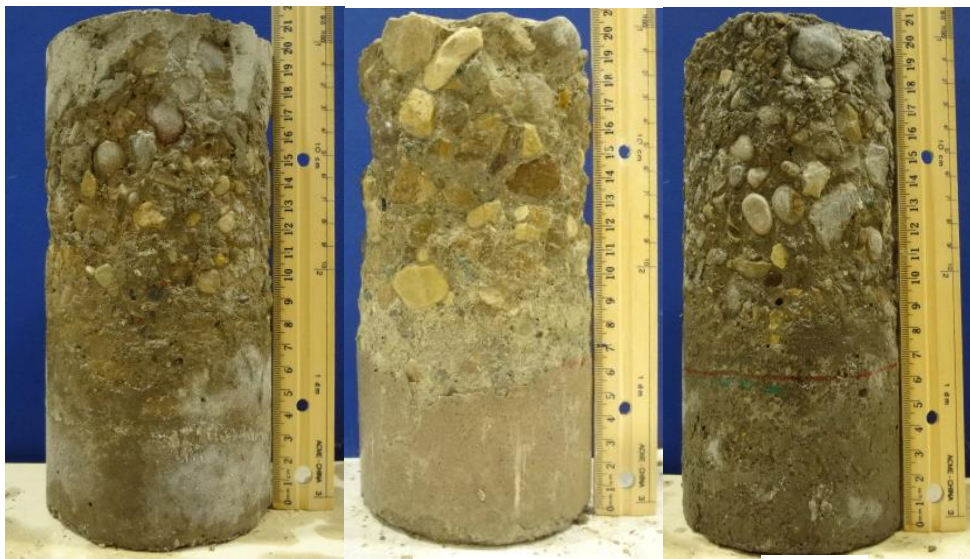
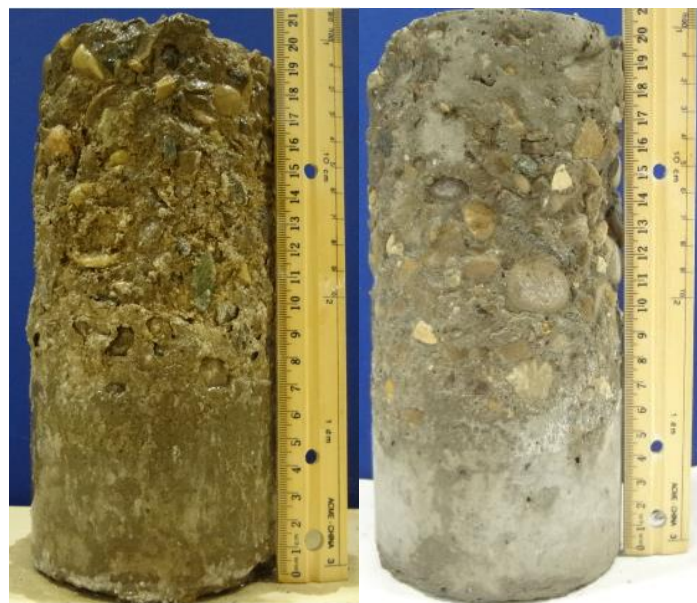
Figure 4.2: Non-cured concrete cylinders made with $w/b = 0.60$ after six months of physical sulphate exposure: (a) concrete made with OPC; (b) OPC + 25% FA; (c) OPC + 8% SF; (d) OPC + 8% MK; and (e) concrete with HS.

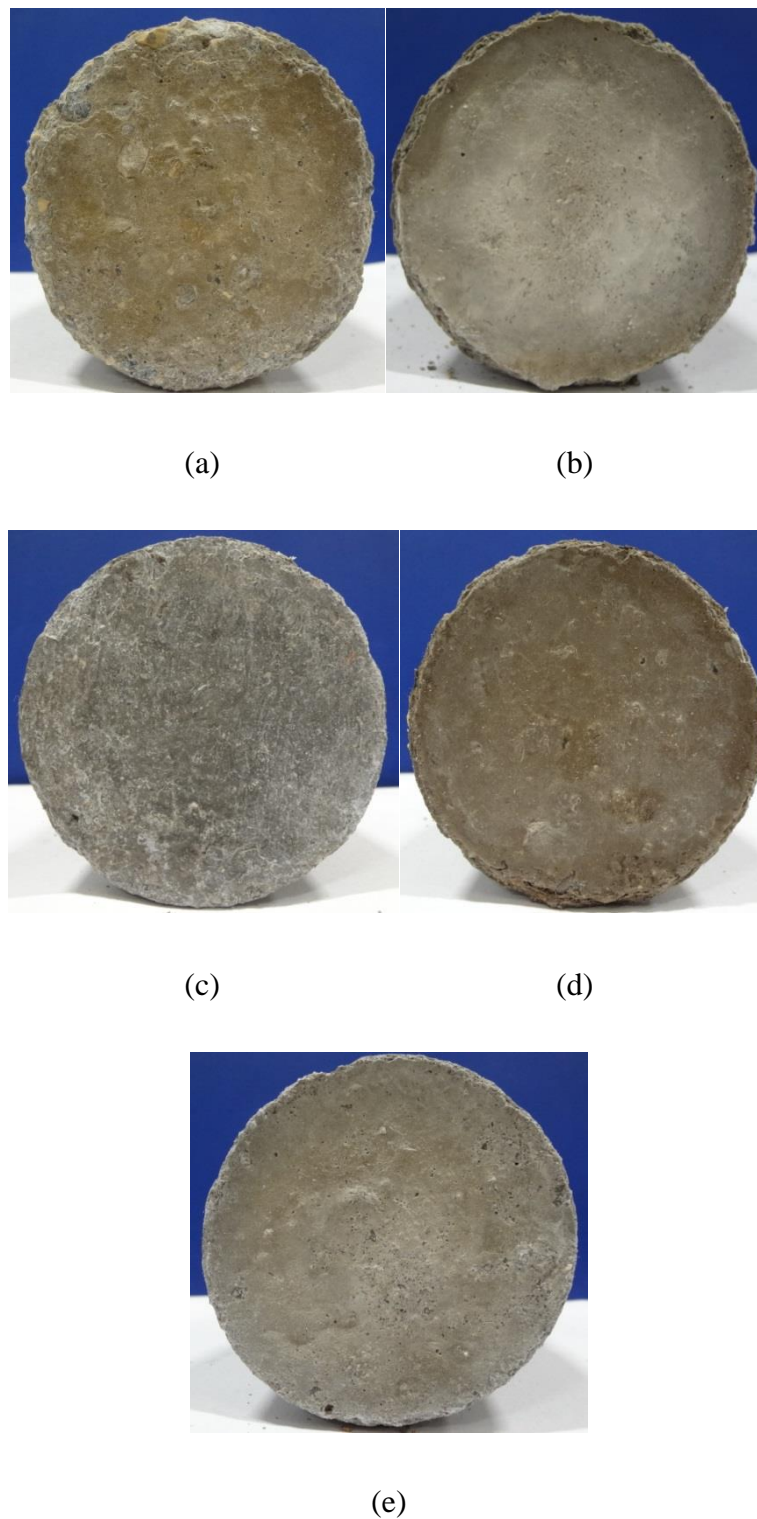
Figure 4.3: Bottom surface of concrete cylinders with $w/b = 0.60$ immersed in sodium sulphate solution for 6 months: (a) concrete made with OPC; (b) OPC + 25% FA; (c) OPC + 8% SF; (d) OPC + 8% MK; and (e) concrete with HS.

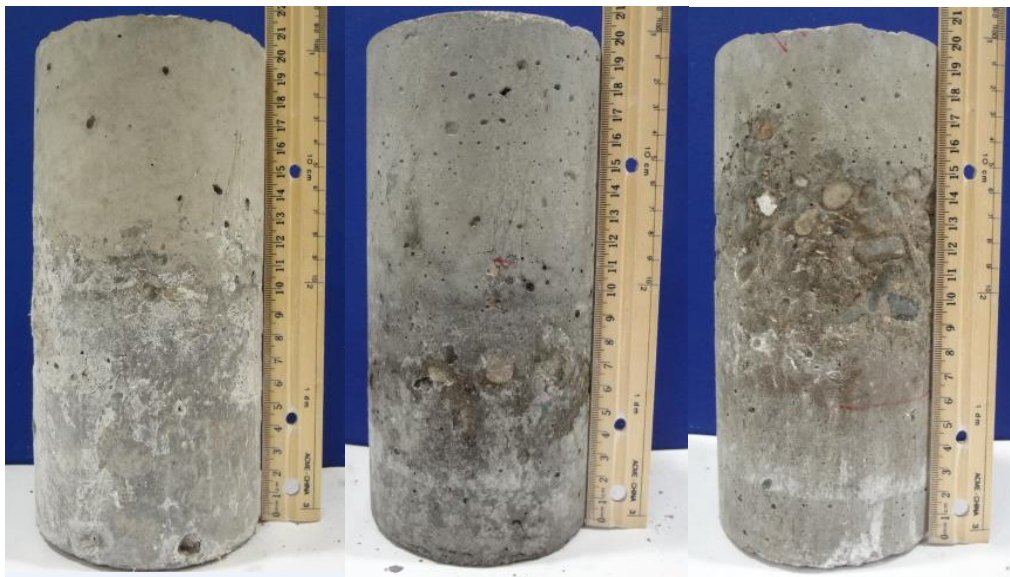
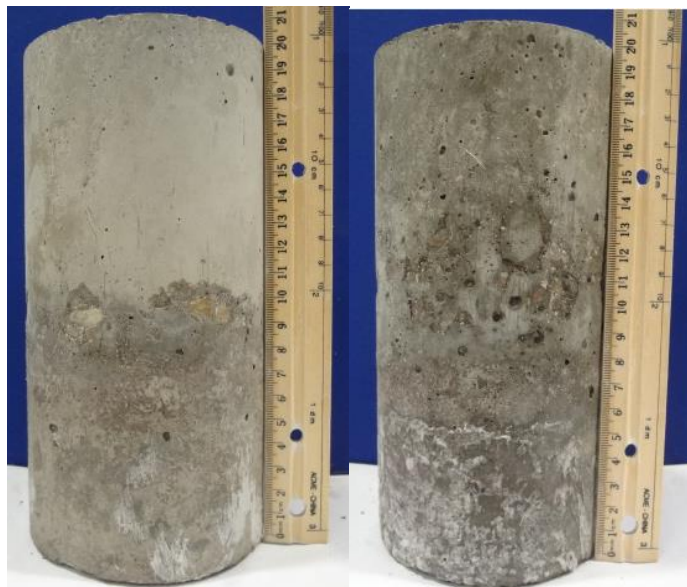
Figure 4.4: Non-cured concrete cylinders made with $w/b = 0.45$ after six months of physical sulphate exposure: (a) concrete made with OPC; (b) OPC + 25 % FA; (c) OPC + 8 % SF; (d) OPC + 8% MK; and (e) concrete with HS.

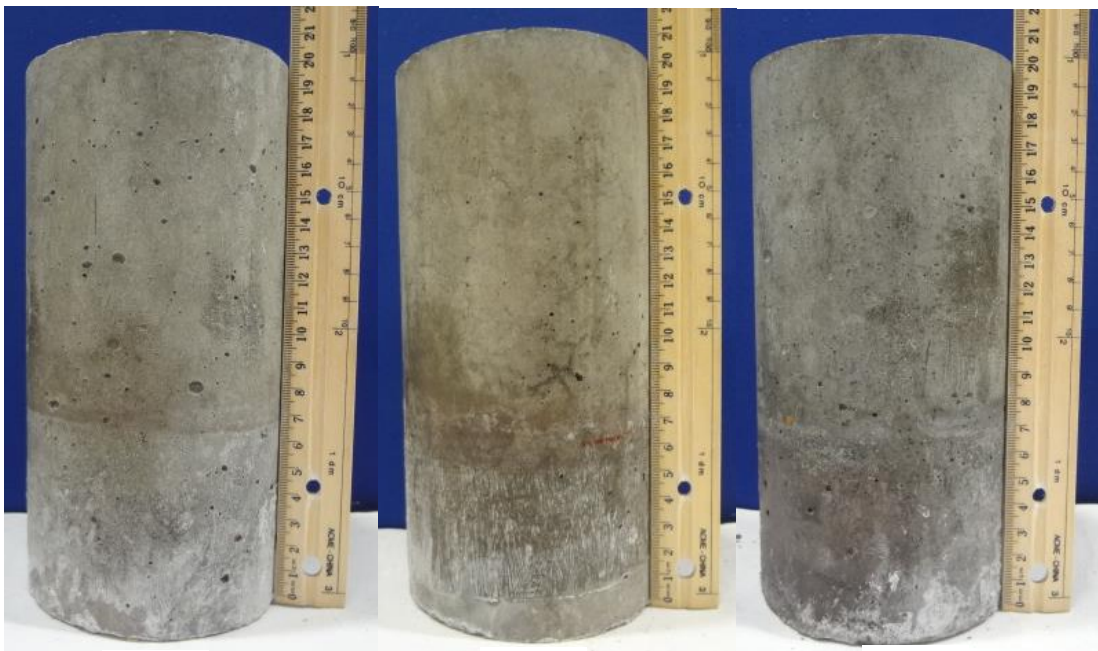
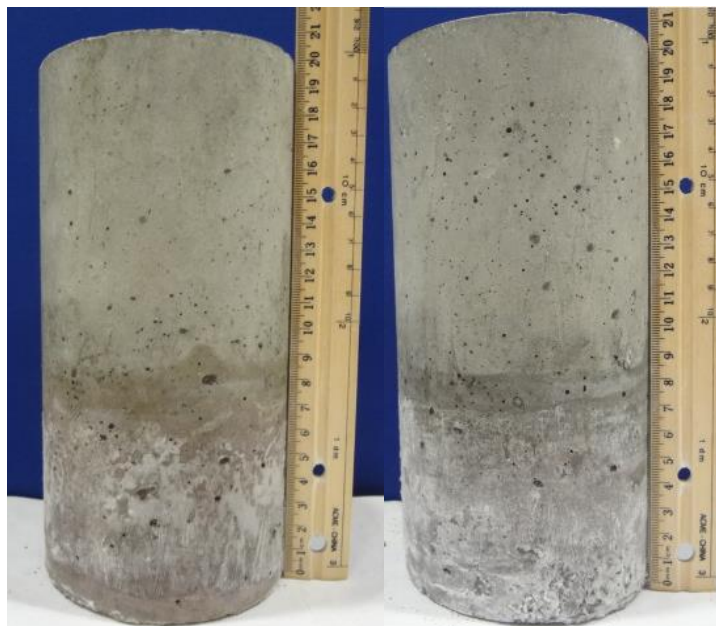
Figure 4.5: Non-cured concrete cylinders made with $w/b = 0.30$ after six months of physical sulphate exposure: (a) concrete with OPC; (b) OPC + 25% FA; (c) OPC + 8% SF; (d) OPC + 8% MK; and (e) concrete with HS.

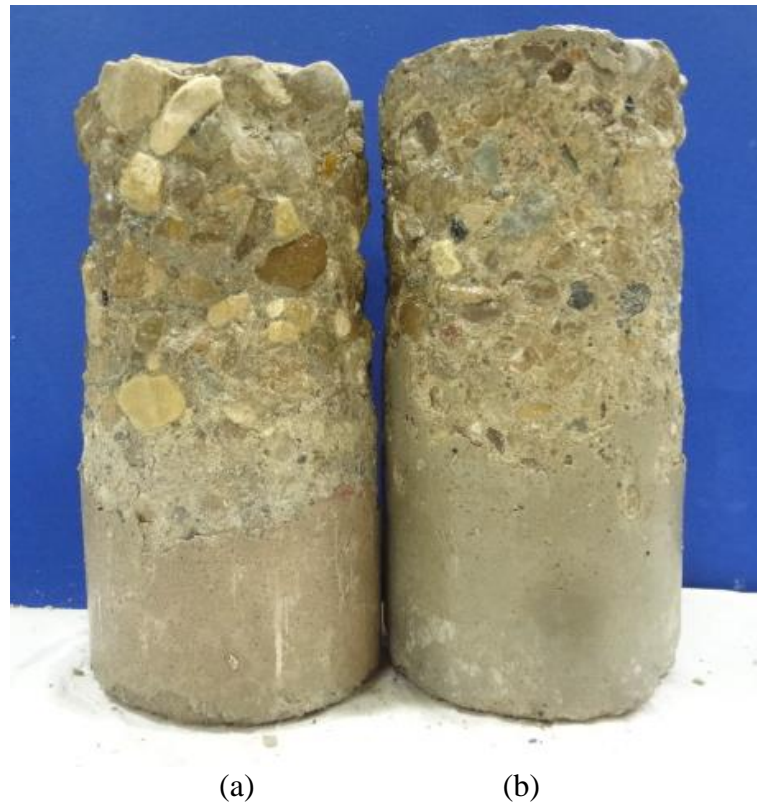
Figure 4.6: Effect of curing on physical sulphate attack of concrete made with OPC +25% FA at $w/b = 0.60$: (a) non-cured specimen; and (b) specimen moist cured for 28 days.

Figure 4.6 illustrates the typical effect of the curing regime on concrete exposed to physical sulphate attack. It can be observed that cured concrete specimens exhibited less surface scaling than that of their non-cured counterparts.

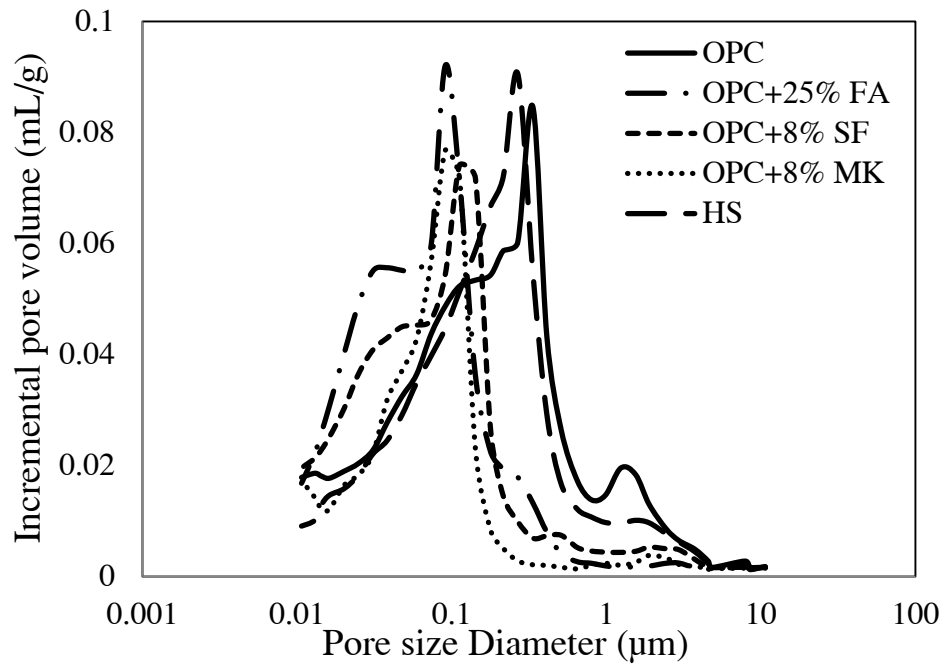
Figure 4.7: MIP results for concrete mixtures made with $w/b = 0.60$ before exposure to physical sulphate attack.

A low w/b ratio caused a significant decrease in the total intrusion volume for the plain and blended cement concrete mixtures due to the increase in the solid volume and subsequent reduction in the total volume of pores. Moist curing the concrete also induced a decrease in the intrusion volume, which also indicates a decrease in the total porosity.

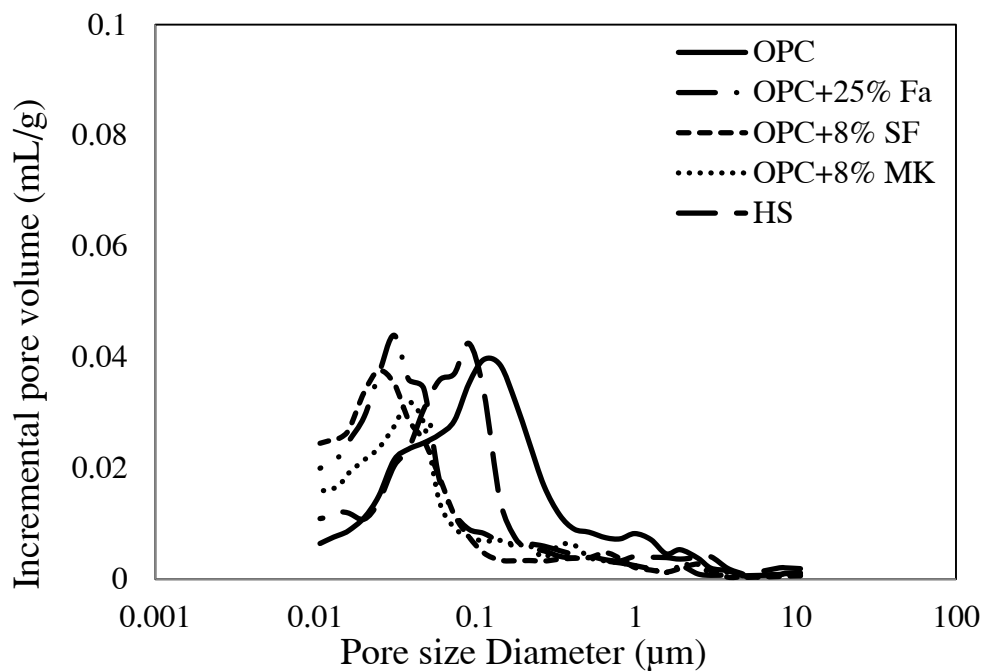
Figure 4.8: MIP results for concrete mixtures made with $w/b = 0.45$ before exposure to physical sulphate attack.

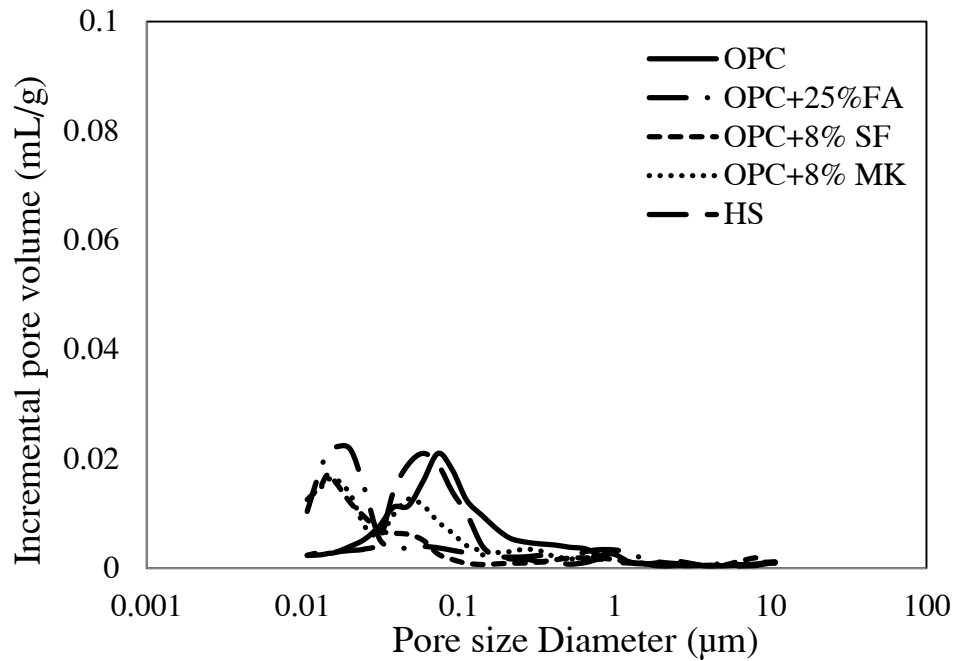
Figure 4.9: MIP results for concrete mixtures made with $w/b = 0.30$ before exposure to physical sulphate attack

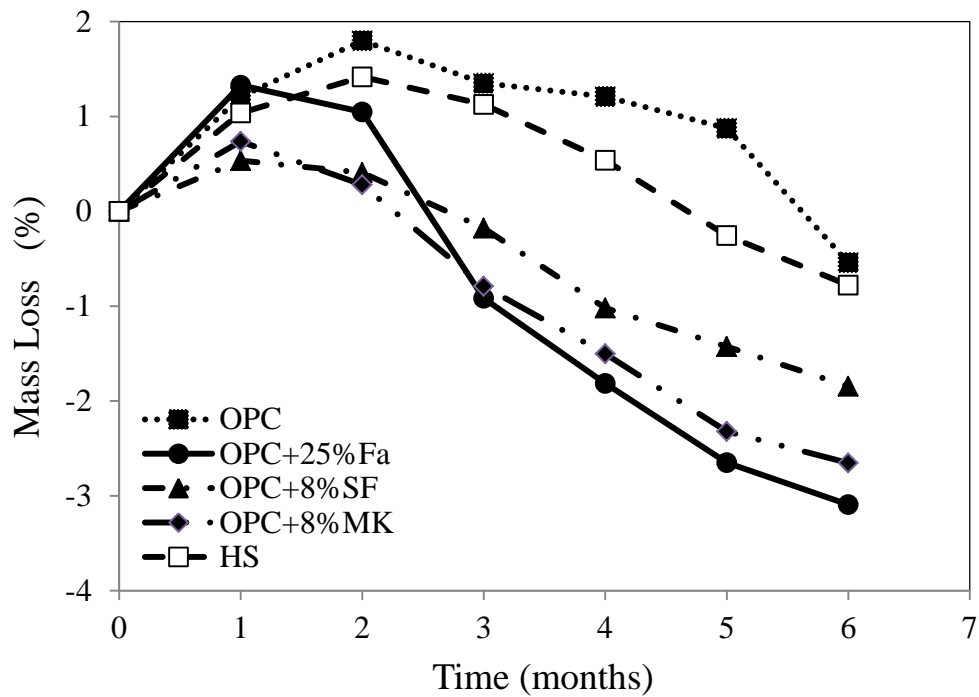
Figure 4.10: Mass loss for non-cured concrete cylinders made with $w/b = 0.60$

The mass loss was monitored for all concrete cylinders that were partially immersed in the sodium sulphate solution and exposed to cyclic temperature and RH. **Figures 4.10 and 4.11**, illustrate the mass loss after 6 months of exposure to physical sulphate attack.

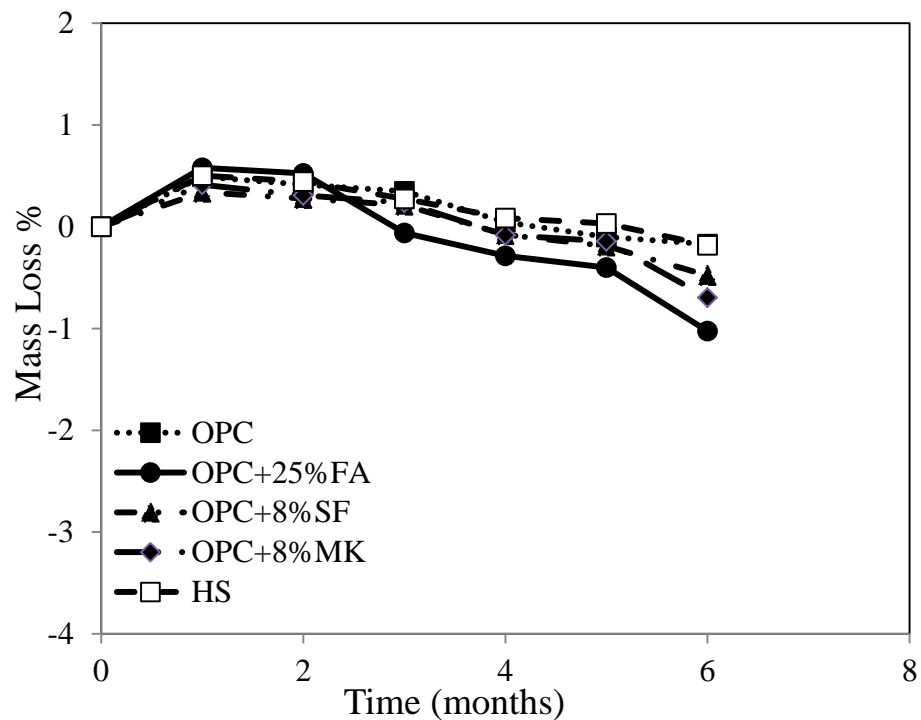
Figure 4.11: Mass loss for non-cured concrete cylinders made with $w/b = 0.45$.

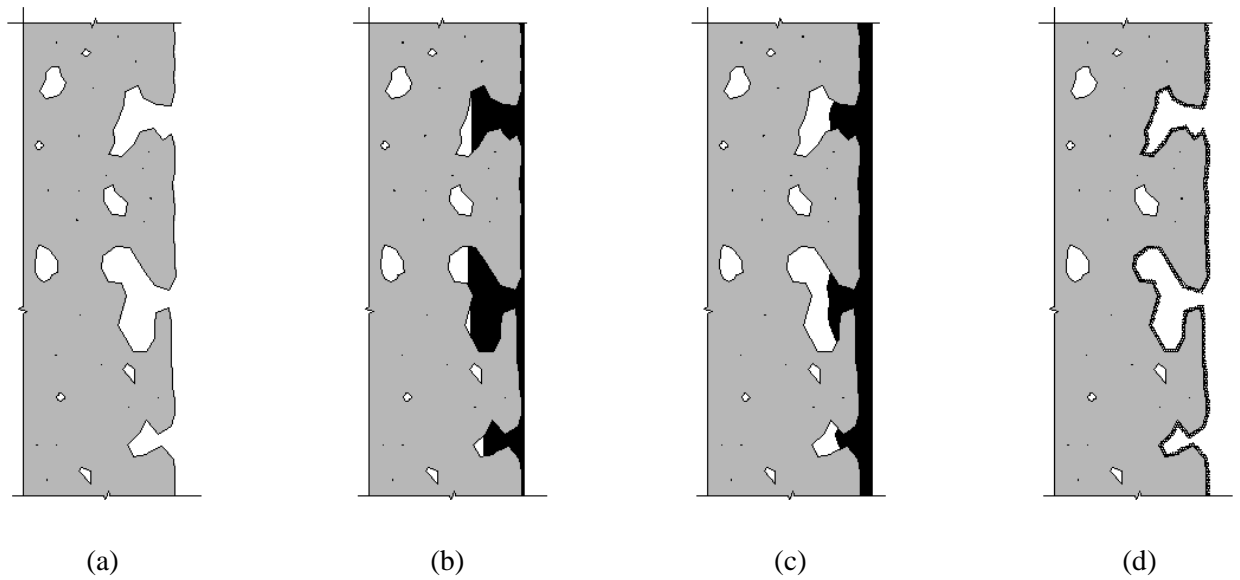
Figure 5.1: Schematic illustration of concrete surface pores and protection mechanism provided by various surface treatment materials: (a) non-coated concrete; (b) concrete surface coated with acrylic sealer; (c) concrete surface coated with epoxy or bitumen that provides an impervious membrane; and (d) concrete coated with silane water repellent.

Figure 5.1 illustrates a schematic of concrete surface pore structure and the proposed protection mechanism provided by each of the four surface treatment materials. **Figure 5.2** shows SEM images of the different coating surfaces. After coatings have dried, cylinders were partially immersed in a 5% sodium sulphate solution and placed inside a walk-in environmental chamber with cycling temperature and relative humidity. Previous study by Haynes *et al.*, (2008) found that the surface scaling escalated drastically when the concrete was exposed to cyclic temperature and RH consisting of two weeks at temperature = 20°C [68°F] and RH = 82% followed by two weeks at temperature = 40°C [104°F] and RH = 31%. Therefore, to accelerate the experiment, cycles were reduced to one week at temperature = 20°C [68°F] and RH = 82% followed by one week at temperature = 40°C [104°F] and RH = 31%.

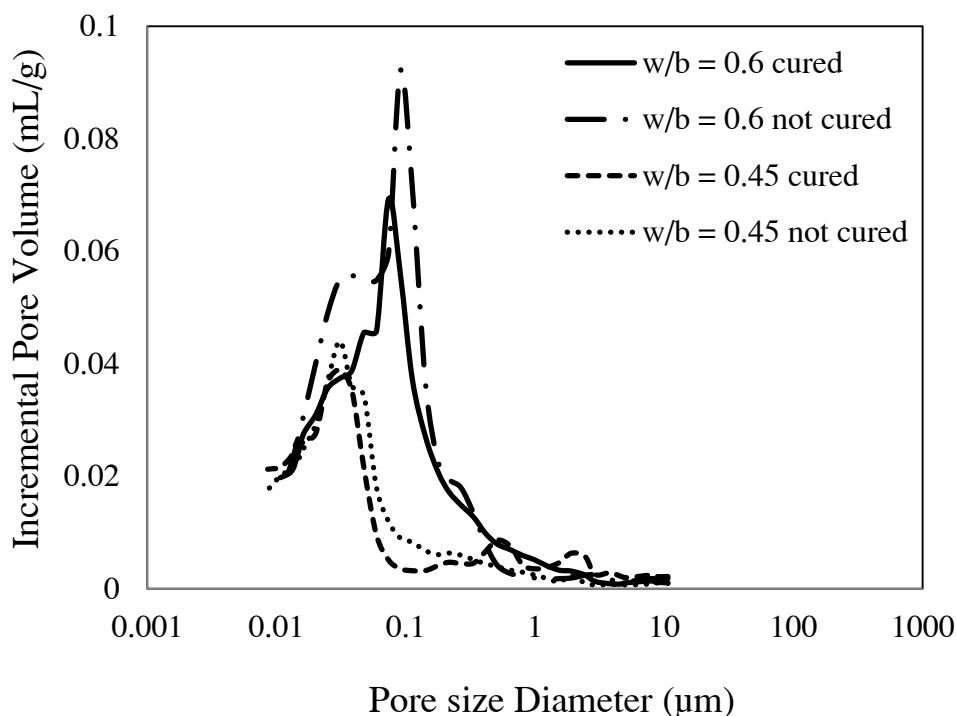
Figure 5.3: MIP test results for concrete specimens before coating and exposure to physical sulphate attack.

be increased, leading to higher capillary rise and increased salt growth on the concrete surface, thus accelerating the damage mechanisms.

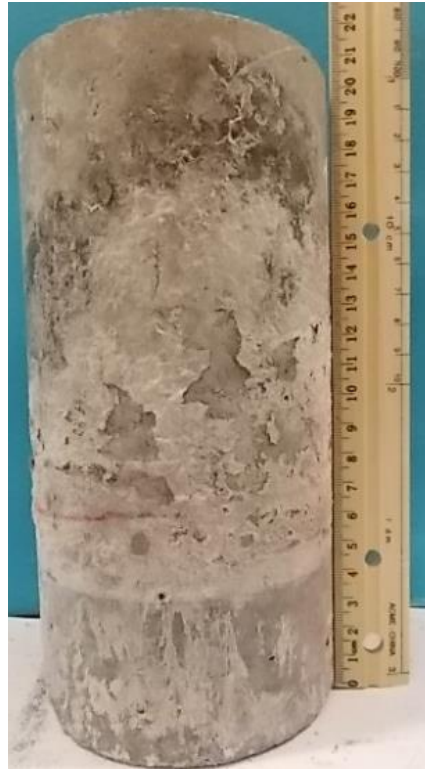
Figure 5.4: Damage of the acrylic layer of coated non-cured concrete made with $w/b = 0.60$ after two months of physical sulphate exposure.

deterioration was observed for the cylinders coated either with epoxy, silane, or bitumen, except for cylinders coated with acrylic.

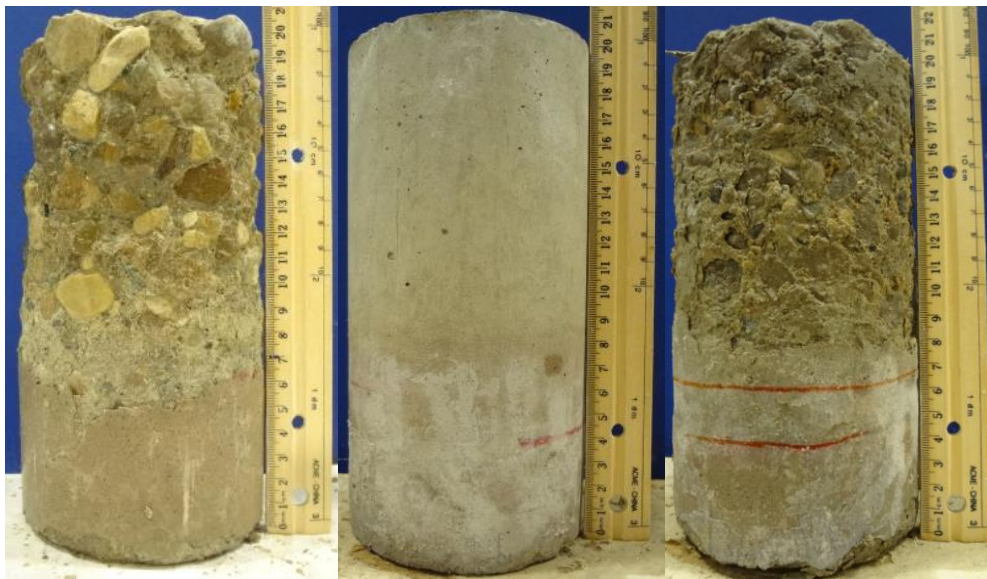
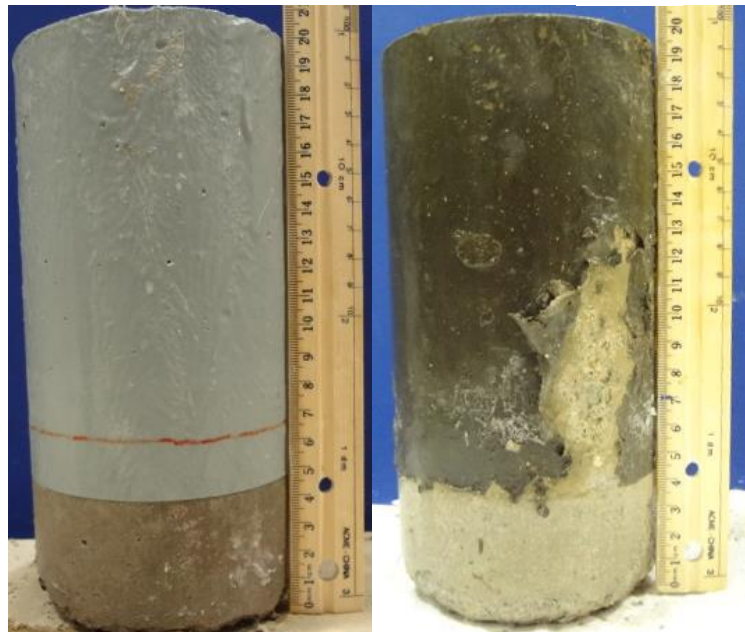
Figure 5.5: Non-cured concrete cylinders made with $w/b = 0.60$ after 6 months of physical sulphate exposure: (a) non-coated and coated with; (b) silane (water-repellent); (c) acrylic solution (curing and sealer); (d) epoxy (membrane); and (e) bitumen (membrane).
