Physical Sulphate Attack on Concrete

Graduate Program in Civil and Environmental Engineering
A thesis submitted in partial fulfillment of the requirements for the degree in Master of
Engineering Science
© Ahmed Ramadan Suleiman 2014

PHYSICAL SULPHATE ATTACK ON CONCRETE

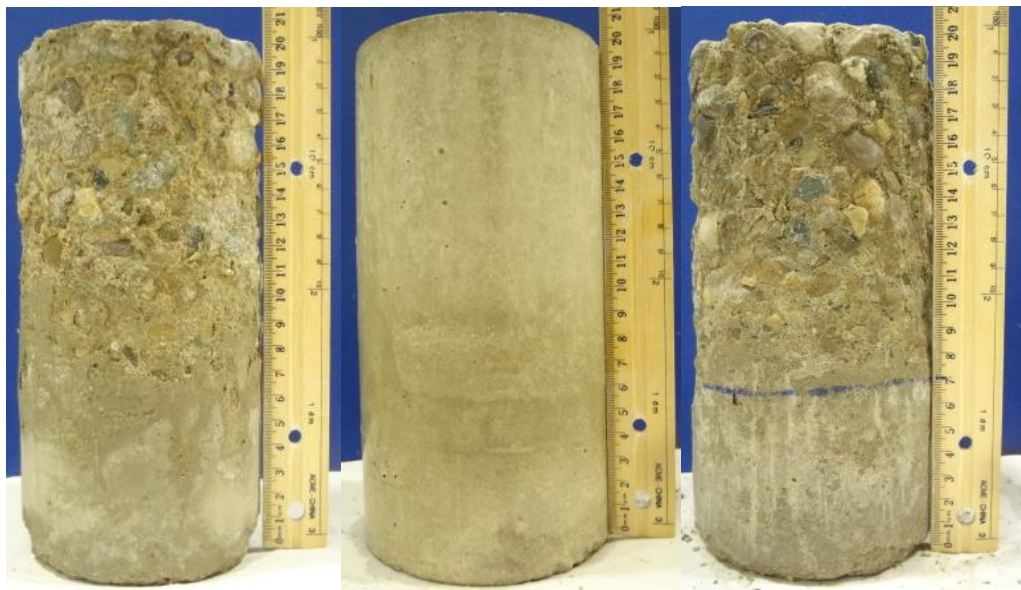
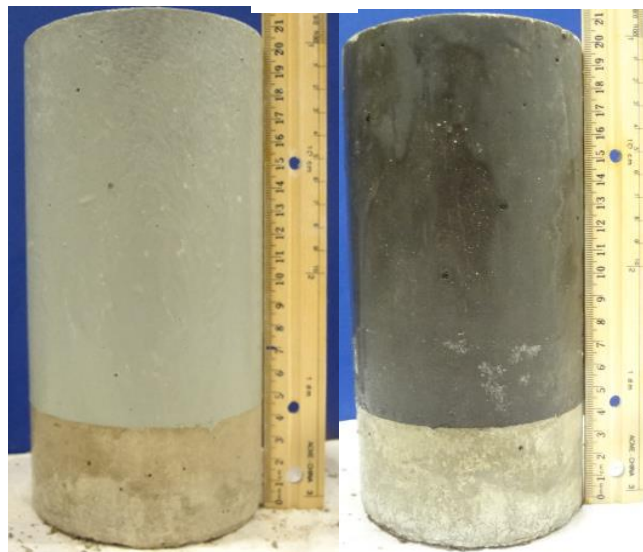
Figure 5.6: Cured cylinders made with $w/b = 0.60$ after 6 months of physical sulphate exposure (a) non-coated and coated with; (b) silane (water-repellent); (c) acrylic solution (curing and sealer); (d) epoxy (membrane); and (e) bitumen (membrane).

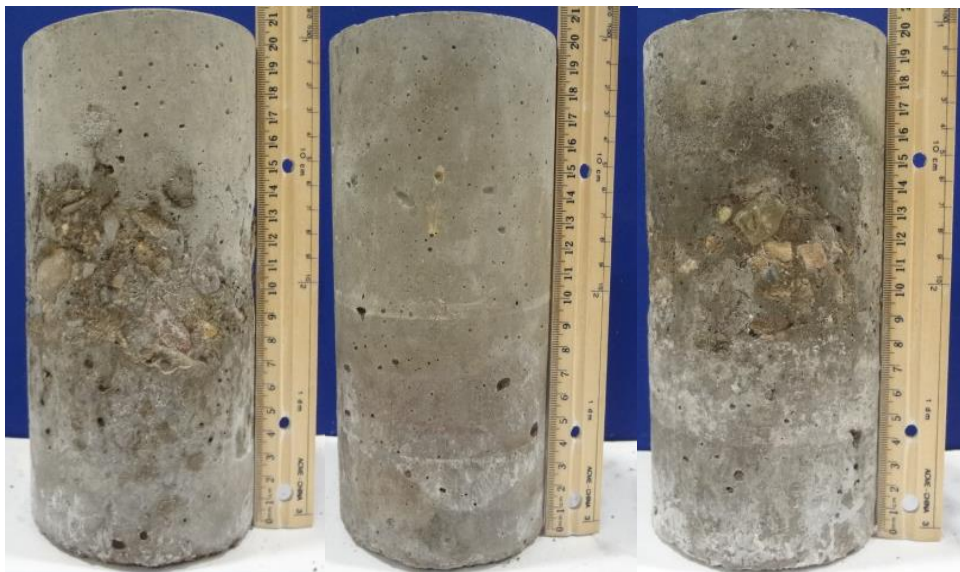
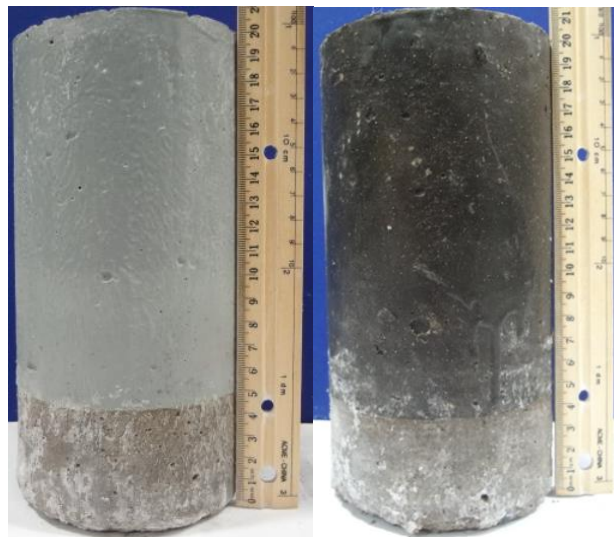
Figure 5.7: Non-cured concrete cylinders made with $w/b = 0.45$ after 6 months of exposure (a) Non-coated, and coated with; (b) silane (water-repellent); (c) acrylic solution (curing and sealer); (d) epoxy (membrane); and (e) bitumen (membrane).

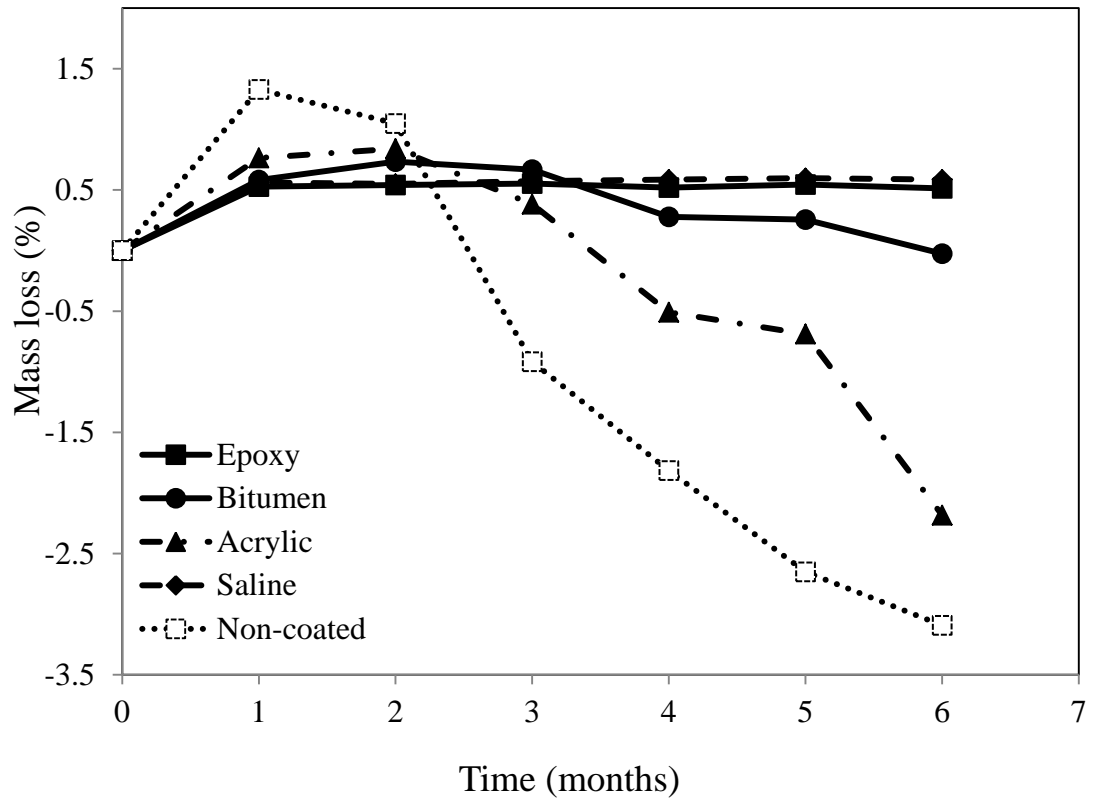
Figure 5.9: Mass loss of non-cured concrete cylinders made with $w/b = 0.60$.

The mass loss of concrete cylinders partially immersed in the 5 % sodium sulphate solution was monitored on a monthly basis. **Figures 5.8; 5.9; 5.10; and 5.11** illustrate the mass loss for both coated and non-coated concrete cylinders after six months of exposure to physical sulphate attack.

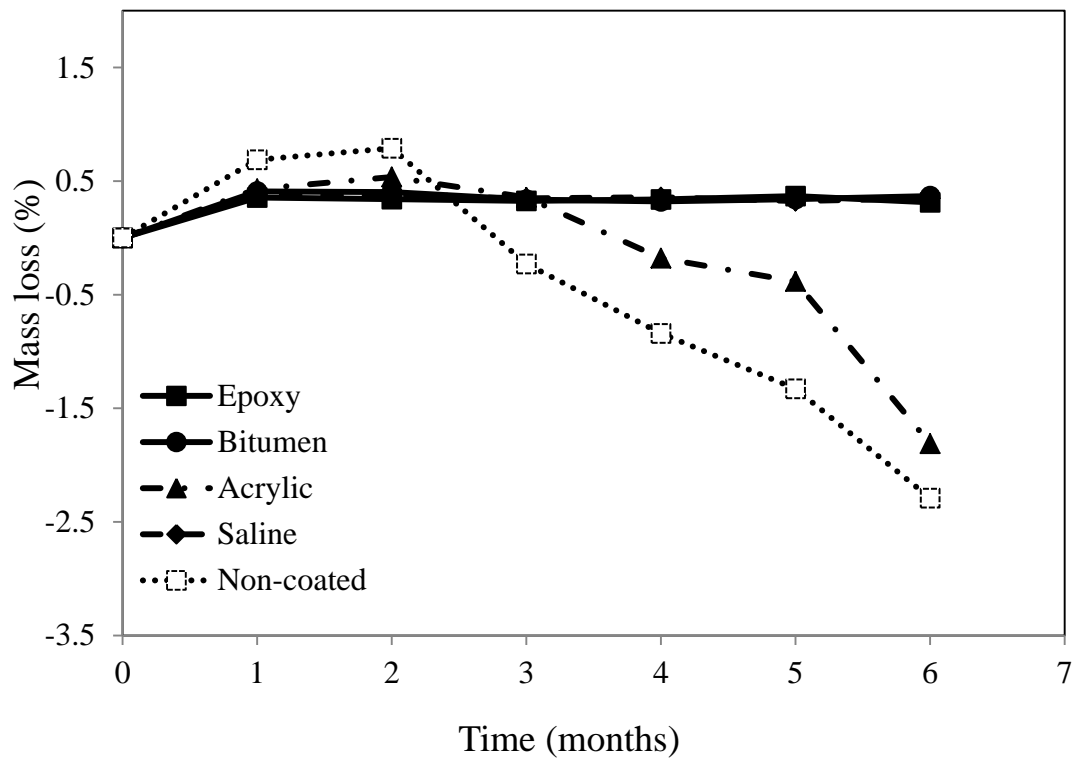
Figure 5.10: Mass loss of cured concrete cylinders made with $w/b = 0.60$.

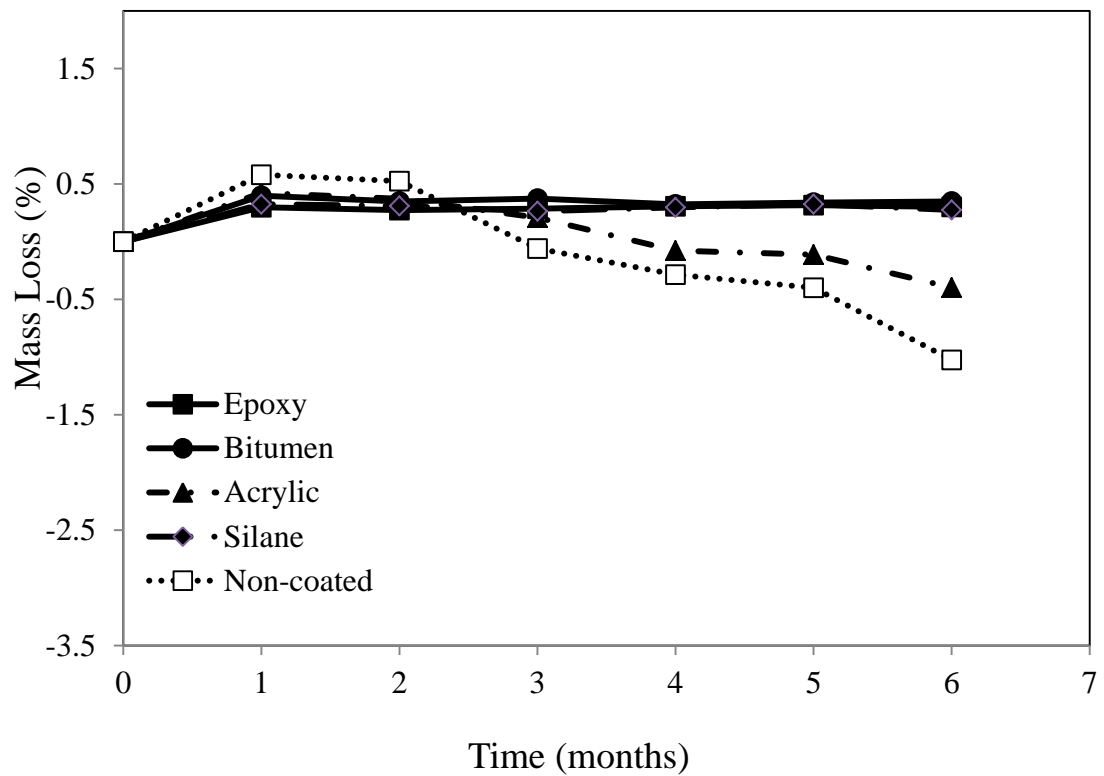
Figure 5.11: Mass loss of non-cured concrete cylinders made with $w/b = 0.45$.

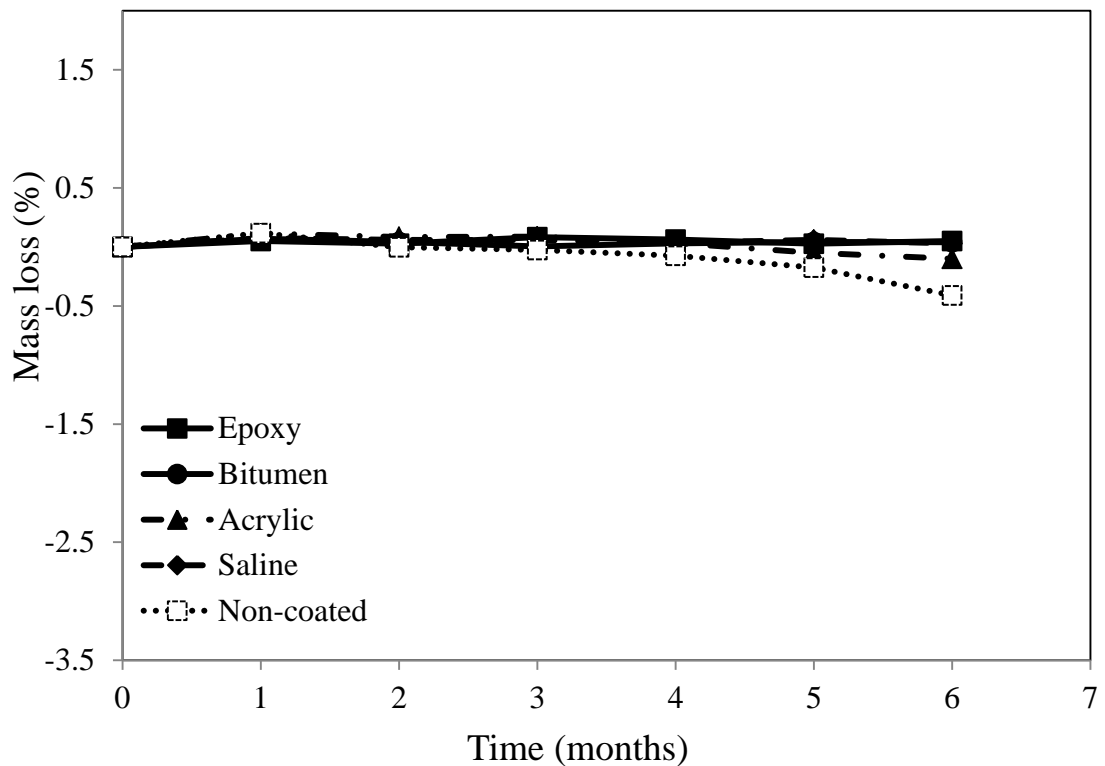
Figure 5.12: Mass loss of cured concrete cylinders made with $w/b = 0.45$.

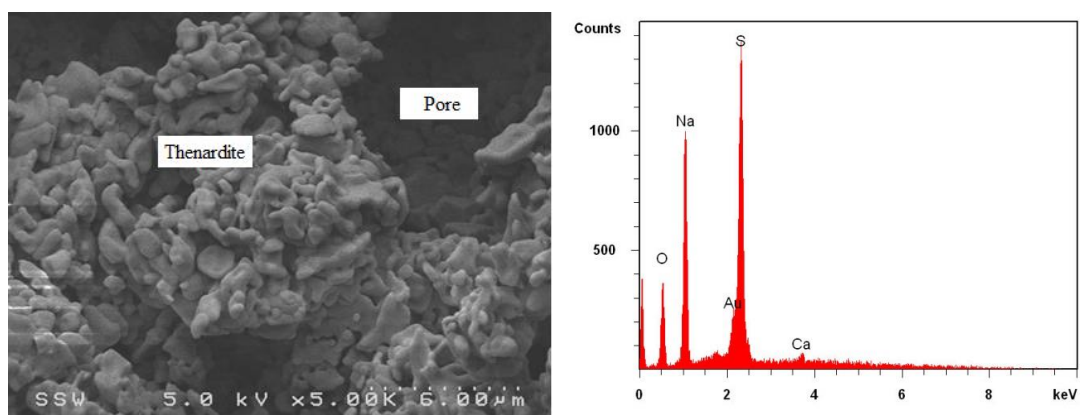
Figure 5.13: SEM and XRD analysis showing thenardite above the solution level.

image and XRD for the precipitated salt (thenardite) filling the pores on the concrete surface above the solution level. The concrete surface above the solution level was exposed to evaporation, which created supersaturation of the sodium sulphate solution. Hence crystals could grow from the supersaturated solution and exert high tensile pressure, thus leading to damage and mass loss of the concrete above the solution level. Therefore, monitoring the mass loss seems to be a useful indication of the performance of concrete exposed to physical sulphate attack.

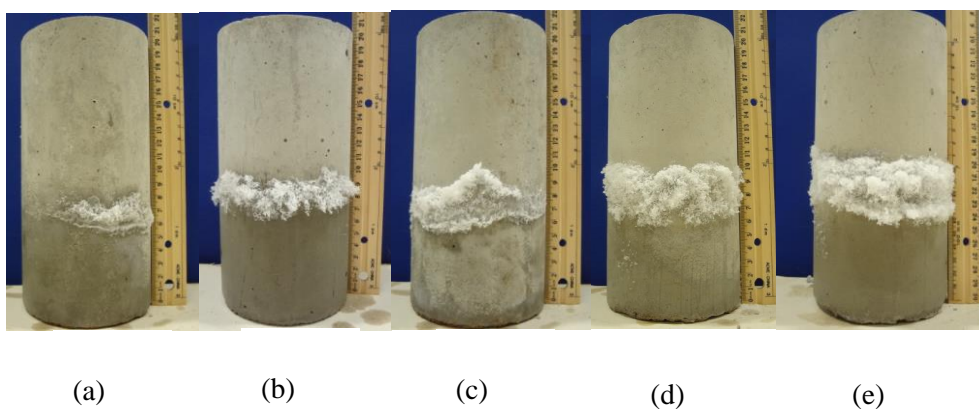
Figure 6.1: Salt crystallisation for concrete made with: (a) OPC; (b) OPC + 5% FA; (c) OPC + 10% FA; (d) OPC + 15% FA; and (e) OPC + 20% FA.

After two days of exposure to a temperature of 20°C [68°F] and RH of 82%, salt precipitation (efflorescence) appeared above the solution level on the drying surface of the concrete cylinders as shown in **Figures 6.2 to 6.5**. This exposure condition is considered as an ideal environment for mirabilite formation according to previous studies (Thaulow and Sahu, 2004; Flatt, 2002; Haynes, *et al.*, 2008). After one week, the exposure was switched to a temperature = 40°C [104°F] and RH = 31%, a condition conducive for thenardite formation. During the second week, the volume of the precipitated salt on the concrete surface decreased compared to that in the first week of exposure. This is related to the transformation of the formed mirabilite to thenardite which results in a volume contraction of about 314% (Tsui *et al.*, 2003).

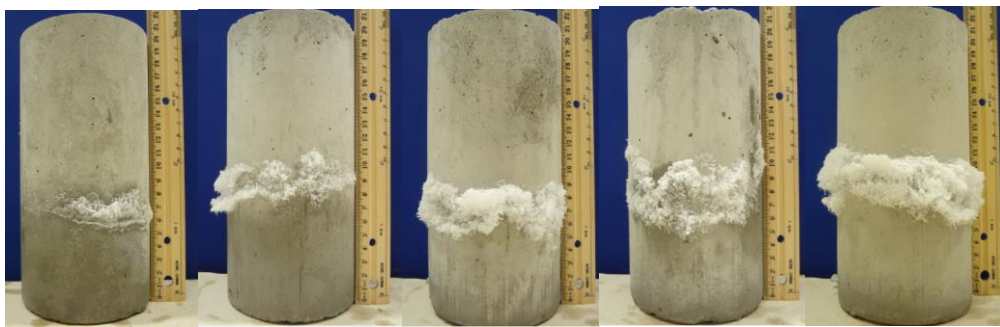
Figure 6.2: Salt crystallisation for concrete made with: (a) OPC; (b) OPC + 5% MK; (c) OPC + 10% MK; (d) OPC + 15% MK; and (e) OPC + 20% MK.

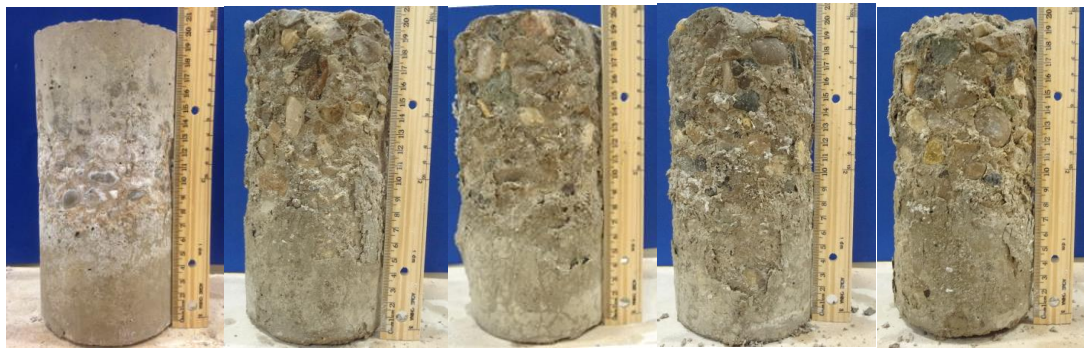
Figure 6.4: Damage due to salt crystallisation for concrete made with: (a) OPC; (b) OPC + 5% FA; (c) OPC + 10% FA; (d) OPC + 15% FA; and (e) OPC + 20% FA.

The exposure was continued for up to six months (24 cycles of wetting and drying) and all concrete cylinders were inspected to diagnose the level of damage. For all tested cylinders, the portion of concrete immersed in the sulphate solution was found in intact condition compared with the damaged above solution part. **Figures 6.5, 6.6, and 6.7** show the typical concrete damage above the solution level.

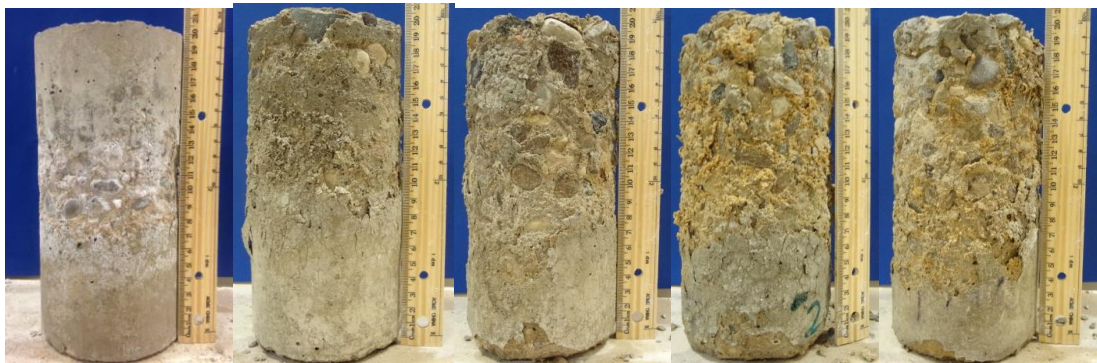
Figure 6.5: Damage due to salt crystallisation for concrete made with: (a) OPC; (b) OPC + 5% MK; (c) OPC + 10% MK; (d) OPC + 15% MK; and (e) OPC + 20% MK.

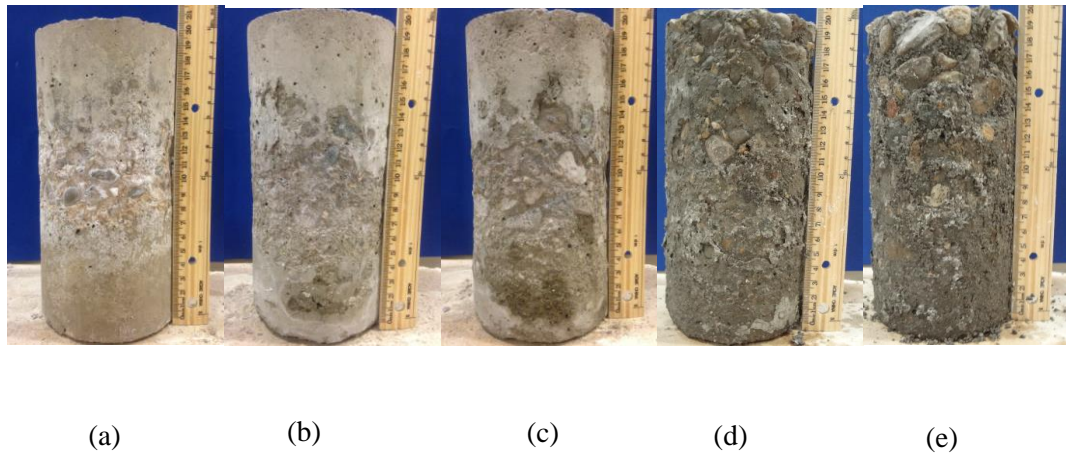
Figure 6.6: Damage due to salt crystallisation for concrete made with: (a) OPC; (b) OPC + 5% SF; (c) OPC + 10% SF; (d) OPC + 15% SF; and (e) OPC + 20% SF.

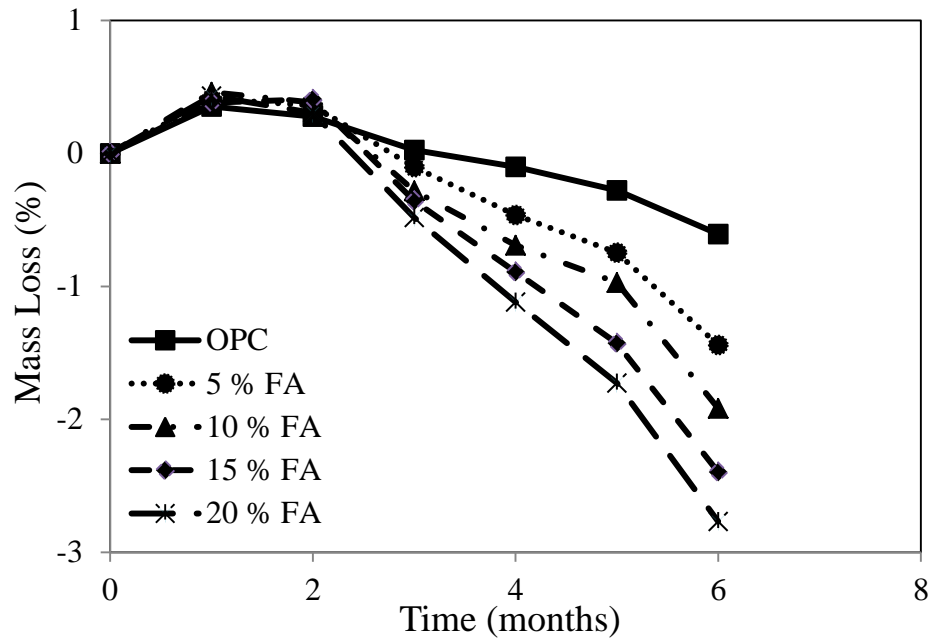
Figure 6.7: Mass loss for concrete cylinders (cement partially replaced with FA).

The mass loss was monitored for all concrete cylinders that have been partially immersed in the sodium sulphate solution and exposed to cyclic temperature and RH. **Figures 6.8, 6.9, and 6.10**, illustrate the mass loss after 6 months of exposure to physical sulphate attack. The mass loss occurred due to scaling of the concrete surface above the solution level. The immersed portion of concrete into the sodium sulphate solution was mostly in intact condition. Both the surface scaling and mass loss increased with increasing the partial replacement level of cement by pozzolanic minerals.

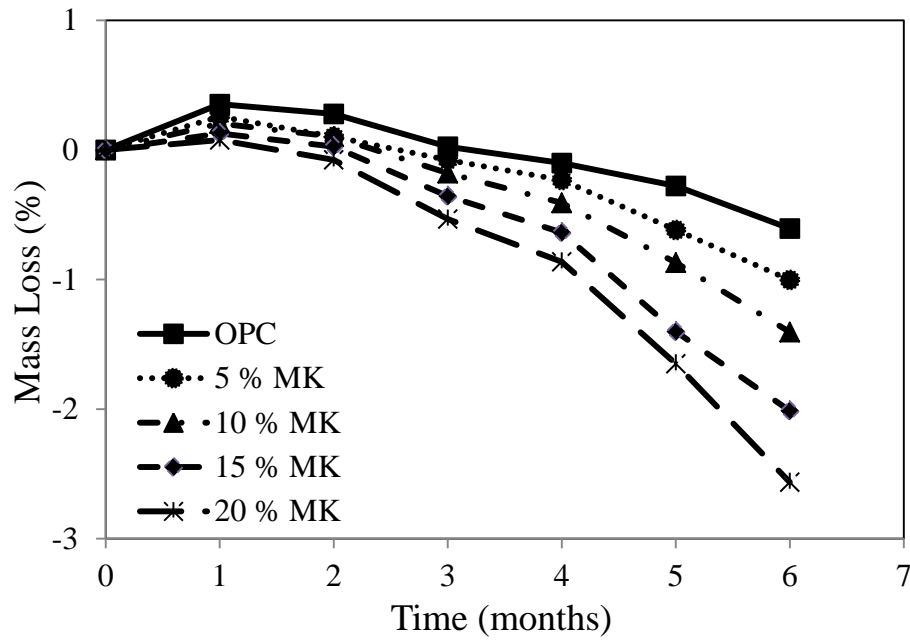
Figure 6.8: Mass loss for concrete cylinders (cement partially replaced with MK).

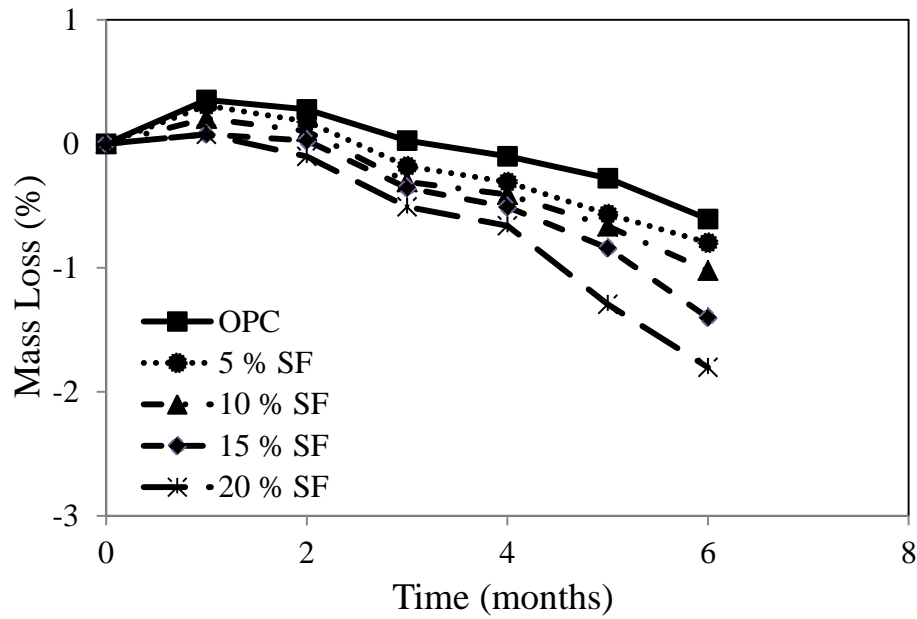
Figure 6.9: Mass loss for concrete cylinders (cement partially replaced with SF).

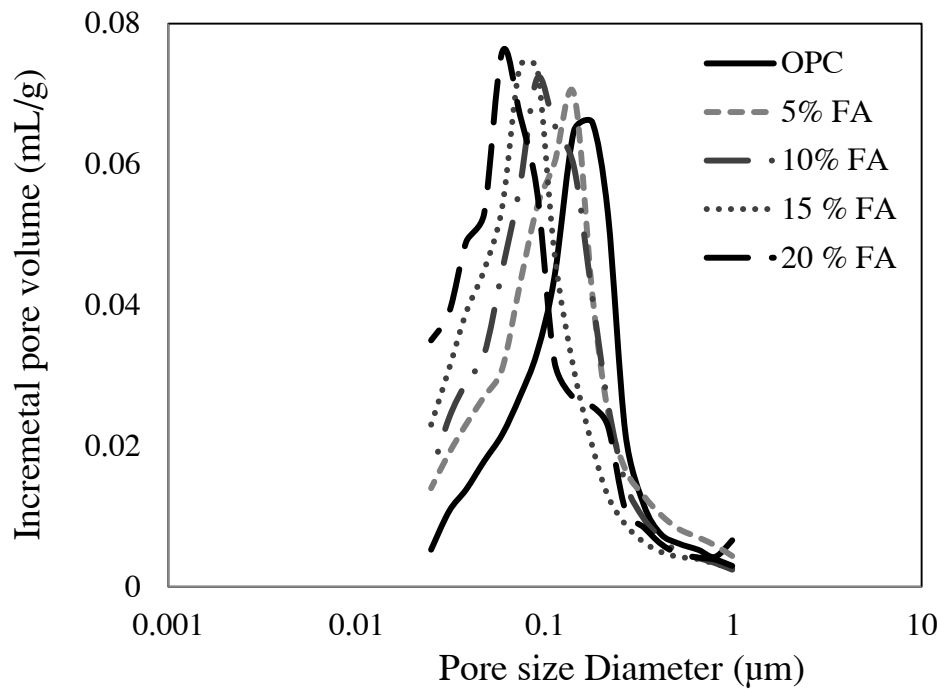
Figure 6.10: MIP results for concrete mixtures before exposure to physical sulphate attack (OPC and OPC + FA).

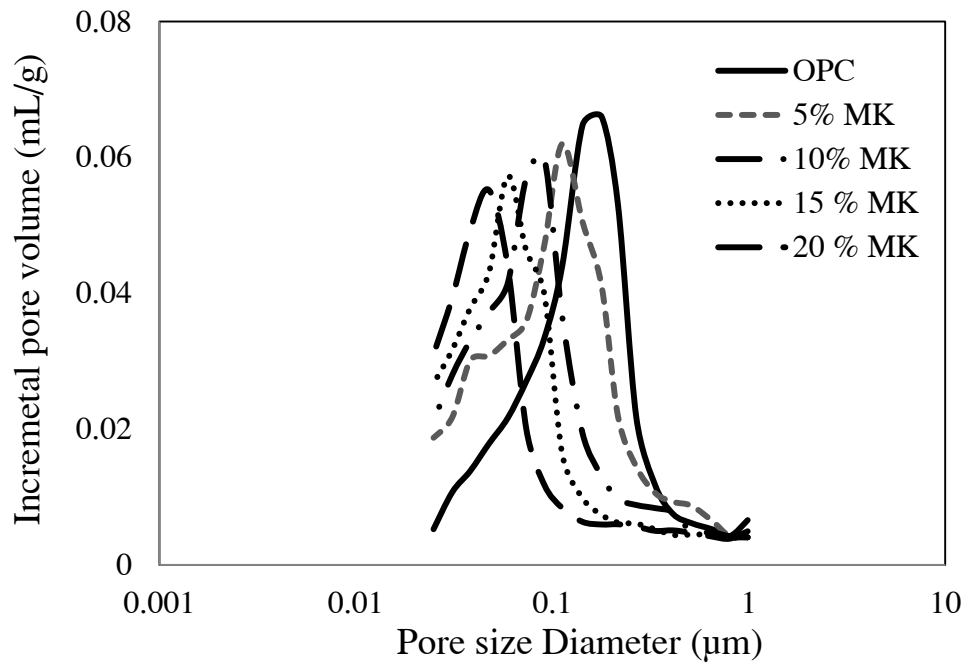
Figure 6.11: MIP results for concrete mixtures before exposure to physical sulphate attack (OPC and OPC + MK).

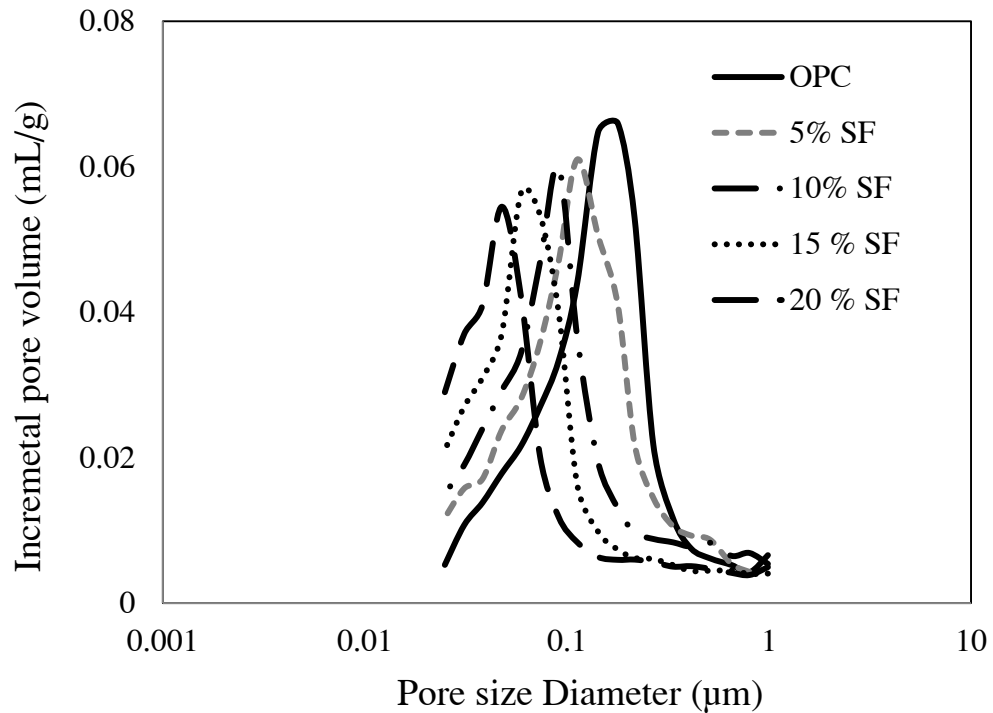
Figure 6.12: MIP results for concrete mixtures before exposure to physical sulphate attack (OPC and OPC + SF).
