# RESILIENT INFRASTRUCTURE

## MONITORING THE CORROSION PROCESS OF REINFORCED CONCRETE FLAT SLAB-COLUMN CONNECTION

### ABSTRACT

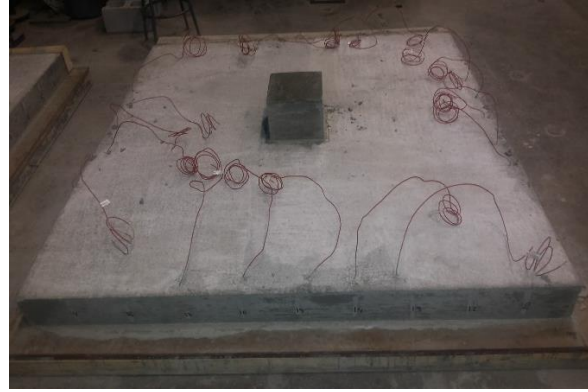
Figure 1: Typical slab specimens: (a) before casting; (b) after casting

Two reinforced concrete flat slab-column connection were cast. Each specimen had dimension of 1900x1900x150 mm and consisted of 250 mm column stub extending 200 mm. The clear cover was 30mm. The main reinforcement was 1% reinforcement ratio, distributed uniformly using 15M bar [ $d_b = 16$  mm] (see Figure 1). The details of the test specimens are showed in Table 1. The slab-column connections designation included a combination of letters and numbers: C0 and C26 to indicate the level of corrosion, where C0 refers to a 0% level of corrosion while C26 refers to 26% level of corrosion.

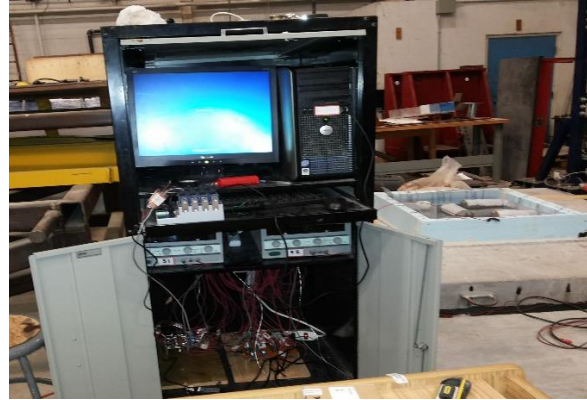
Figure 3: Corrosion current monitoring by data-acquisition system

Accelerated corrosion technique has been used before in previous tests showing a reasonable results about the sensitivity of steel reinforcement to the corrosion (Amleh & Mirza 2000). The accelerated corrosion setup used in this investigation consisted of electrolytic solution (5% sodium chloride (NaCl) by the weight of the water) and steel mesh placed at the top of the slab over the targeted corroded area. Foam sheets were used to construct a tank above the targeted corroded area. The foam tank is immersed with the electrolytic solution as shown in Figure 2. To avoid any change in the concentration of the sodium chloride in the electrolyte solution, the solution was permuted every week. A direct current with constant volt of 15V was applied to the slab, where the steel reinforced bars under the targeted corroded area served as anodes while the steel mesh served as a cathode. A data-acquisition system was used to record the current flow from anode to cathode as shown in Figure 3. The theoretical mass loss is calculated based on Faraday's equation as shown in Eq. (1):

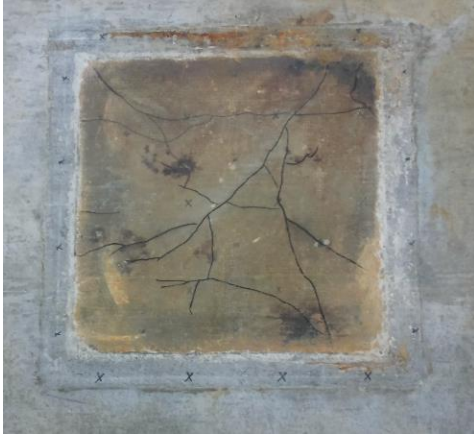
Figure 5: Corrosion-Cracked pattern on the corroded area

Figure 5 shows the crack pattern for the corroded specimen C26 after the completion of the corrosion process. C26 had had a maximum crack width of 0.5 mm before doing the punching test. Figure 6 illustrates the crack width versus the level of corrosion for C26. It can be noted that the rate of widening the crack width was increased with increasing the level of corrosion. This widening can be attributed to the enlargement of the corrosion products around the steel bar with increasing the level of corrosion, which exerted pressure on the concrete cover. Those cracks due to corrosion had contributed on changing the behavior of the crack distribution during the punching test on C26 comparing with C0. Figure 7 shows that C26 had a radial crack pattern distribution after the punching test while C0 had an orthogonal crack pattern distribution. In addition, the maximum crack width for C26 at the end of the test was 7.93 mm while at C0 it was 2.49 mm. This results can be interrupted to the fact that the initiated cracks at C26 is bigger than the pre-cracking of C0 by 0.48 mm, a pre-cracking was done for C0 before punching test. This big difference in crack width also had effected the punching radius; C0 has a big punching radius while C26 had a small punching radius bounded around the corroded area as shown in Figure 7. That reason beside the point of reducing mass loss of steel reinforcement have influence on the punching capacity for C26 which was reduced by 20% comparing with C0.

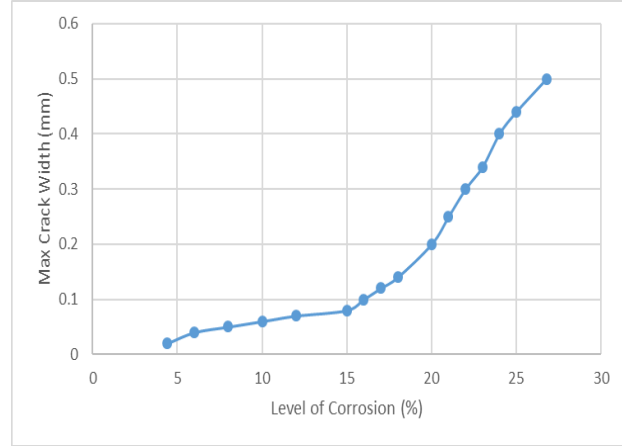
Figure 6: Maximum Crack with level of corrosion

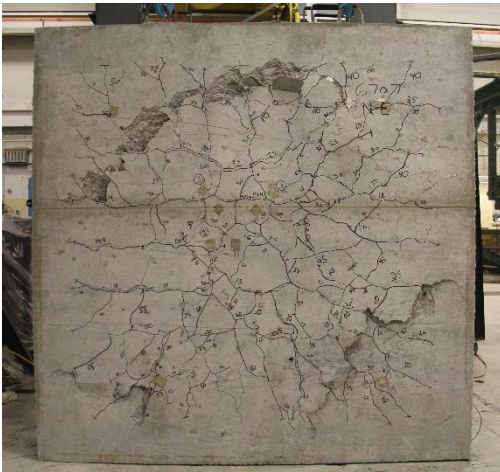
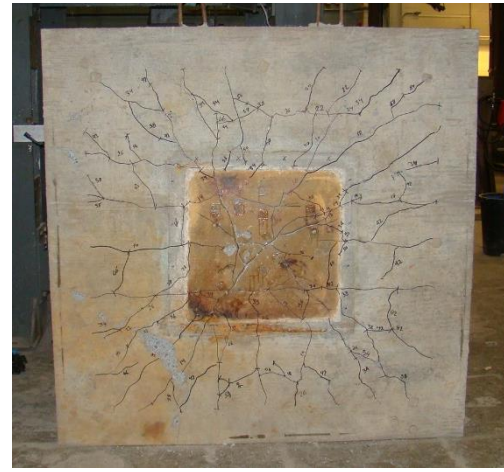
Figure 7: Crack Pattern in |Specimen: (a) C0; (b) C26

- The cracks performance during the punching test in the un-corroded specimen C0 was easily propagated and extended while in the corroded specimen C26 the cracks did not propagate as much as C0. This is can be attributed to the initial crack widths at C26 were bigger than C0, therefore during loading the cracks at C26 specimen become widen while new cracks initiated and propagated at C0.

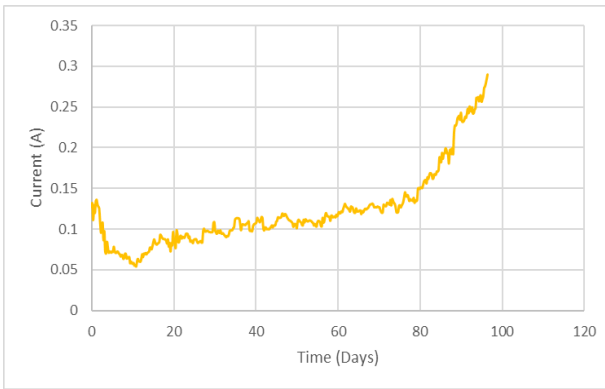
Figure 8: Current time history for C26 specimen

The rate of corrosion was monitored and recorded during the acceleration corrosion test by a computer-controlled data-acquisition system. Figure 8 shows the relation between the current and the immersion time. It can be noted that the current was initially dropped down followed by gently increased till 14% of mass loss then the current rate was gradually increased till the targeted level of corrosion 26% of mass loss. The current dropped down in the first few days is an implication of creation of the passive film around the steel reinforcement, which prevents reinforcement against corrosion. When this passivation layer become weakened due to the ingress of chlorides, the corrosion starts and the corrosion rate increases progressively (ASTM C876 1999). The sudden jump in the current verses time might be caused due to losing the bond between the concrete cover and steel reinforcement and due to starting spalling for the concrete cover (Hassan et al. 2009). Figure 9 shows the mass loss rate with time. Its noted that the rate of losing mass is increased when the current rate increased, which associated with increasing in the rate of corrosion.

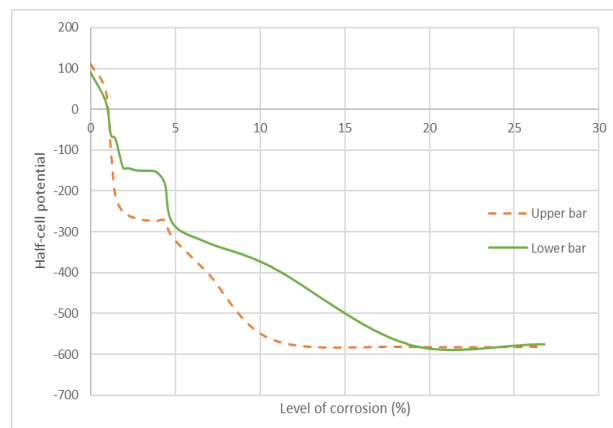
Figure 11: Half-cell potential reading vs. level of corrosion

Figure 10 illustrates the variation of half-cell potential readings over the corroded area with age. The potential reading was measured above each corroded steel reinforcement bar for the top reinforcement mesh. Figure 11 shows the variation of half-cell potential reading versus the level of corrosion. It can be noted from the both figures that the steel bars near the concrete cover give more negative values than the steel bars that are farther, second layer of the steel mesh. The more negative values are an indication of the higher probability of corrosion; the upper bars had bigger probability to corrode faster than the lower steel bars at the top mesh. This was expected because the upper layer of steel mesh had a clear concrete cover of 30mm while the lower layer for the steel mesh had a clear concrete cover of 46mm. Therefore, the upper steel bars were more subjected to chlorides ingress more than the lower one for the top steel mesh. This result was conducted with other researchers that the concrete cover has a big influence in the half-cell potential reading (Klinghoffer 1995). The figures also show that the reading of the half-cell potential test did not give variation in reading when corrosion really occurred; therefore, the half-cell potential test only be used to represent the probability of corrosion for un-corroded slabs, but when corrosion happens it may not give any indication for the level of corrosion.

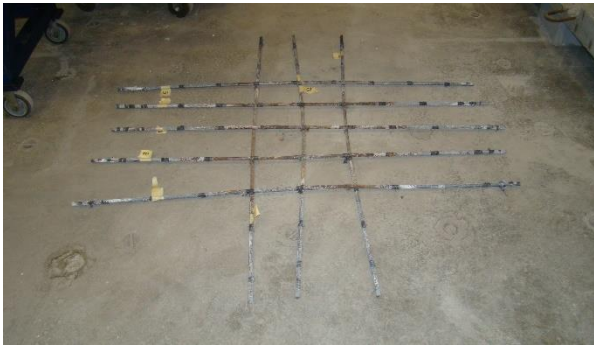
Figure 12: Corroded bars after demolition process

The theoretical mass loss was calculated using Faraday's Eq. (1), this equation is based on the amount of the current that passed across the steel bar. After the punching test had been done, a demolition for the slab-column connection had been occurred using a demolition hammer to extract the corroded bars as shown in Figure 12. The actual mass loss for the corroded bars found to be little bit less than the actual mass loss. The Faraday's equation gives a good relation between actual and predicted mass loss when the current passes through a bar suspended in salt solution. In another hand, when the current passes through embedded bars inside concrete, the theoretical mass loss overestimates the actual mass. This overestimates might be related to losing of some current through concrete cover to reach the embedded the steel reinforcement, which do not contribute on the corrosion (Spainhour & Wootton 2008; Auyeung et al. 2000).

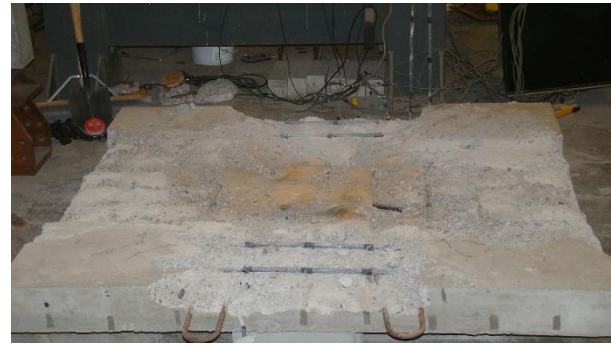
Figure 13: Delamination area around the corroded region

It was observed during the demolition of the slab that the corroded area was easy to destroy comparing with the un-corroded area that was very hard to destroy it. This observation indicates that the bond was diminished under the corroded area and a delamination started to happened as shown in Figure 13. This delamination part effects the punching shear area of C26 comparing with C0 as mentioned in section (3.1).
