# RESILIENT INFRASTRUCTURE

June 1–4, 2016

## CURRENT METHODS AND FUTURE ADVANCES FOR RAPID, REMOTE-SENSING-BASED WIND DAMAGE ASSESSMENT

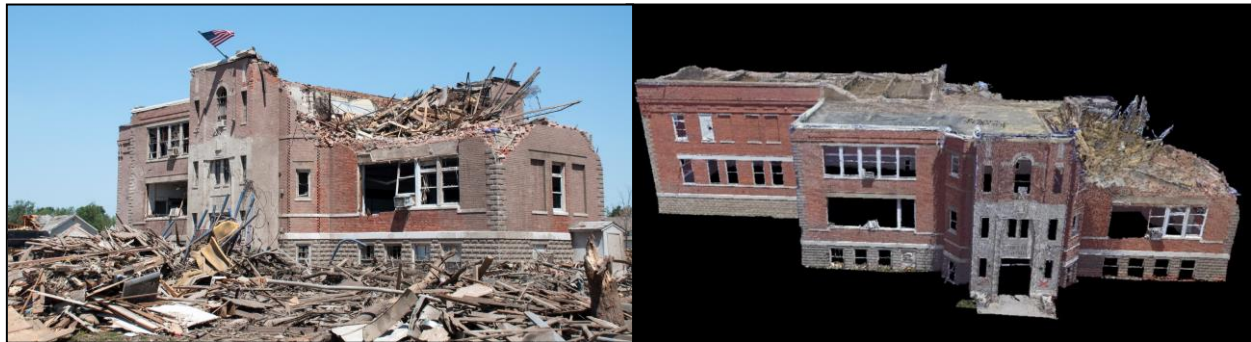
Structural damage was observed at various locations throughout the village. One building on the east side of the village sustaining considerable damage was the Wisner-Pilger Middle School (Fig. 3). Observed damages included airborne missile impacts from the detached nearby grain siloes, wind-pressure-induced window and door failures,

roof-uplift as a result of anchor failures, unreinforced masonry collapse, and extensive nonstructural failures of windows, partition walls, and mechanical-electrical-plumbing equipment.

To characterize the damage to the school's exterior, LiDAR and a tethered UAV with an onboard camera were deployed to create detailed point clouds, which are digital representations of objects with vertices in three-dimensional space. (LiDAR scanning directly produces a point cloud, while the UAV images require further processing via a computer vision technique, Structure-from-Motion (SfM), to reconstruct the scene as a point cloud. Using point clouds, geometry and textural details are captured that can permit non-destructive evaluation of potential damage (Olsen et al. 2012)). For this building, 11 exterior LiDAR scans and numerous UAV passes were conducted to acquire more than 800 images for the SfM algorithm. Fig. 3 illustrates the resultant point cloud of the Wisner-Pilger Middle School that is useful for future analysis and assessment.

Fig. 3: Damaged Wisner-Pilger Middle School: ground-survey image (left) and point-cloud imagery (right).

- The aerial SfM platform (a visible camera mounted on an unmanned aerial system) permits the visual inspection of difficult-to-reach areas, such as the inaccessible roof of this school building. For this study, the performance of two different roof systems was assessed. The light-gauge truss roof section experienced a 50% failure rate compared to a failure rate for rolled-steel W-section roof supports of only 6%.

- Remote-sensing LiDAR and UAV SfM platforms permit more-objective detailed structural damage assessments from point clouds. The level of detail of the assessed damage varies as a function of distance to the structure; however, for the Wisner-Pilger Middle School this is at the sub-centimeter level.

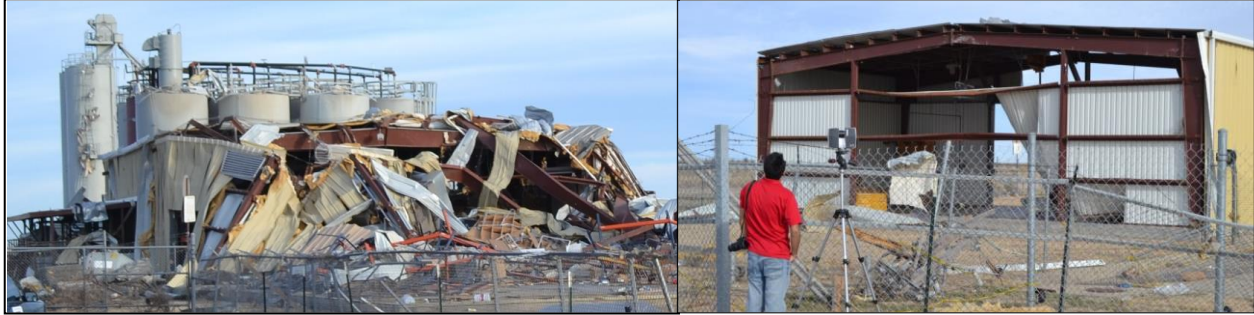
Fig. 4: Tornado damage to Halliburton facility, Pampa, TX.

Due to safety and security liability concerns, facility owners made immediate plans to demolish the damaged buildings and prohibited access to the site; investigators were therefore not able to make direct measurements of structural member sizes and deformations to assist with resistance calculations. Investigators were, however, able to acquire laser scan data from the property line. As structural steel members of the pre-engineered metal buildings were visible, measurements of the member sizes could be utilized in structural analysis models to validate or correct the wind speed estimates for damage to pre-engineered buildings in the current EF Scale. Laser scanning from the property line and UAV imaging (Fig. 6) provided effective solutions for rapidly and accurately preserving damage data for subsequent detailed forensic analysis. Although access to the nearby center-pivot irrigation systems was possible, measurements of the overall structure (approx. ¼ mile long) and deformations were again most readily accomplished by laser scanning and aerial imaging (Fig. 7).

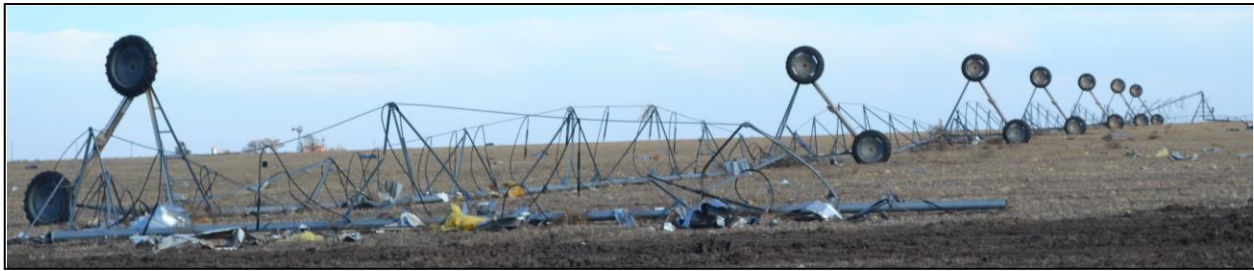
Fig. 5: Center-pivot irrigation system toppled by tornado, Pampa, TX.

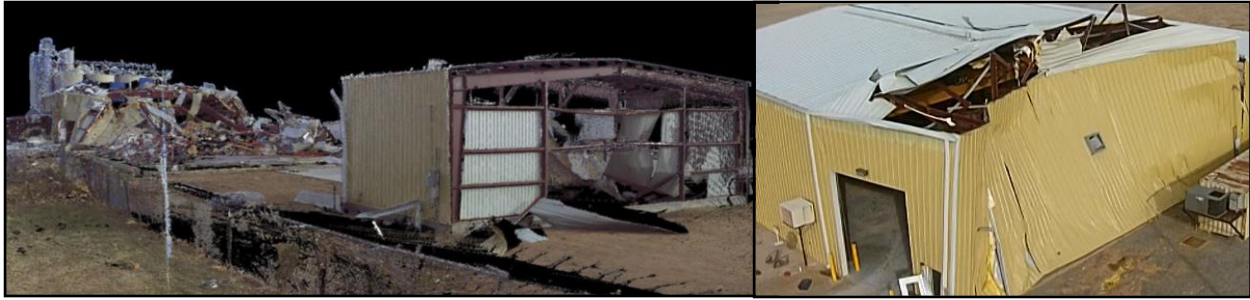
Fig. 6: LiDAR point-cloud data (left) and UAV imagery of damaged Halliburton facility at Pampa, TX (right).
