## IRON ORE MINE WASTE FLOODWATER EXTENT MAPPING UTILIZING REMOTE SENSING DERIVED INDICES

A. M. Elshorbagy\*  
Ryerson University, Canada

A. Shaker  
Ryerson University, Canada

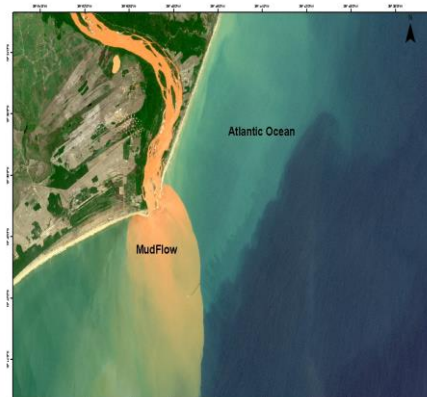
Figure 2: mouth of River (SEN-2 Dated 11 Feb 2016)
