RESILIENT INFRASTRUCTURE

June 1–4, 2016

FATIGUE RESPONSE OF UHPC AS A CLOSURE STRIP MATERIAL IN PREFABRICATED BRIDGE APPLICATIONS

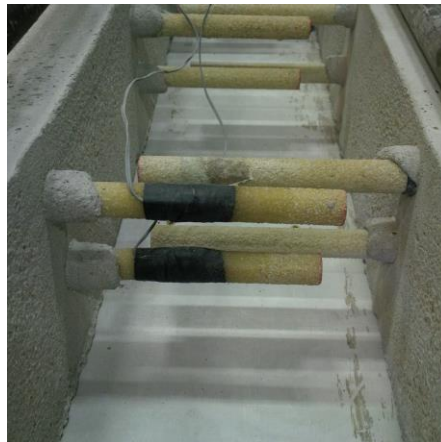
Figure 3: Closure strip prior to UHPC placement.

The transverse deck joint between the precast panels consisted of a 200 mm wide closure strip. During casting of the precast slabs the longitudinal reinforcing bars were positioned to allow for 150 mm of GFRP bar to protrude from the interior face of the precast panel. These bars overlapped the bars from the opposite slab over a distance of 100 mm within the closure strip. The interior faces of the slabs were sandblasted prior to placement to allow for a better bond between the UHPC and precast concrete. Figure 3 shows the closure strip prior to casting of UHPC.

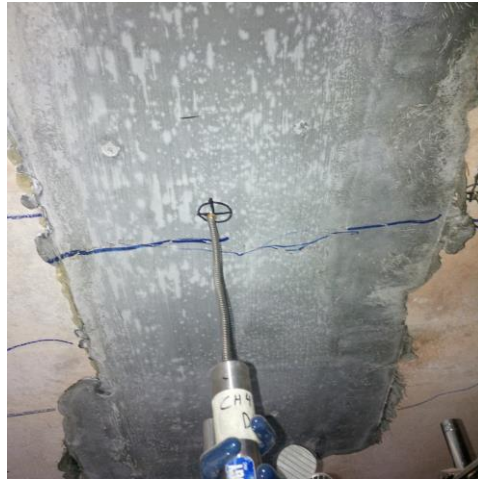
Figure 6: Crack through UHPC during fatigue loading adjacent to the closure strip

Most of the cracks formed in the precast deck panels within the first 100 cycles, with a few additional cracks manifesting throughout the fatigue loading. The first load location in the center of the panel (control location) had cracks that reached the UHPC closure strip but did not extend into the strip. However, immediately after fatigue loading began at the second load location, adjacent to the closure strip, a crack extended across the width of the UHPC joint at the approximate midpoint of the joint. It was clear that the crack was wide enough to break the steel

fibres within the UHPC, thus significantly reducing the tensile properties in that portion of the UHPC. Loading at the third location directly on the closure strip did not increase the number of cracks significantly, however fatigue in this location did increase the size of the crack through the closure strip. Figure 6 shows the crack in the UHPC closure strip.

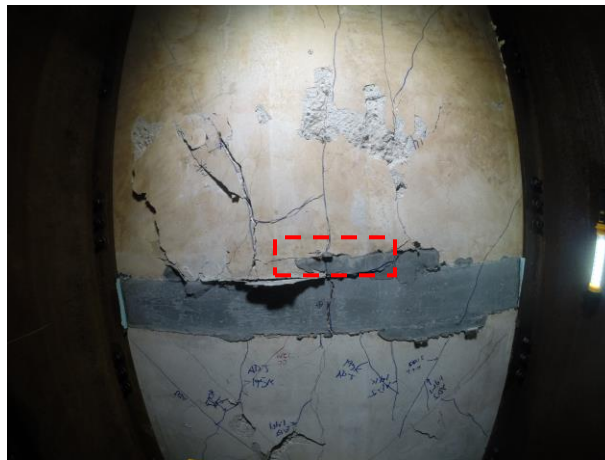
Figure 7: Underside of slab after loading to failure adjacent to panel (load location 2). Red rectangle indicates the approximate load location.

Once fatigue loading was completed at the three load locations, the slab was loaded to failure at location 2 directly adjacent to the closure strip as this was the point of greatest interest due to the influence of the UHPC-to-precast interface. The slab experienced a punching shear failure, however it exhibited a significant amount of strength post-failure. It should also be noted that the punching shear failure plane did not pass through the UHPC (following the typical punching shear cone geometry), but rather was truncated at the interface between the UHPC and precast panel. Figure 7 shows the underside of the loaded area after failure loads were applied.

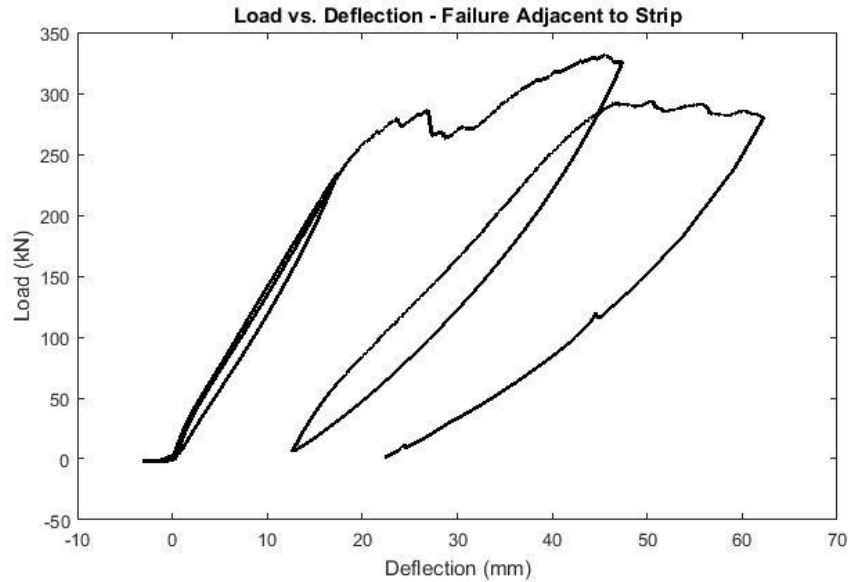
Figure 8: Load versus deflection curves for specimen loaded to failure adjacent to strip.

Figure 8 shows the load deflection curves for the static loading to failure adjacent to the closure strip. Note that the specimen was unloaded and reloaded several times during the static loading history as the interlock limits on the controller were triggered. Punching failure occurred adjacent to the strip at a load of approximately 285 kN as indicated by a sudden drop in the load carrying capacity coincident with the formation of a typical punching shear crack failure pattern. Applied loading was continued after the punching shear failure had occurred. During this time, the applied load increased to 325 kN as the load-carrying mechanism changed to arch action.

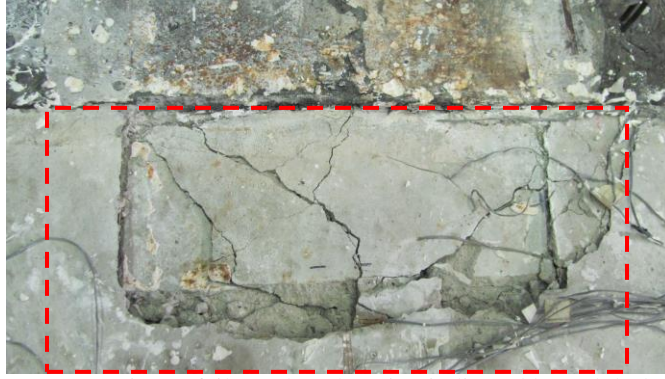
Figure 9: Approximate failure plane location indicated by red dashed line.

Where f_{cr} is the cracking strength of concrete (MPa), f_{pc} is the compressive stress in concrete after prestress losses (MPa), b_o is the critical section perimeter (mm), d is effective depth of reinforcement (mm), and V_p is the shear component from prestressing. For this case, it was assumed that b_o would be measured on the four sides of the loaded area and that d would be measured from the top fibre of the slab to the centroid of the bottom reinforcement layer. Using a resistance factor for concrete of 1.0 (for behaviour prediction rather than design strength) and omitting the prestressing contribution, V_p , since the deck was not prestressed, it was found that the calculated shear resistance of the slab should be 486.5 kN. This predicted value is greater than the punching load experienced, however the predicted failure load does not account for pre-existing damage to the panel (from fatigue loading) and assumes that the failure plane is symmetrical and is centred on the load point. For the case being considered, the load adjacent to the panel only had three standard failure planes since the fourth plane was truncated along the face of the UHPC. That is, the failure plane did not extend into the UHPC to follow the geometry normally assumed for a punching shear failure. It is assumed that the very high strength and toughness of the UHPC relative to the precast concrete panel resisted extension of the punching shear failure plane into the UHPC. Figure 9 shows a diagram of the approximate failure plane based on a top view of the slab after punching failure.

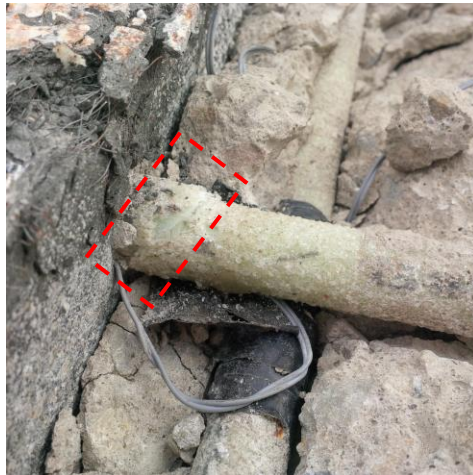
Figure 10: Shear failure of top GFRP bar after failure load adjacent to the closure strip.

In order to apply the CSA A23.3 provisions to the deck loading position adjacent to the UHPC joint, it was assumed that the truncation of the failure cone by the UHPC had a similar effect to that of an edge column. As well, the bond between the precast panel and UHPC joint was assumed to be negligible, and the dowel action of the panel reinforcement extending into the UHPC joint was neglected. Using Equation 2 with β_c of 0.75 the shear stress was found to be 2.23 MPa. Using Equation 3 α_s taken as 3 for a case with three planes of failure, the predicted failure shear stress for the location adjacent to the panel would be 3.68 MPa. Finally, Equation 4 finds a shear stress of 2.54 MPa. For a four sided failure plane, the failure load is calculated to be 377.8 kN. However, assuming the failure area is the three sides of a punching failure cone defined by the depth of reinforcement and critical perimeter, b_o , the predicted punching shear failure load in this case is 225.7 kN using the shear stress from Equation 2. Therefore, the failure load of 285 kN is between the three and four sided failure plane assumptions. This difference may be caused by the contribution of the shear or bond on the interface between the UHPC and precast panel which is insufficient to transfer the entire shear stress through the UHPC. Once the punching shear failure cone developed and slip occurred at the UHPC to panel interface, the GFRP did not appear to provide significant shear resistance in dowel action. Upon removal of the top layer of panel concrete, the top layer GFRP bar under the load position was found to have sheared near the UHPC to precast concrete interface. Figure 10 shows the shear failure through this bar.

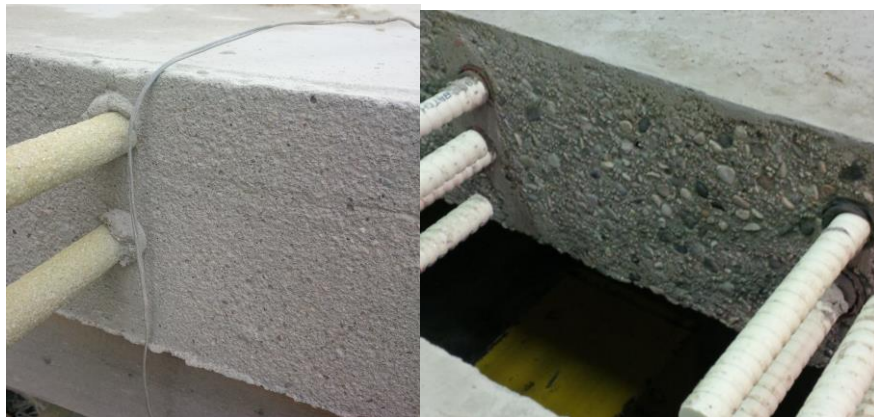
Figure 11: Previous sandblasted surface (left) and the new coarse aggregate finish (right).

Further tests will be conducted using a similar method of construction and loading. Two additional slabs will be created utilizing GFRP bars from a second manufacturer and one additional slab with same bar type used in the experiment described above. One difference for these tests is the precast concrete interface will have a greater surface roughness through an exposed coarse aggregate finish, rather than simply sandblasted. Figure 11 shows the difference between the tested sandblasted surface and the new coarse aggregate surface.
