# Natural Degradation of Earthworks, Trenches, Walls and Moats, Northern Thailand

Spencer H. Wood  
*Boise State University*

## Abstract

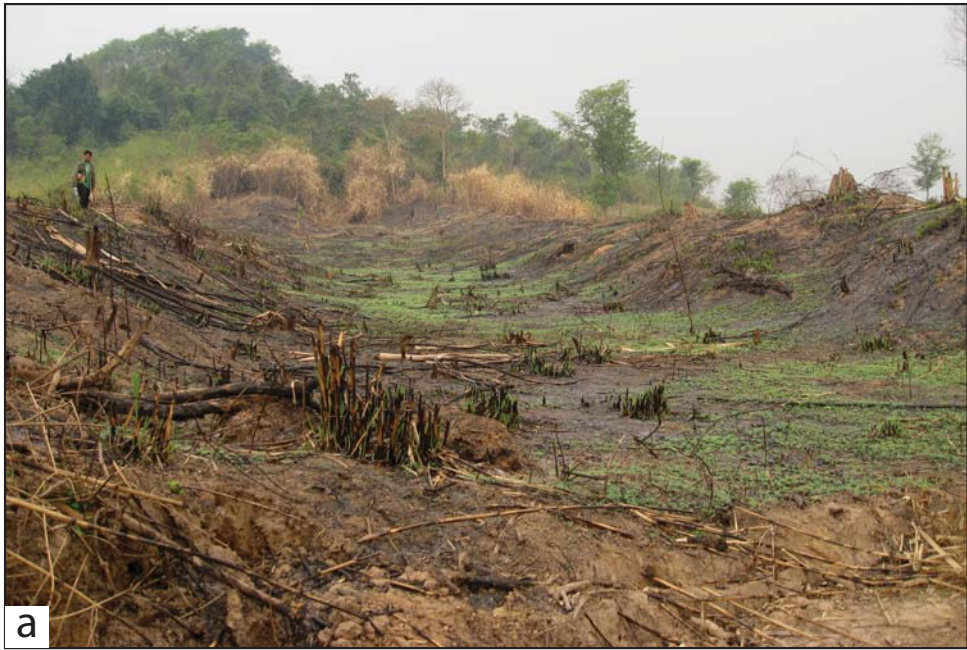
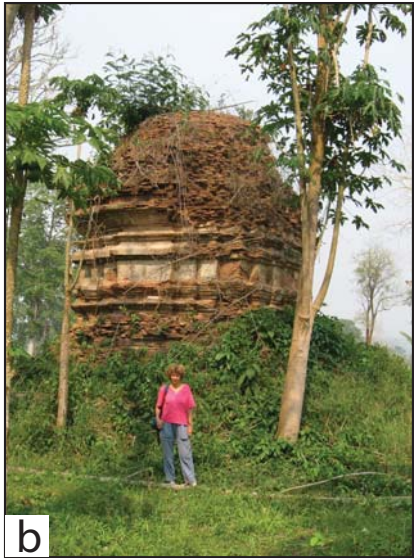
FIG. 9 (a) View looking west and uphill of the trench earthwork at Souvannakhomkham and location of profile A in FIG. 8. Person at left (south side) for scale. Bottom of trench is 10-m wide, and trench is 3-m deep. The trench system runs up the 40-m high hill in the distance and could not have held water. (b) ruins of a bell-shaped stupa at location R (FIG. 8) (c) ruins of a redented style (stupa-form terminology from Leksukam, 2005) stupa at location P on FIG. 8. (d) photo showing the earthen-walled moat and the partially reconstructed brick wall of the city of Chiang Saen. Degraded slopes down to the left are similar to those of most other earthworks in the region.
