Report No 26

March 1975

PLYNLIMON FLOODS OF AUGUST 5th/6th 1973

MALCOLM NEWSON

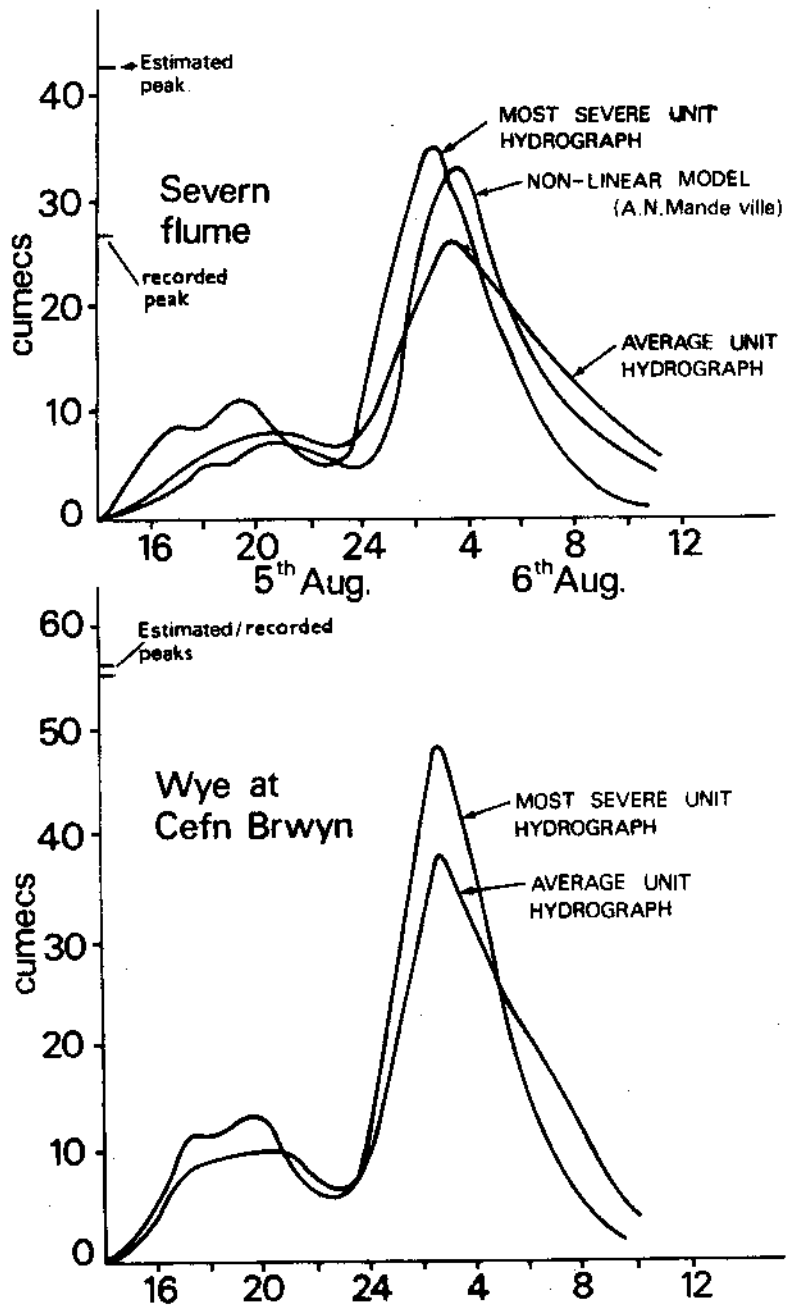
Figure 10. Use of unit hydrographs and predictive model to estimate peak flows with recorded rainfall (allowing 100% runoff).

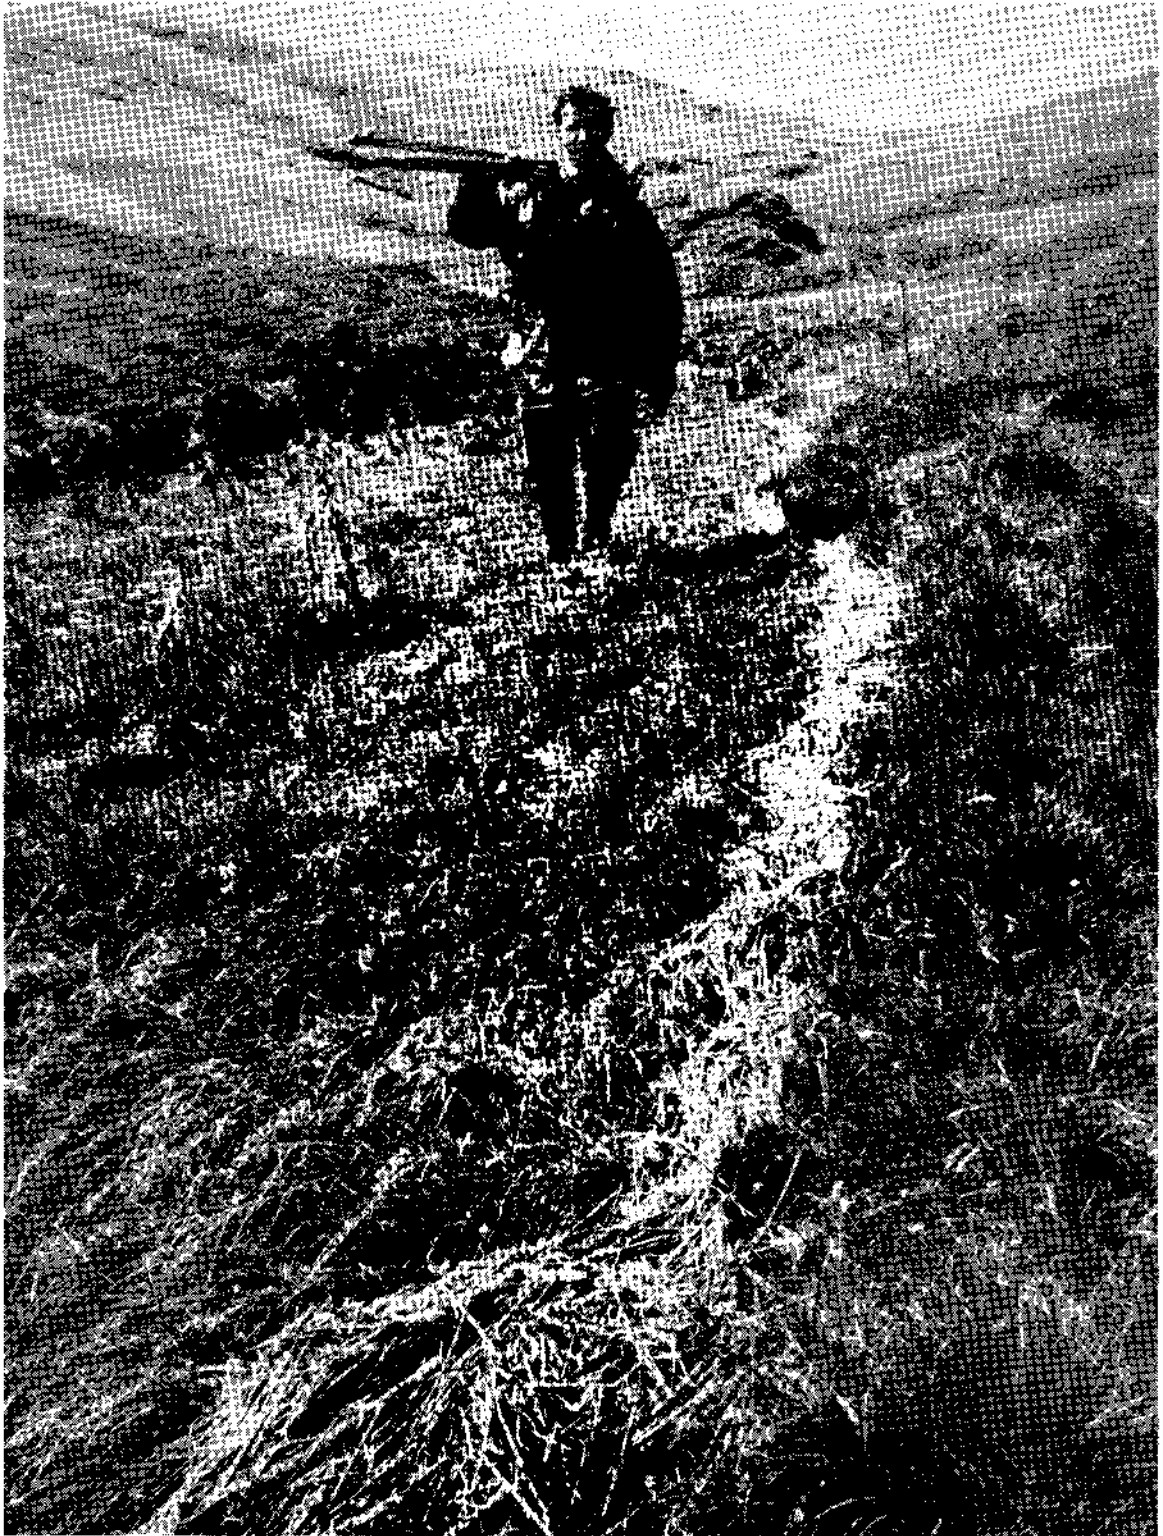
Plate 1. Rack marks on the left bank of the Cyff, upstream of the flume.

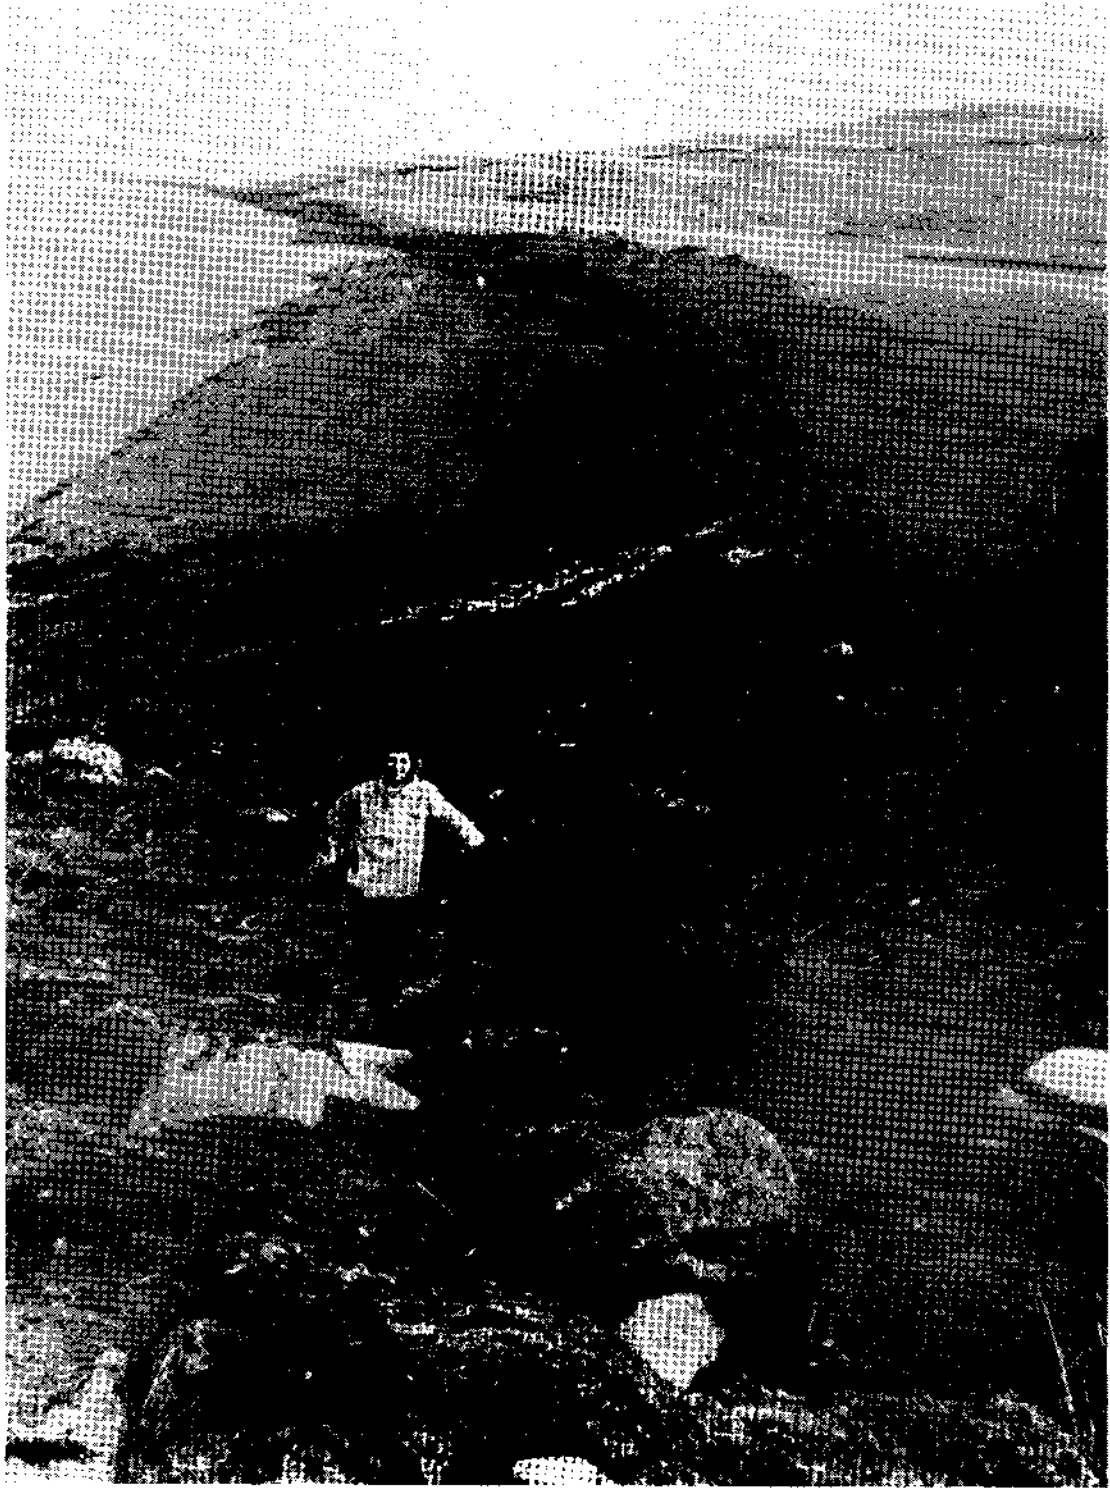
Plate 2. Lower end of burst flush, Cerrig-yr-wyn, Wye catchment.

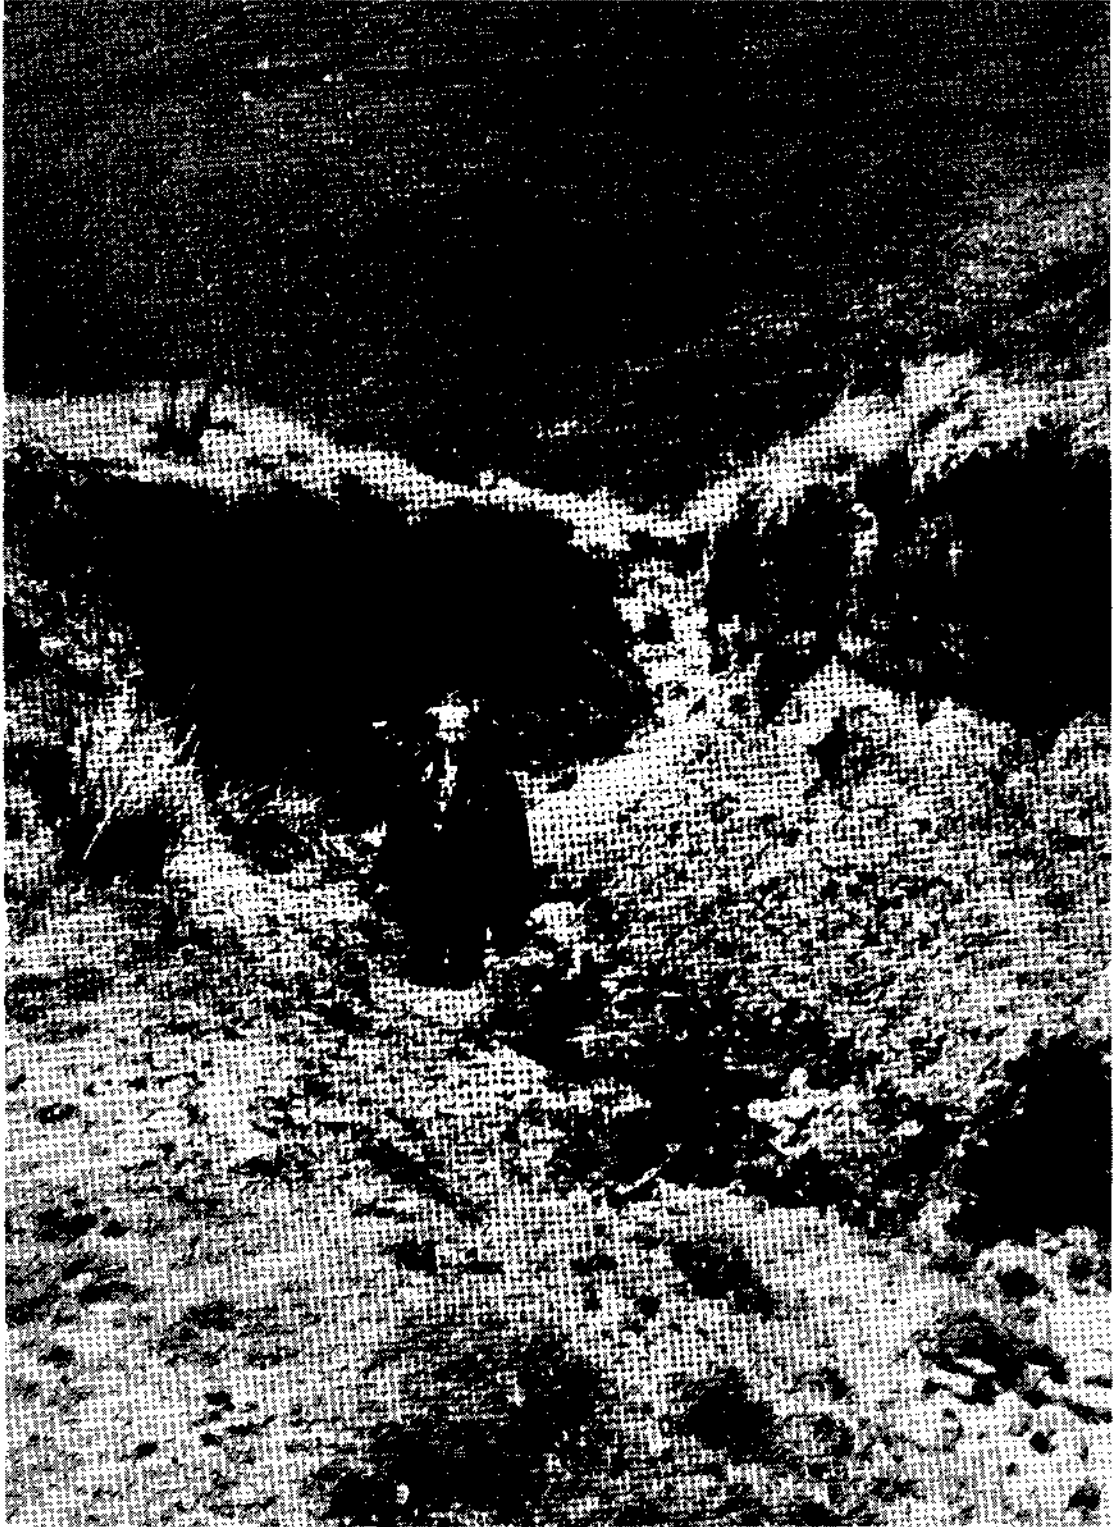
Plate 11. Gullied stratified scree (and slope-waste) below Eisteddfa Gurig road.

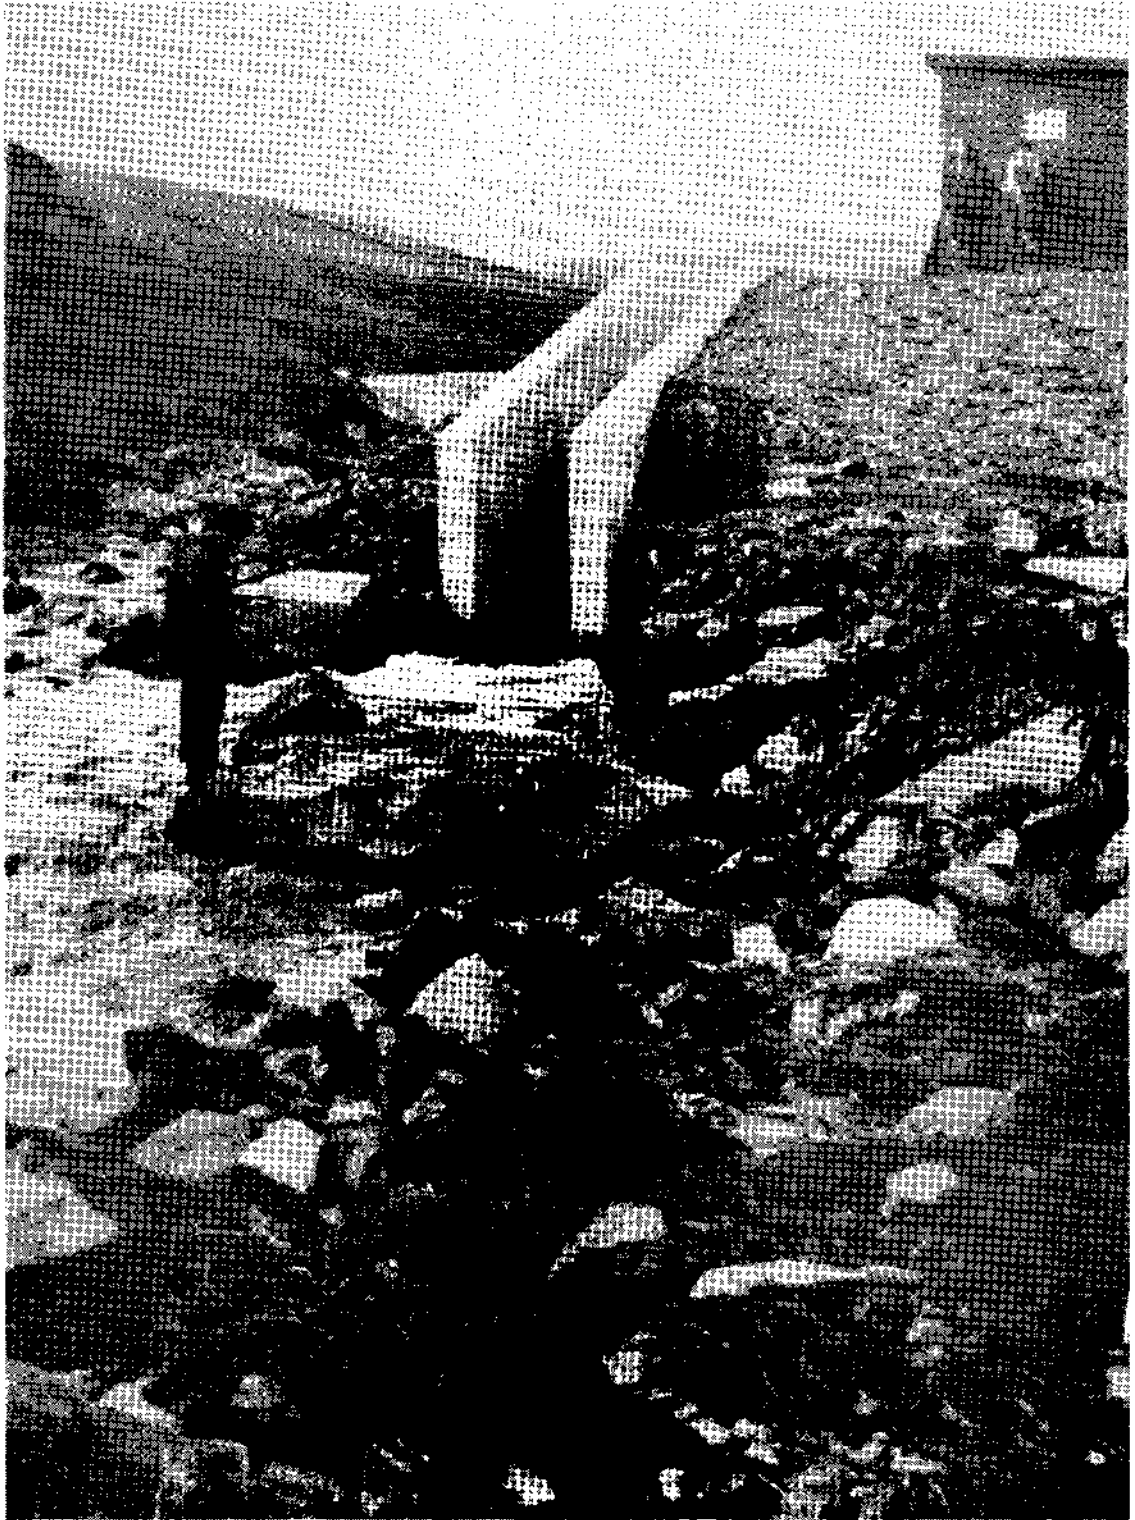
after such an event there were individual cases of very large boulders having moved (see Plate 16). Velocity estimates performed as part of peak discharge estimates are between 2.13 m/sec and 2.70 m/sec, quite sufficient for material of over 10 cm in diameter to be moved. Since the Plynlimon channels contain numerous huge glacially-derived boulders, there is no shortage of all sizes of material already in the channels. Neither the largest boulders nor bedrock exposures in the channels showed any effects of the flood except for losing their upper covering of moss and lichen. In the finer size ranges the main contribution of tributary streams (see Plate 17) and forest drains/roads seems to have been of gravel and small cobbles. Unlike boulders on the one hand or fines on the other, which move respectively too slowly and too fast to be of nuisance, it was shoals of this size range taking a period of weeks after the flood to move out of the catchments which caused most problems at the flumes (see below).

Plate 16. Boulder movement at the Gwy flume. The boulder being measured apparently passed through the flume.

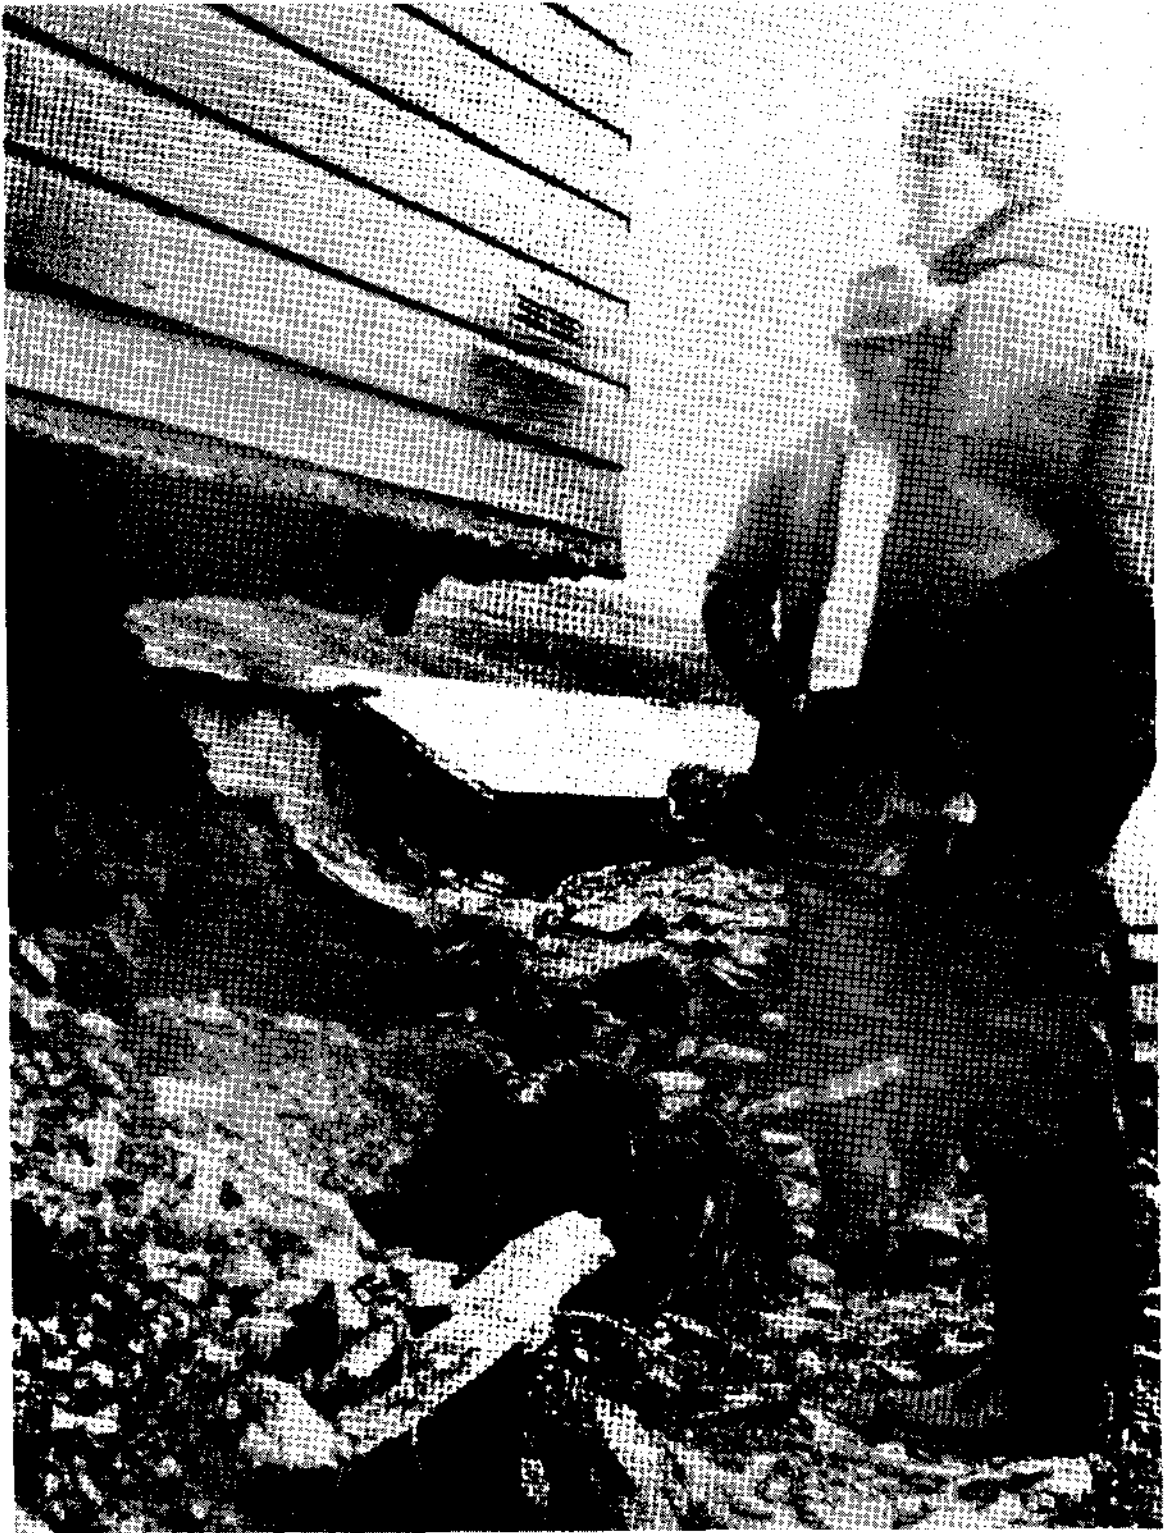
not more damage was done by an event of such rarity: only the Hafren was badly damaged, although the concrete of the Severn flume was abraded and the Gwy recorder hut undermined (Plate 20). Other damage was restricted to fill material (Hore and Hafren). Smaller weirs and rated sections used for process studies in the Gerig were extensively damaged. Sedimentation was not a problem in the steep-stream structures since these transport gravelly and finer material quite well. Only boulders accumulate at the base of the entry ramp (see Plate 21) and whilst these no doubt affect the accuracy of calibration during the flood they do not cover the tapping point and make level records inaccurate. The Severn flume, however, develops shoals of finer material which block the tapping point and it should be borne in mind that the recorded flow for the August flood is considerably lower than that estimated by slope area surveys on the tributaries or from rack marks at the flume itself. Silt was removed from the tapping pipe after the flood and the anomalous shape of the flood peak suggests that blockage had occurred. At Cefn Brwyn the situation is simpler: both estimated and recorded floods are slightly in excess of the structure's capacity and this supports observations on site. A further problem concerns the uncertainty of calibration for the Plynlimon structures: at the time of the flood, theoretical calibrations did not exist for the steep-stream structures and none of the now-available calibrations has been checked at full capacity. The bypassing of the Gwy and Cyff structures produces a broad hydrograph peak and is of uncertain effect on the calibration: the relatively low bypasses were introduced to prevent the flumes flowing at full depth.

Plate 20. Undermining of Gwy flume hut by overtopping flood waters.
