**INTERNATIONAL CONGRESS ON  
Science and Technology  
for the Conservation  
of Cultural Heritage**

**Santiago de Compostela, Spain,  
2-5 October 2012**

**BOOK OF ABSTRACTS**

# **Research Advances for the Conservation of Cultural Heritage**

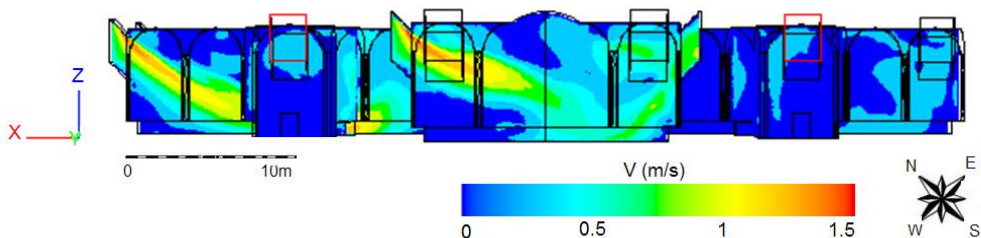
Figure. Airflow velocity in the Crypt (simulated scenario with four opened windows).

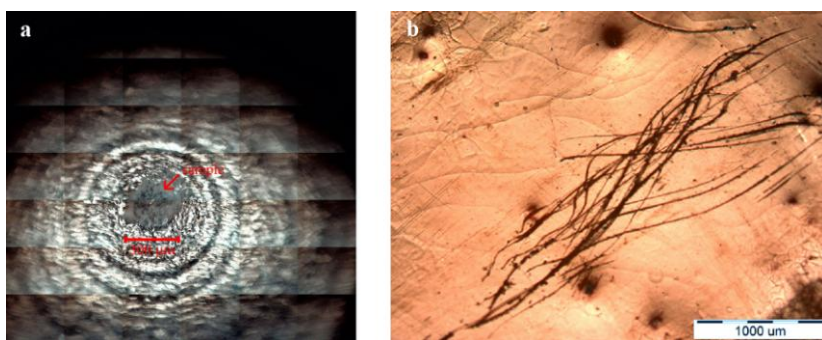
Figure a. Photomicrograph of a sample on a diamond holder recorded with FTIR microscope, b. surface of a model painting after sample removal.

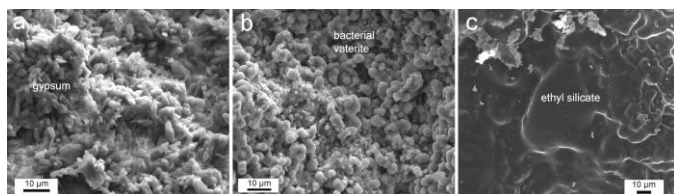
Figure a. SEM photomicrographs of gypsum plasters before and b. after bacterial bioconsolidation treatment, and c. consolidation with ethyl silicate.

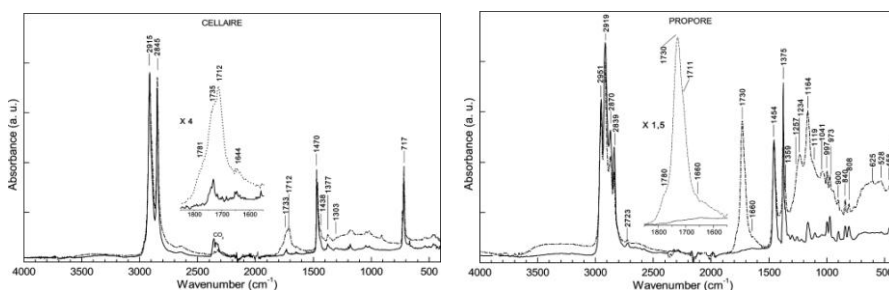
Figure. FTIR-ATR spectra of polyolefins before and after having being exposed to arc-xenon ageing for 1800 hours: a. Cellaire® (LDPE): b. Propore® (PP)

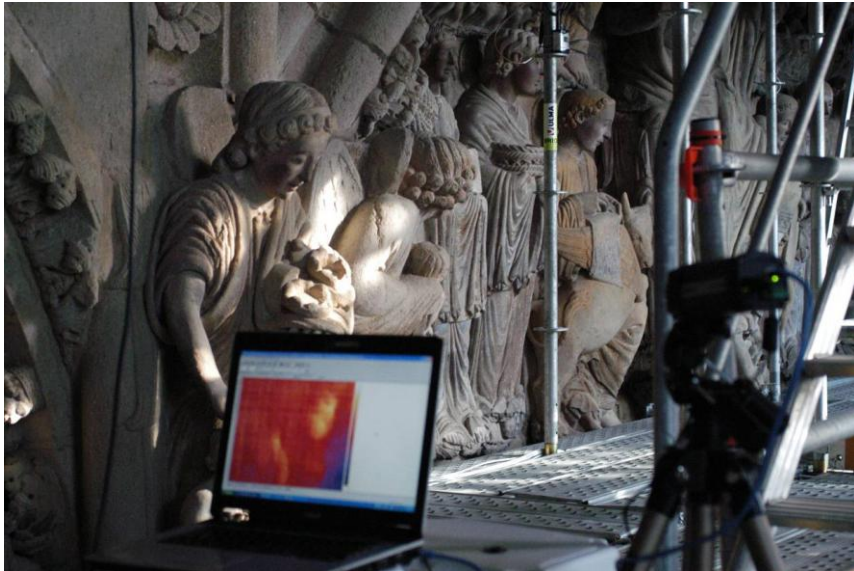
Figure: Experimental setup of the termographic camera.

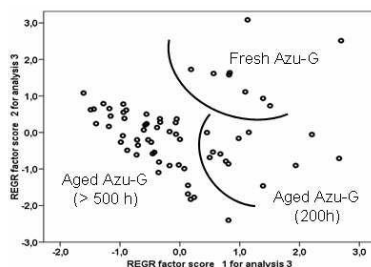
Figure. Scores plots for PC1 and PC2 of the UV-ageing of the azurite tempera model samples in the mass interval between 1760 and 2500 m/z.

One of the main goals in Heritage Science is to characterize painting components and their interactions under diverse conditions to promote their conservation. This work is based on an overview of the analytical procedures to deal with problems that concern the field of art paintings. The approaches are based on the combination of spectroscopic techniques with multivariate statistical tools, particularly, principal component analysis (PCA). Chemometric evaluation of spectral data is well accepted as a powerful tool for different purposes, including sample identification and recognition. In particular, PCA is a powerful data-mining technique that reduces data dimensionality, obtaining more interpretable representation of the system under investigation. In the context of these studies, we present research performed applying PCA to Diffuse Reflectance Infrared Fourier Transform Spectroscopy (DRIFTS), Transmittance-Fourier Transform Infrared Spectroscopy (T-FTIR), Raman Microscopy (RM) and Matrix-Assisted Laser Desorption/Ionization-Time of Flight Mass Spectroscopy (MALDI-TOF MS) data from painting model samples (i.e. inorganic pigments, proteinaceous binders and tempera model samples). These studies were devoted to studying the ageing process of the proteinaceous binders when mixed with inorganic pigments and also to discriminate among samples according to different composition and possible interactions. Results showed an excellent ability of PCA on DRIFTS and first derivative Raman spectra to discriminate replica samples according to pigment chemical class and the presence of proteinaceous binder. In addition, PCA on first derivative Raman spectra allowed identification of slight changes in the characteristic C–H stretching region related to interactions between metal-rich pigments interacting with egg yolk binder. Regarding ageing processes, PCA performed on MALDI-TOF MS and T-FTIR data separately discriminated samples based on different UV-ageing states of proteinaceous binder, corroborating the photostabilization of the glue against UV irradiation and the additional photostabilization of the tempera when azurite is present (Figure).

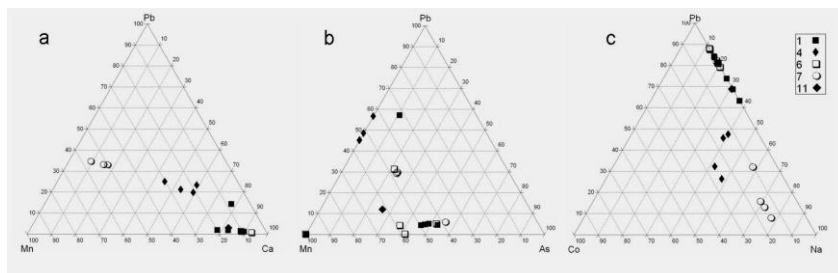
Figure. Ternary phase diagrams of red enamel of horse harness pendants

In addition, a detailed observation of ternary phase diagrams showed that some pendants were lead-rich, cobalt/calcium-poor while others were mainly manganese/calcium/potassium/sodium-rich and arsenic/lead-poor (Figure). According to the literature, a high PbO content increases the degree of the depolymerization of the silicate network; it could increase the sensitivity to alteration processes in glasses, corroborating the degradation of the red enamels with higher PbO content. Consequently, surface weathering could be produced and hence, ionic exchanges might explain the low alkali and alkaline earth metal contents of some pendants. These facts could suggest a low production cost and consequently, poor quality glasses. A manufacture without controlling the atmosphere was also recognized thanks to the presence of copper as oxide.

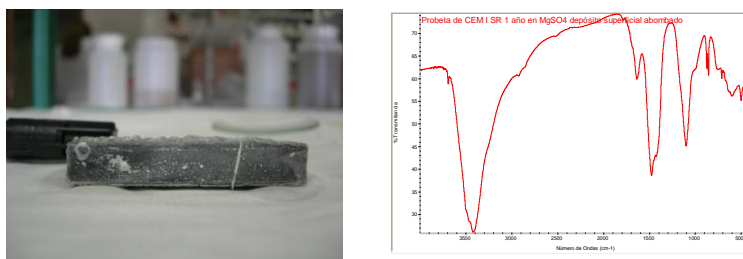
Figure. Sample CEM I SR 1 immersed 1 year in  $\text{MgSO}_4$  (1500 ppm) solution.  
FTIR analysis of the formed salt.

Thermodynamic results indicated that all solutions will be in equilibrium with thaumasite. Additionally samples immersed in  $\text{MgSO}_4$  solution will be also in equilibrium with magnesium silicate and magnesium silico-aluminate and different magnesium carbonates (i.e.  $\text{MgCO}_3 \cdot \text{Mg}(\text{OH})_2 \cdot 3\text{H}_2\text{O}$ ;  $\text{MgCO}_3$ ;  $\text{CaMg}_3(\text{CO}_4)_3$ ). However thaumasite was only formed over the surface of the sample CEM I SR exposed 1 year to  $\text{MgSO}_4$  solution as can be observed in the Figure.
