Subsidence 2008 - Gunn

Remote thermal infrared surveying to detect abandoned mineshafts in former mining areas

¹Gunn, D.A., ¹Marsh, S.H., ¹Gibson, A., ¹Ager, G.J., ¹McManus, K.B., ²S. Caunt & ¹Culshaw, M.G.

1 - British Geological Survey, Kingsley Dunham Centre, Keyworth, Nottinghamshire, NG12 5GG.

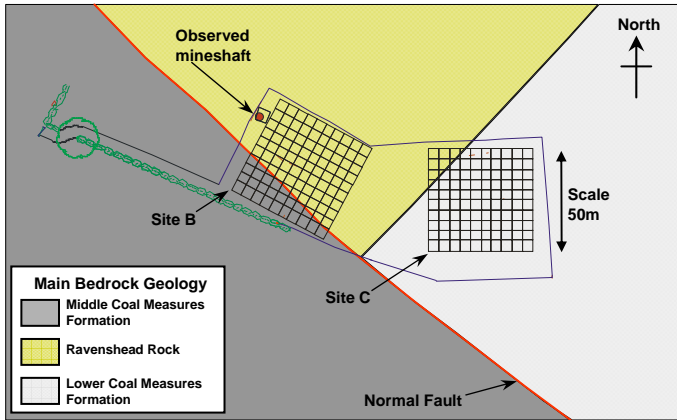
a. Orientation of survey grids relative to bedrock geology. (arrows pointing to the origin on both Grid B and Grid C.)

The Pewfall Colliery was roughly mid-way between St. Helens and Wigan. Since the cessation of mining the site has been returned to agriculture, but some fenced off mineshafts remain in neighbouring fields. Bedrock geology consists of the Lower Coal Measures Formation, the Middle Coal Measures Formation and the Ravenshead Rock with a regional dip of 30° to the south-east. The site is cut by a normal fault that is downthrown to the south-west, with a dip of 70° and strikes to the south-east (Fig. 1a). The bedrock geology is overlain by Glacial Till to an unknown thickness but, possibly up to 10m thick. Two 50 m x 50 m survey grids were established and denoted Site B, which was on a gentle, south-west facing slope, and, Site C, which was in a shallow trough that widened and whose axis also dipped to the south-west (Fig. 1b). The focus of this paper is site C but the Gunn *et al.* 2006 provide detailed field methodologies and results for both sites. The x-axis of Grid C was orientated approximately west to east, but dipped to the south-east by 3°. The origin of the grid was located at BNG co-ordinates 355209E, 398346.88N. The elevation range across the grid was 3 m.

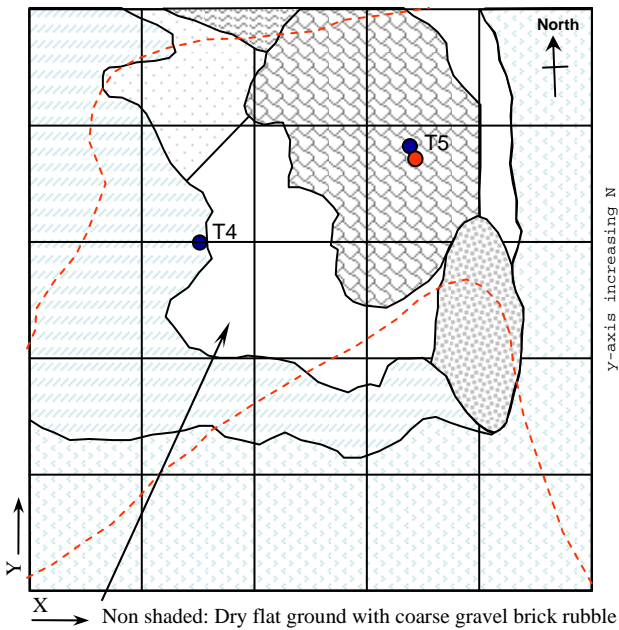
b. Field sketch of the ground conditions over grid C.

Looking across Grid C, long grass generally covered the area below $y = 13$ m and beyond $x = 44$ m (Fig. 1b); generally long grass gave way to very short grass up to $y = 20$ m and below $x = 15$ m; vehicle rutting was confined to a small zone near $y = 50$ m; an island of wet, disturbed and turfed up ground roughly 20 m in the x-dimension by 25 m in the y-dimension was centred about $x=32$ m, $y=36$ m; standing water / ice occurred over a 5 m wide island in the trough along a section of $x = 40$ m from $y=15$ m to 32 m, over the Coal Measures sub-crop; other areas comprised dry, flat ground with coarse brick and stone gravel sized rubble.

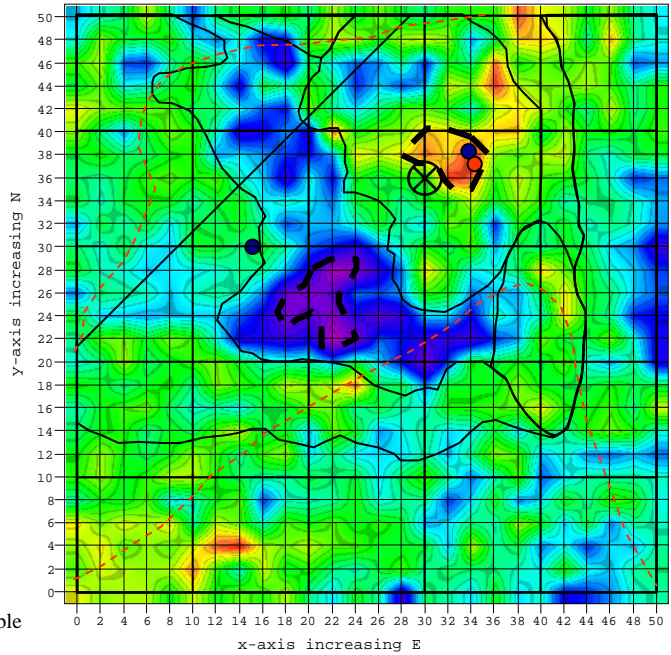
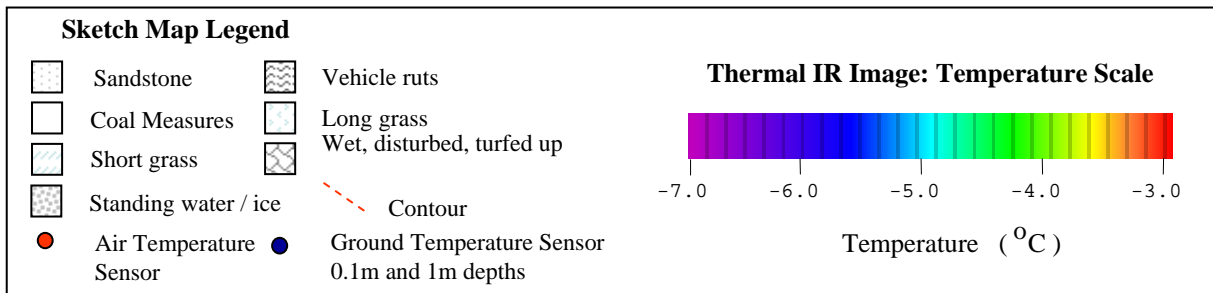
Fig. 1. Geology, orientation, ground conditions and thermal IR radiation for the site at Pewfall, St. Helens.

c. Image of thermal IR radiation from ground at grid C.

The thermal IR emitted from the ground over Grid C is shown in Fig. 1c. The line work overlay delineates the key surface and underlying geological features over the grid (from Fig. 1b). The confirmed position of a 3 m diameter brick-lined, back-filled mineshaft is denoted by the circular target with a diagonal cross at 28 m, 14 m. The coldest parts of the grid coincide with the dry, flat ground containing coarse brick rubble. In fact, the amount of brick rubble was sufficient to give this area of ground a brown-red colour. This ground appeared to be of low moisture content and very well draining. The low temperatures are suspected to be due to heat losses caused by evaporation. A large cold target centred approximately at x=21 m, y=25 m has been highlighted for possible further investigation, but it is suspected that the anomaly is due to the large amount of brick rubble in the ground, for example consistent with buildings located here formerly. Another notable cold target is centred along x=50 m from y=20 m to y=36 m. This is within the zone of long grass, within which there are areas of very long, dry wispy grass that had frosted up where pockets of cold air may have been trapped. It is possible that this cold zone is related to variability to the underlying ground, which may comprise made-ground associated with former railway works that were understood to have once occupied the site. The cold target within the wet, disturbed and turfed up ground coincides with a small island of brick rubble.

Warm targets of note include an oval zone roughly 5 m by 4 m centred at x=32 m, y=37 m, and also lesser targets at x=36 m, y=44 m; x=38 m, y=50 m and x=13 m, y=4 m. It was noted that the first three targets occur in grass-free areas, whereas the target at x=13 m, y=4 m occurred within the zone of long grass. The target at x=38 m, y=50 m coincided with standing water and ice that was observed during the

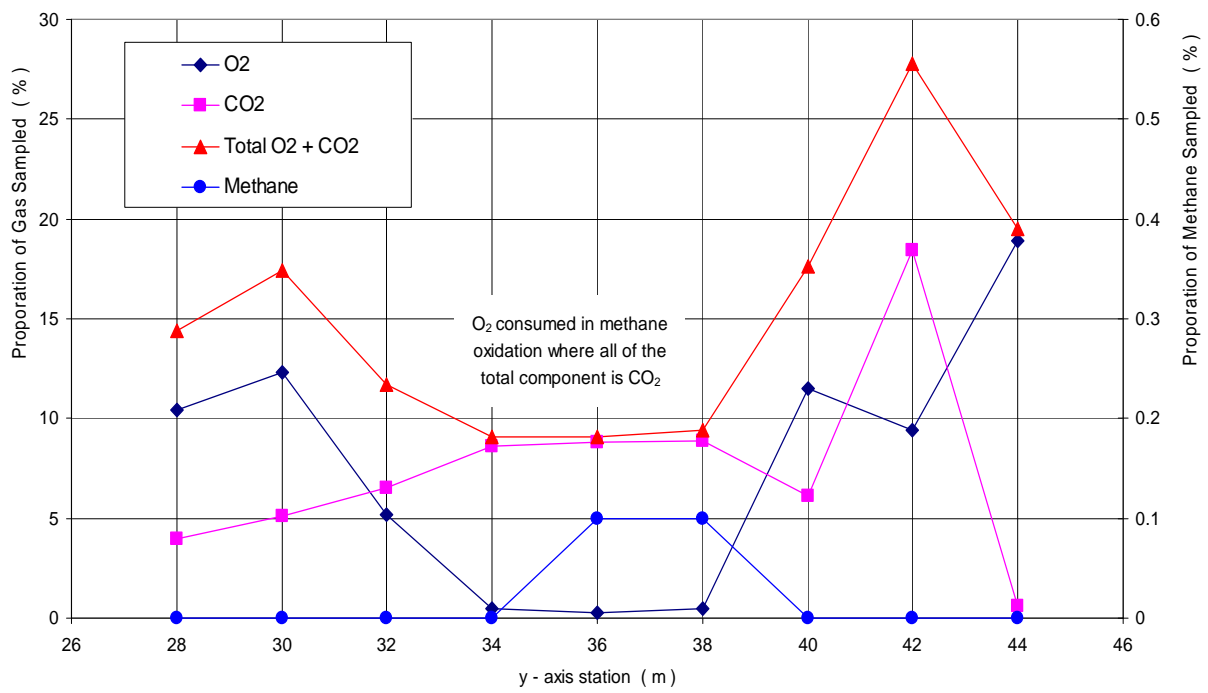
Fig. 2. Detection of methane in soil gas samples along $x=32\text{m}$ - Grid C.

survey, and it is suspected that the target at $x=36$ m, $y=44$ m was also associated with ice. Soil gas sampling across the largest anomaly at $x=32$ m, $y=37$ m indicated the presence of very minor amounts of methane and complete deficiency of oxygen in the ground that is compatible with methane oxidation. Fig. 2 shows a profile of analyses of gas samples taken along $x = 32$ m across the warm target at $y=37$ m. Exothermic oxidation of methane would provide additional heat into the ground and this is very compelling evidence for the presence of a mineshaft in the zone highlighted.

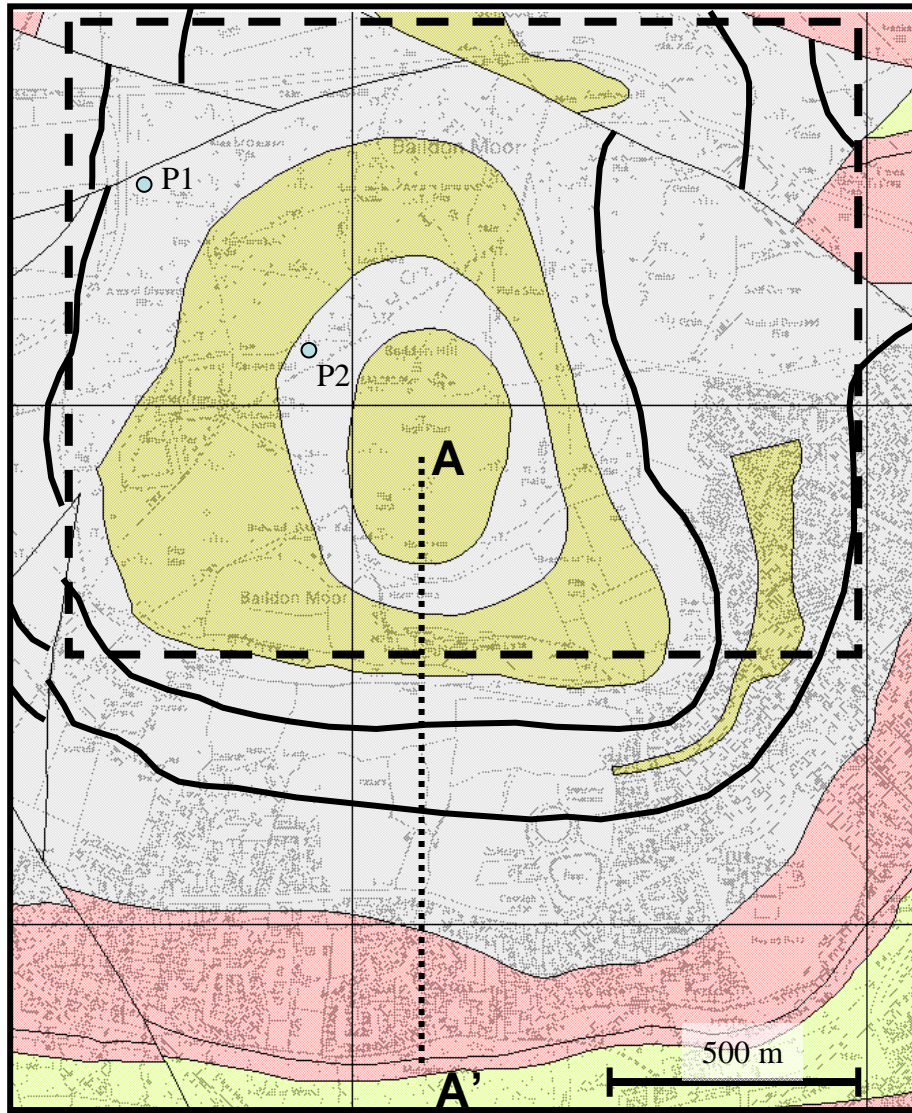
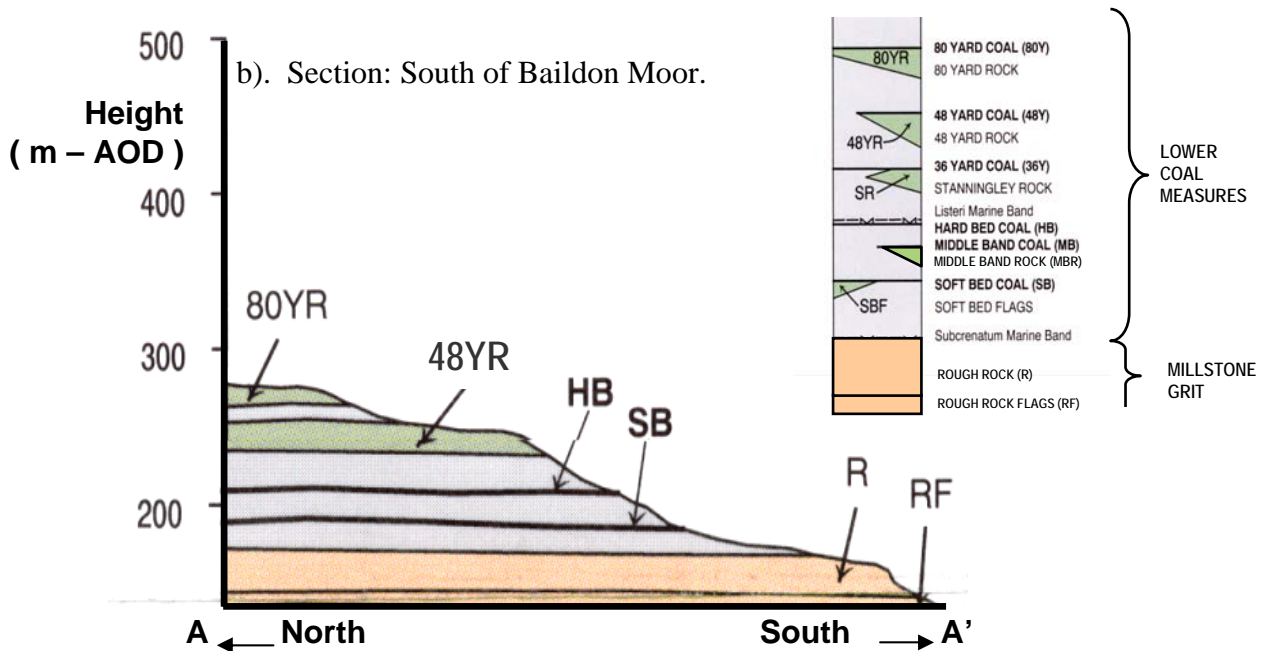
a). Geology map. Extent of interpreted thermal image
 OS topography © Crown Copyright. P1 Location of photographs
 All rights reserved.

Fig. 3 Geology of Baildon Moor including the Hard Bed and Soft Bed coal seams. (modified from Waters *et al.*, 1996)

Baildon Moor comprises an outlier of Coal Measures resting conformably upon the Millstone Grit Group (Fig. 3). The word Baildon can be translated as 'the hill of pits or mines', where mining may have begun during the occupation of the Roman Legions, about 200 AD. Baildon town is located in West Yorkshire, England, about 10 km north of the City of Bradford. Baildon Moor covers about 20 km² and has an elevation of 280 m above sea level at the summit. It rises above Baildon town on a thick scarp of the hard Rough Rock sandstone (R in Fig. 3b). The flat top is formed by the 80 Yard Rock sandstone-capping layer. About 20 m below is an extensive plateau, which is formed in the 48 Yard Rock sandstone. Coal-bearing rocks of the Lower Coal Measures (Waters *et al.* 1996) are sandwiched between this lower plateau and the thick scarp above Baildon town. The Coal Measures show a gentle dip of between 1° and 4° to the south-south-west within the area of Baildon Moor. Therefore, over much of the study area the depth to coal seams, the Hard Bed (HB in Fig. 3b) and Soft Bed (SB in Fig. 3b), was largely a function of the surface topography. Shallow depth, bell pits into the Coal Measures are distributed around the perimeter of the lower plateau, and larger diameter, deeper mineshafts can be found in, and above the lower plateau. However, in the north and west of the study area the depth to coal is controlled by displacement along a series of steeply dipping normal faults (Fig. 3a).

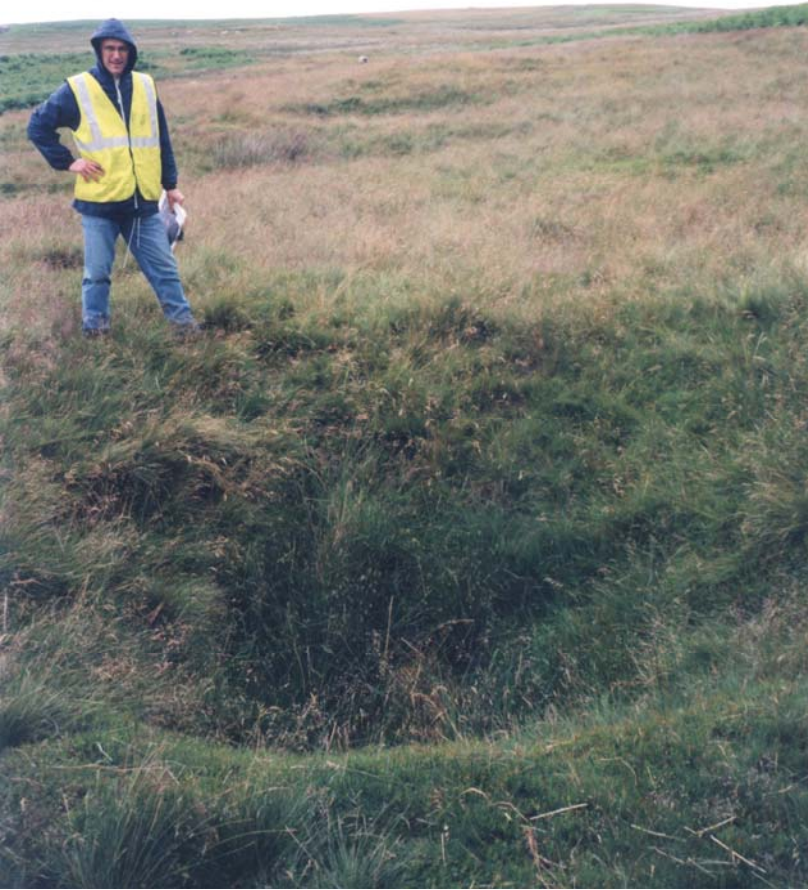
Fig. 4. Bell pit from NW flank of Baildon Moor. Conical depression with bilberries on the E-SE arc-side of cone and reed grass in the centre. 4m across and 2m deep.

Bell pits were usually initiated from shafts with a diameter of approximately 1 m - 2 m down to the coal seam with a maximum depth of around 10 m (Waters *et al.* 1996). Coal was then excavated at the base to a maximum diameter of around 6 m, limited only by the collapse potential of the roof. However Littlejohn (1979) does record excavations up to 20 m in diameter. The majority of bell pits are associated with working of the Hard Bed Coal. As bell pits were only excavated to approximately 10 m depth, it is presumed that they lie exclusively between the outcrop of the Hard Bed Coal seam and the base of the 48 Yard Rock sandstone. It is unlikely that any casual bell pit development would have been undertaken through this hard sandstone and so the base of the 48 Yard Rock can be used as a reasonable upper boundary to the presence of bell pits. Many of the bell pits were characterised by a conical depression of up to 4 m diameter and 2 m deep (Fig. 4 shows a typical example). Spoil rings when present, appeared as a low lying circular ring less than 0.5 m high with an outer diameter of up to 6 m.

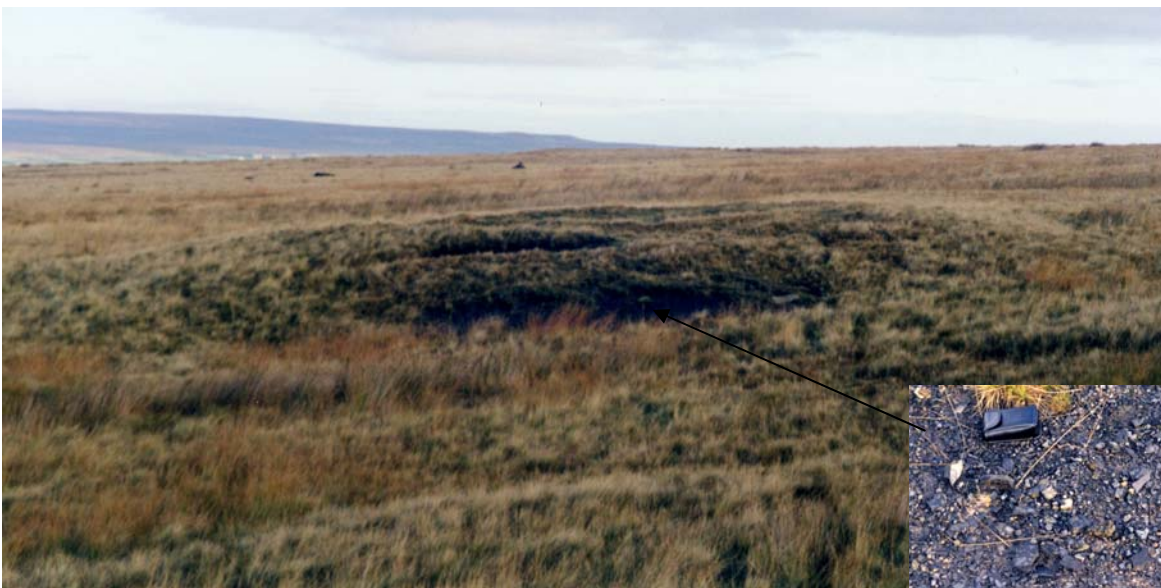
Fig. 5. Deeper shafts to the Hard Bed Coal on or above the 48 Yard Rock plateau. Depression 12m dia and 3 m – 4m deep often filled with reed grass. Spoil ring 20 m dia / 3m high; including coal and carbonaceous mudstone

Mining in excess of 25 m probably began occurring in the UK in the 18th or 19th Centuries, requiring more efficient winding gear and techniques of pumping out groundwater. It is believed that in the early works at Baildon, the coal would have been removed by a shafthead windlass. While the maximum depth of shaft using this method limited to 20 m – 25 m, it was still sufficient to mine the Hard Bed Coal. The shafts over the plateau formed by the 48 Yard Rock in the vicinity of Dobrudden Caravan Site appear to have been of this type. The arrangement of these mineshafts is in a grid of approximately 100 m dimensions. Mining was in the form of room and pillar away from each shaft centre. Also, ventilation of the deeper pits would have involved an up- and a down-shaft, to allow a through flow of air. Many of the abandoned shafts were characterised by a spoil ring with a 20 m outer diameter around a central zone of around 12 m diameter (an example is shown in Fig. 5). This central zone can be flat with infill soil, water filled or a conical depression up to 5 m deep. The spoil ring can be built up to 3 m above the outer ground level or a low lying annulus less than 0.5 m high.

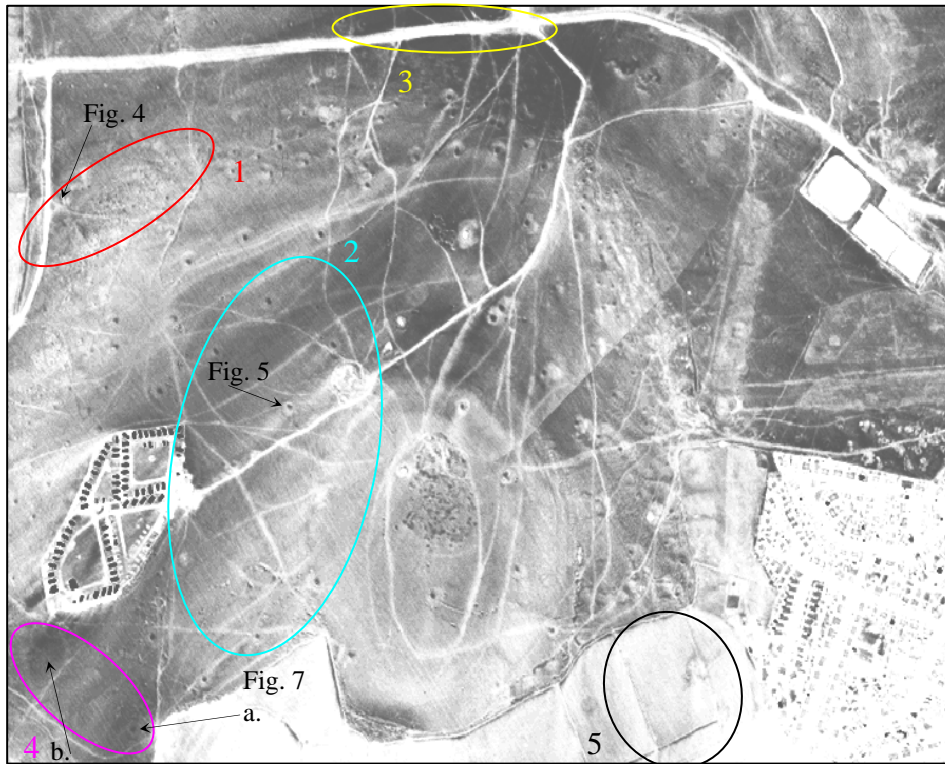
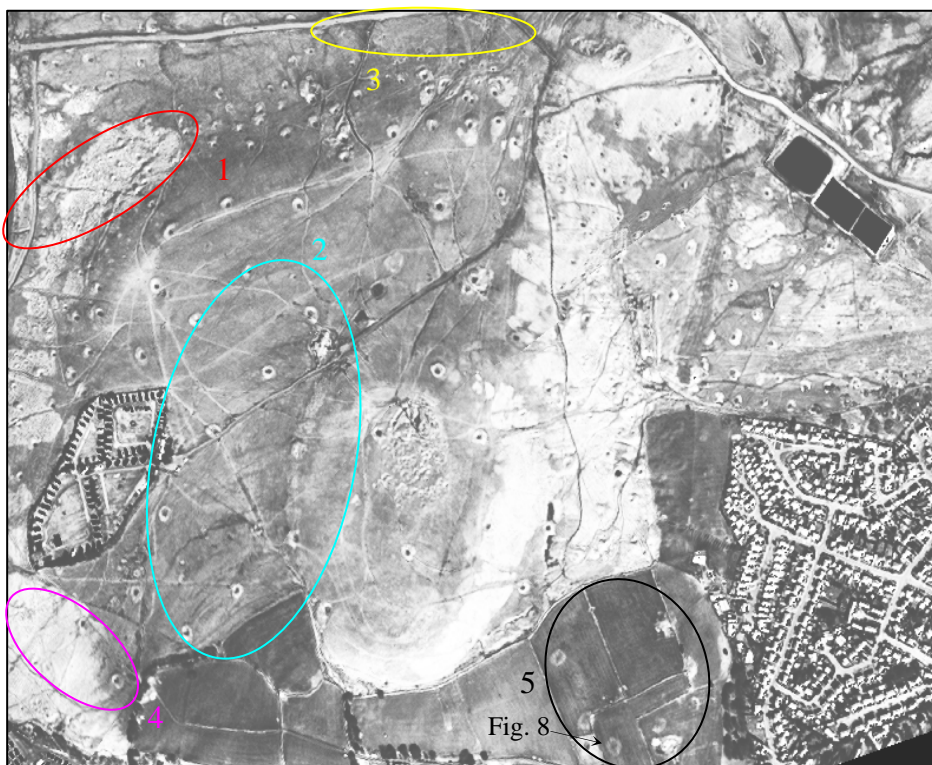
Fig. 6. Thermal images of Baildon Moor, flown 2nd May, 1997.

a. Pre-dawn image.

b. Late morning image.

(Darker tones represent cooler radiant temperatures, lighter tones represent warmer radiant temperatures.) Coloured rings indicate classes.

Data available for the study, in addition to the thermal images, were a 1:2,500-scale mine abandonment plan, a 1:10,000-scale field survey map and a set of 1:25,000-scale aerial photographs acquired on the same date as the May 1997 thermal data. A comparison was made between the location of anomalies identified in the thermal images, the location of mapped mineshafts and mineshafts with a clear surface expression in the aerial photography. Examples of the criteria used in the comparison (as explained above) are summarised in Table 1. The classification of the thermal anomalies was based upon the degree of difficulty in observing the ground disturbances on aerial photographs and in the field. For example, areas 4 and 5 provide thermal evidence for the presence of shafts where there is little or no visible expression of the entry. Visual observation of mine entries in area 4 was obscured by very thick bracken cover. Shaft entries were characteristically a 12 m diameter depression of up to 3 m deep surrounded by a narrow spoil ring of about 15 m diameter. Where the bracken cover was thin, for example at the shoulder of the plateau formed by the 48 Yard Rock, mine entries were still visible and thus mappable (Fig. 7a). However, the bracken was very thick on the slope of the hill where mine entries were not necessarily observed and mapped. However, Fig. 7b shows the depression, believed to be an abandoned mineshaft, of approximately 15 m diameter associated with a cluster of thermal anomalies in this area.

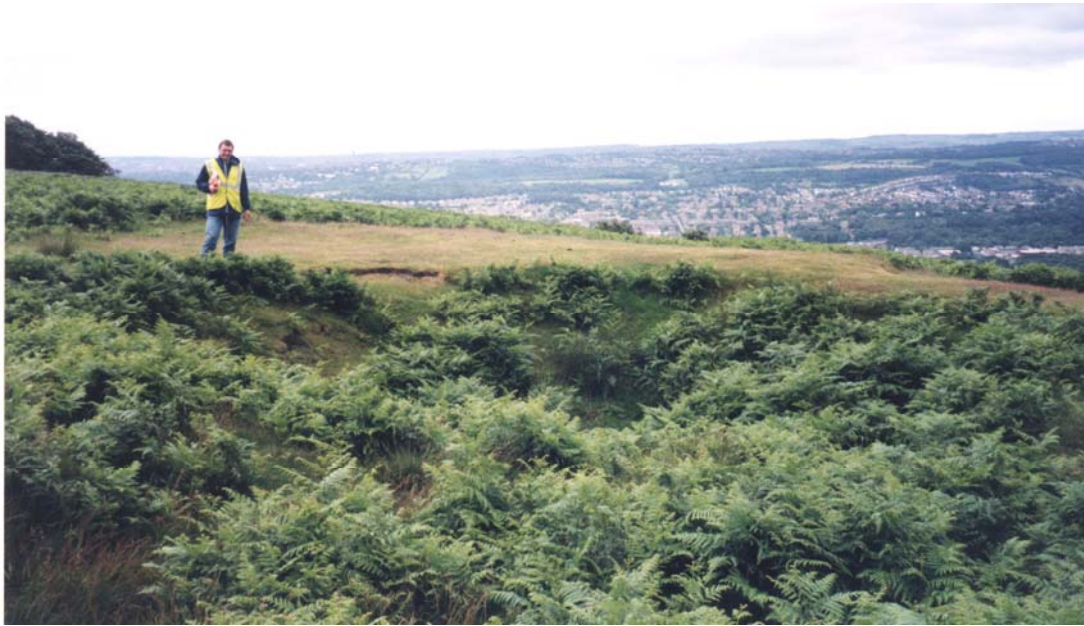
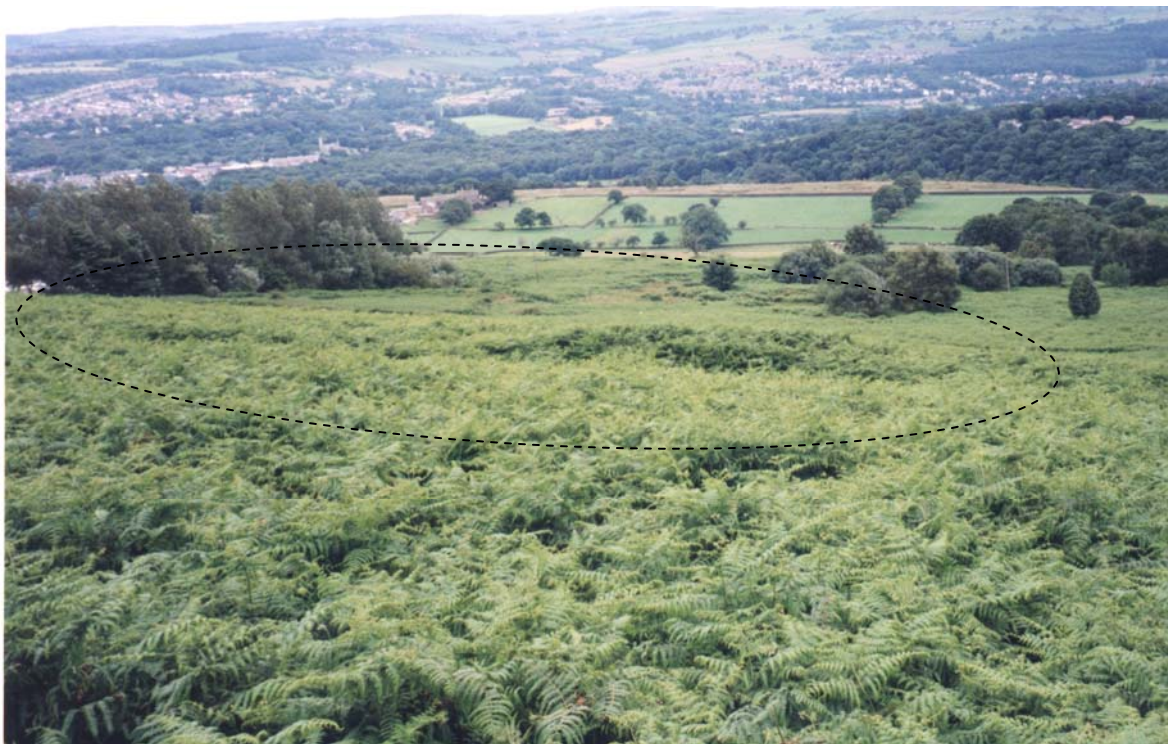
Fig. 7. Degrees of masking by dense vegetation of mineshafts to Hard Bed coal.

a. Shaft to Hard Bed coal: 12 m diameter / 2-3 m deep; low bracken cover but mapped.

b. Shaft to Hard Bed coal: 15 m diameter; dense bracken cover and unmapped.

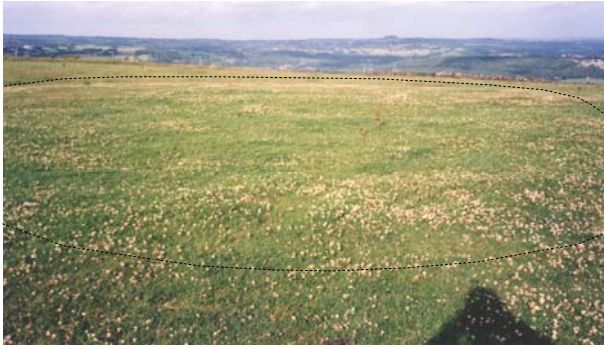
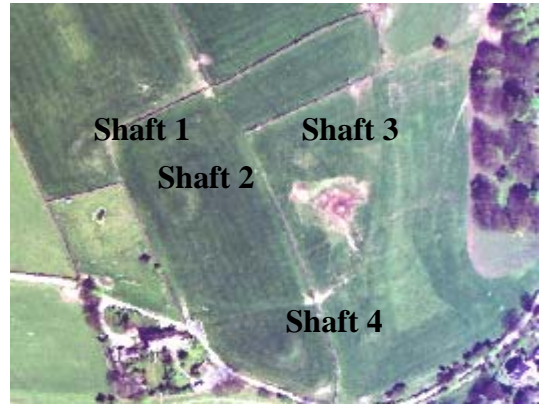
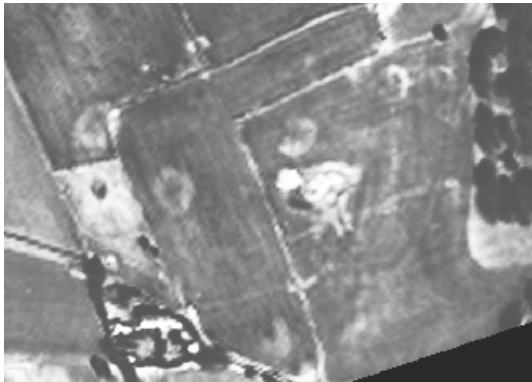
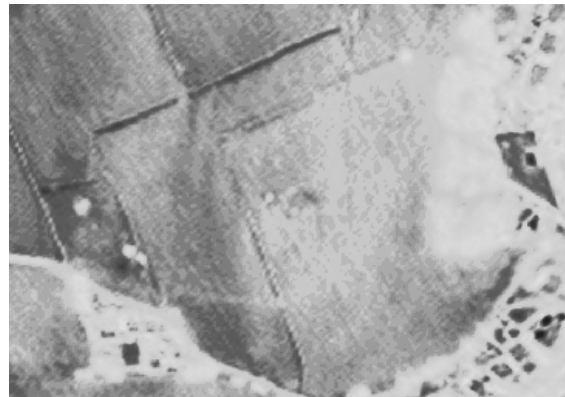
a. Photo of Shaft 2 in the Hope Farm area.

b. Aerial photograph

c. Late morning thermal image

d. Pre-dawn thermal image

Fig. 8. Mineshafts in farming areas. The four shafts were more clearly visible on the late morning thermal image than in aerial photographs and in the field.

Mine entries in area 5 have been disturbed by later farming activities, such as ploughing, and the ground in this area is generally flat with little obvious surface expression. Thus, field observation of abandoned shafts was very difficult, where only the subtlest of vegetation changes indicate the presence of a former shaft, such as a concentration of clover over a former spoil ring as shown in Fig. 8a. In this case, the change in vegetation was visible on the aerial photograph, but other abandoned shafts, such as Shafts 1, 3 and 4 in Fig. 8b were not so clear, and thus, missed during interpretation. However, the 'bull's-eye' target features at the locations of Shafts 1 to 4 were visible on the late morning thermal image (Fig. 8c), and were interpreted as former shafts, but were not readily observed in the pre-dawn image (Fig. 8d).

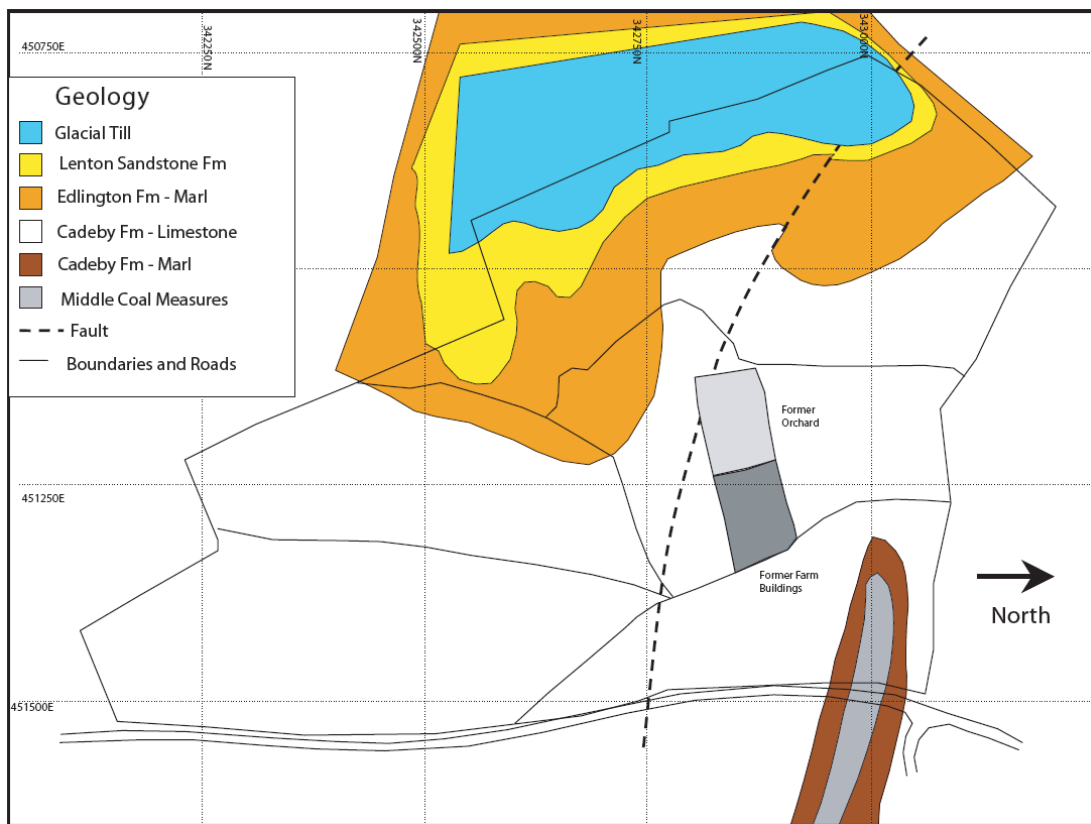
Fig. 9 Location and geology of the Chilwell Dam study site, West Nottingham.

b. Solid and drift geology across the site.

Chilwell Dam Farm was situated on the west side of Nottingham, within the city limits, as shown in Fig. 9a. It is approximately 800 m at its widest and 1.8 km at its longest. It comprised a roughly triangular area of farmland with its eastern boundary along the A6002, its northwestern boundary along the M1 motorway and other boundaries formed by hedgerows. Access to the site was via a slip road that runs off the A6002. Limestone of the Cadeby Formation carbonate facies (formerly the Lower Magnesian Limestone) outcropped over most of the site (Fig. 9b). Dip was sub 10° with a prevailing easterly direction. A normal fault striking ESE – WNW with a northerly down throw side cut through the site. To the west of the site the Lenton Sandstone overlies the Edlington (Marl) Formation, which overlies the Cadeby Formation carbonate facies. At the NE corner of the site the Cadeby Formation carbonate facies is underlain by the Cadeby Formation mudstone facies (formerly the Lower Marl), which rests unconformably on Middle Coal Measures. A cover of Glacial Till was found on the small hill formed by the Lenton Sandstone on the west side of the site.

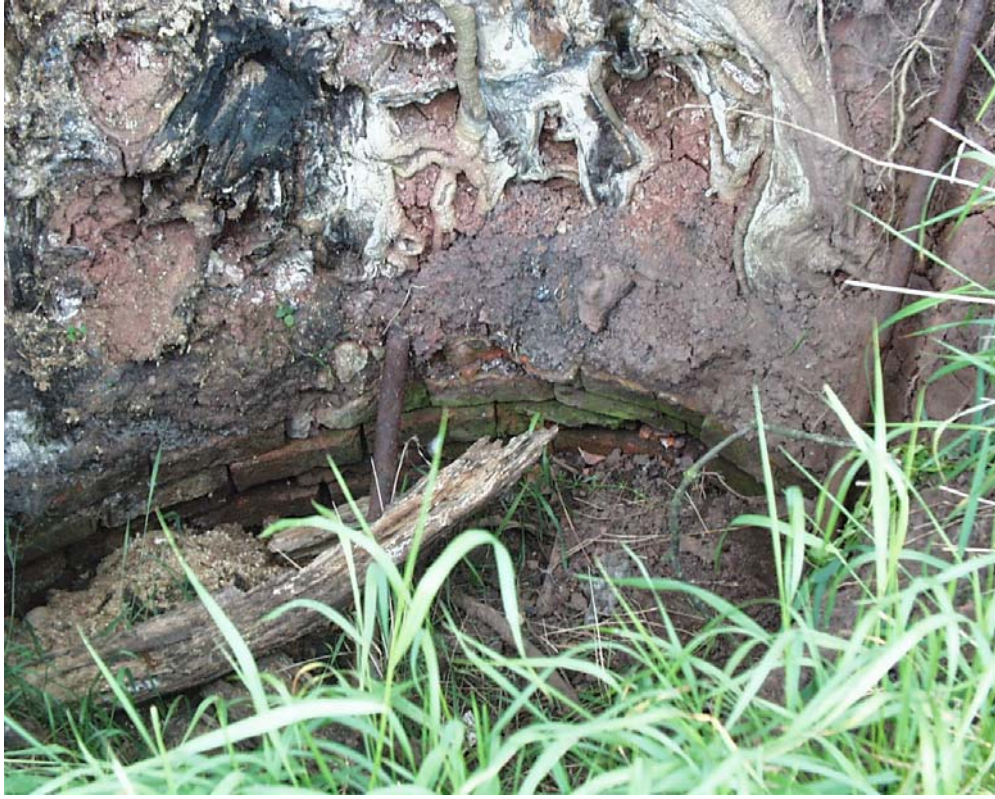
Fig. 10. Brick-lined mineshaft on Chilwell Dam Farm, (BNG 51285, 42342).
Green algae on some brick suggests previously only partial light and possible recent collapse of the shaft cover.

Thermal anomalies were identified to coincide with the expected position of approximately half of the known mineshafts listed in Table 2, as shown in Fig. 11. Generally, lack of detection was due to other features obscuring the localised anomaly caused by the shaft. For example, Shaft 8 was masked on the thermal image by a cold dark zone caused by very damp ground. Many of the shaft locations occurred beneath trees, whose warm thermal signatures would have obscured the effects of the shafts. Non-detected shafts included Shaft 20, which appeared in the field as a large oval of 12 m diameter up to 2 m deep with a pool of water 1m deep, and also, Shaft 32, which appeared as a lined opening (Fig. 10).

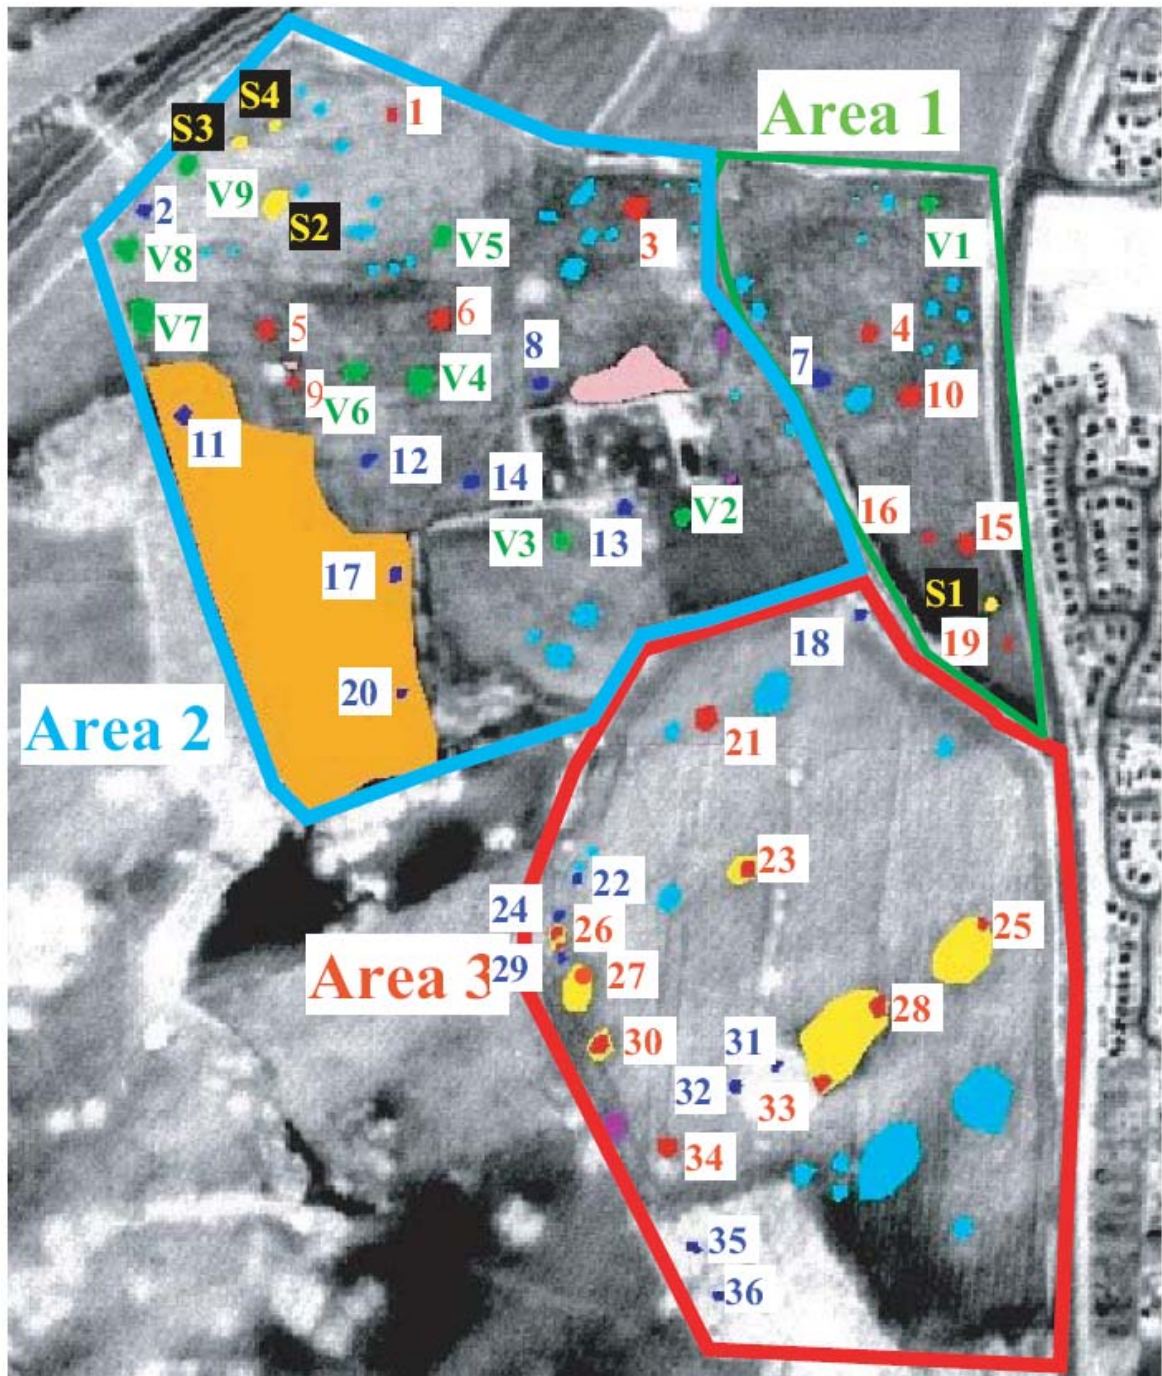
Thermal anomalies corresponding with:

Fig. 11. Interpreted pre-dawn thermal image of Chilwell Dam Farm, flown 12th March 2001.

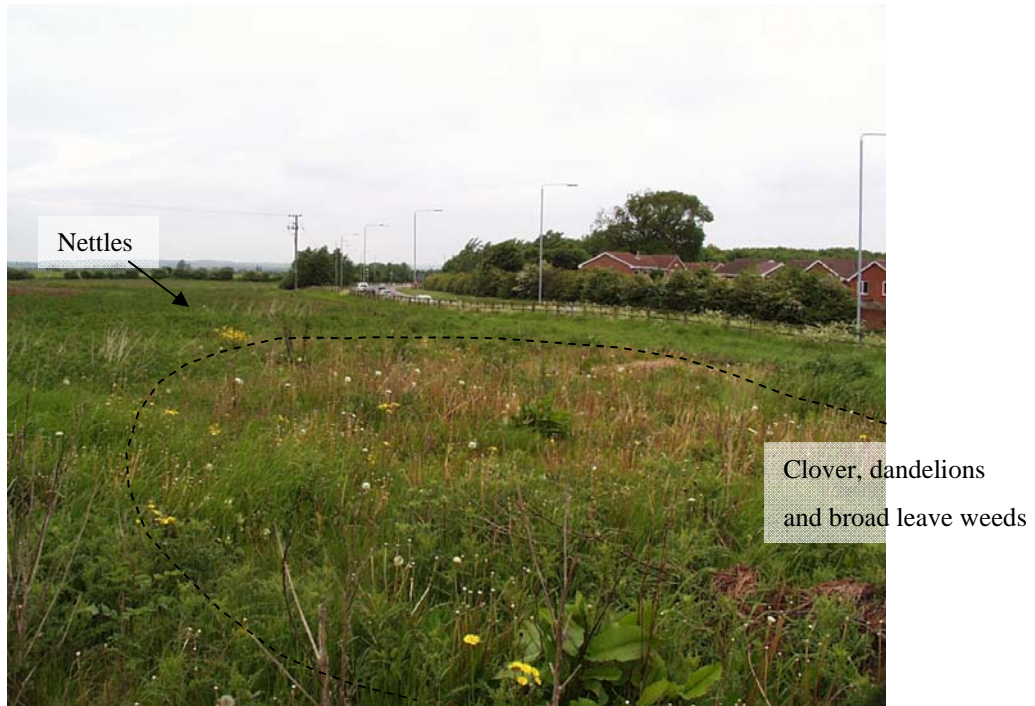
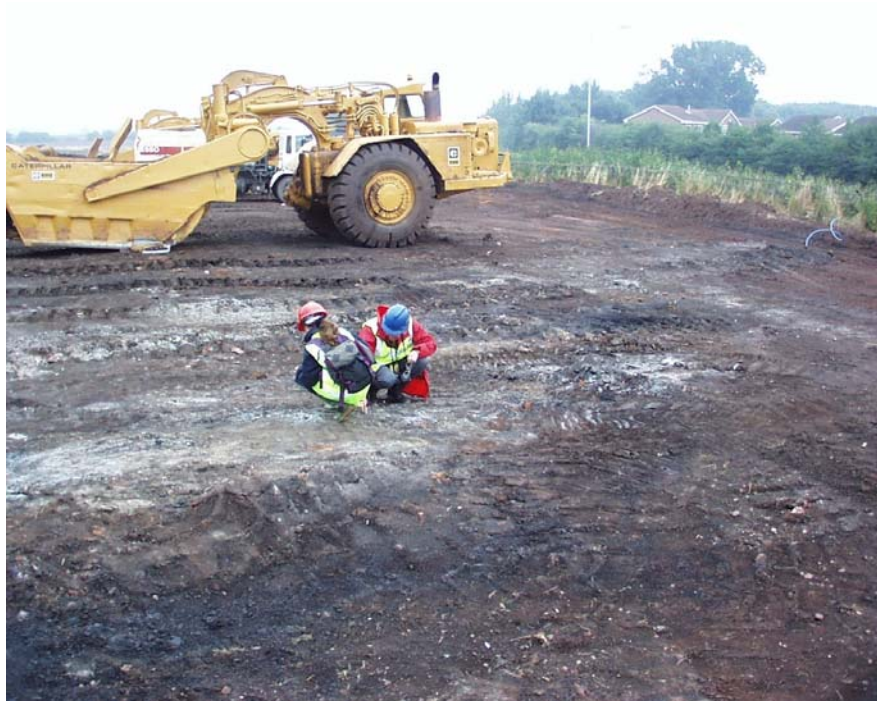
Fig. 12. Shaft 15: Ground conditions at time of thermal survey and after soil stripping.

a. Vegetation change over a mound about 0.5 m in height.

b. Soil mixed with coal measures mudstone, brick and coal at shaft.

Over the site, spoil had been reused to backfill the shafts on closure, causing localised soil changes via introduction of mostly mudstone, coal and brick fragments. Backfilling with extraneous materials would have led to topographic changes leaving mounds and soft ground, and also, resulted in changes in local soil chemistry and ground conditions, thus favouring subtle differences in localised vegetation. Evidence of backfilling was more readily observed where the land had been very recently farmed, such as at Shaft 10. However, many of the primary soil changes were not completely detected until after the site was stripped of the top soil. The thermal anomaly related to Shaft 15 from Area 1 in Fig. 11 coincided with a 0.5 m high mound, approximately 30 m across, with a circumferential ring of nettles surrounding a central core of clover, dandelions and broad leaf weeds (Fig. 12a). Only slight soil darkening by coal was noted during the initial site visit, but soil stripping revealed localised backfilling with light grey Coal Measures

mudstone, brick and coal fragments (Fig. 12b). The changes in vegetation were very subtle resulting in many shaft locations, such as Shaft 3 coinciding with a cluster of anomalies. Soil stripping revealed this area to be of very variable stiffness, where soft patches coincided with backfilling of mudstone, coal and brick fragments. Shaft 5 coincided with a patch of nettles approximately 15 m in diameter. Shaft 6 coincided with a very minor vegetation change to lush, longer grass over an area of about 3 m in diameter, where geophysical surveys revealed very large, localised perturbations in the electrical conductivity and magnetic field profiles indicative of magnetic materials such as bricks of scrap-iron (Fig 13).

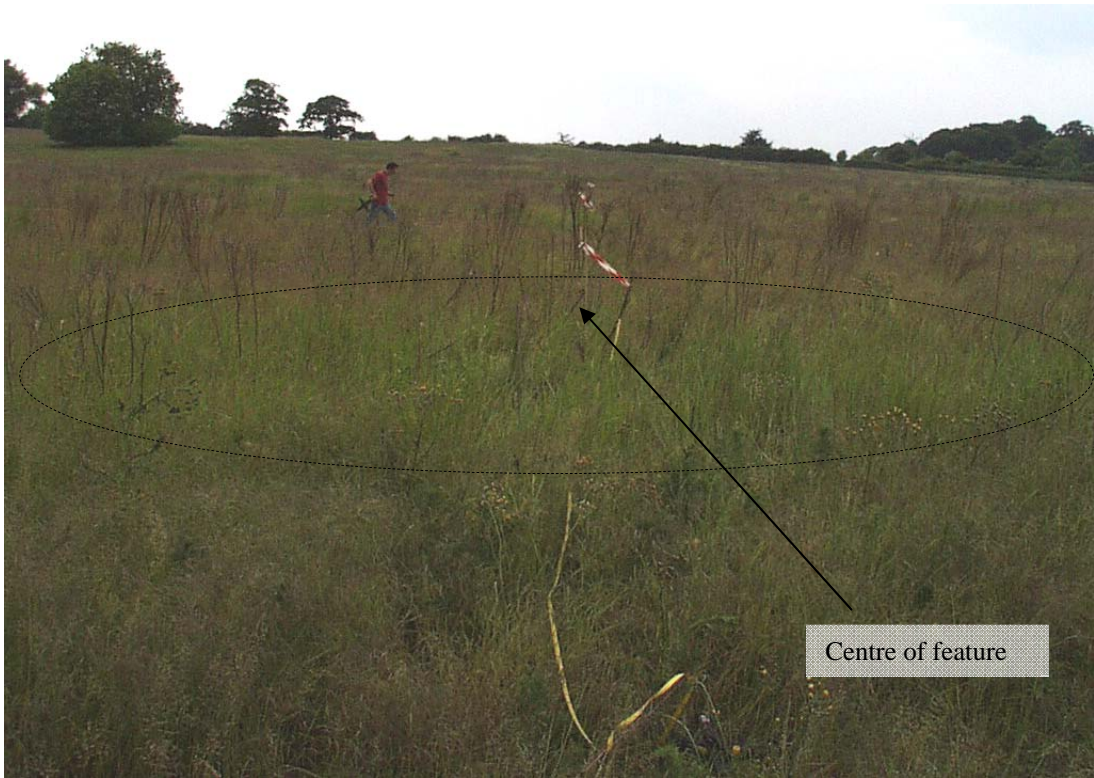
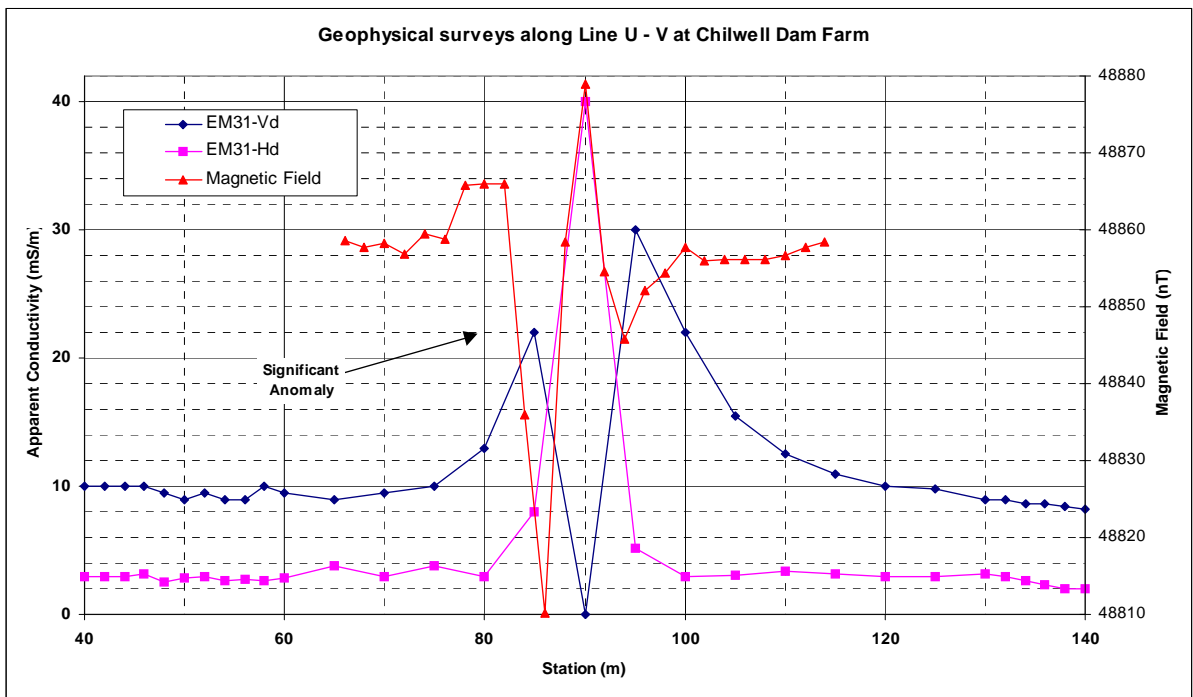
Fig. 13. Shaft 6: Ground conditions at time of thermal survey and geophysical response.

a. Localised change in the grass coincident with thermal and geophysical anomalies.

b. Localised perturbations to electrical conductivity and magnetic field over shaft.
