## Preliminary Results of an ERT in a Vineyard in Estremoz, Portugal

A.M. Correia\* (Evora University) & J. Passos (R&P Business, Lda.)

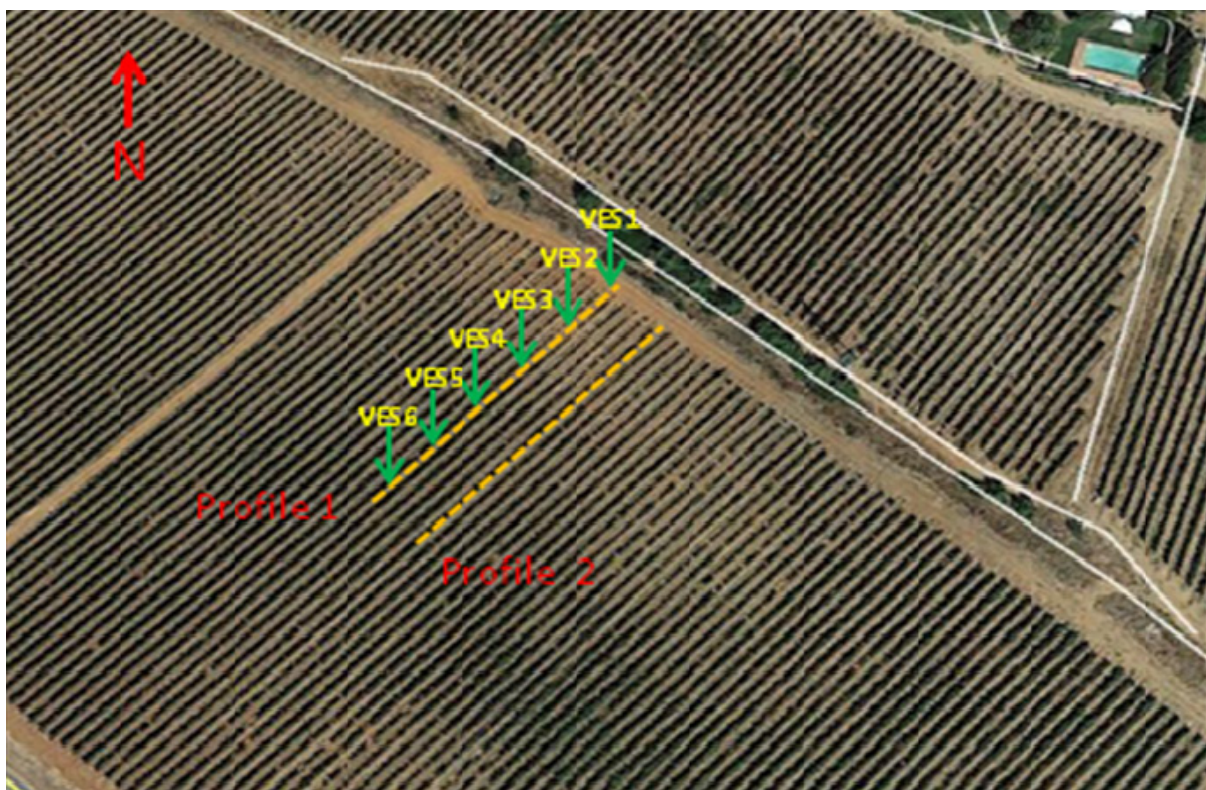
**Figure 1** Location of the six vertical electrical soundings (VES1 – VES6) along Profile 1 which was also the orientation of the first electrical resistivity tomography. Profile 2 indicates the location of the second electrical resistivity tomography which will not be discussed in this abstract.

First six vertical electrical soundings (VES) were performed in February 14, 2014 (see Fig.1). In September 2, 2014, an electrical resistivity tomography was done along the direction defined by the six VESs (Profile 1 in Fig. 1); finally, that same profile was repeated in December 22, 2014, and a new one (Profile 2) was done 11 m southeast of Profile 1. Only the work concerning Profile 1 will be presented here.

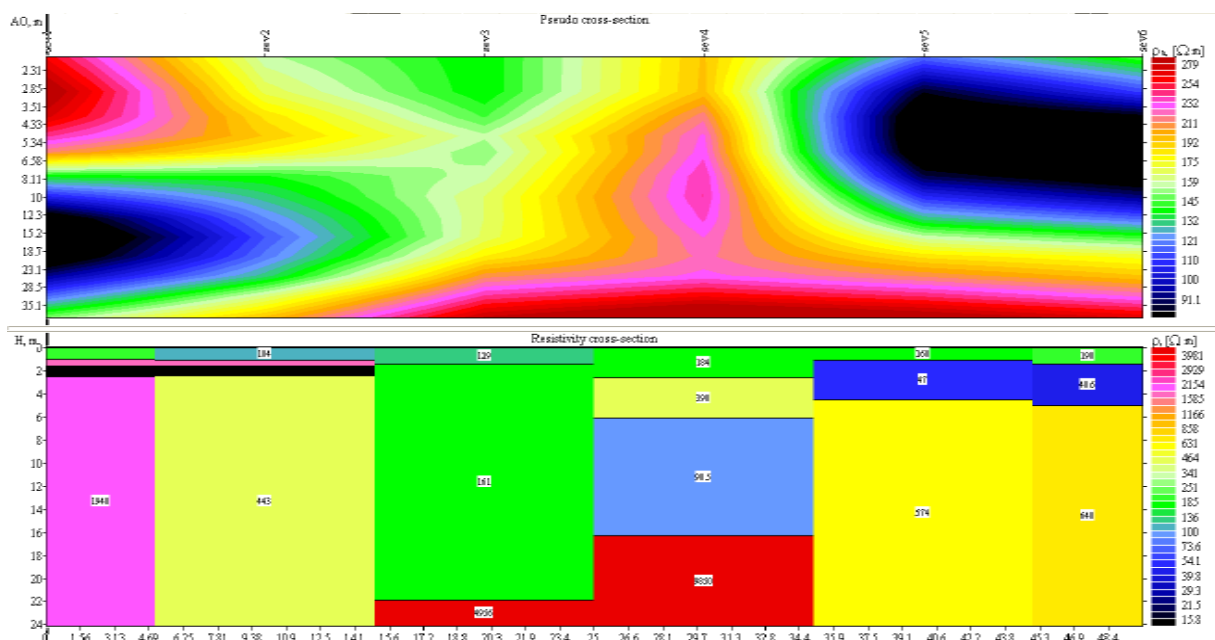
**Figure 2** Pseudo section generated from the six vertical electrical soundings (top) and geoelectrical block structure generated with the results of the interpretation of the six vertical electrical soundings (bottom).

The interpretation of the VES indicates that the soil and bedrock in the vineyard's area present several blocks of different electrical resistivities which vary from a few  $\Omega.m$ , at the surface, to hundreds of  $\Omega.m$  at depths of about 3 to 22 m (Fig. 2).

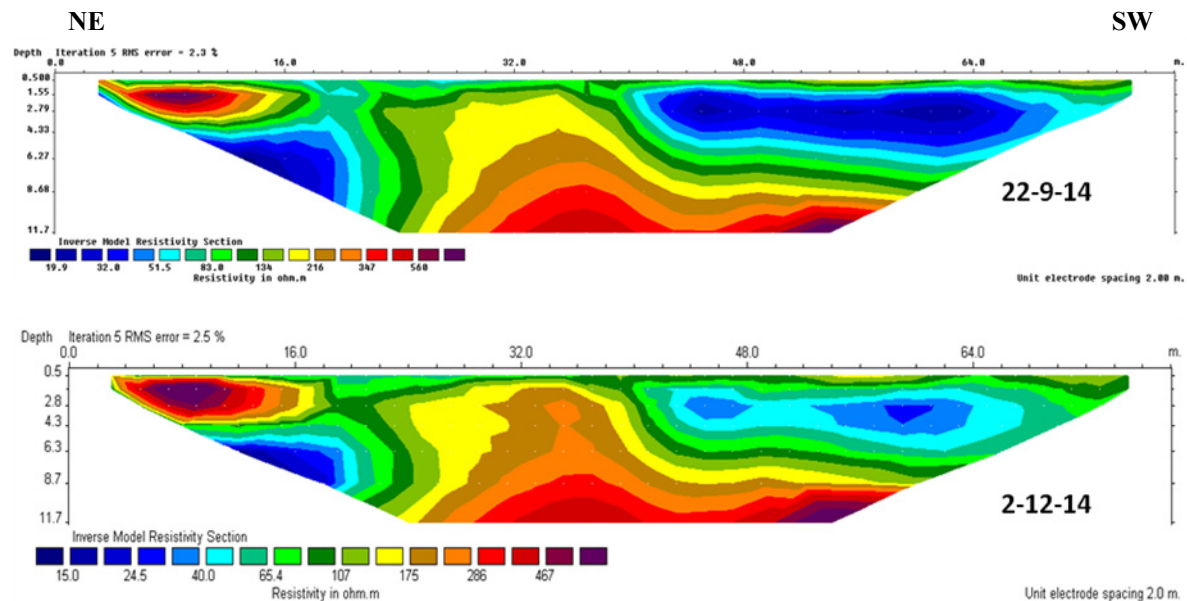
**Figure 3** Electrical resistivity tomographies done along Profile 1 of Fig. 1 in September and December 2014.

1996) was used for inverting the apparent electrical resistivity values into two-dimensional models of electrical resistivity of the ground (Fig. 3). The models are a representation of the distribution of the electrical resistivity of the ground to depths of about 11 m along profiles 78 m long.

To refine the geoelectrical structure along the set of the six VES, and to verify whether there would be any change in time resulting from increase or decrease of moisture in the ground, two ERTs were done within a time span of about three months. Fig 3 shows the two electrical resistivity tomographies done on February 14, 2014 and on December 22, 2014.

Generally speaking both electrical tomographies are very similar and show that, at the surface, the southwest portion presents lower electrical resistivities than the northeast portion. At the same time, between 30 and 36 m, almost outcropping, there is a higher electrical resistivity block. Beneath the high electrical resistivity area in the NE side of the electrical resistivity tomographies there is a low electrical resistivity zone which has electrical resistivity values similar to the ones at the surface on the SW zone.

So, the high electrical resistivity zone between 30 and 36 m in Profile 1 is presumably creating some kind of barrier that influences the quality and vitality of the vines. It appears that SW of that zone the ground presents a higher content of moisture than in the NE zone.

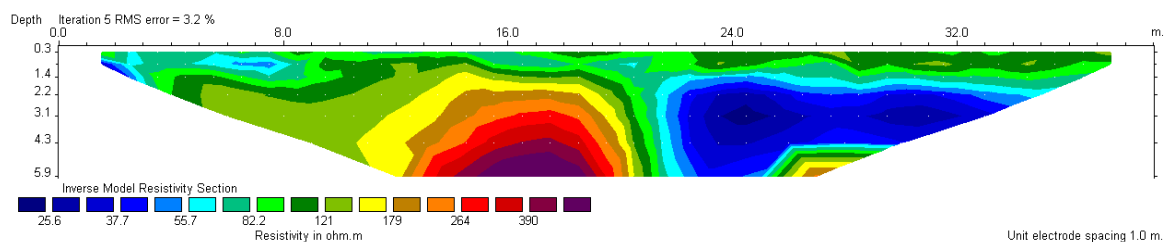
**Figure 4** Electrical resistivity tomography done in the middle portion of Profile 1 of Fig.1 and Fig. 3. In comparison with the profiles in Fig. 3, this electrical resistivity profile is shorter (39 m long) but has higher horizontal and vertical resolution.

To try to decipher the geological situation of the ground, another electrical resistivity tomography was done in the middle region of Profile 1 using an electrode spacing of 1 m instead of 2 m used in the first electrical resistivity tomographies. The new electrical resistivity tomography, which is shorter

that the first ones, is shown in Fig. 4; it has higher horizontal and vertical resolution than the first electrical resistivity tomographies.

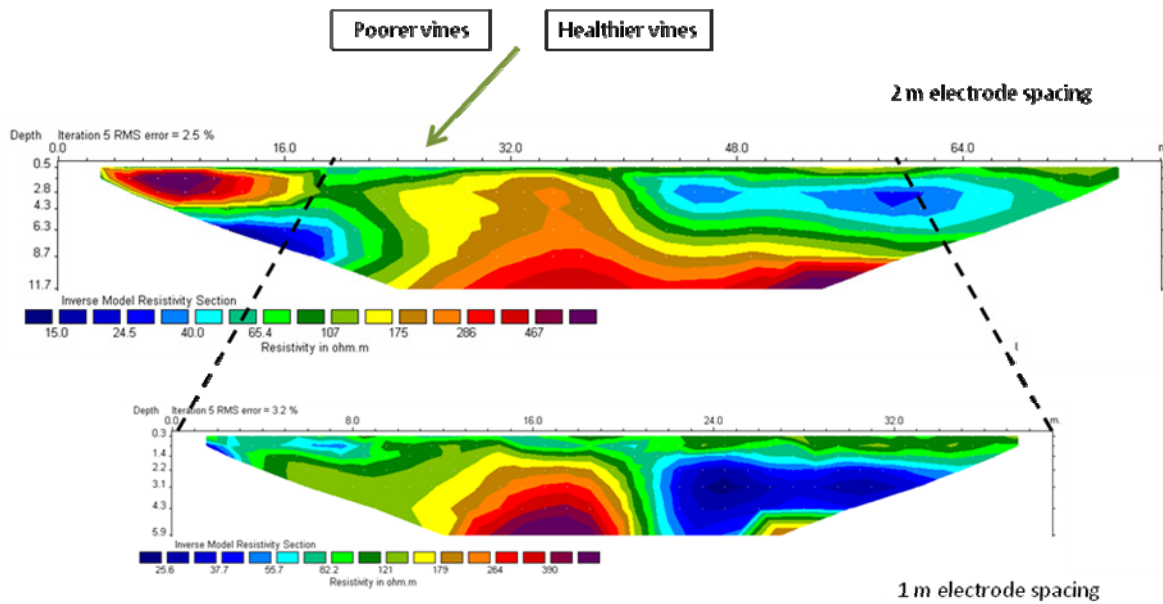
## December 2, 2014 – Profile 1

**Figure 5** Location of the short ERT (bottom) in the long ERT (top). Also shown is the limit that separates good from poor vines.

These are preliminary results and indicate the great potential for using these methodologies in characterizing and managing soil productivity; other geophysical work and soil analysis are planned for the near future. Fig. 5 is a cartoon showing the location of the short electrical resistivity tomography in the longer one. It also shows the limit that separates the good from the poor vines.
