**DEVELOPING A GEODETIC-BASED BUILDING INFORMATION MODEL
FOR DAMAGE ASSESSMENT AND REPAIR STRATEGIES FOR HISTORIC
MASONRY STRUCTURES**

Ph.D. THESIS

Esra TEKDAL

Department of Geomatics Engineering

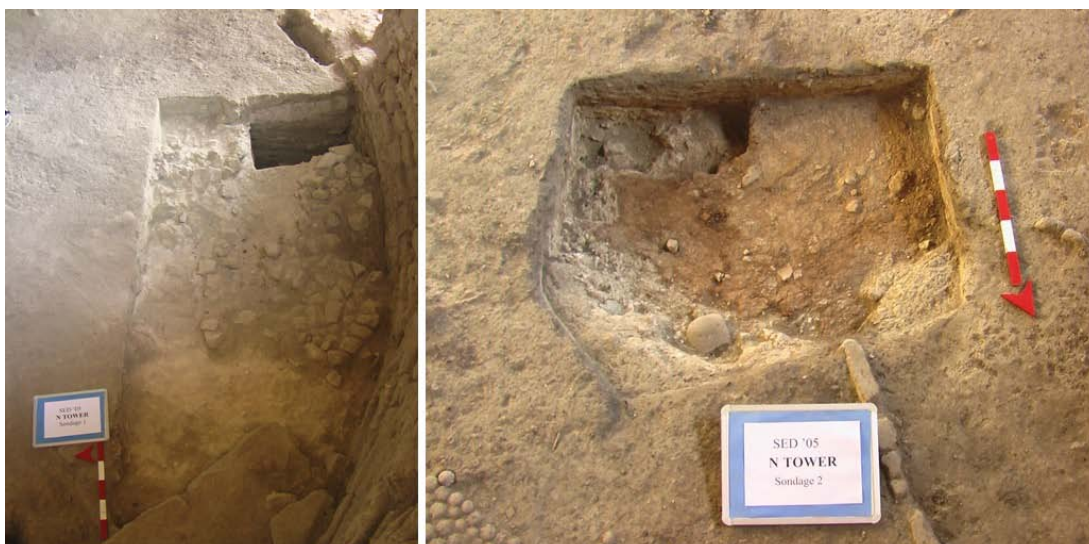
Figure 2.4 : Two sondages opened in North Tower [10].

Two sondages in the north tower, seen in Figure 2.4, were made to the depth of 1.20 meters and 0.56 meters to determine the level of the foundations but again the risk of destabilizing this tower contributed to the decision to excavate a larger surface area of the tower interior rather than continue to excavate to a greater depth. Immediately below the surface of this tower's floor was a surface of inverted pine cones and brick. This surface and the central area of the tower revealed a thick layer of charcoal and located in this tower is an indication that there was a small foundry of some sort, perhaps the worksite of a metal smith [10].

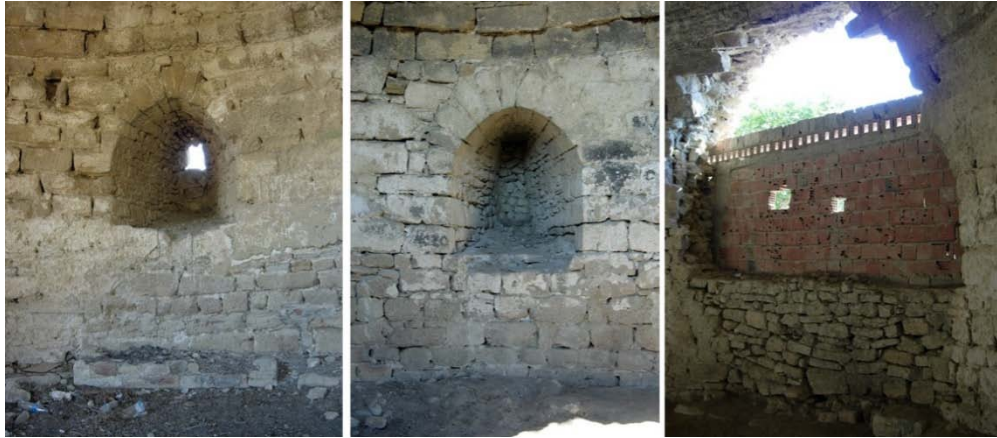
Figure 2.7 : East porthole (left), north porthole (middle), west porthole (right)[10].

There are three porthole windows in the interior part as seen in Figure 2.7. The east porthole is partially open, the north porthole is completely closed. On the west side of the tower, only the beginning part of the porthole can be observed [3].

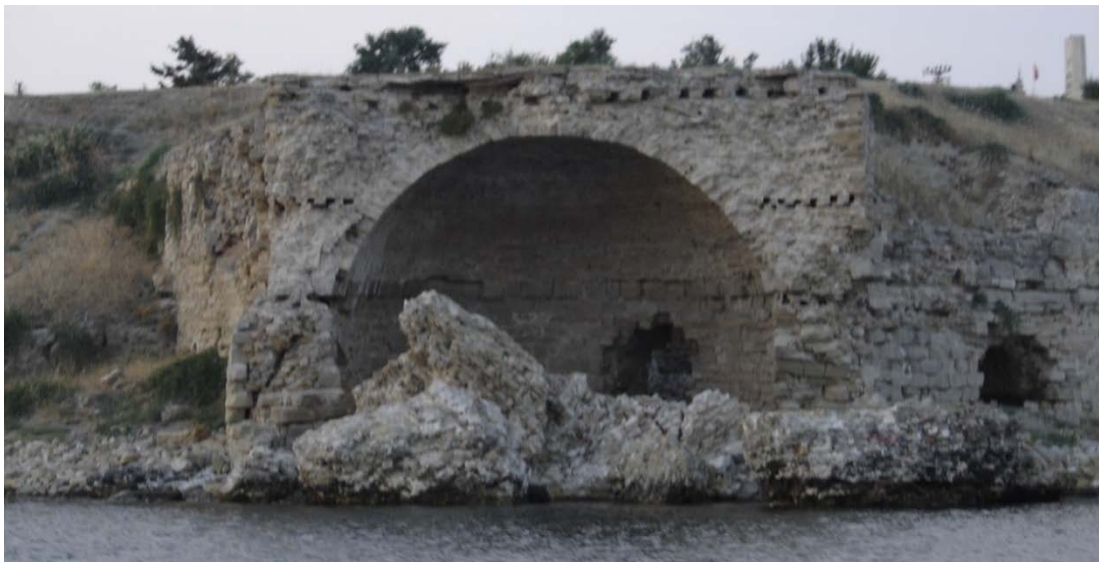
The South Tower of Seddülbahir fortress has a circular plan both inside and outside. The south half of the tower has completely collapsed and large pieces of rubble stone and mortar lie inside the sea as seen in Figure 2.8.

Figure 2.8 : General view of South Tower[10].

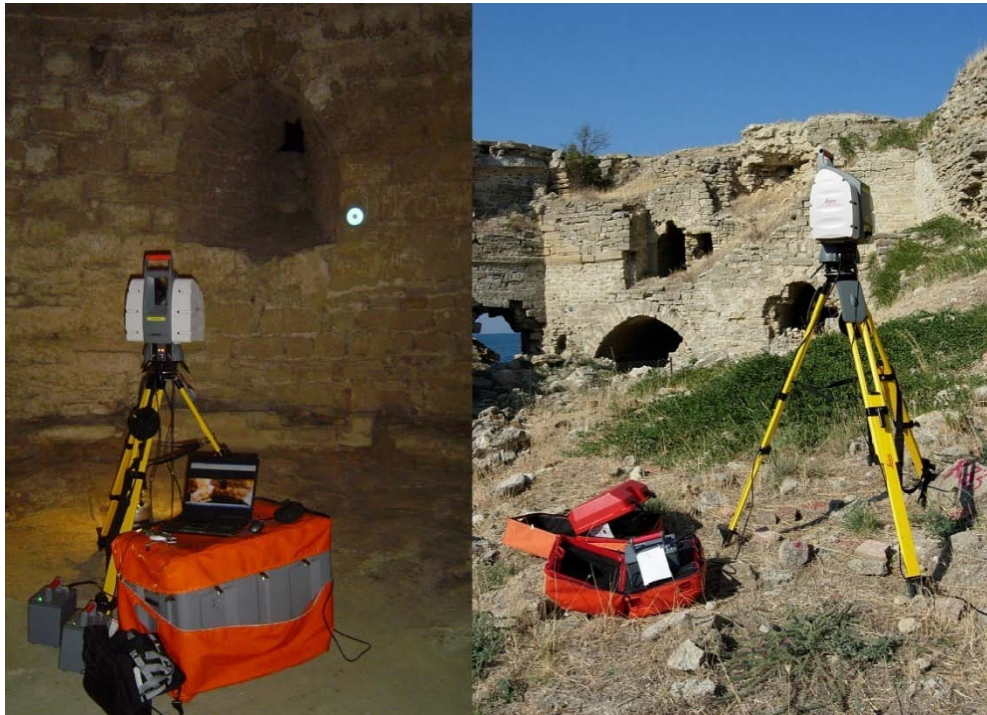
During the terrestrial laser scanning measurements Leica HDS 3000 (Figure 4.1) time-of-flight laser scanner with its 360° horizontal field-of-view (FOV) and 270° of vertical FOV was used. With its tripod and optical plummet it can be set on previously established points. This equipment has a built in camera which enables the user to capture panoramic images before scanning and allows for scanning of the desired area or the object separately. It has a 6mm 3D positional accuracy at 50m. The device is operated with a laptop and collected data is stored as point clouds on hard disk.

Figure 4.1 : Leica HDS 3000 terrestrial laser scanner[10].

Before the scanning procedure a detailed observation of the site was carried out. After the initial observation the scanning resolution was decided as 5mm. The resolution defined indicated the distance between the individual points of the point cloud.

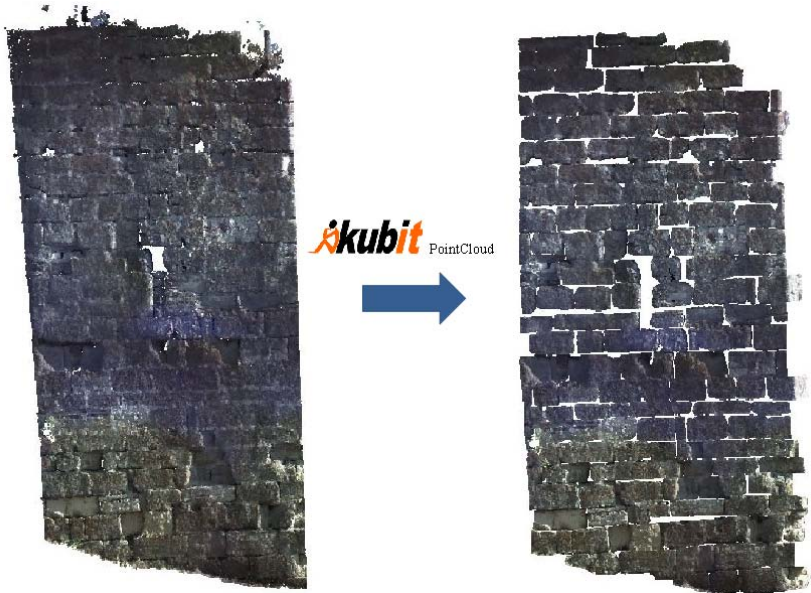
Figure 4.4 : Segmented stones on façade 4 of the North Tower.

Kubit PointCloud software that enables the user to work with the point clouds in AutoCAD environment using standard and special drawing tools to trace the appearance of each stone, without any automation was employed for the segmentation. The result of the manual segmentation process can be seen in Figure 4.4.

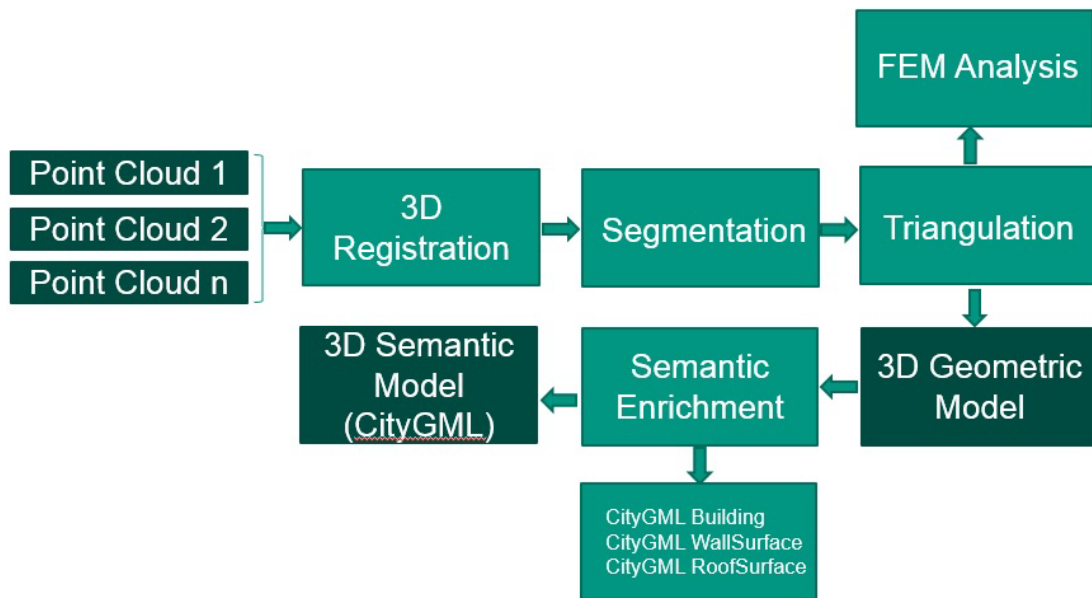
Figure 5.4 : The workflow of the evaluation procedure.

As the real world is three dimensional, there is a tendency to represent the world in three dimensions. Due to this growing trend, cities in a certain geographical area can be investigated in three dimension without risk and effort with the help of visualization. In order to visualize and evaluate the North Tower of Seddülbahir fortress CityGML tools are used and the steps seen in Figure 5.4 are followed.

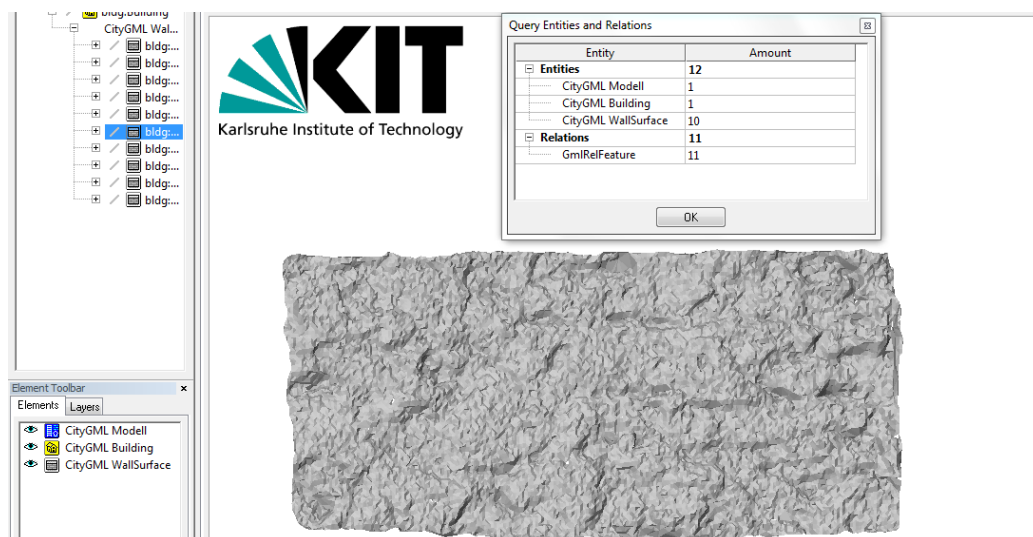
Figure 5.5 : Detailed view of a segmented stone [1].

The final model is comprised of individually segmented stones which enables the user to detect the current surface condition of the stones comprising the tower as seen in Figure 5.5.

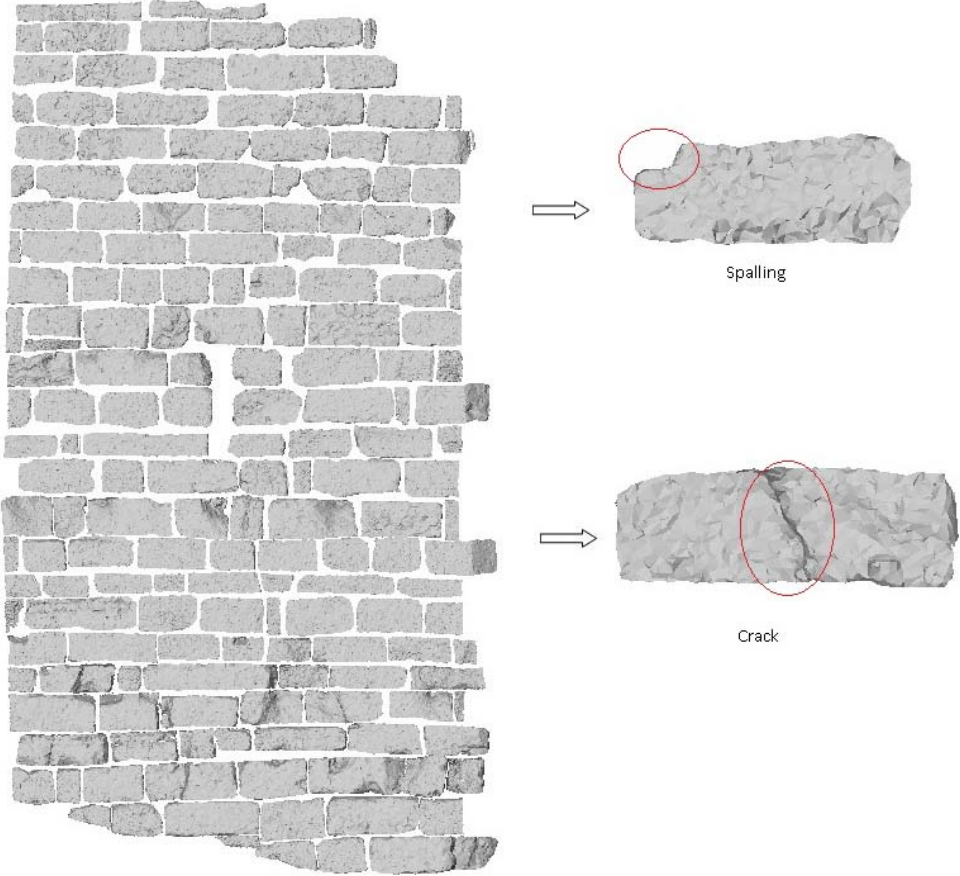
Figure 5.6 : Detailed view from a façade of North Tower segmented into stones [7].

A detailed view of a façade of North Tower visualized by using IfcExplorer, a software developed by the members of Karlsruhe Institute of Technology, Institute for Applied Computer Science, can be seen in Figure 5.6.

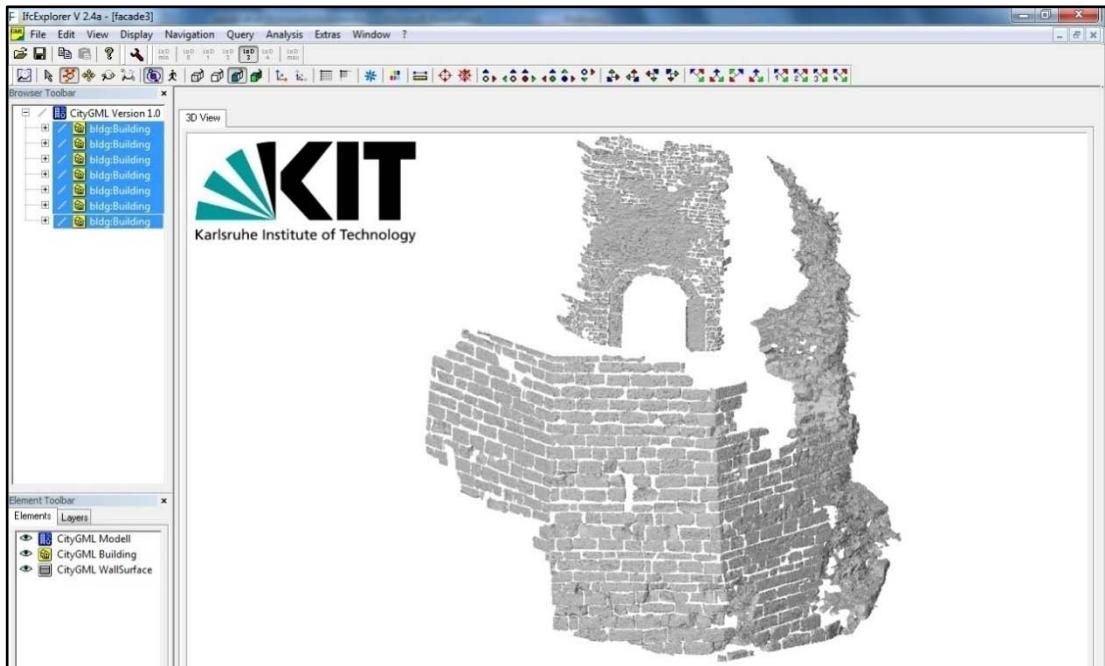
Figure 5.7 : Outer façade of the North Tower.

The quality of the geometric input is one of the important factors affecting the quality of the 3D model. Since the preliminary purpose of our end product is to serve as a data model for architectural renovation and restoration projects, it is very important to detect the current surface condition of the stones in the final model to make decisions for restoration. In Figure 5.7 outer façade of the North Tower can be seen.

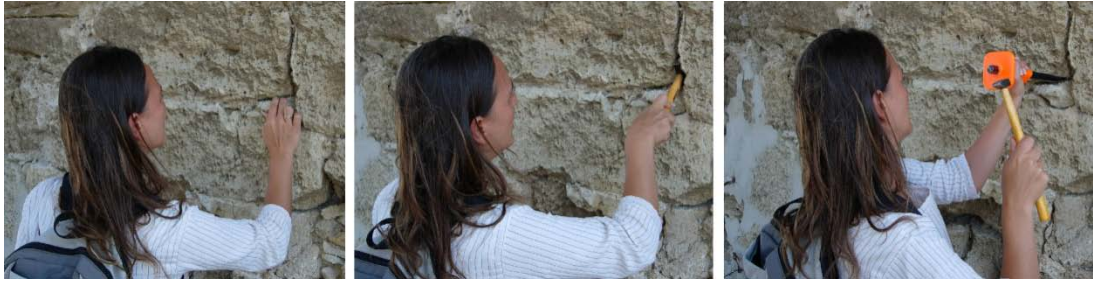
Within the framework of this procedure detailed observations were made inside and outside the towers façades and walls in order to choose the most appropriate stone and mortar samples. In the field during the collection of samples, materials that can be easily removed from the façades and walls and not lead to deformation were chosen. Samples were collected by hand or with a hammer and chisel when necessary as seen in Figure 6.1.

Figure 6.1 : Sample collection for analyses [10].

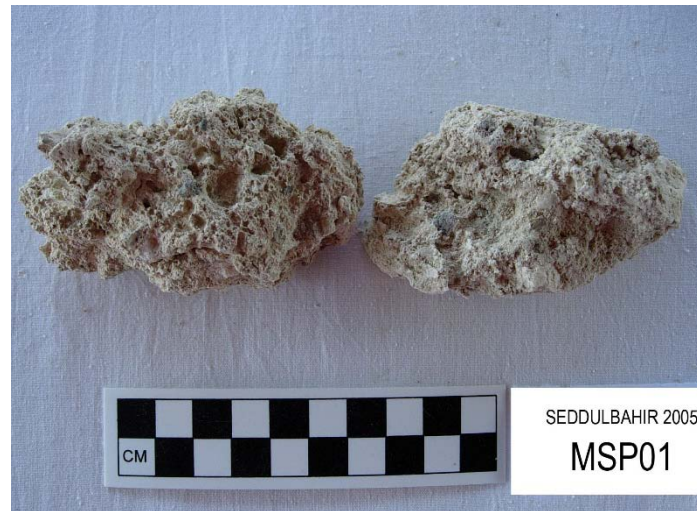
Macroscopic Inspections: In order to determine the texture and aggregate distribution of samples, visual inspection and detailed analysis were made and the scaled photos of samples are given as seen in Figure 6.3.

Figure 6.3 : Stone sample taken from the Fortress of Seddülbahir [10].

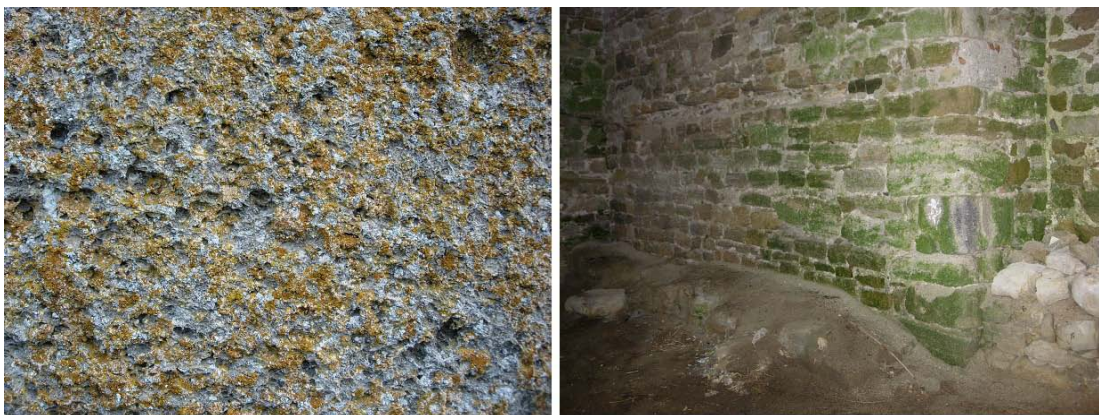
Figure 7.1 : Biological species formation observed on walls [10].

The presence of water and humidity in masonry structure causes formation of algae, shallow molds, discoloration, and decay, prepare a suitable environment for biological species which lead to deteriorations (Figure 7.1).

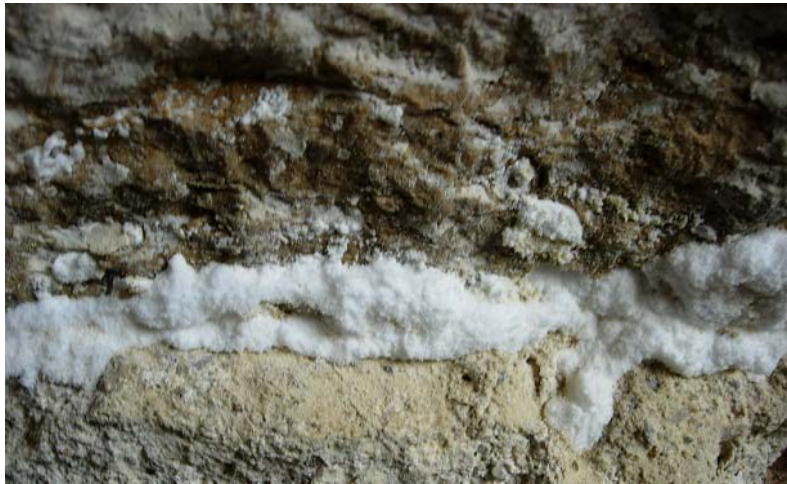
Figure 7.2 : Efflorescence observed on stone surface [10].

In structures whose drainage system has not been set or damaged, groundwater is absorbed by capillarity within the masonry material and salts dissolved in water reveals to material deterioration (Figure 7.2).

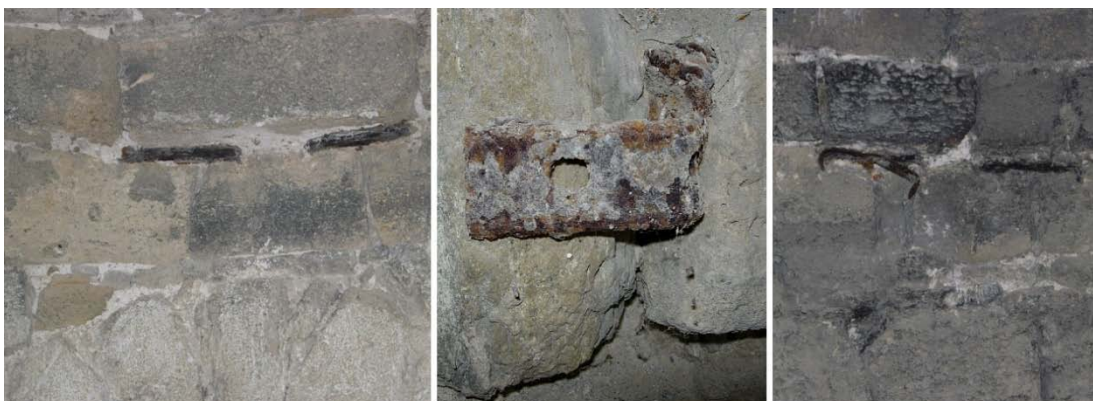
Figure 7.3 : Corroded metal clamps observed on façades [10].

Metal materials such as iron and steel rust because of contact with moisture present in the air. In stone, brick masonry structures metal elements such as clamps, tie rods, column circles, etc. are used. These metal components of the masonry structures oxidize in time because of water penetrating the structure and humidity. Oxidized elements cross section grows and cause cracks which can cause decrease in the load bearing capacity of the structure (Figure 7.3).

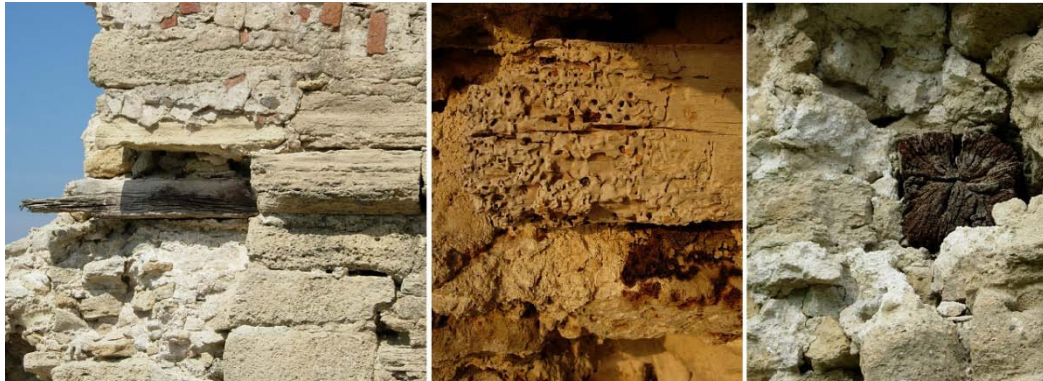
Figure 7.4 : Deteriorated wooden beams [10].

the effect of wind which causes moisture to penetrate into the structure and prepare suitable conditions for fungal growth (Figure 7.4).

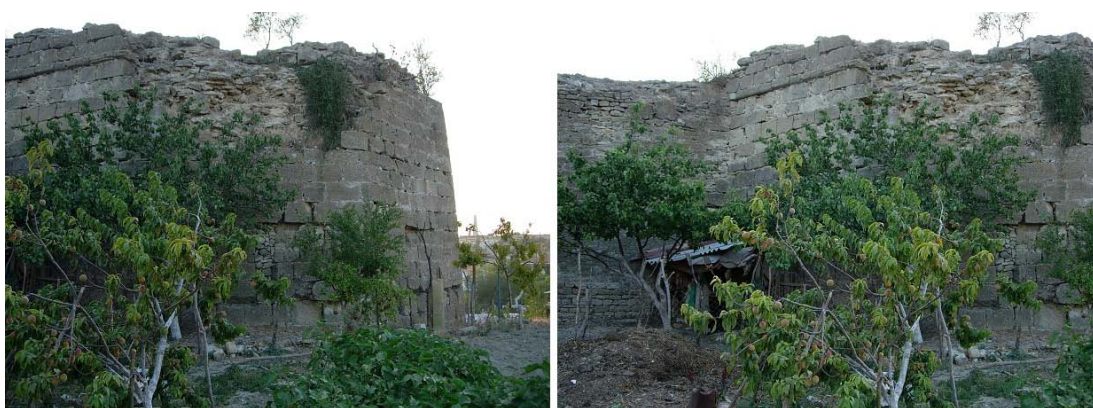
Figure 7.5 : Plants and tree roots observed [10].

Wind borne seeds and spores set in the empty joints on the surface of the structure and cause growth of plants. Creepers and other plants acquire a living environment by clinging on elements such as walls. Plant and tree roots enter the wall structure causing disintegration and even integrate with the structural element (Figure 7.5).

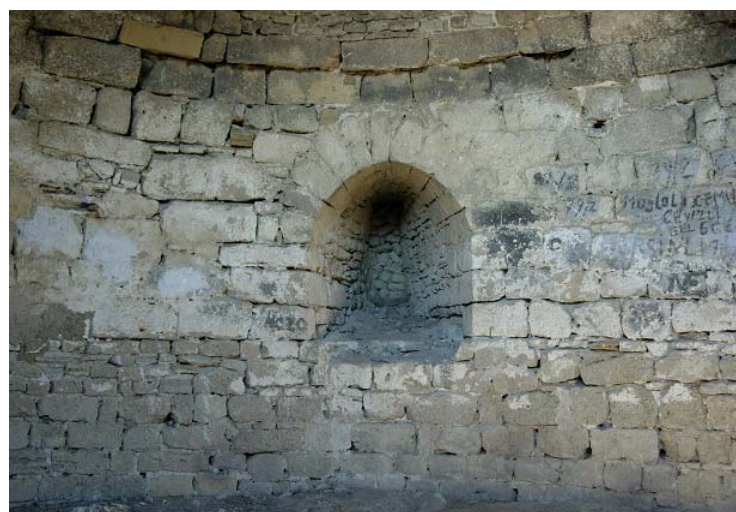
Figure 7.6 : Graffiti and paints observed on walls [10].

Vandalism is defined as performing deliberately bad actions. People with tendency to vandalism give serious harm to historical structures such as; writing on the walls, use the structure as shelter at night, theft, break structure elements, etc. (Figure 7.6).

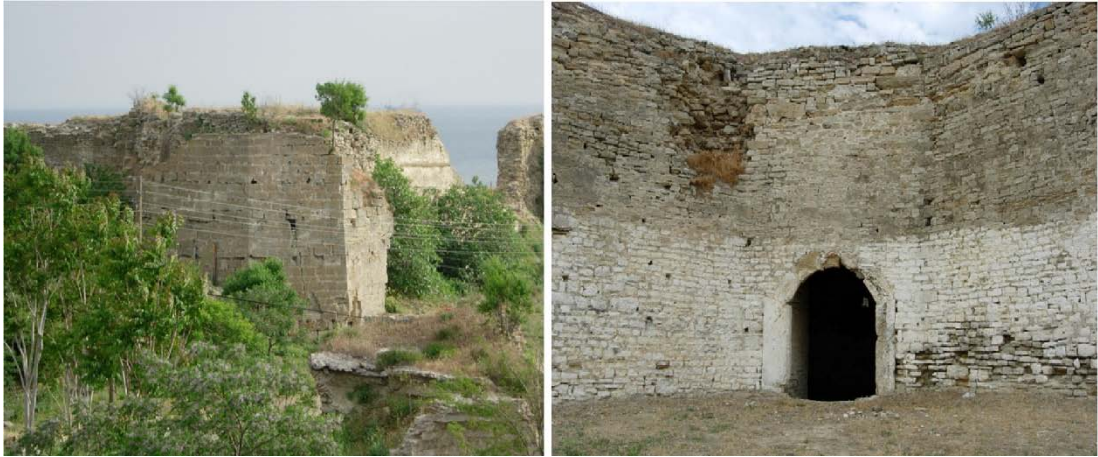
The North Tower can be preserved in the current state as seen in Figure 7.10 and restoration measures can be taken according to the research that has been done and approved by the Kaletakımı and the Çanakkale Conservation Council.

Figure 7.10 : View from the North Tower [10].

A primary intervention that can be recommended for this tower is to renew damaged or removed wooden beams at the walls. During renewal original size wood that has reached equilibrium moisture content should be used. The deteriorated remaining beams should be cleaned. Wooden elements that are going to be placed in the beams should be fixed with mortar that is similar to the mortar used in the construction of tower as seen in Figure 7.7 and galvanized bolts should be used for joining beams together.

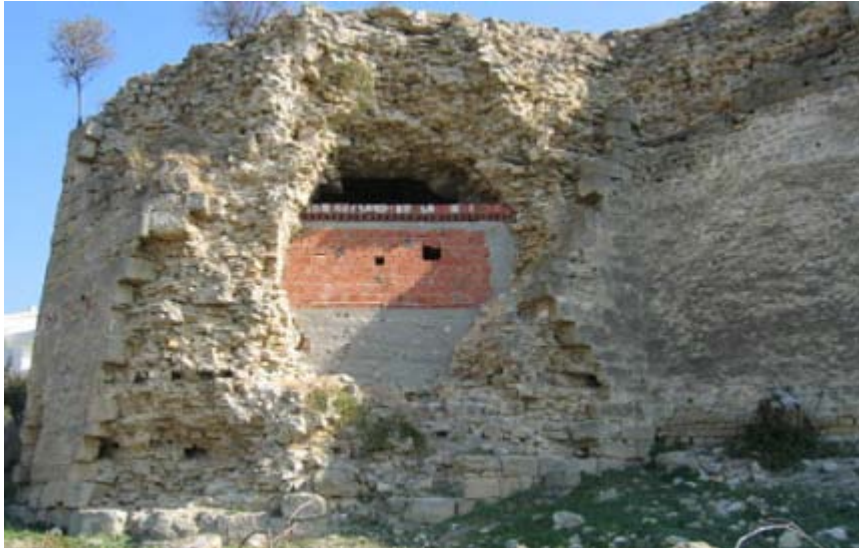
Figure 7.11 : Brick wall built to the window cavity of North Tower [10].

The brick wall that was built to the window cavity seen in Figure 7.11 should be removed. The damaged area around window cavity should be repaired with original material and loose stones should be stabilized.

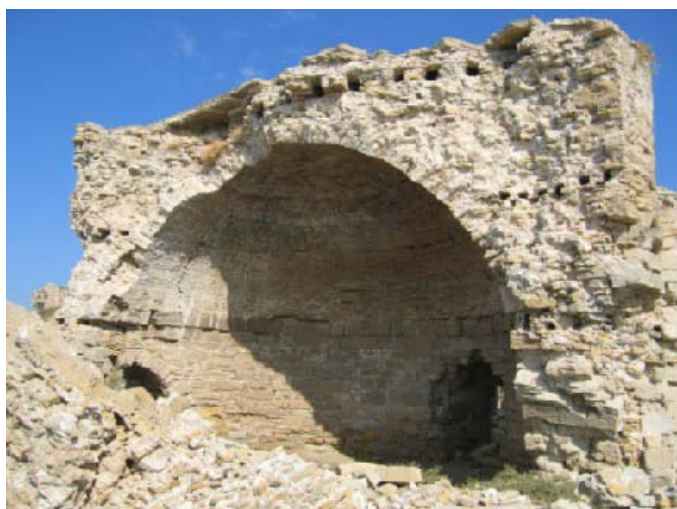
As seen in figure 7.12 half of the tower is damaged but the peak of the tower stands. FEM analysis carried out on the tower showed that maximum deformations are observed on the peak of the tower as seen in Appendix F.

Figure 7.12 : View from the South Tower [10].

In order to protect the current status of South Tower, standing parts of the tower should be stabilized urgently and temporarily by a steel frame arch seen in Figure 7.13.

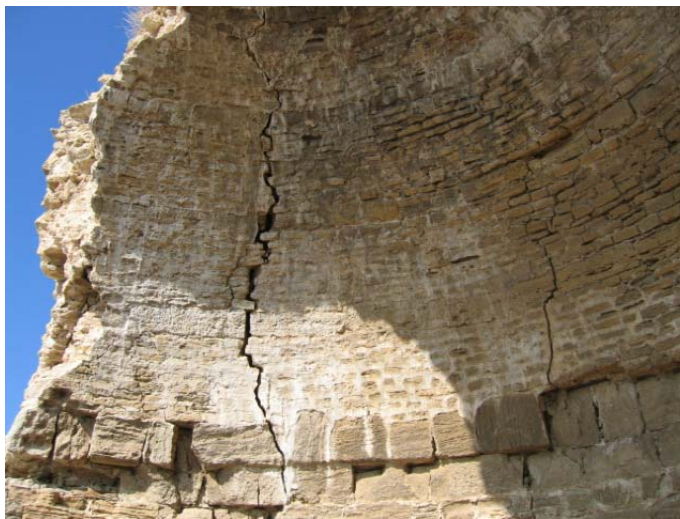
There are two vertical cracks with 3-6 cm (on the left) and 1.5-2 cm (on the right) width as seen in Figure 7.15. Width of the cracks are measured from the point cloud data of South Tower. Large, and capillary cracks seen in figure 7.15 can be repaired with techniques recommended in Figure 7.9 and 7.8 respectively.

Figure 7.15 : Large crack (left) and capillary crack (right) observed on South Tower [10].

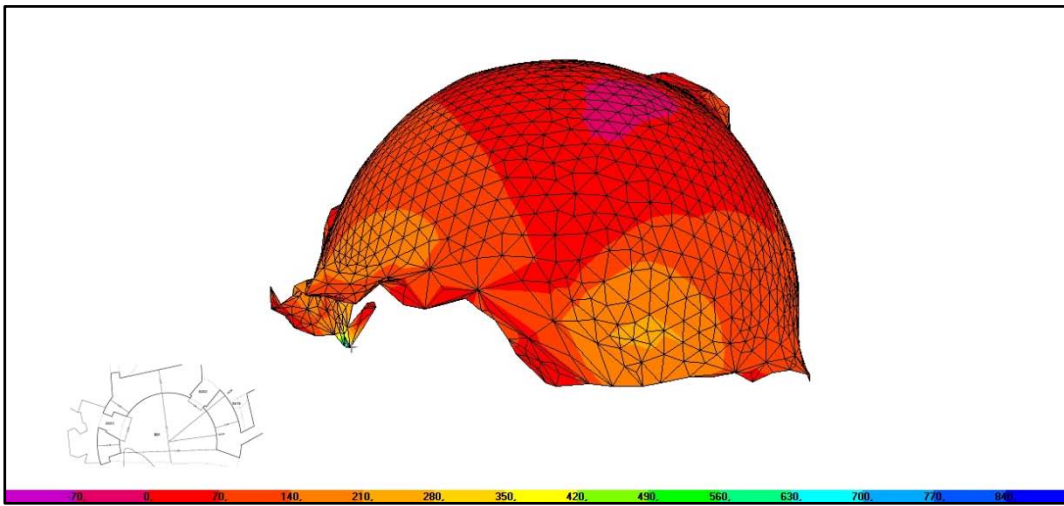
Figure D.3 : S22 maximum values observed on South Tower (kN/m^2).

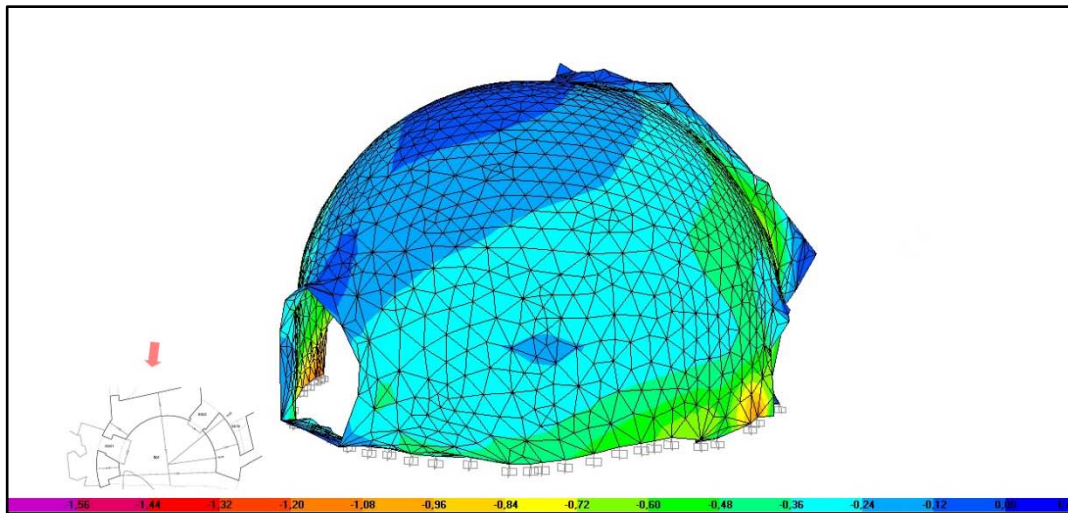
Figure D.4 : S22 minimum values observed on South Tower (MPa).

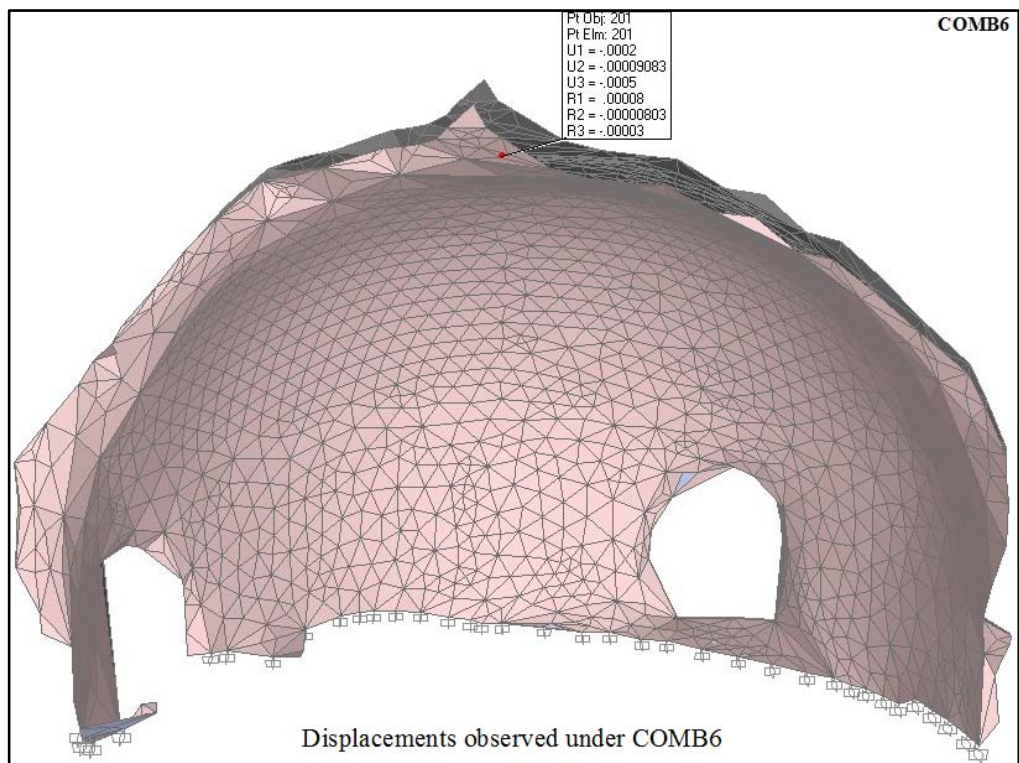
Figure F.1 : Displacements of South Tower observed for different loading combinations.
