**SELF-HEALING OF HIGH-PERFORMANCE FIBRE-REINFORCED
CEMENTITIOUS COMPOSITES**

M.Sc. THESIS

Department of Civil Engineering

NOVEMBER 2011

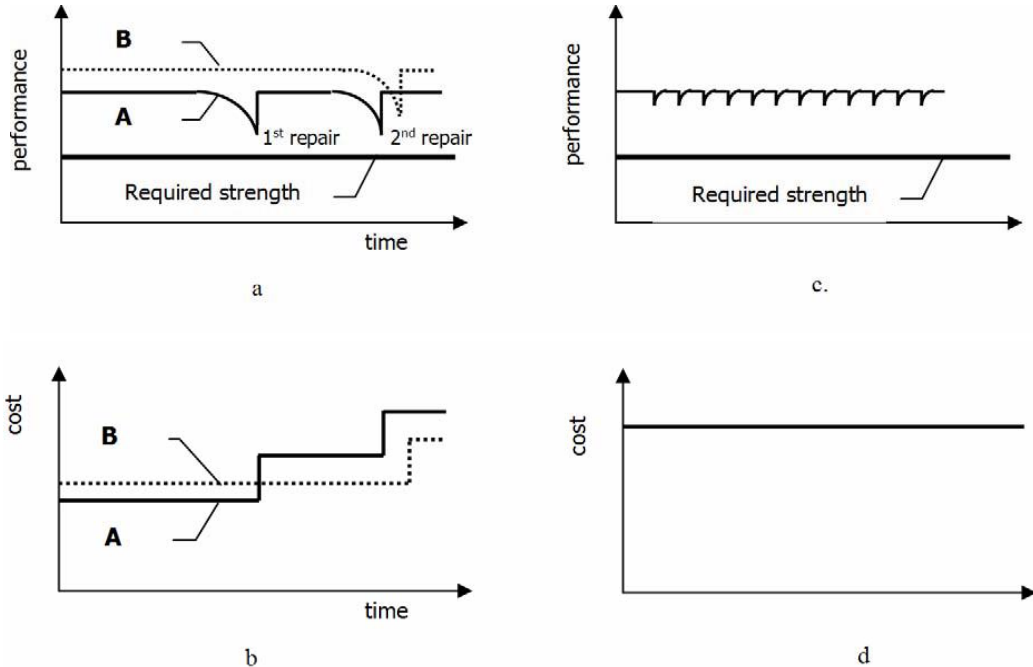
Figure 1.1 : Performance (a) and costs (b) with elapse of time for normal and high quality structures. Performance (c) and cost (d) of a structure made with self-healing material (concrete) with elapse of time. [8].

of structures and elapsed time is presented. For normal quality structures mostly two or more repairs are needed during the service life of concrete structure. With an initial higher cost, high quality structures need mostly one repair or less than normal quality concrete structures. As seen in figure (1.1.b) after two or more repairs general maintenance and repair costs are higher than high quality structures at the end of service life. Curve (1.1.c) schematically shows the performance of a structure with self-repairing materials will regain initial level of performance after occurring and healing process of cracks and such deformations. By using such kind of materials, maintenance and repair costs will be nearly at the same level during all service life of self-healing concrete structure [8].

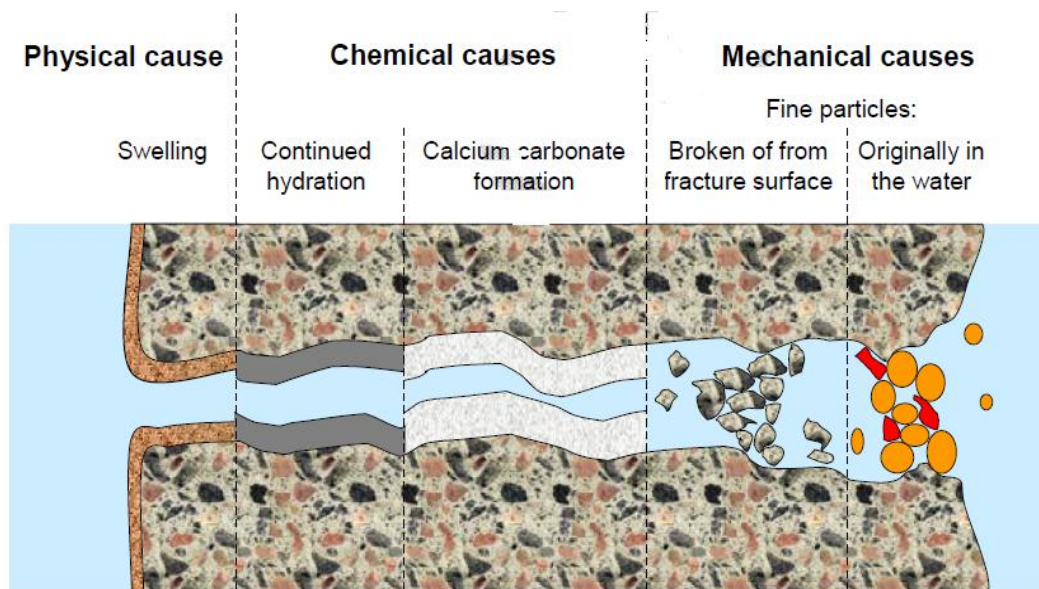
Figure 1.3 : Different causes of autogenic self-closing [11].

In the physical cause, swelling occurs when water is absorbed by hydrated cement paste and reaches the space between the constituents of hydrated cement paste. The effect swelling is reduction of the fluid flow is less than 10% [2].

One of the chemical causes of self-closing is continued hydration of cement in the concrete. These new reaction products grow into the free space of the crack but the continued hydration of cement cannot be responsible for a complete self-closing. The second chemical process is the formation calcium carbonate and growth of these crystals on the crack faces. According to this chemical process, calcium ions from the pore water of concrete (Ca^{2+}) react with the carbonate ions of the water in the crack (CO_3^{2-}) and combine CaCO_3 to which precipitates in the crack. In a study, it is

The mechanical effects have minor importance than the other effects. In this type of self-closing fine particles, broken from fracture surface or already present in water, may reduce the crack width [2].

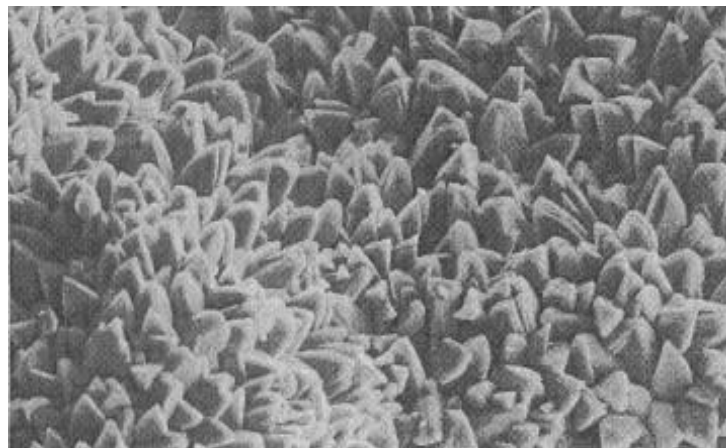
Figure 1.4 : Calcite crystals on a crack face after opening the crack [11].

Concrete is a compound of matrix and aggregates and when the cement hydrates calcium silicate hydrates (C-S-H), aluminates and calcium hydroxide are formed. In addition, calcium hydroxide is soluble in water and it is necessary for the formation of calcium carbonate in the cracks. In composite cements, a part of calcium hydroxide is used for the formation of hydration products by the second constituent like fly ash and pozzolanas. Mostly pozzolanas use calcium hydroxide as an activator. Portland cement has relatively more calcium hydroxide than other cement composites with fly ash or blast furnace slag. Moreover the type of aggregates like limestone may positively affect self-closing. The shape of aggregates grains and the grading curve can influence the crack geometry and so self-closing. Finally, water is the most important factor for self-closing. Water is important for chemical reactions and for the transport of fine particles that are mentioned in self-closing phenomena. With the presence of water calcium carbonate are formed and grows on the crack surface and the calcite crystals (CaCO_3), as seen in the figure below [11], form a dense layer which blocks the flow of water, [12].

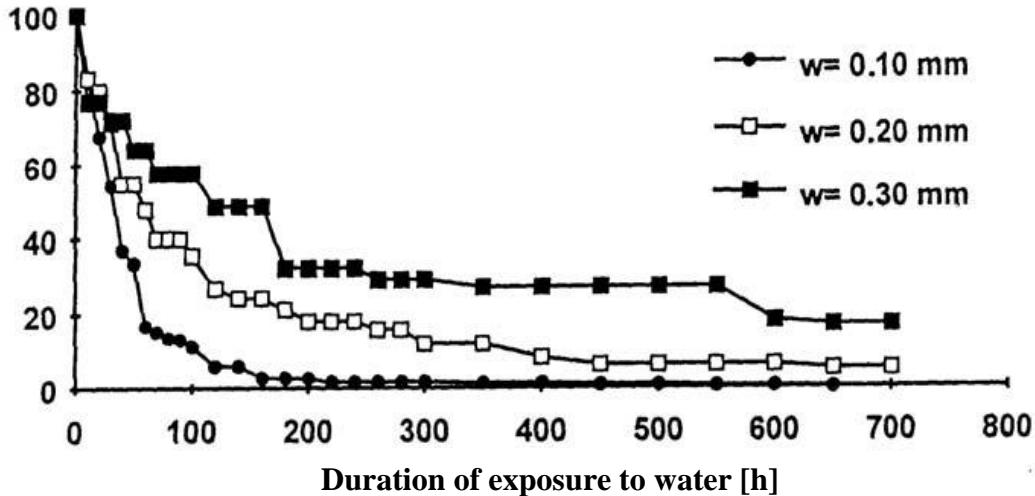
Figure 1.5 : Influence of crack width on flow relative to initial flow [11].

Water permeability tests were performed on small specimens with a single tensile through crack [11]. The effects of water source (hardness), type of addition in concrete, type of aggregate, pressure gradient and the crack width were studied. The first three parameters have nearly no effect and the effect of crack width and pressure gradient are shown in the following figures. As seen in the figure 1.5 and 1.6, the crack width of 0,1 mm has generally the best self-closing. Evaluating these figures together makes it possible to conclude that the reduction of flow in absolute sense is strongest for the larger crack width. The self-closing effect by crystallization of CaCO_3 in the cracks was explained [11]. X-ray diffraction experiments from crack faces show CaCO_3 is the main element for the self-closing.

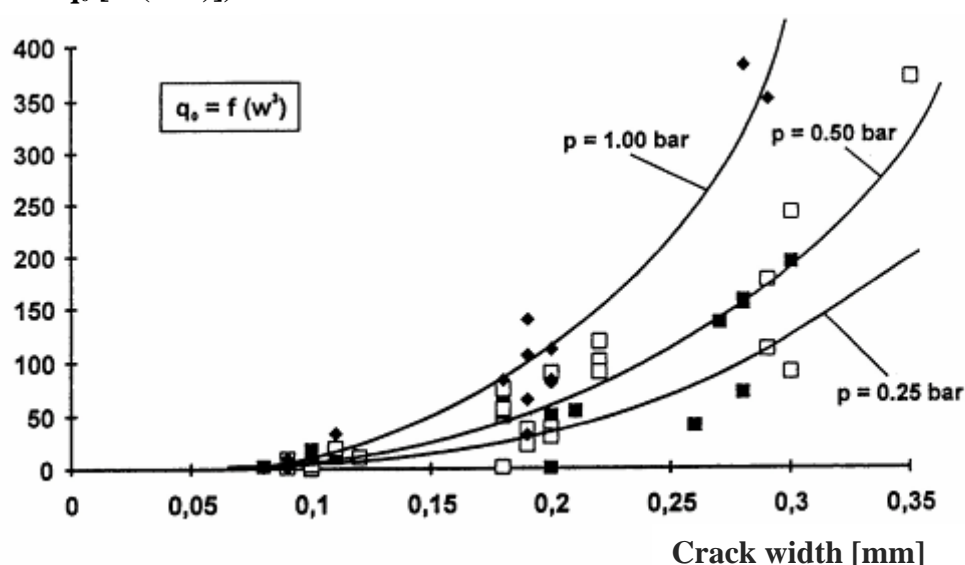
Figure 1.6 : Initial flow through cracks of various widths for 1 m length [11].

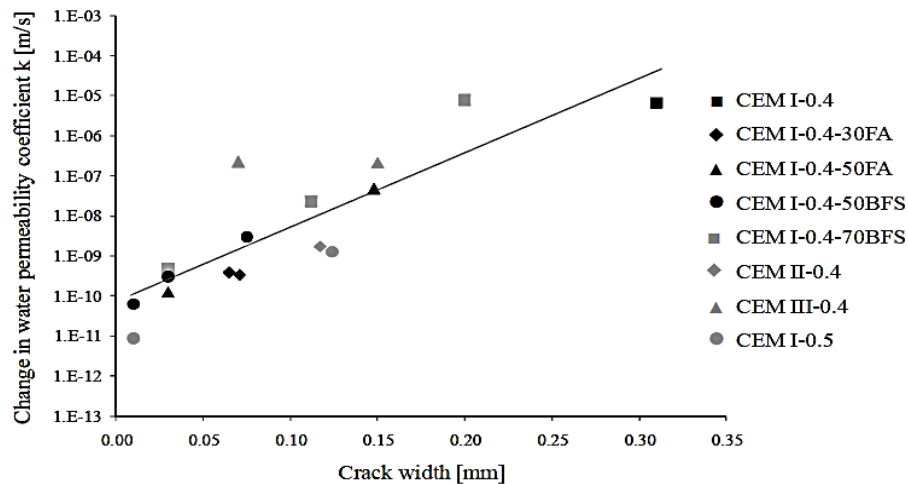
Figure 1.7 : Decrease in water permeability coefficient k [m/s] due to autogenous closing of the crack in specimens with different crack widths [mm] and with different mix compositions; the grey line indicates the mean change in water permeability [19].

Specimens were cured for one and half month and then they were fractured in a crack opening controlled splitting test. Subsequently, the crack width of each sample was measured at different locations, equally divided along the crack length. The average value was used to characterize the crack width of each specimen. The effect of the mortar composition on the self-closing potential was investigated by measuring the change of water permeability of the cracked specimens. A low pressure permeability test setup was used and water permeability coefficient k was calculated according to Darcy's law. Permeability coefficients were measured at the beginning and the end of first 5 days and at the end of 15 days. As shown in the following figure, during the test, water flow through the specimens decreased. It was determined that for increasing crack widths, the difference in water permeability coefficient and consequently the self-closing potential also increased [19]. It was supposed that mixes with a higher amount of cement particles or lower water to binder ratio would contain more unhydrated particles and thus result in a higher degree of self-closing. But there was no big difference in self-closing between the water to binder ratios 0,4 and 0,5. The degree of self-closing was higher when a higher amount of slag was used and there was no big decrease in water permeability in the case Portland clinker was replaced with fly ash. They stated that reaction of fly ash is slower than reaction of blast furnace slag. However it was concluded that the self-closing potential of cementitious materials may be changed by the changing of mixture composition. Another type of experiments was carried out [20,21] that consisted of damaging concrete cubes by rapid freeze-thaw cycles, and then storing them in 20 °C water for 3 months. Two types of concrete at water-cement ratio of 0.4, one with silica fume and the other without silica fume, were tested. Deterioration and healing was measured by resonance frequency (converted to dynamic modulus of elasticity) and compressive strength. Freeze-thaw cycles led to loss in both properties. Self-healing gave a substantial recovery of the frequency, but only a small recovery in compressive strength. It was explained by SEM observations that the cracks were only partly filled with new products. Most of the crystals seen in the cracks were newly formed C-S-H. Portlandite ($\text{Ca}(\text{OH})_2$) was also observed locally. The study showed that self-healing is less apparent in concrete containing silica fume than in concrete without silica fume.

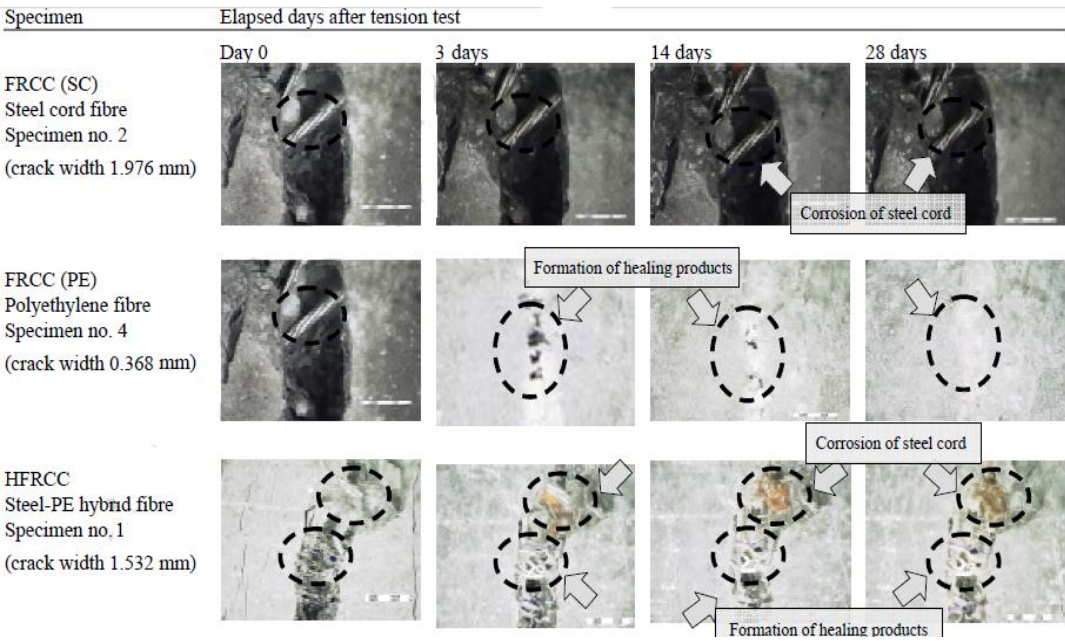
Figure 1.8 : Microscopic observation of self-healing products at a crack surface [28].

In their microscopic observation it can clearly be seen in photographs that the crack surface of all specimens after the tension test is clear and there are no products on the surface. These photographs of the crack surface of FRCC(PE), FRCC(SC), and HFRCC can be seen in Figure 1.8. After 3 days the crack surfaces in FRCC(PE) and HFRCC were attached by self-healing products and the crack width decreased as the time passed. The crack surface in FRCC(SC) was not decreased by the self-healing products. It could be because there were too few fibers that self-healing products could attach to. On the other hand in the place where of a lot of micro PE fibers bridged over the crack, especially in most of FRCC(PE) specimens, there were many attachment of self-healing products. Even in case of FRCC(PE), however, if there were rather a few fibers, the attachment of self-healing products depended on the volume content of PE fibers. Therefore it was concluded that amount of the PE fiber per volume has a great influence on self-healing. After 3 days, it was seen that the steel cords on the crack surface in FRCC(SC) and HFRCC were corrosive and the volume expanded.

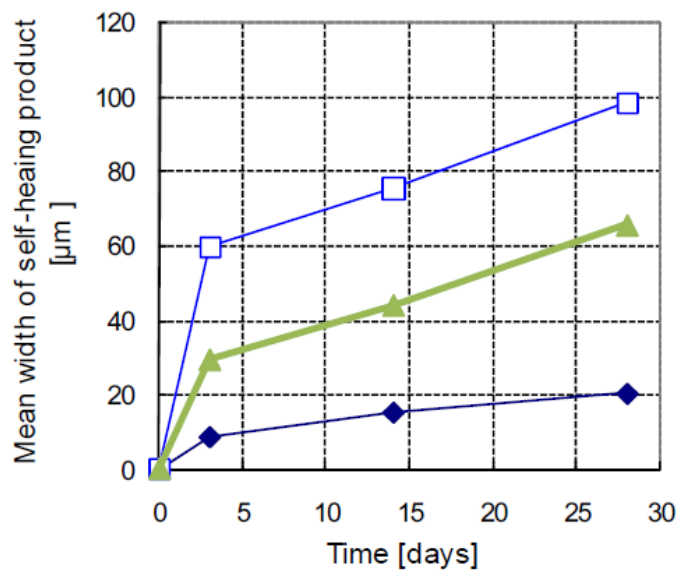
Figure 1.9 : Time dependence of mean size of self-healing products attached at the crack surface [28].

Size of self-healing products was also studied as a function of time. As seen in the following figure, the increasing rate of the mean size during the first 3 days is higher than after first 3 days. This may be because of decreasing Ca_2^+ diffusion speed from the inside of FRCC. Self-healing product layer made diffusion decreased. The amount of the attached products in was FRCC(PE) materials were the higher however number of mixed in fibres per volume in this group of specimens was the highest. Therefore it was concluded that the number of mixed in fibre per volume has a dominant influence on the crack self-closing effects.

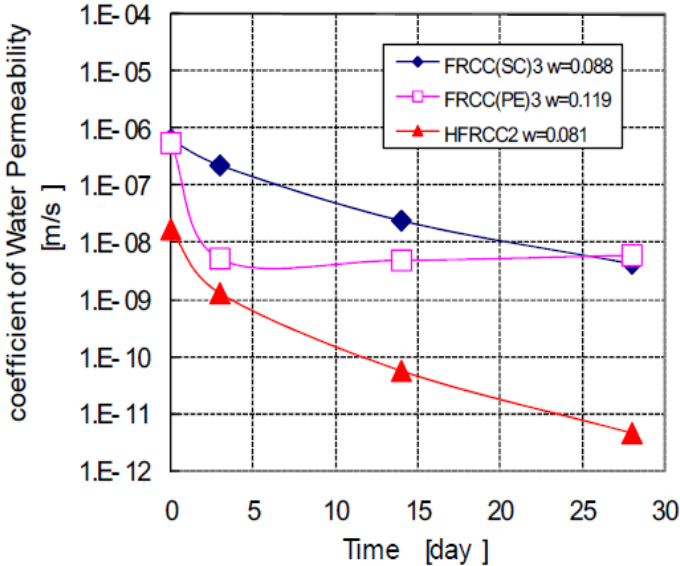
Figure 1.10 : Influence of time dependence of water permeability coefficient due to type of FRCC [28].

te crystals has a great effect on self-healing of cracks. It can be seen in the Figure 1.10 that shows the influence of time dependence of water permeability coefficient due to type of FRCC, the decrease of the water permeability coefficient in FRCC(PE) and HFRCC is more than that in FRCC(SC). The self-healing products could attach to the crack surface more in FRCC(PE) and HFRCC than in FRCC(SC).

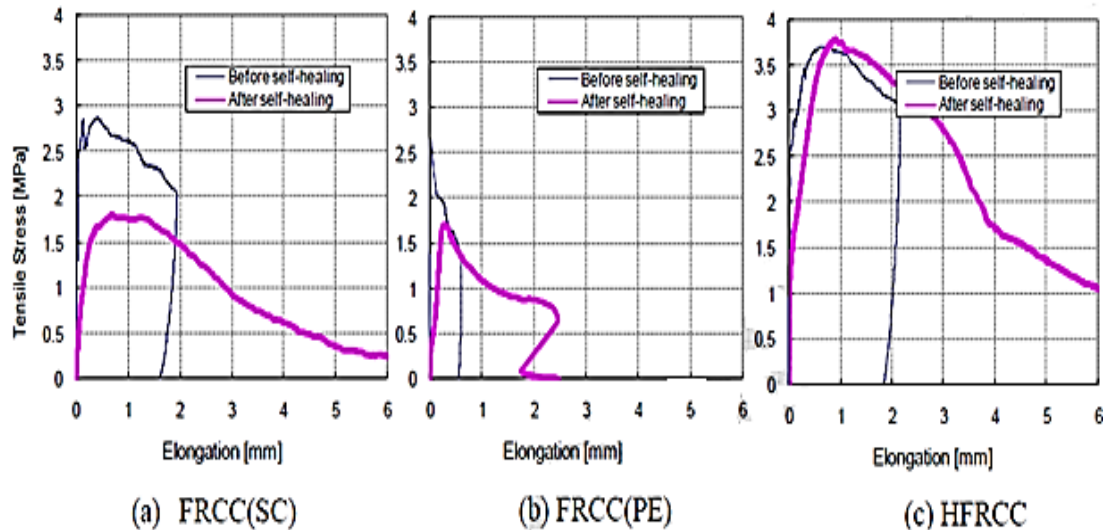
Figure 1.11 : Comparison of tensile property of specimens before and after 28 days of self-healing [28].

In order to evaluate the effect of self-healing on the tensile properties, the self-healed FRCC specimens were tested by uni-axial tension test again in the same study [28]. Figure 1.11 shows the tensile stress-elongation responses before and after the self-healing. As it can be seen in the figure, after self-healing period specimens gained their tensile strengths at different levels. It is surely because of new forming self-healing products. Calcium carbonate crystals attach the crack surface and fibers and this mechanism of self-healing may make tensile strength recoverable. In the HFRCC group, the elongation was less than 1,5 mm and the recovery rate was higher than 100%. This may be because of many newly formed calcium carbonate attached the crack surfaces with very fine fibers. Moreover, bond property of steel fibers might be healed by self-healing products. They also found in the crack surface investigation after tension test that, corrosion of steel fibers was both inside and outside in FRCC(SC) group. On the other hand, in HFRCC group corrosion was only outside. Lots of calcium carbonate crystals attached to the matrix around steel fibers may be cause of this situation and it corresponds with the increase of tensile strength after self-healing [28].

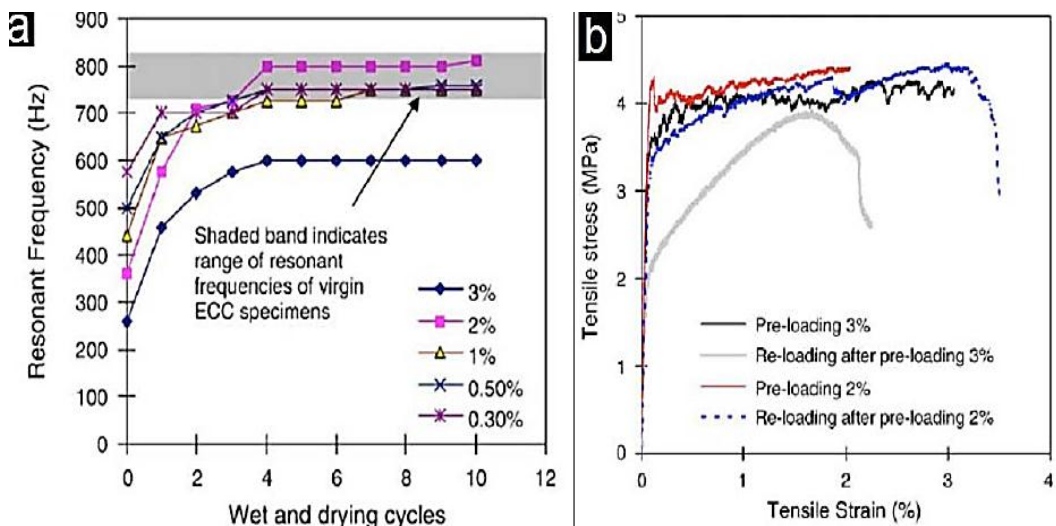
Figure 1.12 : a) Resonant frequency recovery of ECC specimens pre-loaded between 0.30 and 3.0% after 10 wet/dry cycles; b) tensile stress/strain relationships of ECC specimens pre-loaded to 3.0 and 2.0% before and after 10 wet/dry cycles [33].

In a study, resonant frequency recovery of ECC specimens were observed by pre-loading specimens between 0.30 and 3.0% strains after 10 wet/dry cycles [33]. As it can be seen in the following figure, specimens reached nearly same frequencies of virgin specimens except specimens which were pre-loaded 3%. However, tensile stress/strain relationships of ECC specimens pre-loaded to 3.0 and 2.0% before and after 10 wet/dry cycles were investigated. As seen in the figure recovery ratio of the specimens that were loaded to 2.0%, was higher than the specimens that were loaded to 3.0%.

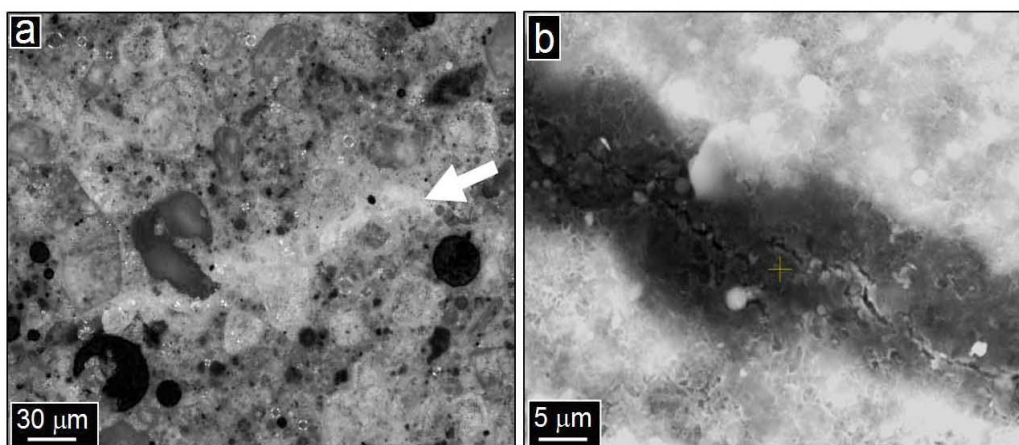
Figure 1.13 : a) optical micrograph of healing product in ECC cement (arrow); b) SEM micrograph of a healed crack [26].

Healing products can be easily identified by optical microscopy (Figure 1.13a) or electron microscopy (Figure 1.13b); observation by eye is also possible in ECC. Micrographs of the healing products were made [36] and assuming it to be calcite based on the works [12,10,37]. Each concluded that the healing product to be calcite based on EDS spectra.

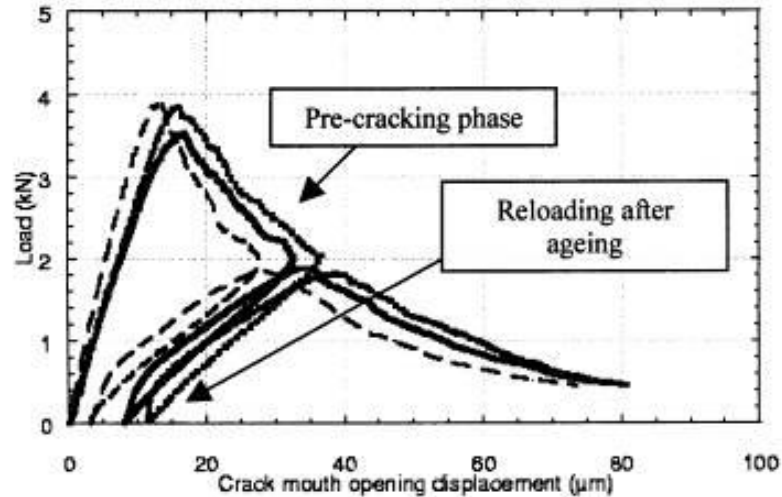
Figure 1.14 : Load-Displacement behaviour of virgin specimen (Pre-cracking phase) and reloading after 3 weeks in air [42].

Ultra High-Performance Concrete (UHPC) is a cementitious material which has very low water-cement ratio [2]. In a study [42] used a water-cement ratio of 0,2 and additionally silica fume in their studies. They cured the specimens after 2 days water curing with heat-cure at 90°C and 100% RH for 48 h. In the three-point bending test, the prismatic specimens with a center notch were loaded in a displacement controlled manner till the top and further until a crack mouth opening displacement of about 30 µm. Then the specimens were stored in water for a certain time. Figure 1.14 illustrates the deflection-softening behaviour of UHPC. The peak bending stress is about 7,3 MPa at 15 µm. Unloading took place at a load level of 2 kN which corresponds to a bending stress of 3,75 MPa. Reloading follows the original curve.

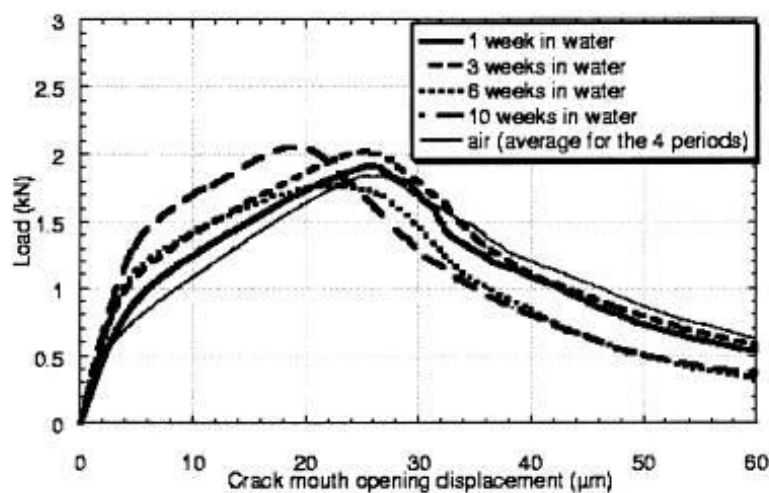
Figure 1.15 : Load-Displacement behaviour of cured specimens and non-cured ones [42].

The storage in water led to slightly different behaviour as shown in Figure 1.15. Water cured specimens showed an increase in bending stress compared to non-cured specimens. The initial stiffness of cracked specimens (reloading stiffness) after 10 weeks storage in water was almost the same as the one of the virgin specimens. Crack mouth opening distance decreases with increasing time of water storage. Resonance frequency and acoustic emission measurements showed that self-healing effect was present. The cause of self-healing was seen in the formation of new products in the crack due to continued hydration of fractured unhydrated cement grains [43].

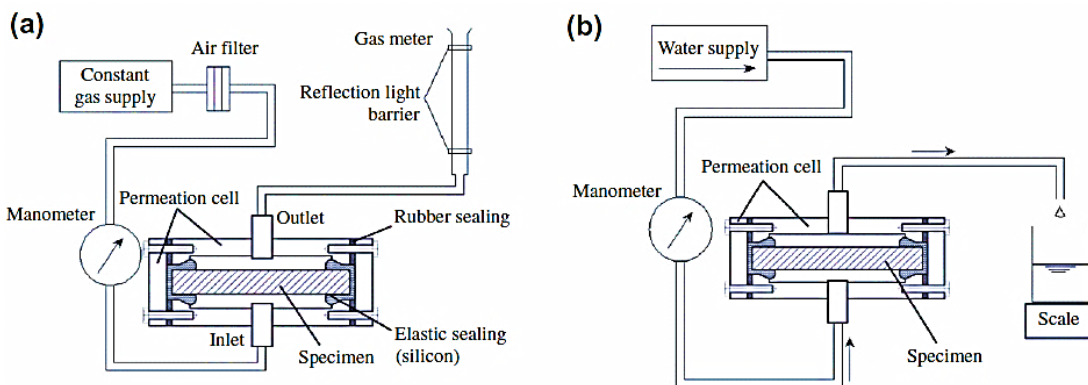
Figure 1.17 : Schematic view of the test setup for (a) gas permeability, (b) water permeability [56].

As seen in the following figure, for permeability testing special equipment was developed to enable measurement of the water and gas transport behavior of cracked TRC in-situ, under uniaxial tension, and at chosen strain levels. The results in the study indicate a very low permeability and capillary absorption of the crack-free material and with uncoated textile increase in the fineness of the yarns showed considerable increase in water absorption. It is concluded that multiple cracking with relatively small crack widths in comparison to ordinary cracked concrete generally results the increase of ingress of corrosive substances (e.g. chlorides or sulfates) , which may lead to a deterioration of concrete and steel reinforcement. Nevertheless, the self-healing of fine cracks indicated a pronounced reduction in the transport rates of water and gas over time.

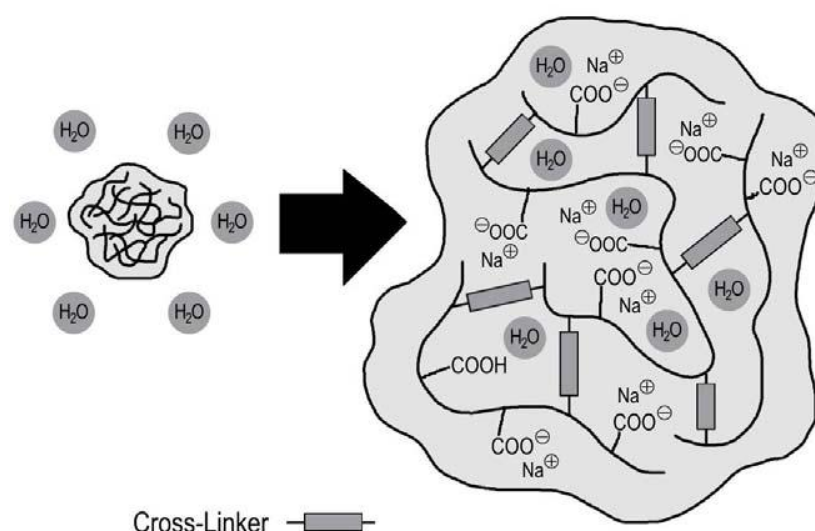
Figure 1.19 : SAP based on polyacrylic acid [63].

From a chemical point of view, SAPs are cross-linked polyelectrolytes which start to swell upon contact with water or aqueous solutions resulting in the formation of a hydrogel. In the hygiene industry only SAPs based on cross-linked poly acrylic acid are used (Figure 1.19), which is partially neutralized with hydroxides of alkali metals, usually sodium. There are traditionally two markets of SAP: Hygiene industry and technical SAPs. Technical SAPs, which can be based on acrylamide and acrylic acid, are used in landscaping, cable isolation, firefighting, food packaging.

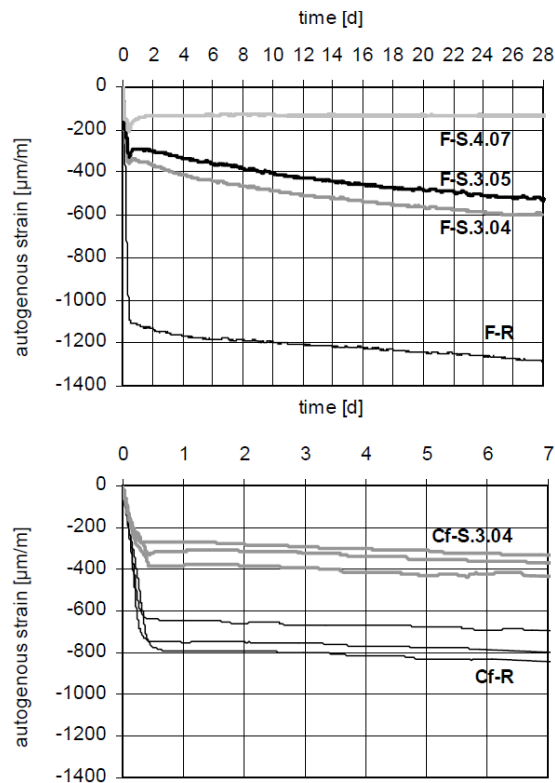
Figure 1.20 : Autogenous shrinkage of fine and coarse grained UHPC measured starting after the final set [68].

shrinkage of UHPC dramatically. This effect becomes even more pronounced with increasing amounts of SAP and extra water.

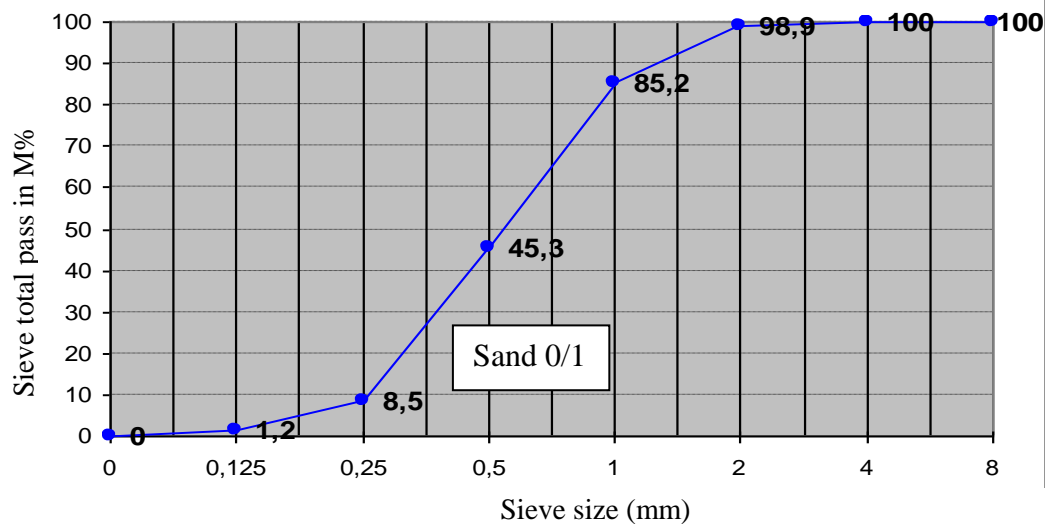
Figure 2.1 : Grain size curve of sand 0/1 mm.

Sieve total pass (%) through mesh sizes										D-Sum	k-value
	0,125	0,25	0,5	1	2	4	8	16	31,5	63		
Sand 0/1	1,2	8,5	45,3	85,2	98,9	100	100	100	100	100	739	1,62

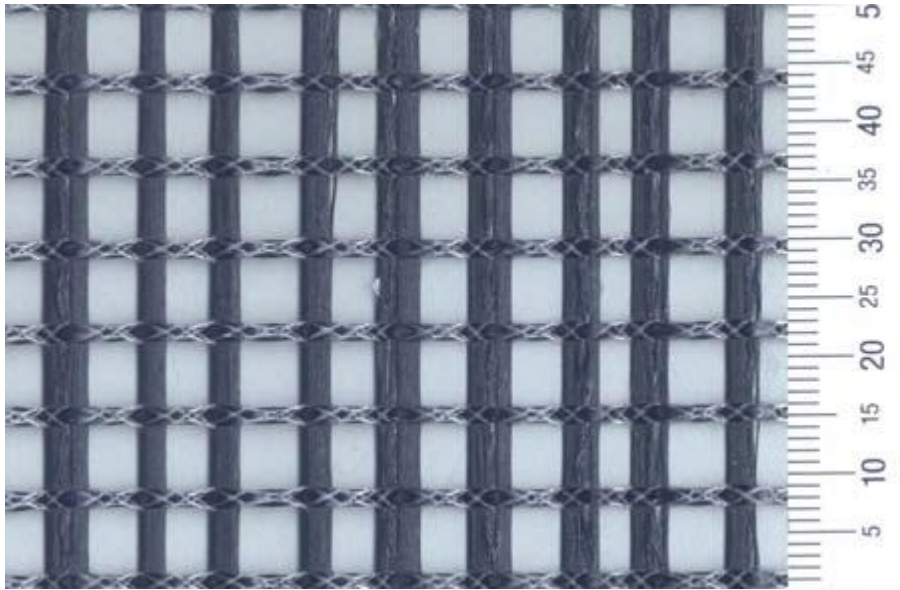
Figure 2.3 : Biaxial textile reinforcement made of carbon multifilament yarns.

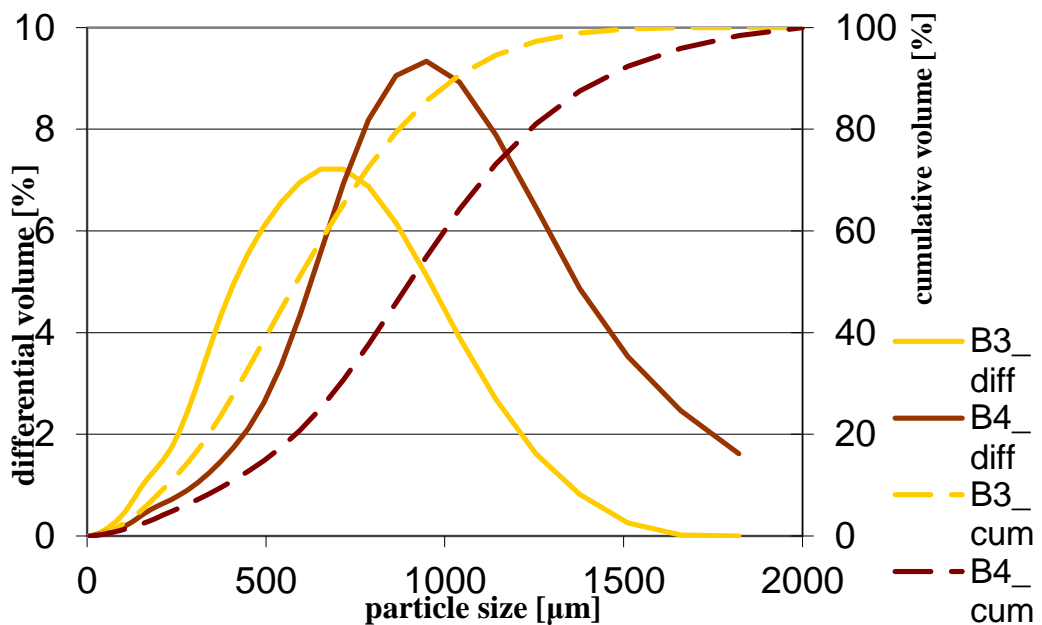
Figure 2.4 : Particle-size-distribution of SAP material.

In this thesis two SAP products were used, which are here called B3 and B4 in accordance to the studies performed by Michaela Gorges [77] in the TU Dresden Construction Materials Institute. Particle size distributions of these SAP materials are given below.

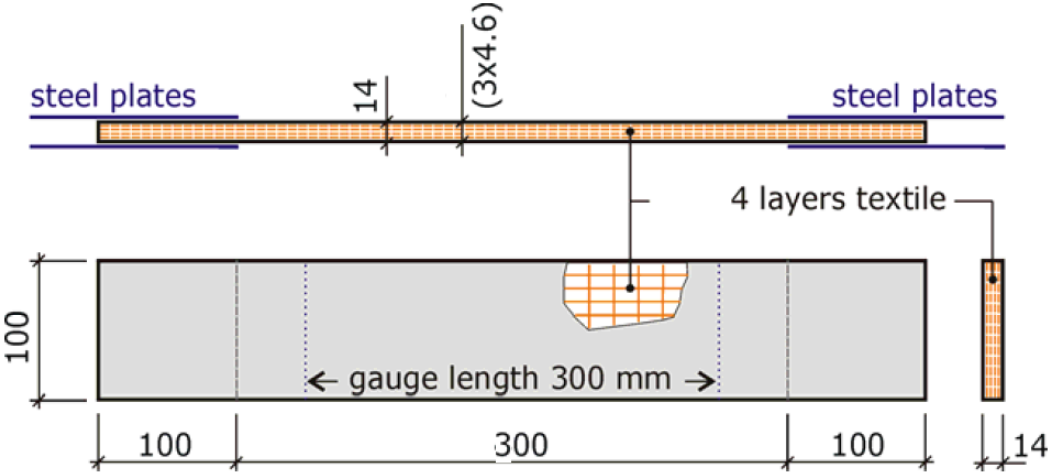
Figure 2.5 : Geometry of TRC tension test specimen.

Concrete mixtures were prepared in batches of 0.08 m³ in a laboratory pan mixer. 100x500x14 mm plastic plate moulds were used for specimens and compaction was done by a vibratory table. Specimens were produced with laboratory procedure for producing TRC specimens in the laboratory of TU-Dresden Construction Materials Institute. Ingredients were mixed dry, with water and finally with admixture for defined time periods. The specimens for the investigations of self-healing processes are rectangular TRC plates 500 mm long, 100 mm wide, and 14 mm thick (Figure 2.5). The specimens are produced with 3 layers of carbon-fibre textile reinforcement in the preliminary work and 4 layers of textile reinforcement were used in the main part of thesis. The arrangement of the textile layers is symmetrical and parallel to the plate’s surface.

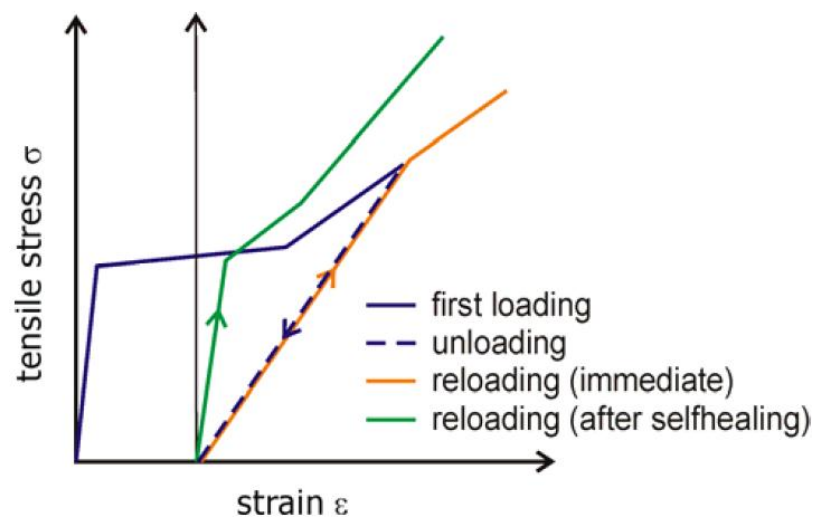
Figure 2.6 : Loading of a TRC tension test specimen.

In order to obtain several crack characteristics and crack widths similar to those under actual service conditions, the uniaxial tensile TRC specimens were preloaded up to two different strain levels and then unloaded to the desired crack width resulting from the remaining strain (Figure 2.6).

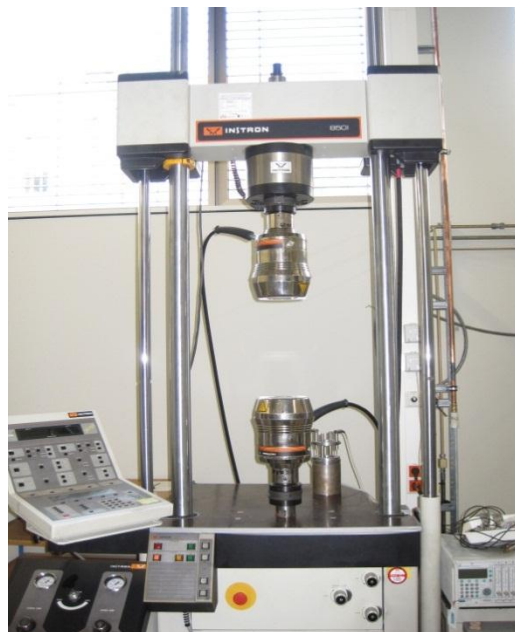
Figure 2.8 : Uniaxial tension test machine.

- type: INSTRON 8501
- Load measuring range: 100 kN
- Displacement capacity of hydraulic jaw: 250 mm
- Electronic capture of load, deformation of machine
- Measurement of specimen deformation by means of 2 lateral fixed LVDT
- Measuring range of LVDT is 10 mm.

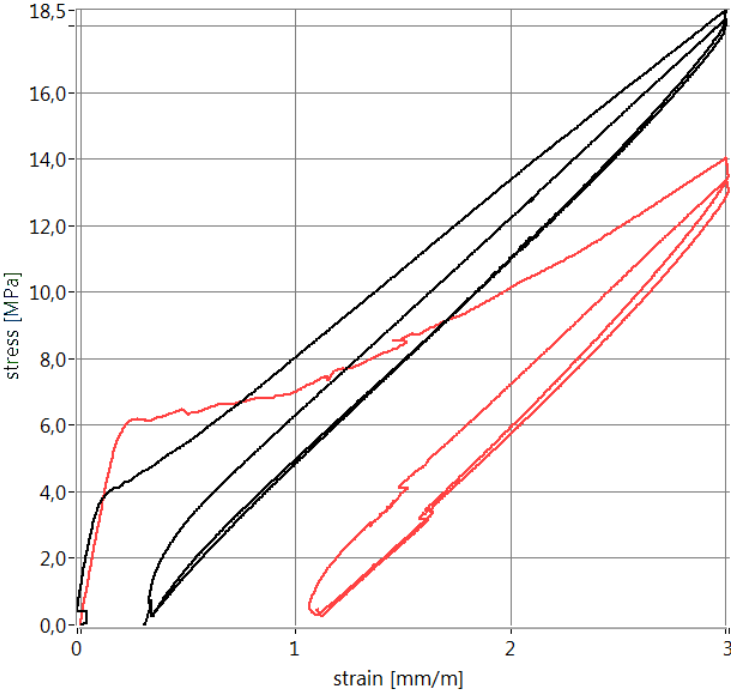
Figure 3.1 : Stress-strain curve of C1WD and 2C1WD.

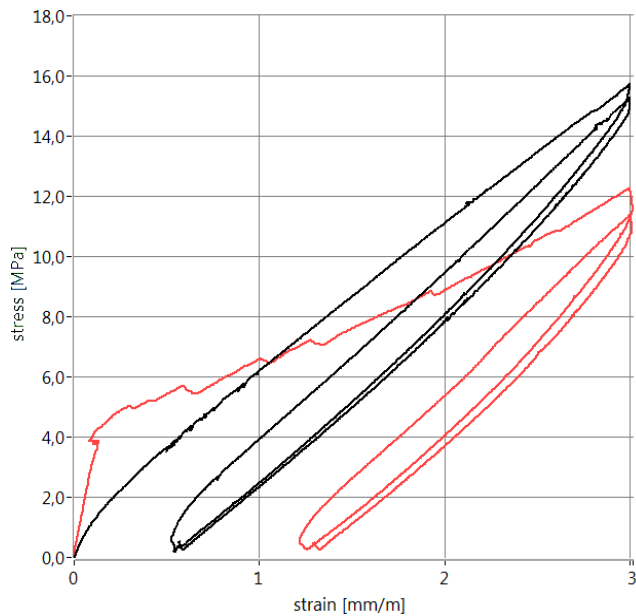
Figure 3.3 : Stress-strain curve of **C1W** and 2C1W.

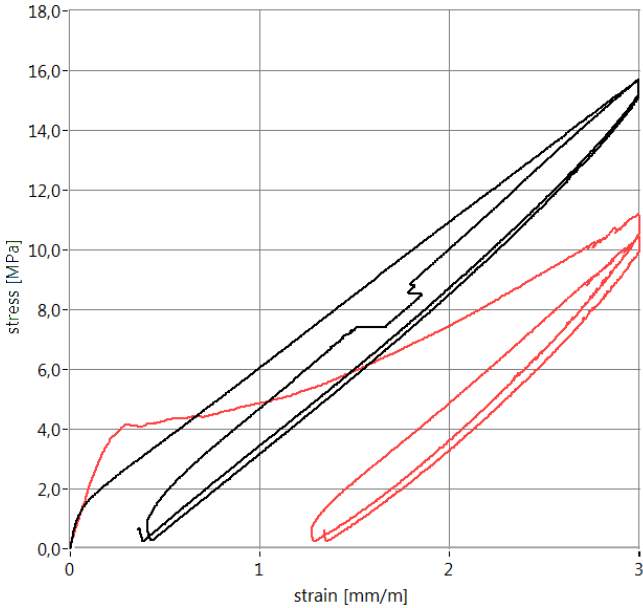
Figure 3.4 : Stress-strain curve of C3WD and 2C3WD.

The cement is replaced with fly ash and silica fume in the second group of concrete mixtures. Fly ash reacts with Ca(OH)_2 from cement hydration and produces C-S-H gel. It is thought to be less influenced by the availability of free water than the hydration reaction of cement. Specimens are exposed to same curing conditions that are air, water curing and wet-dry cycling. In the following figures (3.4, 3.5, 3.6) stress-strain curves of mixtures can be seen. The wet-dry cycling group seems to be best self-healing effect as in the pure Portland cement group. Nevertheless self-healing ability of the specimens made of CEM III and pozzolana led to much less pronounced crack bridging. The brief self-healing period was too short to generate a sufficient amount of hydration products in the slow hydrating binder combination. The self healing behaviour of such a mixture are studied again in the final part of the thesis again. It can be said for the air curing group that there was no self-healing products which are effects the machanical properties of specimens. Water curing group also showed a self-healing behaviour mechanically, however this effect was less than wet-dry cycling group. It has to be mentioned that some newly formed self-healing products that have a stress level less than 1,5 MPa; were present in the specimens.

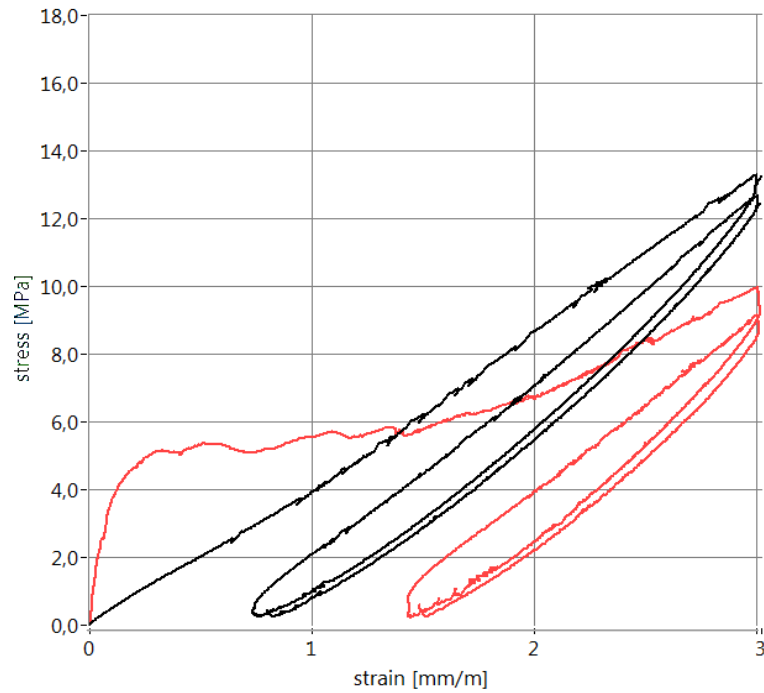
Figure 3.13 : Stress-strain curve of **C3A41-2C3A41**.

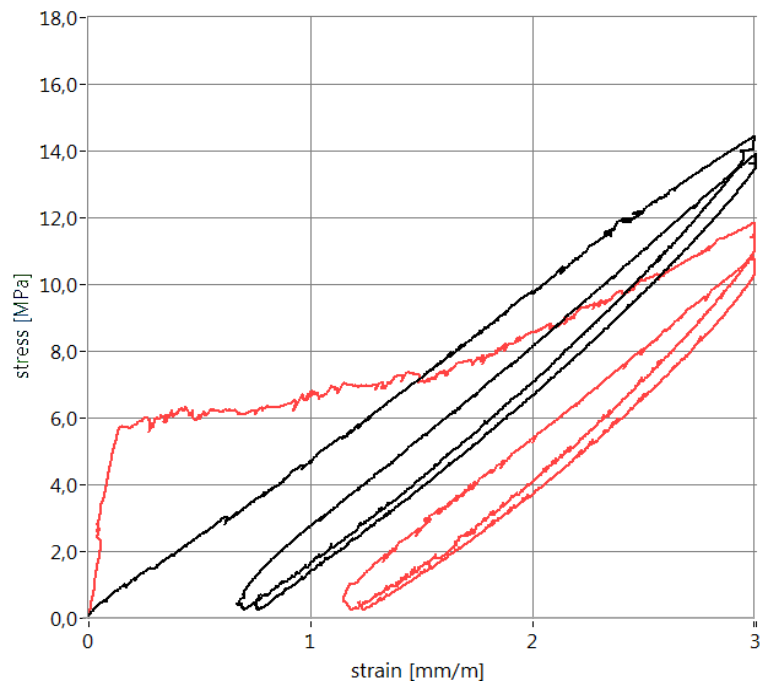
Figure 3.14 : Stress-strain curve of **SAPA21-2SAPA21**.

SAP materials was unable to absorb water during the period that specimens were exposed to air conditions. However, SAP materials did not show any effect on self-healing properties.

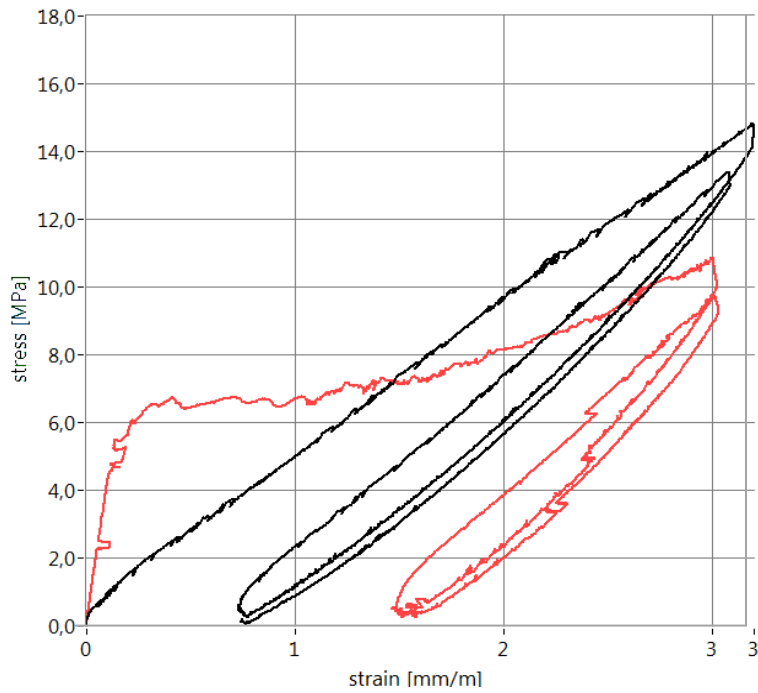
Figure 3.15 : Stress-strain curve of **SAPA41-2SAPA41**.

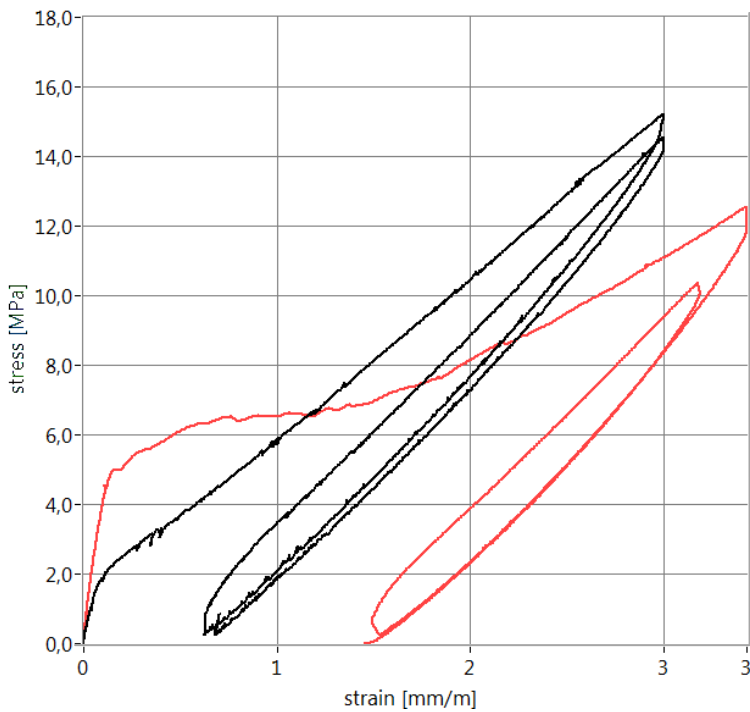
Figure 3.16 : Stress-strain curve of **C1W22-2C1W22**.

As it can be seen in the figures 3.16-21, specimens made of CEM I cement have showed higher tensile strength recovery after curing. However, as expected, specimens that are cured for 4 weeks had higher degree of self-healing on mechanical properties than 2 weeks cured specimens.

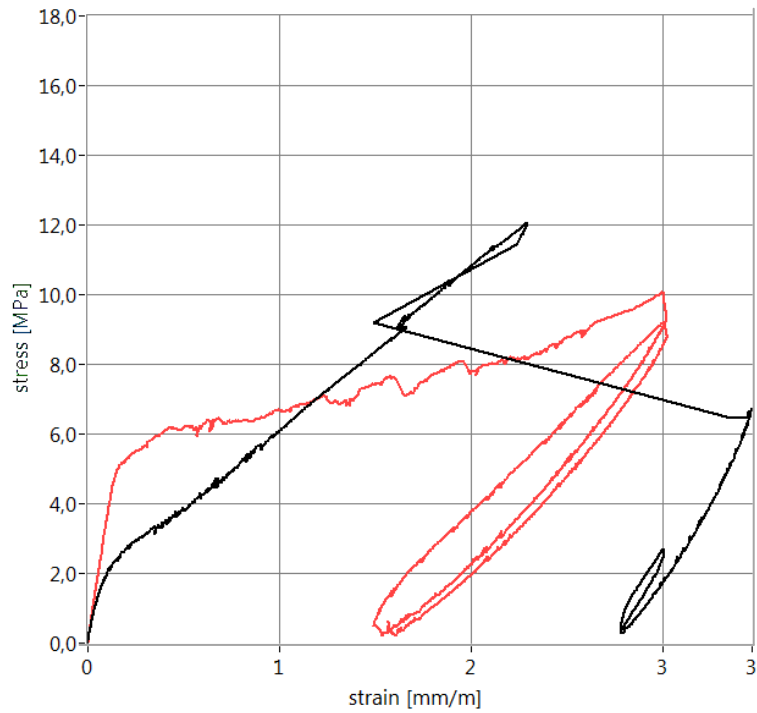
Figure 3.17 : Stress-strain curve of C1W41-2C1W41.

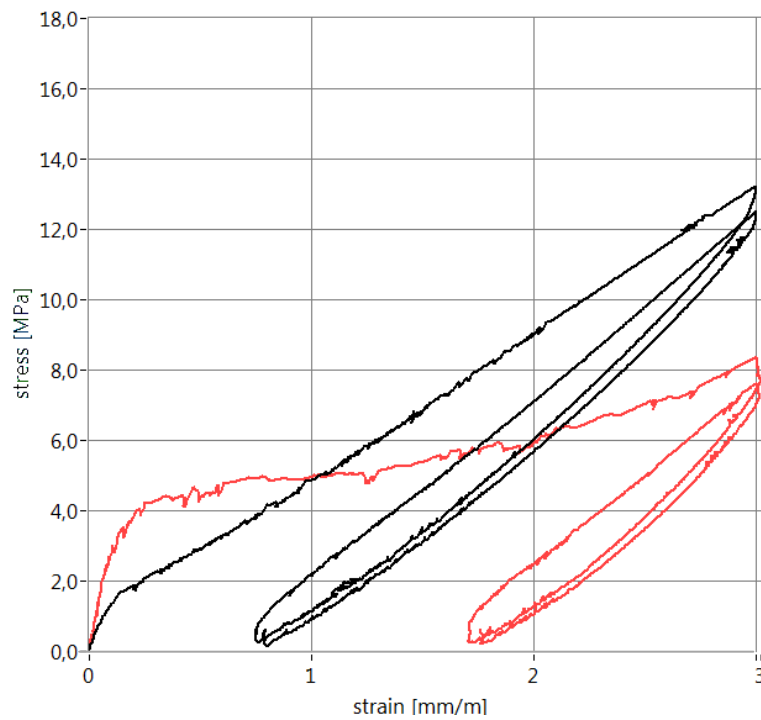
Figure 3.18 : Stress-strain curve of C3W22-2C3W22.

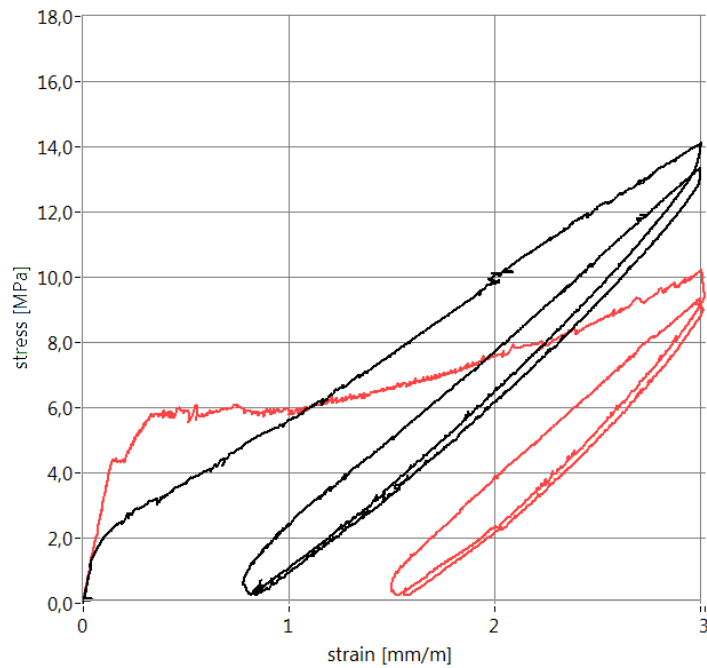
Figure 3.22 : Stress-strain curve of C1WD121-2C1WD121.

Similarly, the wet-dry cycle-1(water storage (20°C) for 1 hour, drying at lab climate (20°C) for 23 hours) cured specimens that were cured for 4 weeks have showed better mechanical properties recovery than 2 weeks cured ones. Because of the composition of concrete, mixtures with CEM I showed the highest strength. As it can be seen in the following 6 figures, CEM I group specimens that were cured for 4 weeks reached the maximum mechanical self-healing.

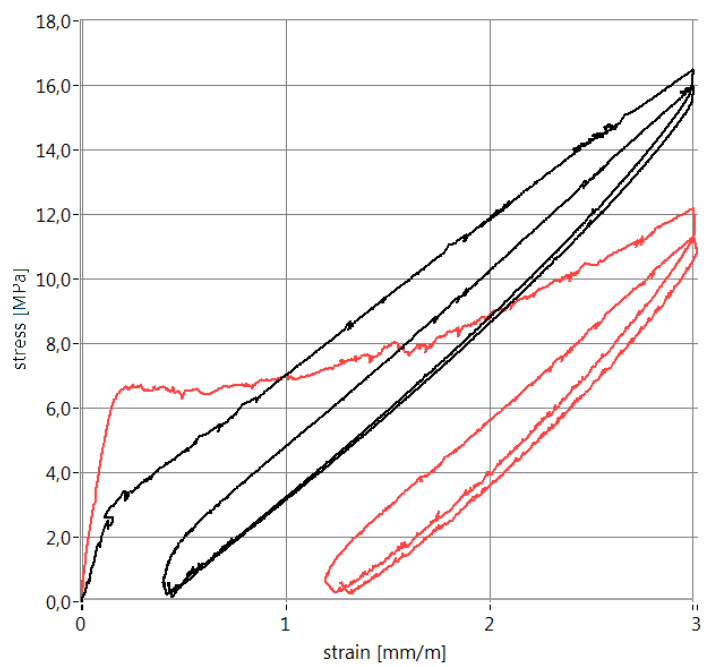
Figure 3.23 : Stress-strain curve of C1WD142-2C1WD142.
