**SELF-HEALING OF HIGH-PERFORMANCE FIBRE-REINFORCED
CEMENTITIOUS COMPOSITES**

M.Sc. THESIS

Department of Civil Engineering

NOVEMBER 2011

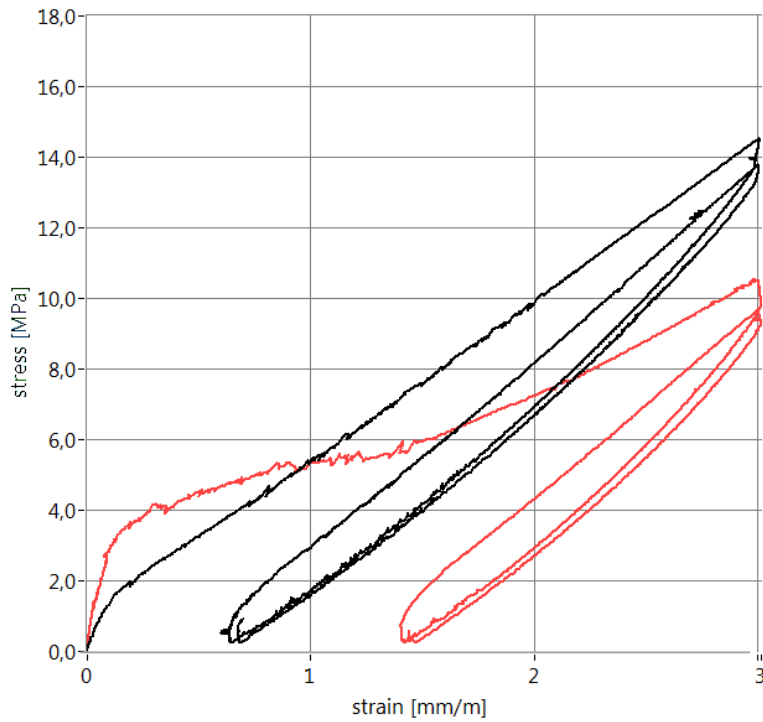
Figure 3.24 : Stress-strain curve of C3WD123-2C3WD123.

Concrete specimens gained nearly 60% of their initial tensile strength. CEM III group specimens had less initial tensile strength but the effect of self-healing was clear. SAP materials did not give any positive effect in comparison to the pure CEM I group.

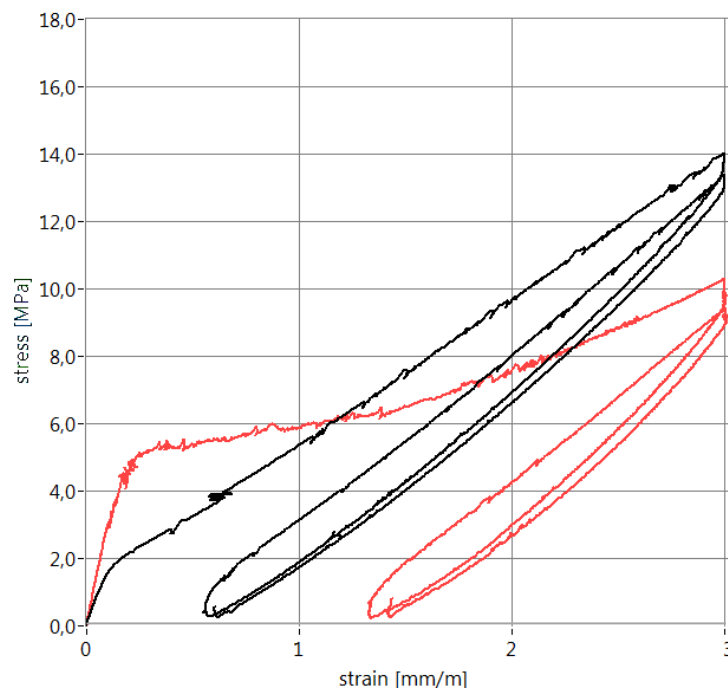
Figure 3.25 : Stress-strain curve of C3WD142-2C3WD142.

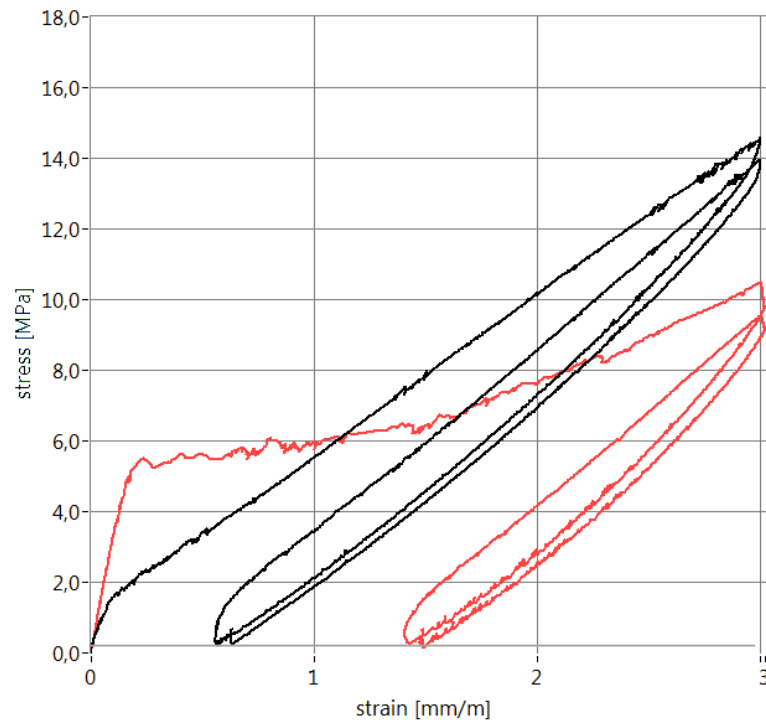
Figure 3.26 : Stress-strain curve of **SAPWD121-2SAPWD121**.

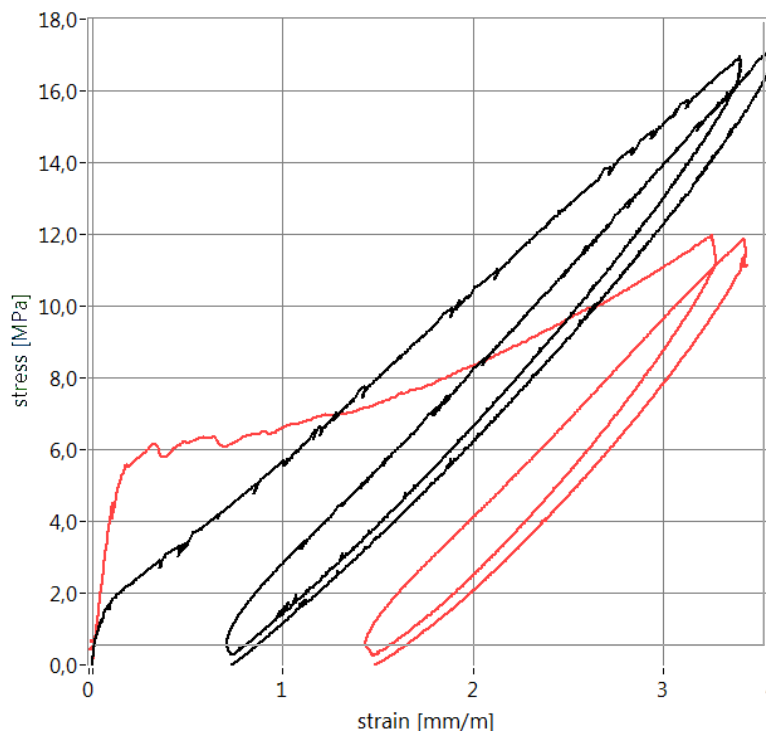
Figure 3.27 : Stress-strain curve of **SAPWD141-2SAPWD141**.

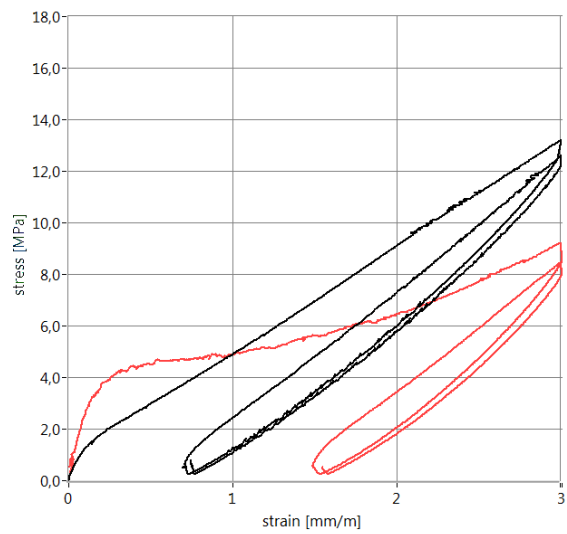
Figure 3.30 : Stress-strain curve of **C3WD221-2C3WD221**.

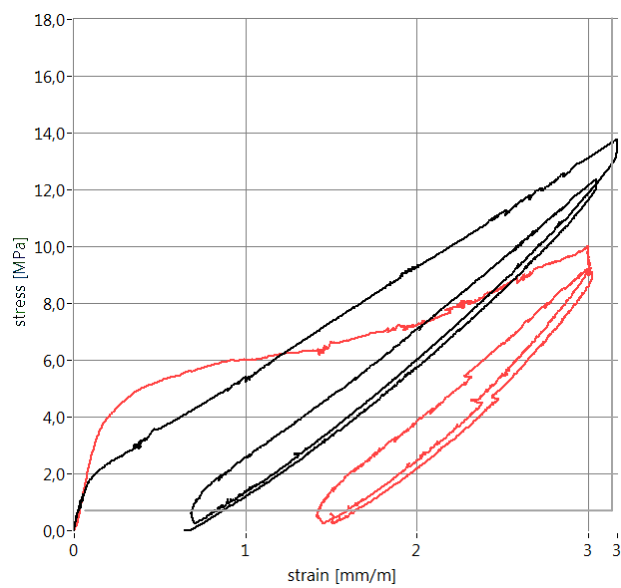
Figure 3.31 : Stress-strain curve of C3WD243-2C3WD243.

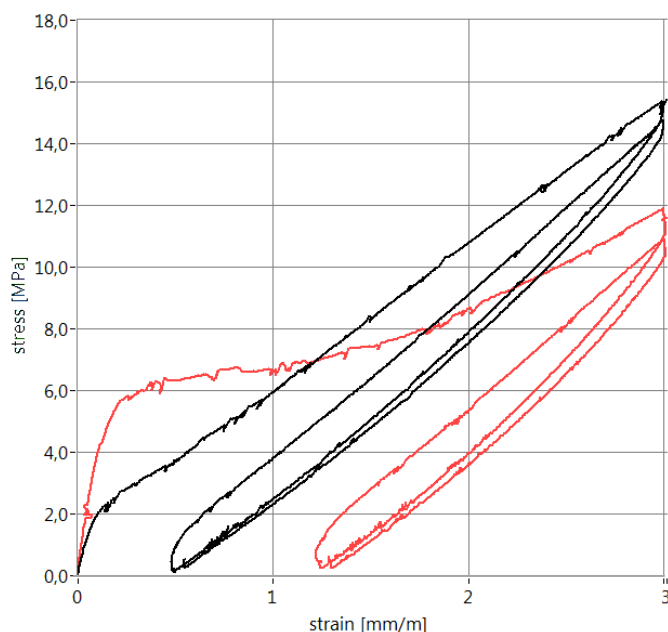
Figure 3.33 : Stress-strain curve of **SAPWD243-2SAPWD243**.

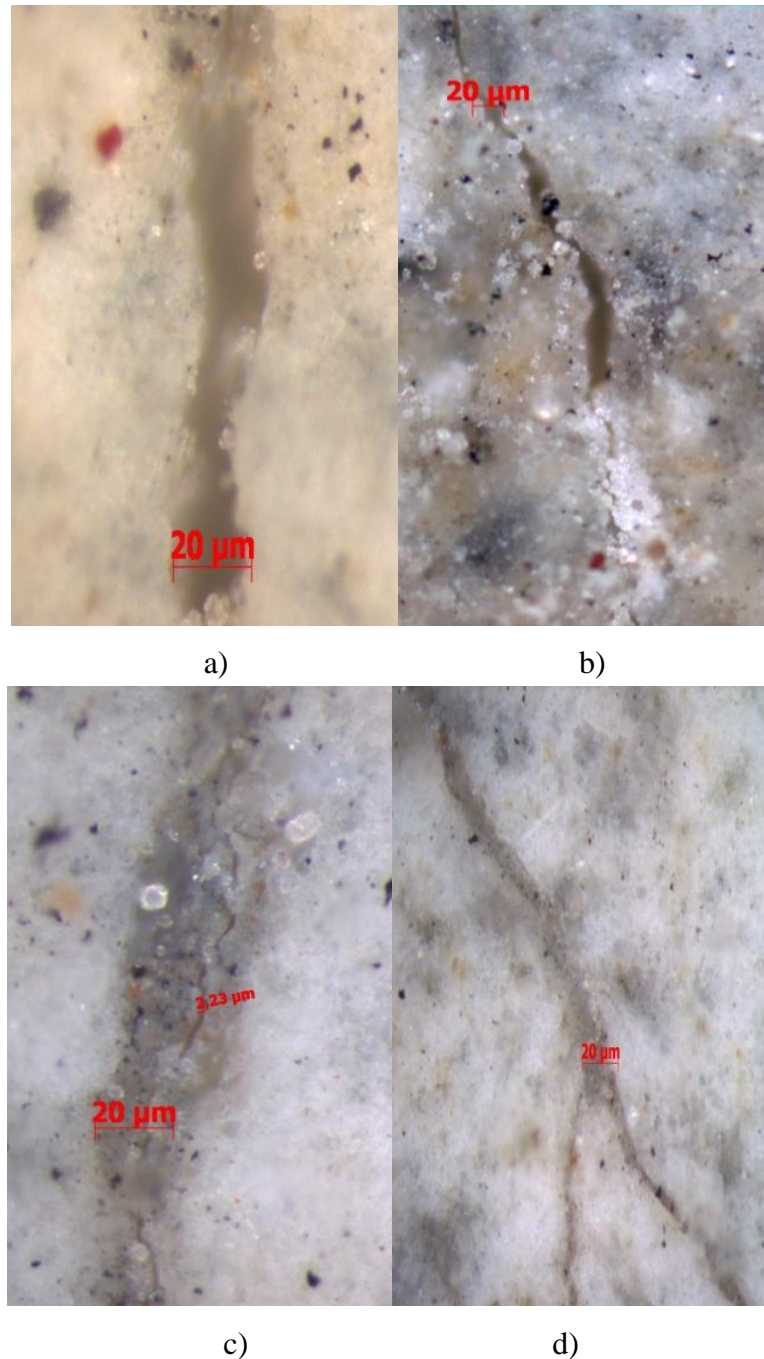
Figure 3.34 : Optical microscope photos of a) C1A, b) C1W, c) C1WD1 and d) C1WD2 specimens.

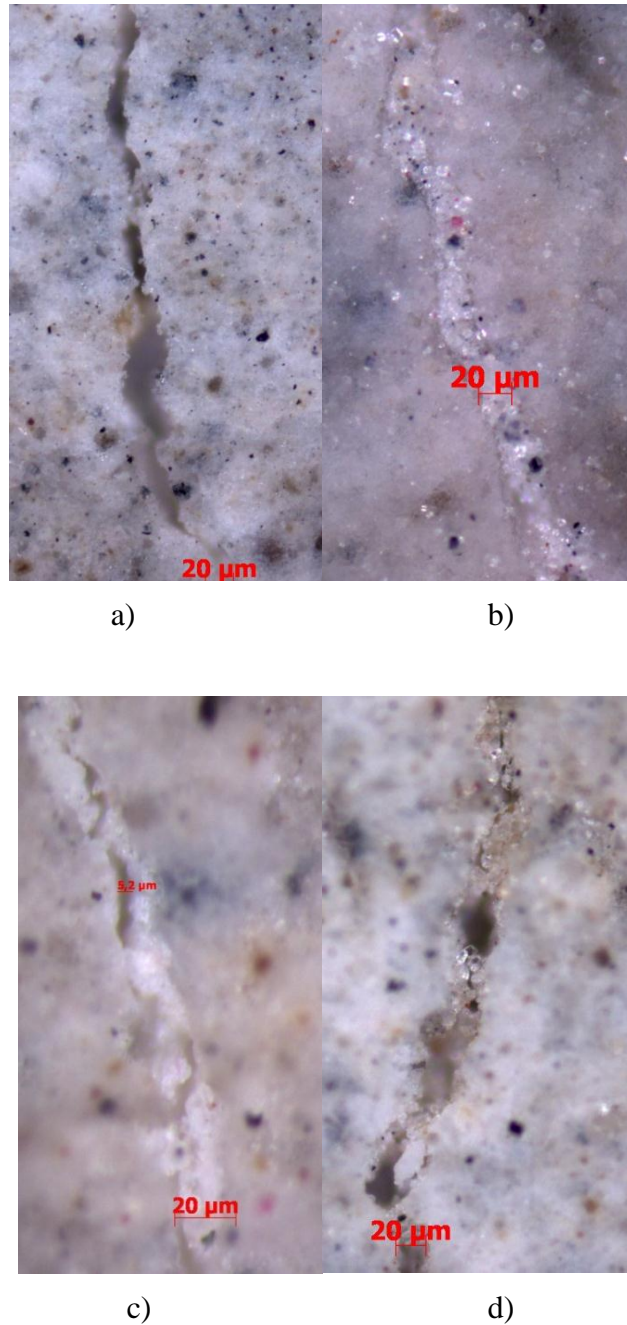
Figure 3.38 : Optical microscope photos of a) C3A, b) C3W, c) C3WD1 ve d) C3WD2 specimens.

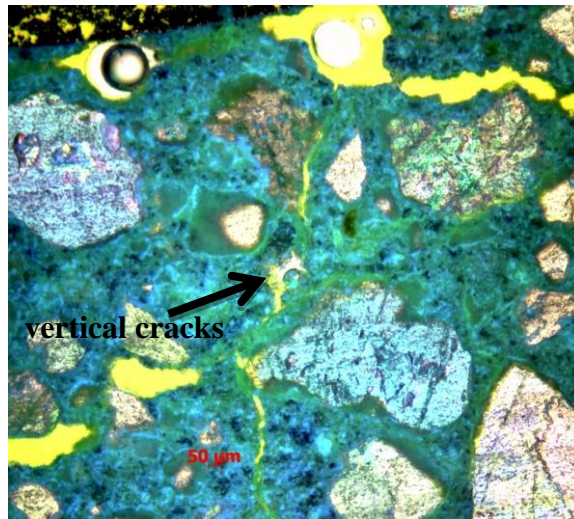
Figure 3.40 : The optical microscope photo of CEM I reference (pre-cracked and no cured) specimen.

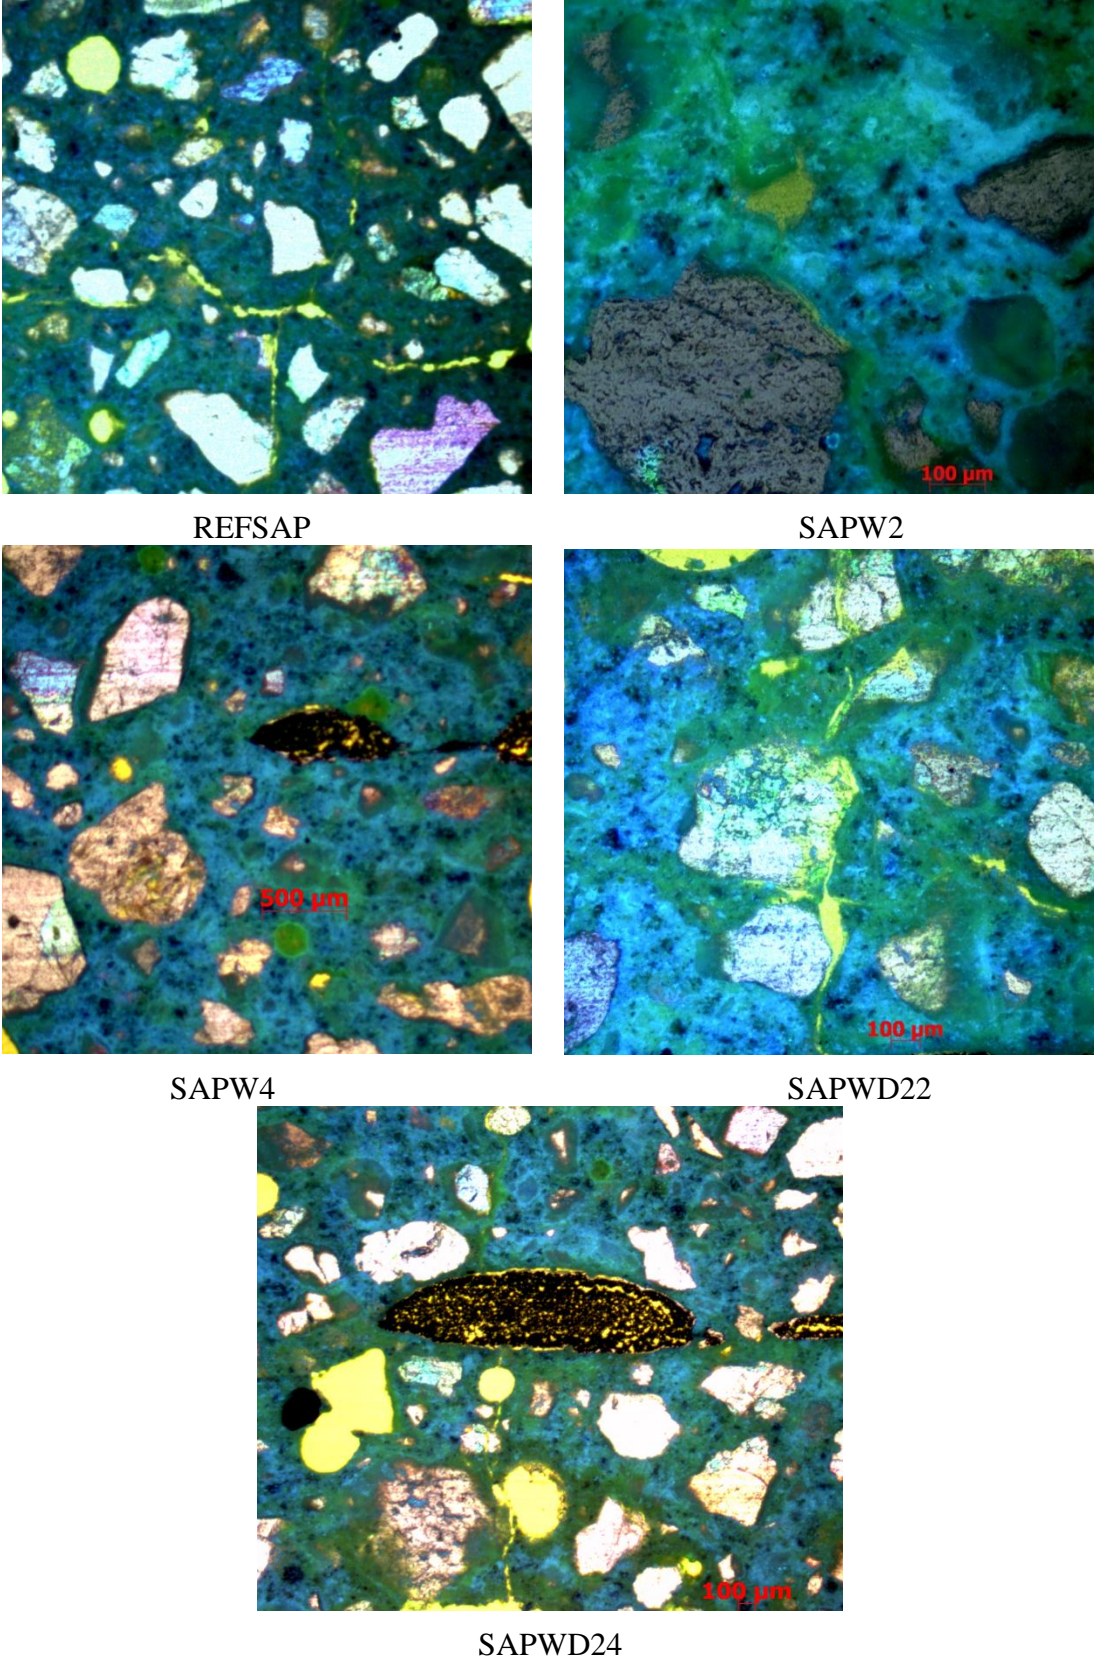
Figure 3.45 : The optical microscope photos of SAP group specimens after various exposures.

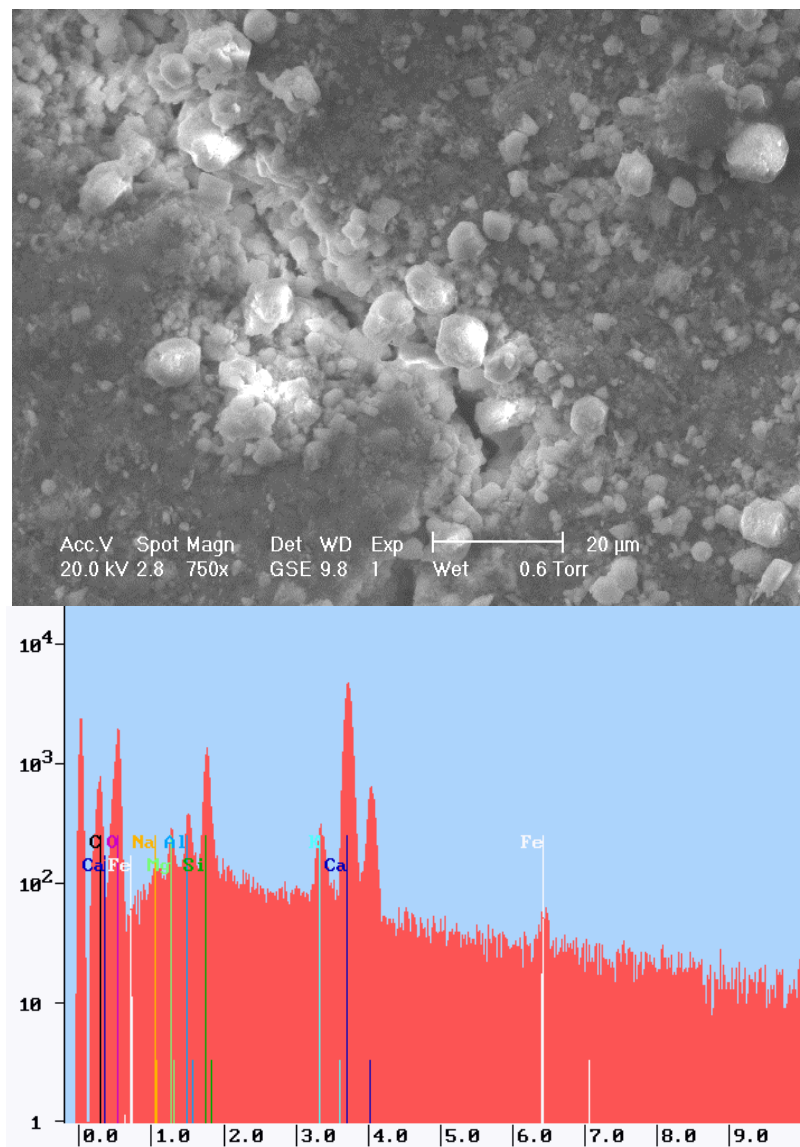
Figure 3.46 : SEM picture of a crack and EDX analysis of the specimen C1W4.

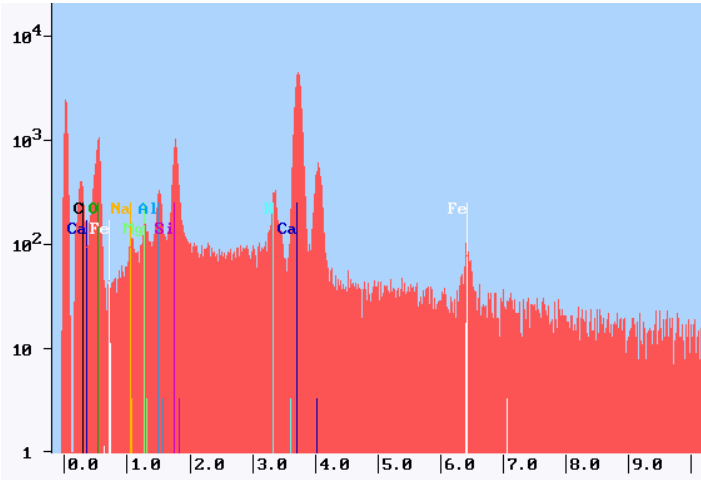
Figure 3.47 : EDX analysis of the specimen C1WD14.

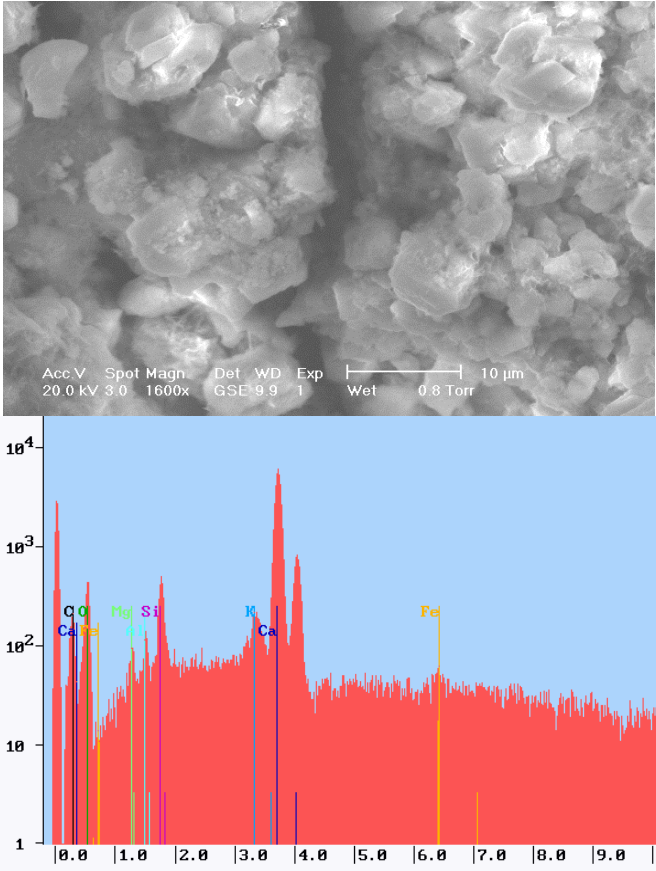
Figure 3.48 : SEM picture of a crack and EDX analysis of the specimen C3W4.

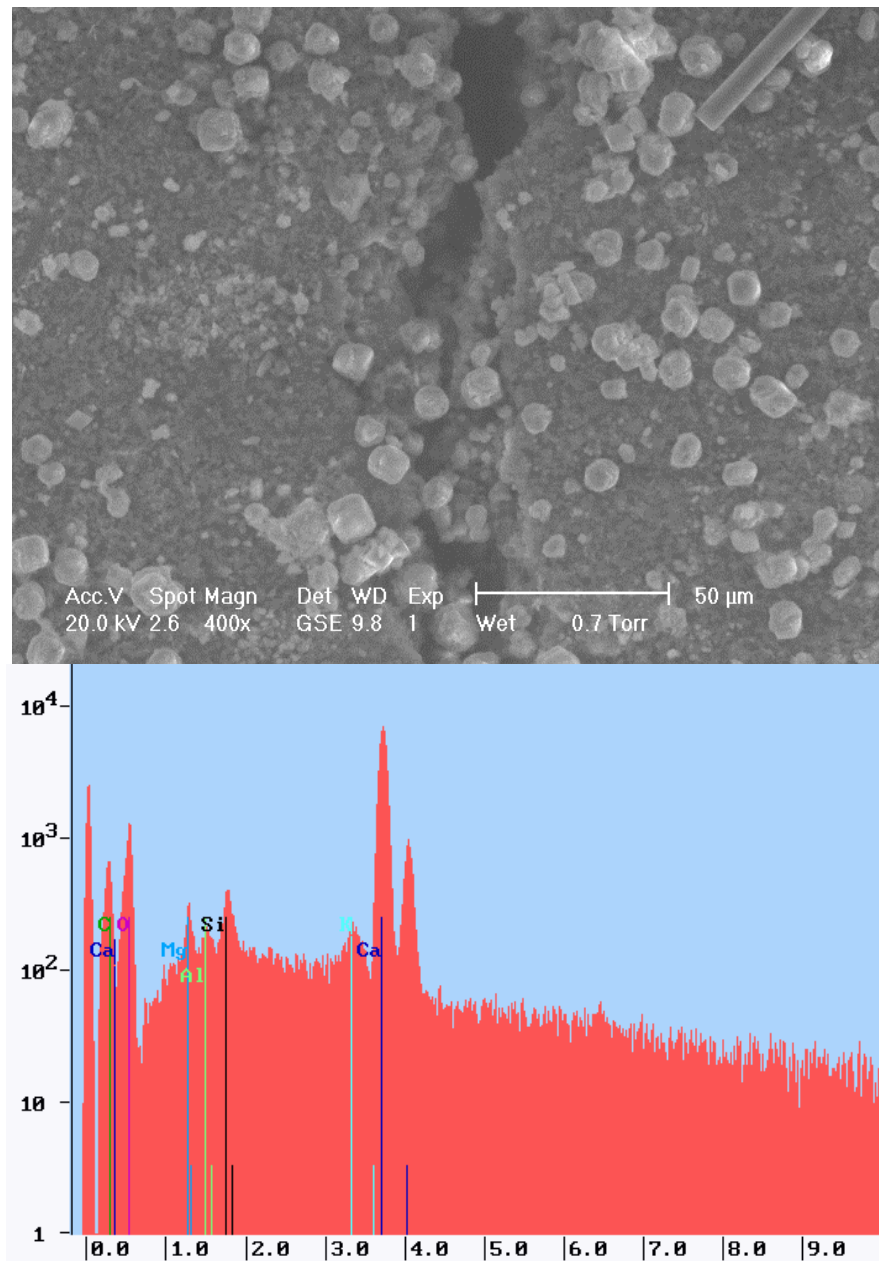
Figure 3.49 : SEM picture of a crack and EDX analysis of the specimen SAPW4.

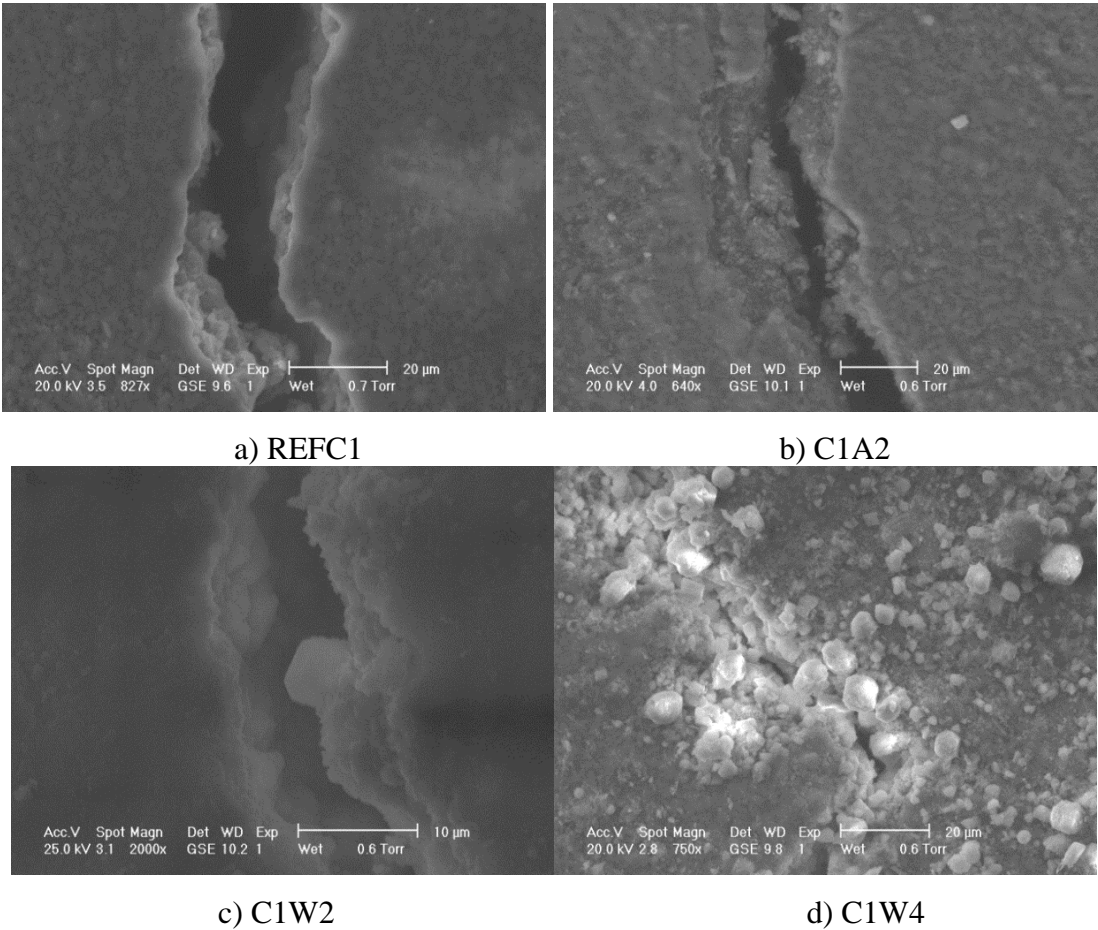
Figure 3.50 : SEM pictures of CEM I group specimens.

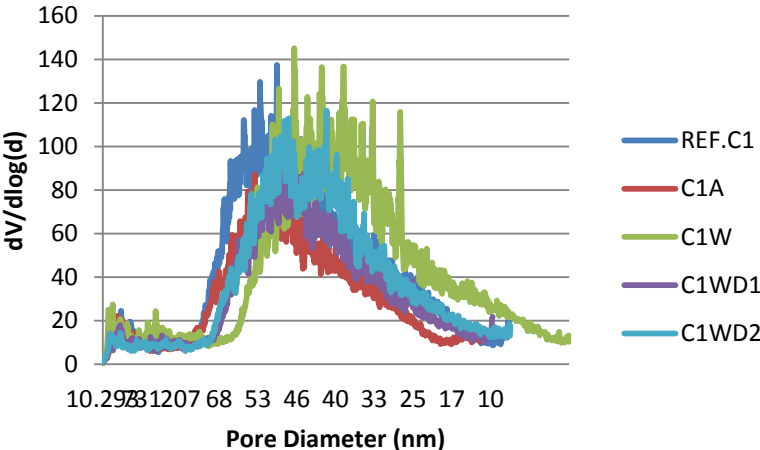
Figure 3.53 : Total pore size distribution of C1 group specimens.

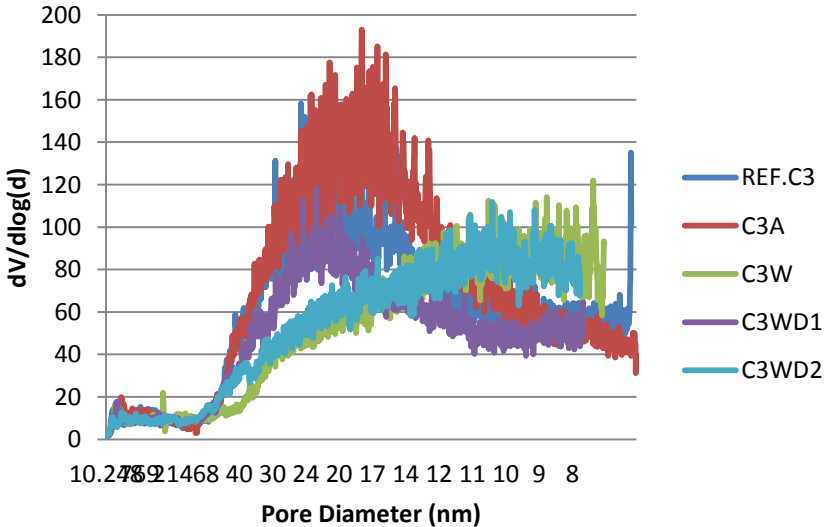
Figure 3.54 : Total pore size distribution of C3 group specimens.

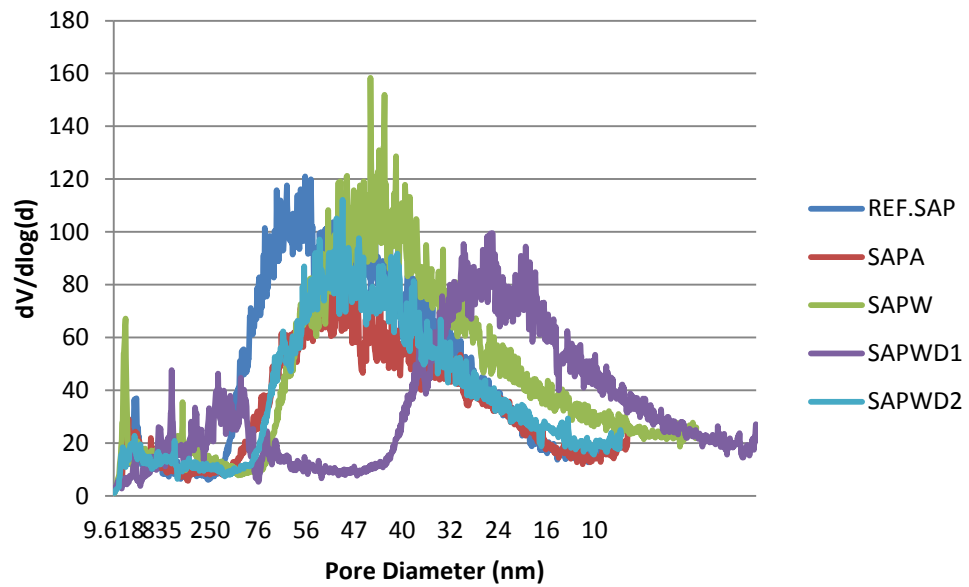
Figure 3.55 : Total pore size distribution of SAP group specimens.
