**REHABILITATION OF CORROSION DAMAGED SUBSTANDARD RC
COLUMNS WITH USING FRP**

M.Sc. THESIS

Aras KALYONCUOĞLU

Thesis Advisor: Prof. Dr. Alper İLKI

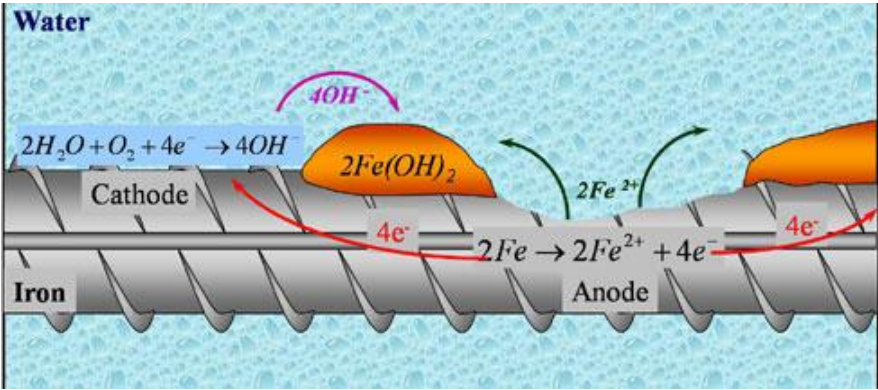
Figure 2.1 : Corrosion process on reinforced concrete steel bar (URL-1).

Electrochemical process of the corrosion is shown in Figure 2.1.

The increases in volume as the reaction products react further with dissolved oxygen leads to internal stress within the concrete that may be sufficient to cause cracking and spalling of the concrete cover.

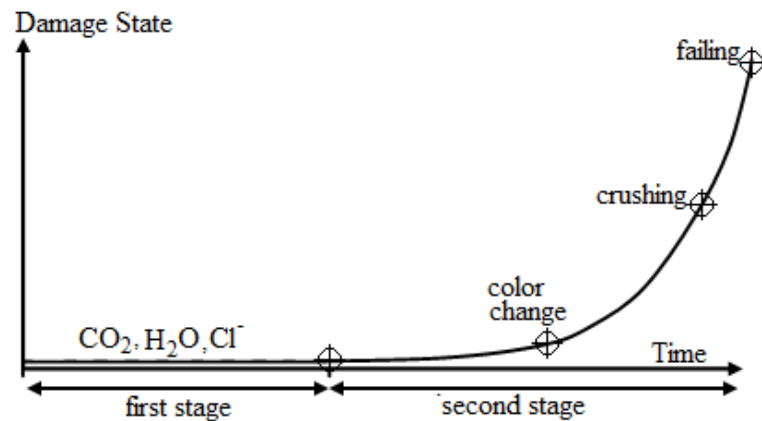
Figure 2.2 : Stage of corrosion on reinforced concrete with rusting (Gulikers, 2005).

Stage of corrosion in reinforced concrete with rust products are shown in Figure 2.2. As seen from the figure firstly uncorroded materials were exposed to CO₂, H₂O and Cl. After a time of exposure, concrete starts to change its color. After a time it starts to crushing and at last it fails.

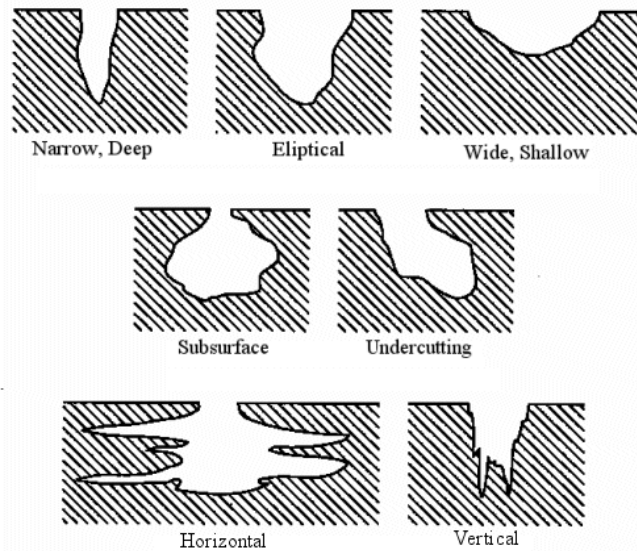
Figure 2.3 : Standard visual chart for rating of pitting corrosion due to ASTM-G46.

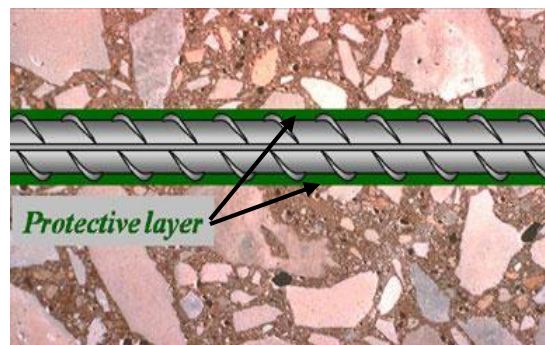
Although steel has a natural protector for corrosion reactions. The alkaline environment of concrete provides steel to corrosion protection (shown in Figure 2.4). At the high pH, a thin oxide layer forms on the steel and prevents metal atoms from dissolving. This passive film does not actually stop corrosion; it reduces the corrosion rate to an insignificant level. For steel in concrete, the passive corrosion rate is typically $0.1\mu\text{m}$ per year. Without the passive film, the steel would corrode at rates at least 1,000 times higher (ACI222, 2001).

Figure 2.4 : Illustration of corrosion protector layer of steel (URL-1).

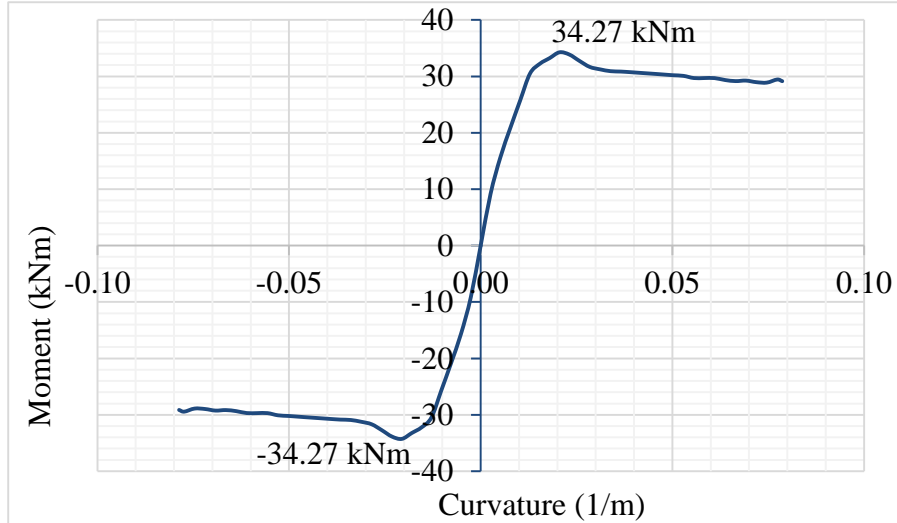
The cyclic behavior of the columns was dominated by flexure damage. The average moment capacities of the columns were calculated as 34.2 kNm (Figure 4.1) by XTRACT(2007) computer program. For the moment-curvature analysis, the models proposed by Mander et al (1988) are used for unconfined and confined concrete stress-strain behavior. Steel reinforcing bars are assumed to behave in an elastic-plastic manner with strain hardening. Concrete and steel material models of reinforced concrete section is shown in Figure 4.2.

Figure 4.1: Theoretical moment-curvature relationships of the reference column.

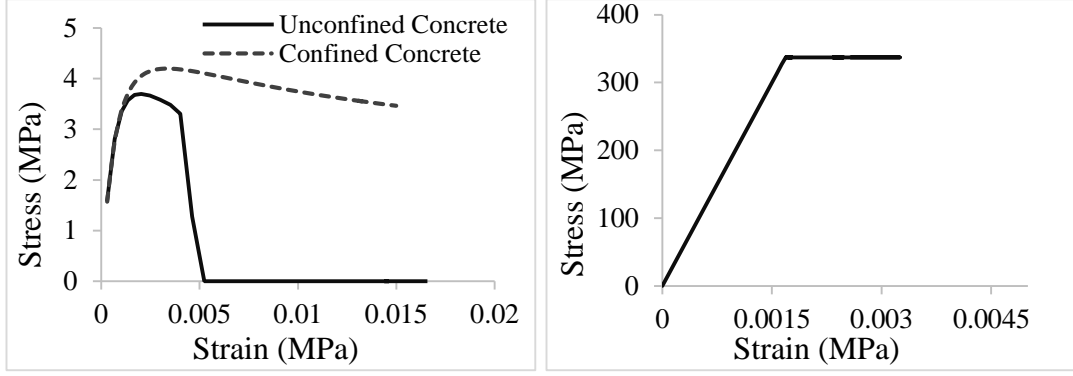
Figure 4.2: Concrete and steel material models of reinforced concrete section of reference column.

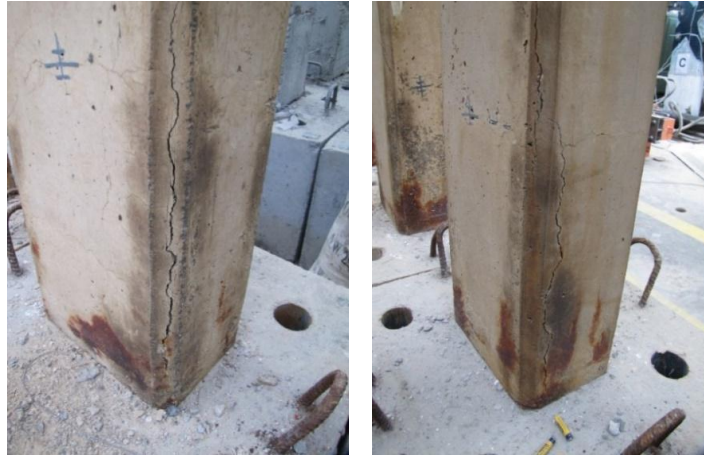
Figure 4.3: Photos of the cracked sections on specimens.

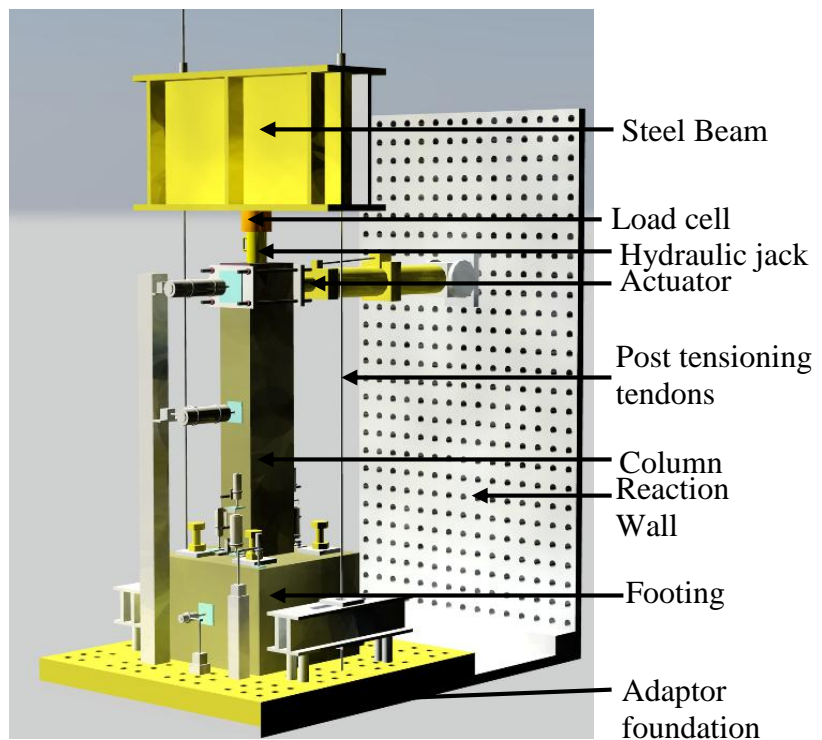
Figure 4.6: Test Setup.

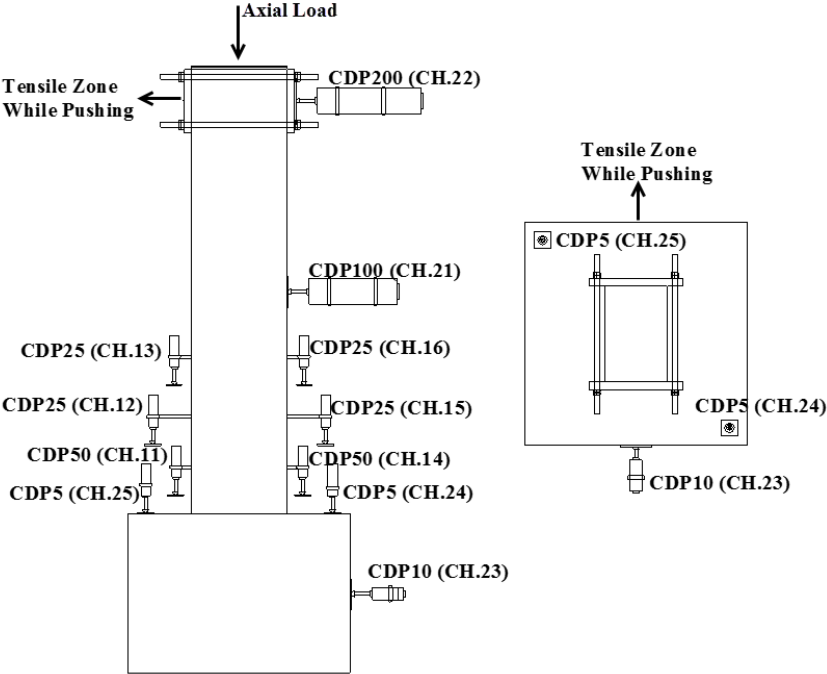
One of the most important thing in the experimental studies are installing the measuring system. Therefore, LVDTs were used to estimate the column displacements during the test. The LVDT or Linear Variable Differential Transformer is a well established transducer design which has been used throughout many decades for the accurate measurement of displacement and within closed loops for the control of positioning. Six LVDTs were placed parallel to the column bottom up in 20 mm, 150 mm and 300 mm evaluate curvature values of the specimens. Two of six were CDP50 which have 50 mm gage length and rest of the LVDTs were CDP25 which have 25 mm gage length. For the lateral displacement of the column, a reference LVDTs which was SDP200 (200 mm gage length) were placed to tip of the column length and another one which was CDP100 (100 mm gage length) were placed to mid of the column length. Two LVDTs which were CDP5 (5 mm gage length) were placed on the footing for measuring the rotations and another LVDTs which was CDP10 were placed horizontally at the midpoint of the footing for measuring the possible footing displacements. The locations of the LVDTs are shown in Figure 4.7.

Figure 4.7: Locations of the LVDTs.

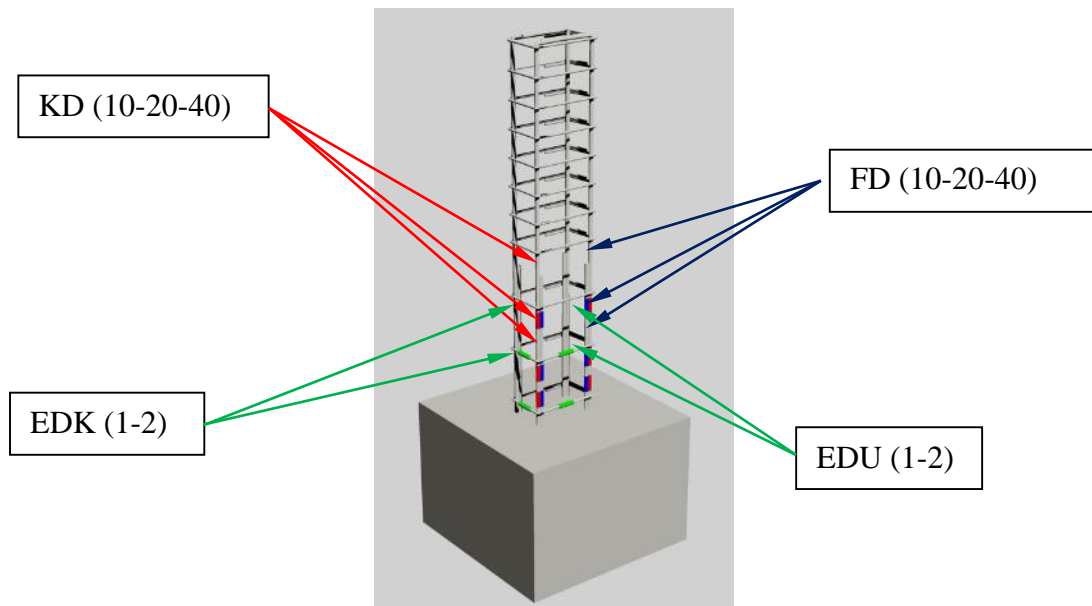
Before attaching the strain-gauges, the place where the strain-gauge attaches was cleaned with coarse and sharp corundum. Strain-gauges were glued to totally cleaned places on bars with a glue that includes cyanoacrylate. After adhering the strain gauges, those were wrapped with the N-1 waterproof material and VM Tape for the humidity and other external factors. Notes and numbers were written on the cables for understanding which strain-gauge was where. All strain-gauges were tied in bunches and were taken off from the nearest point on concrete.

Figure 4.8: Strain-Gauge locations.

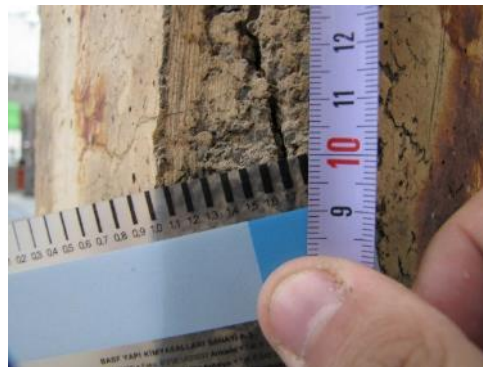
Before any process on the specimens, all cracks measured with a crack measuring card from three different part of the specimens. Most of the corrosion damage and section lose were occurred on the foundation, column joint section at the specimens. For this reason first part was 0-15 cm section of the column specimens for determine how much crack width occur cause of the corrosion lose. Second part was 15-60 cm and it shows the lap-splice area. And the last one shows the least corroded place. Crack measuring for 0-15 cm section is shown in Figure 5.1.

Figure 5.1 : Crack measuring of the specimen.

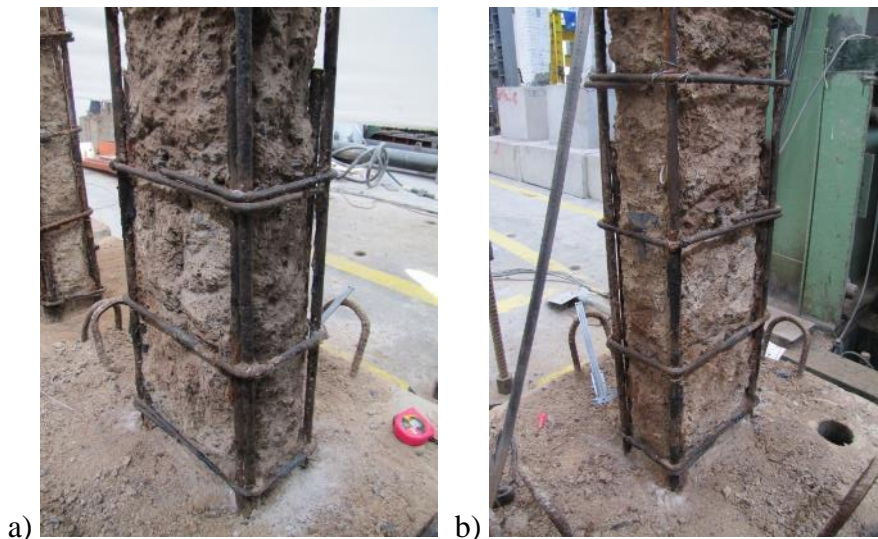
Since generally the cover concrete is weak and deteriorated due to corrosion of internal reinforcing bars in case of sub-standard existing RC structures built with low quality concrete, the process of removing of concrete cover does not require a significant effort. When concrete cover cleaned, longitudinal and transverse bars were cleaned also by using metal brush. Cover concrete cleaned specimen is shown in Figure 5.2.

Figure 5.2 : Concrete cover cleaned specimen.

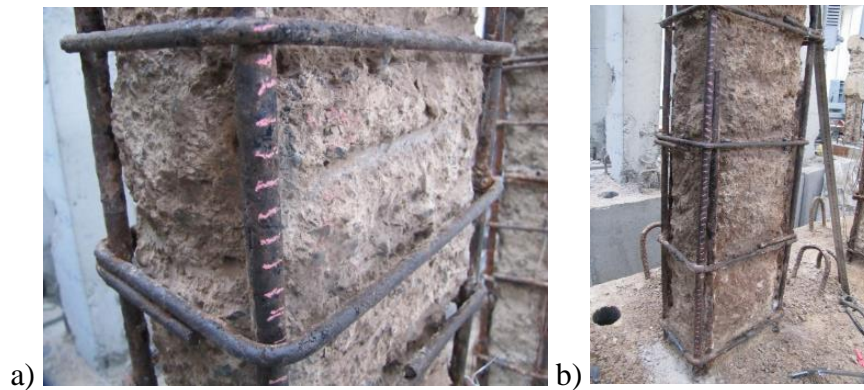
existing cross-sectional area after corrosion was determined by dividing the bottommost 300 mm part of four longitudinal bars of each specimen into 10 mm long pieces, and averaging or taking the minimum diameters of each 10 mm long piece both in 0° and 90° directions after mechanical cleaning of the rust on reinforcing bars. The difference in determining the cross-sectional losses of reinforcing bars for specimens was due to different failure modes of the specimens. Minimum cross-section is taken into consideration for X47-M-CFRP1, X43-M-CFRP2 and X44-M-CFRP3 due to their failure mode were rupture of the starter bars, while average cross-section is consider for other specimens.

Figure 5.3 : Marked bars for measuring on specimens.

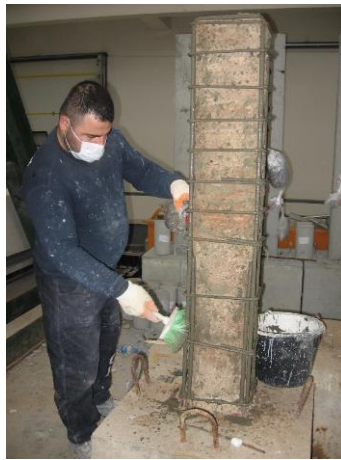
In previous part the concrete cover was cleaned mechanically. Steel reinforcement surfaces was cleaned from any concrete traces and rust of the corrosion products. After cleaning process reinforcement of the specimens were covered with a corrosion inhibitor material Masterseal 300T. This material prevents is an anti-corrosion coating and primer which is protect the reinforcement from corrosion. Applying of corrosion inhibitor material is shown in Figure 5.4.

Figure 5.4 : Specimens were covered with a corrosion inhibitor material.

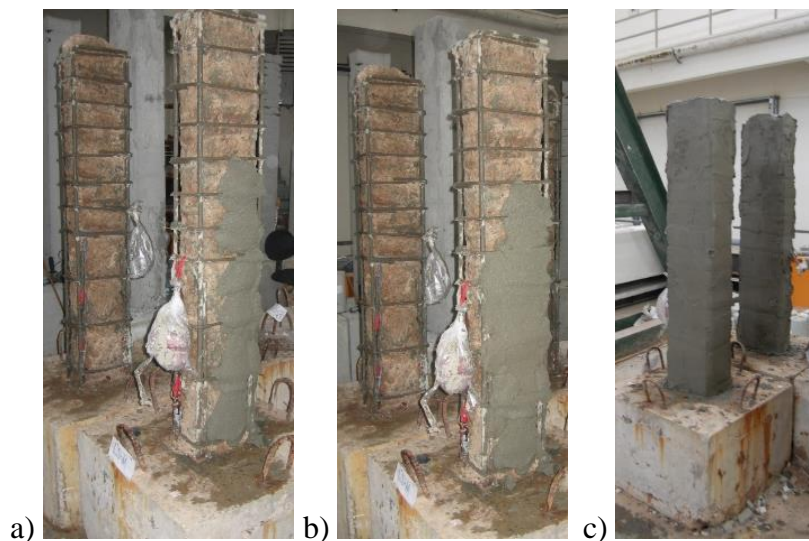
After the corrosion inhibitor dried, specimens strengthened with EMACO S88 repair mortar with no gap around columns. Strengthening process of the specimens is shown step by step in Figure 5.5

Figure 5.5 : Rehabilitation process of the specimens with repair mortar.

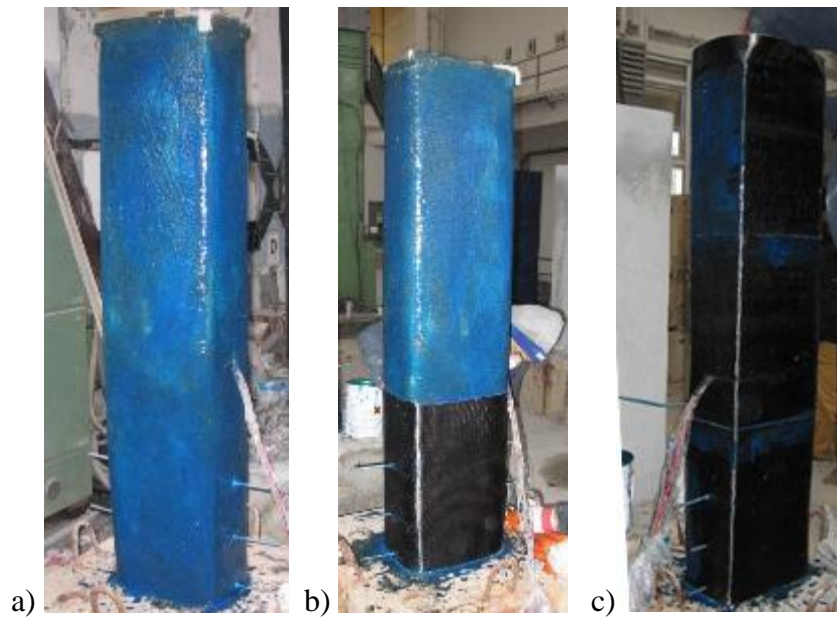
As a final step for specimens which will be retrofitted by carbon fiber reinforced polymer sheets, were wrapped around the specimen externally one, two and three times in transverse direction with 150 mm overlap at the end of the wrap to enhance the deformability and to avoid potential shear failure due to increased flexural strength. Retrofitting process of the specimens with CFRP is shown step by step in Figure 5.6. Other functions of CFRP sheets wrapped around the members in transverse direction were to contribute to the bond between the core concrete and repair mortar, and to contribute to prevention of buckling of internal steel. It should be noted that, all retrofit application was carried out within the thickness of the original concrete cover.

Figure 5.6 : Retrofitting process of the specimens.

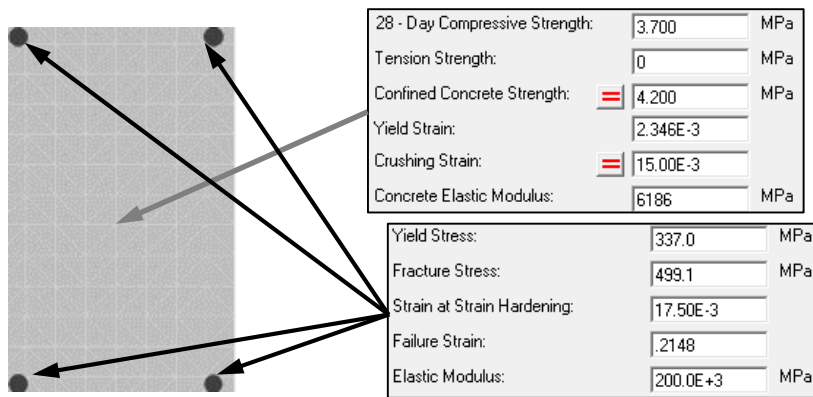
Theoretical predictions of X26-REF2 and X26-M were calculated by using method which proposed by Mander et al. while X-47-CFRP1, X-43-CFRP2 and X-44-CFRP3 were calculated by using Mander et al. after unconfined part of the section had calculated according to method suggested by A.İlki et al. for the CFRP strengthened beams. Diameter of bars were taken from Table 5.2. Then the section was modelled as given in Figure 6.1 for X26-REF2. Contribution of cracked cover concrete of X26-REF2 was disregarded in calculations. Moment – curvature diagram for X26-REF2 was given in Figure 6.2.

Figure 6.1 : Theoretical section and material properties of X26-REF2 specimen.

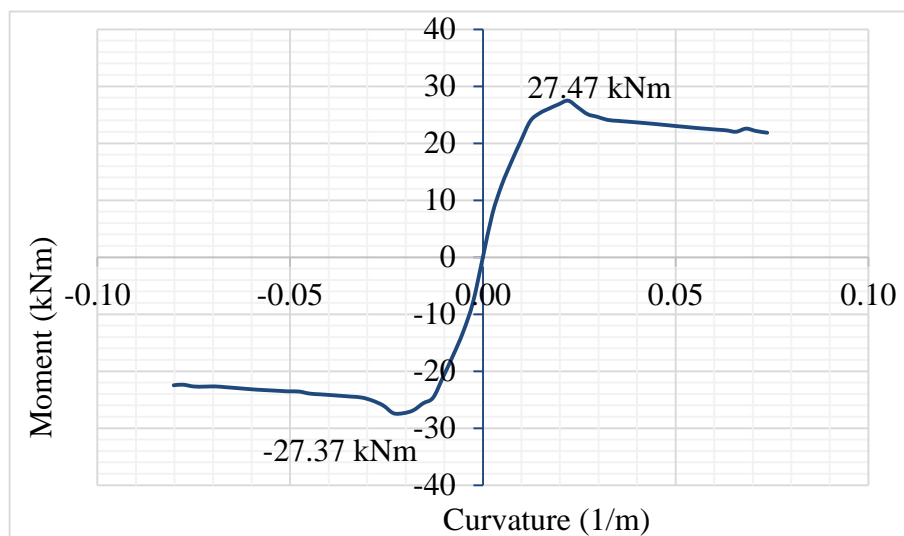
Figure 6.2 : Theoretical Moment – Curvature Diagram of X26-REF2 specimen.

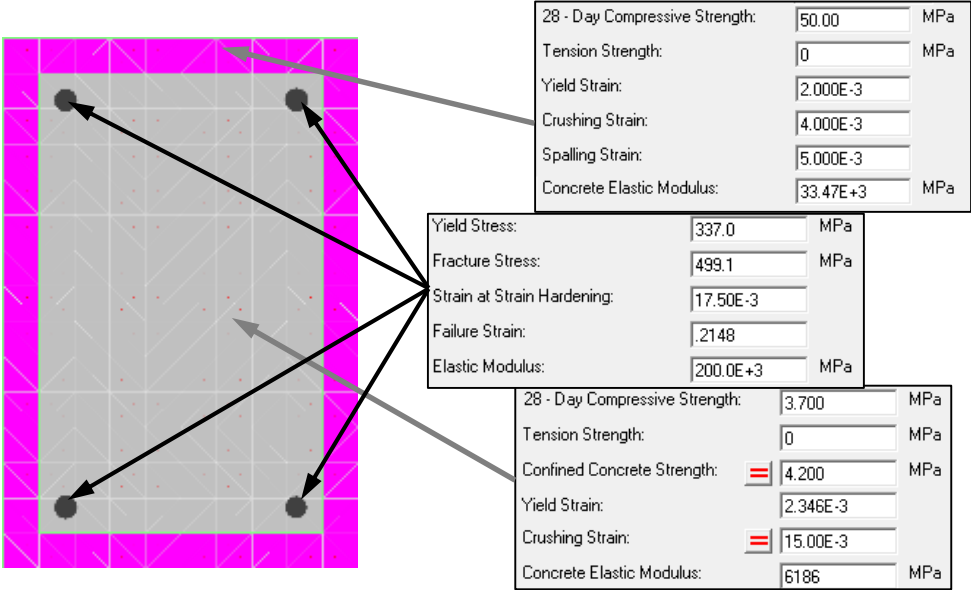
The section was modelled as given in Figure 6.3 for X26-M. Properties of unconfined concrete were taken from manufacturer firm of EMACO S88. Moment – curvature diagram for X26-M was given in Figure 6.4.

Figure 6.3 : Theoretical section and material properties of X26-M specimen.

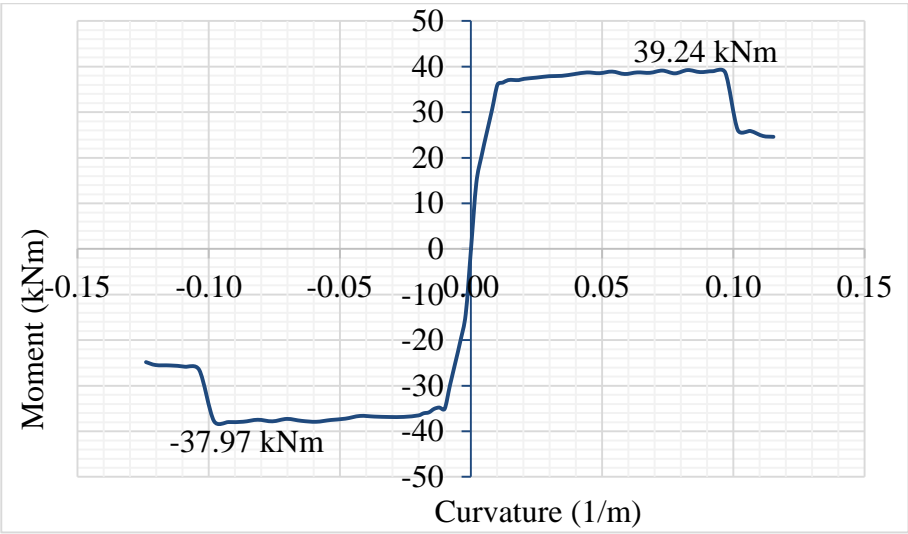
Figure 6.4 : Theoretical Moment – Curvature Diagram of X26-M specimen.

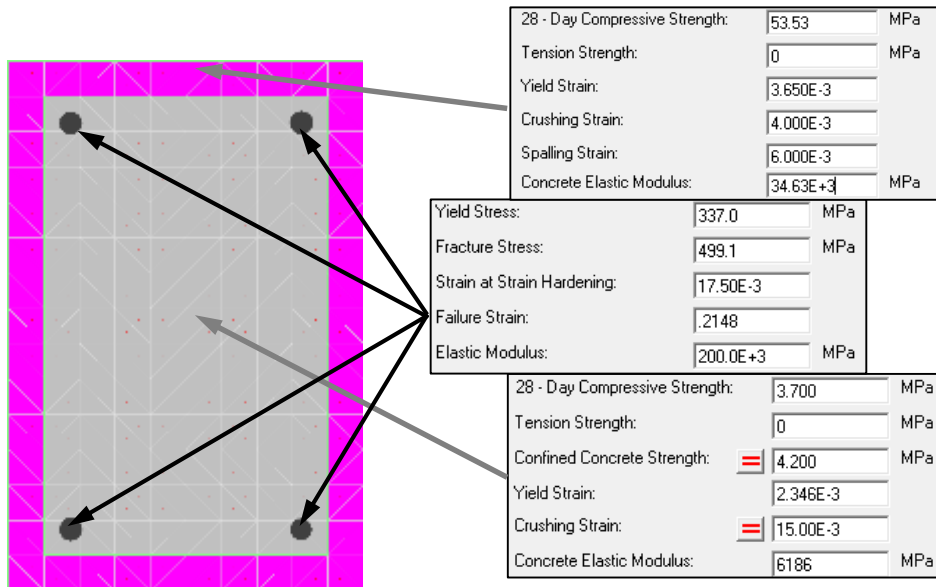
Then cross-section of specimen X47-M-CFRP1 was modelled in XTRACT as given in Figure 6.5. Moment – curvature diagram for X47-M-CFRP1 was given in Figure 6.6.

Figure 6.5 : Theoretical section and material properties of X47-M-CFRP1 specimen.

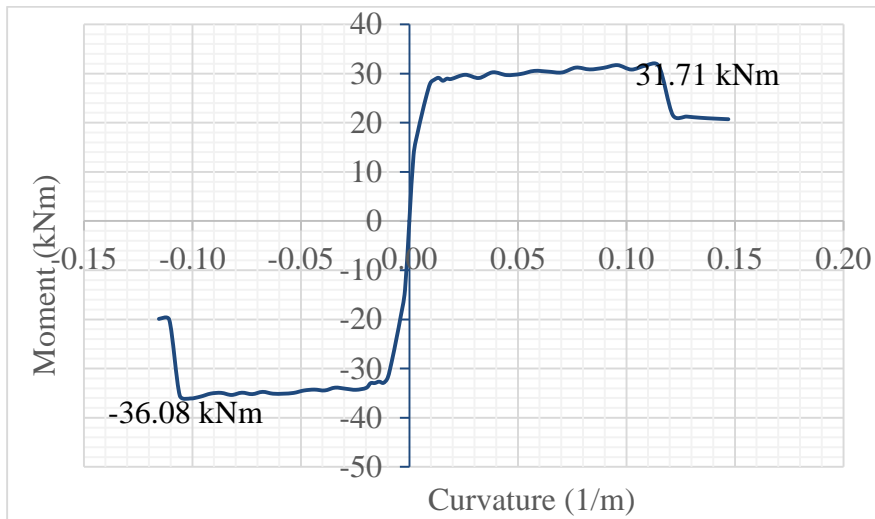
Figure 6.6 : Theoretical Moment – Curvature Diagram of X47-M-CFRP1 specimen.

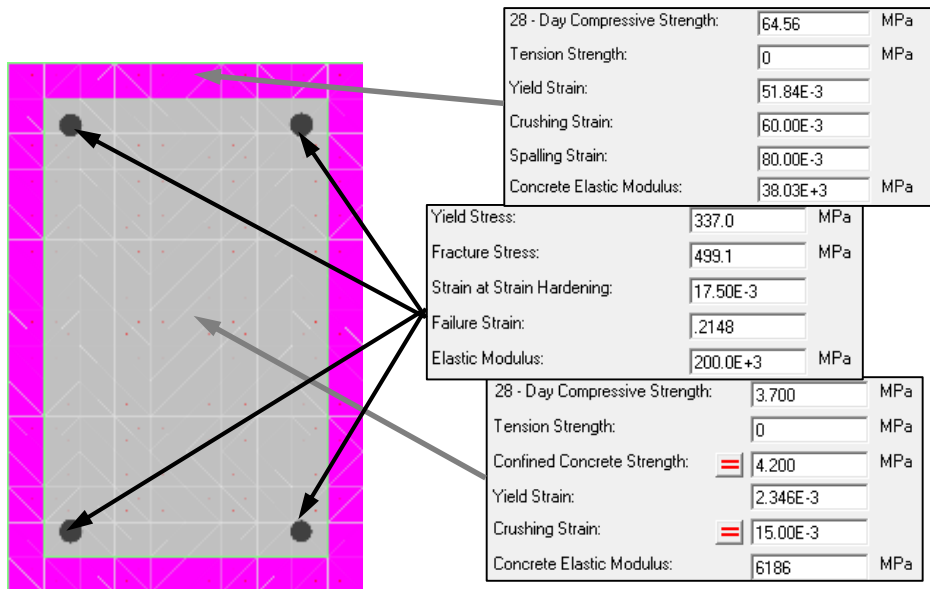
Then cross-section of specimen X43-M-CFRP2 was modelled in XTRACT as given in Figure 6.7. Moment – curvature diagram for X43-M-CFRP2 was given in Figure 6.8.

Figure 6.7 : Theoretical section and material properties of X47-M-CFRP2 specimen.

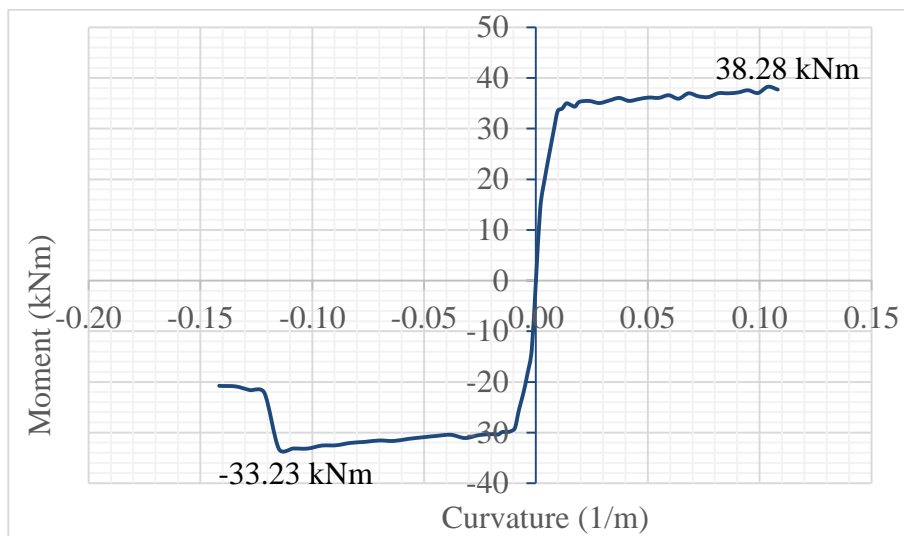
Figure 6.8 : Theoretical Moment – Curvature Diagram of X43-M-CFRP2 specimen.

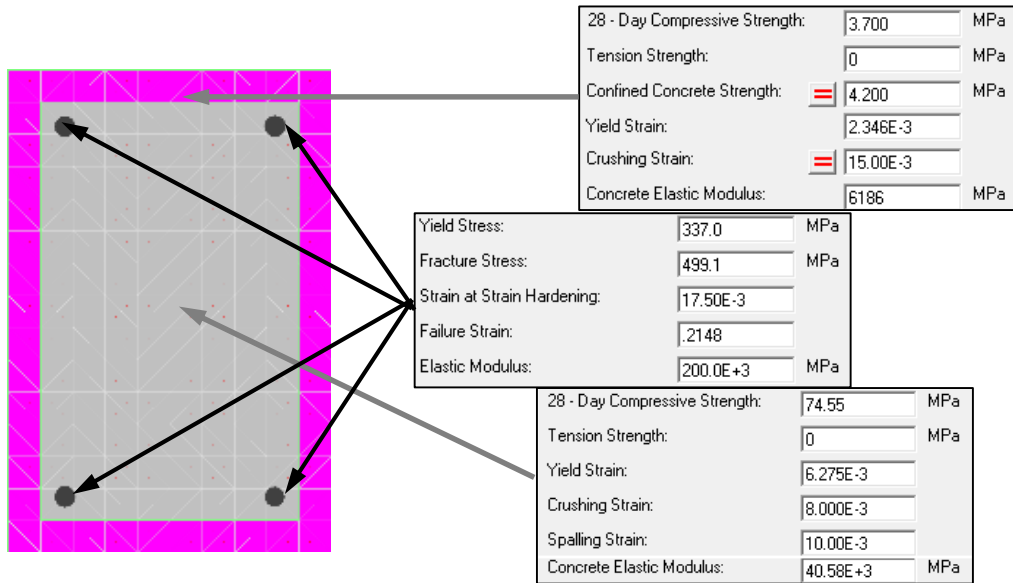
Then cross-section of specimen X44-M-CFRP3 was modelled in XTRACT as given in Figure 6.9. Moment – curvature diagram for X44-M-CFRP3 was given in Figure 6.10.

Figure 6.9 : Theoretical section and material properties of X44-M-CFRP3 specimen.

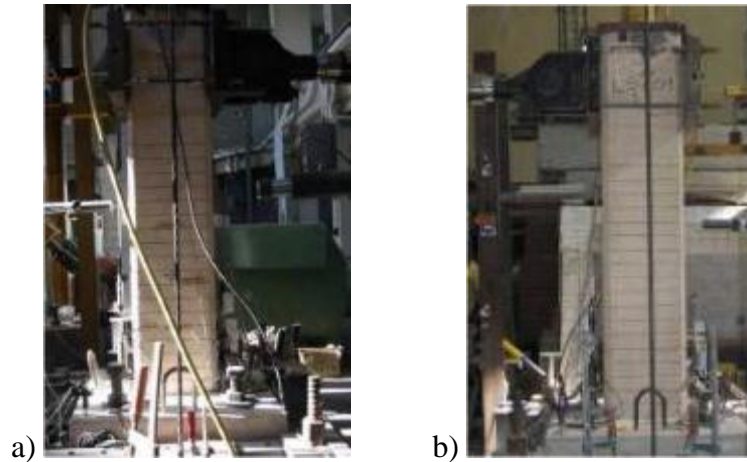
No cracks were observed while loading to target displacements of ± 1.2 mm (drift ratio 0.10%) and ± 3 mm (drift ratio 0.25%). First flexural crack was observed at the interface of the column and footing during loading to target displacement of 6 mm (drift ratio 0.5%). The view of the specimen X0-REF1 after 0.50% drift ratio is shown in Figure 7.1.

Figure 7.1 : a) North, and b) South view of the X0-REF1 specimen after -0.50% drift ratio. (Goksu, 2012)

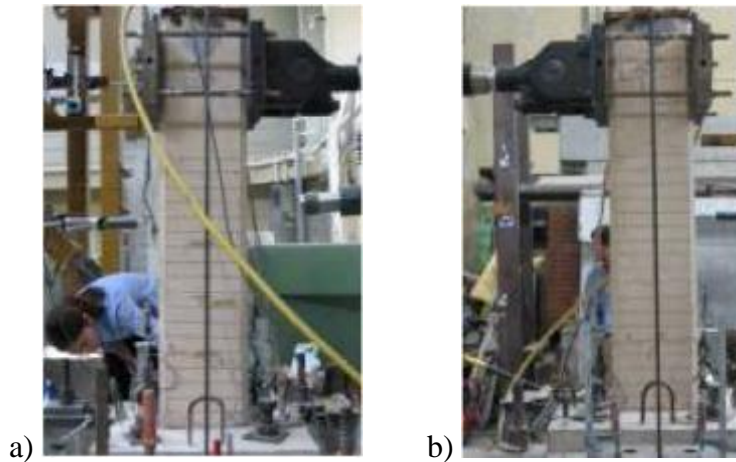
Second flexural crack was observed 250 mm above the footing during loading to target displacement of 12 mm (drift ratio 1.00%). The view of the specimen X0-REF1 after -1.50% drift ratio is shown in Figure 7.2.

Figure 7.2 : a) North, and b) South view of the X0-REF1 specimen after -1.50% drift ratio (Goksu, 2012).

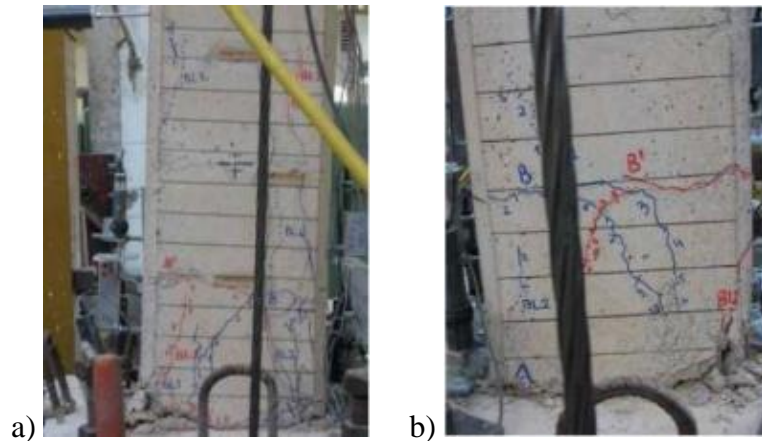
Figure 7.4 : a) North, and b) South view of the X0-REF1 specimen after -5.00% drift ratio (Goksu, 2012).

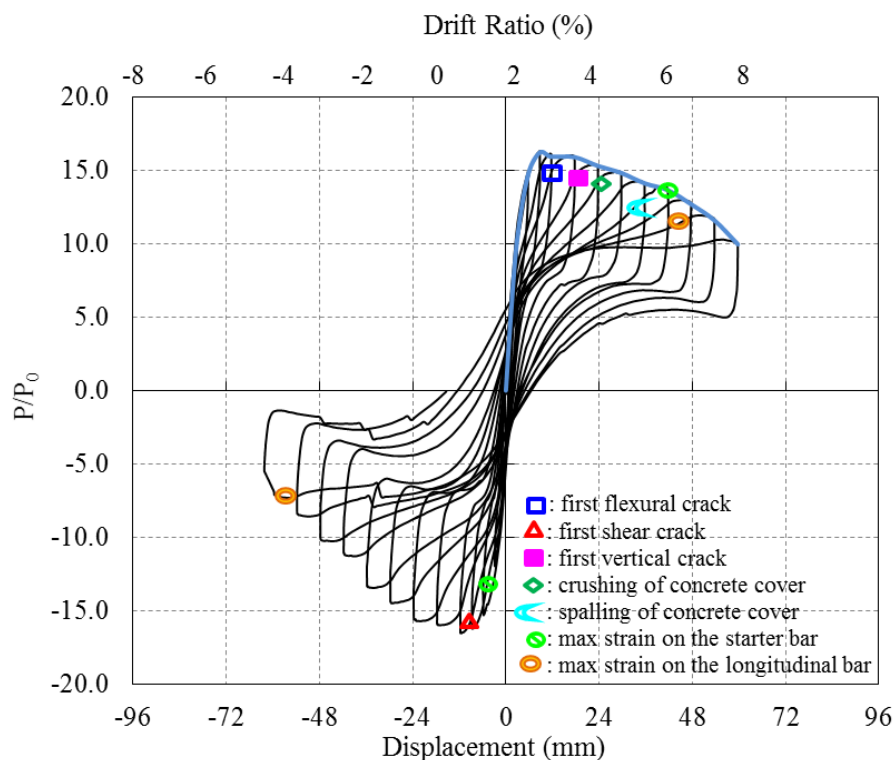
Figure 7.5 : Lateral load/Theoretical load capacity capacity versus displacement for X0-REF1 (Goksu, 2012).

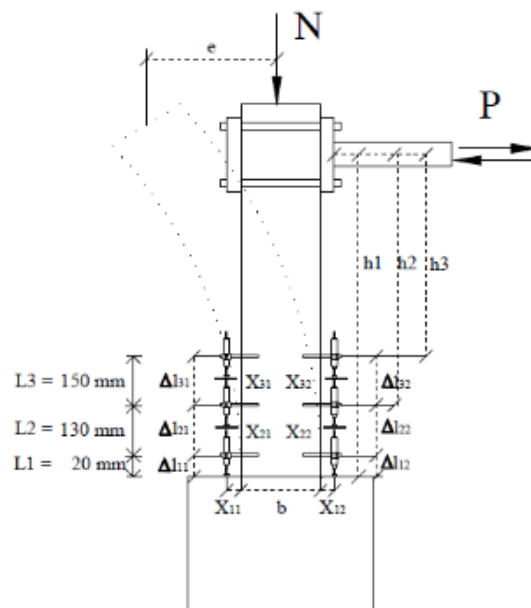
Figure 7.6 : Test setup with measurement system used in obtaining moment-curvature relationship (Goksu, 2012).

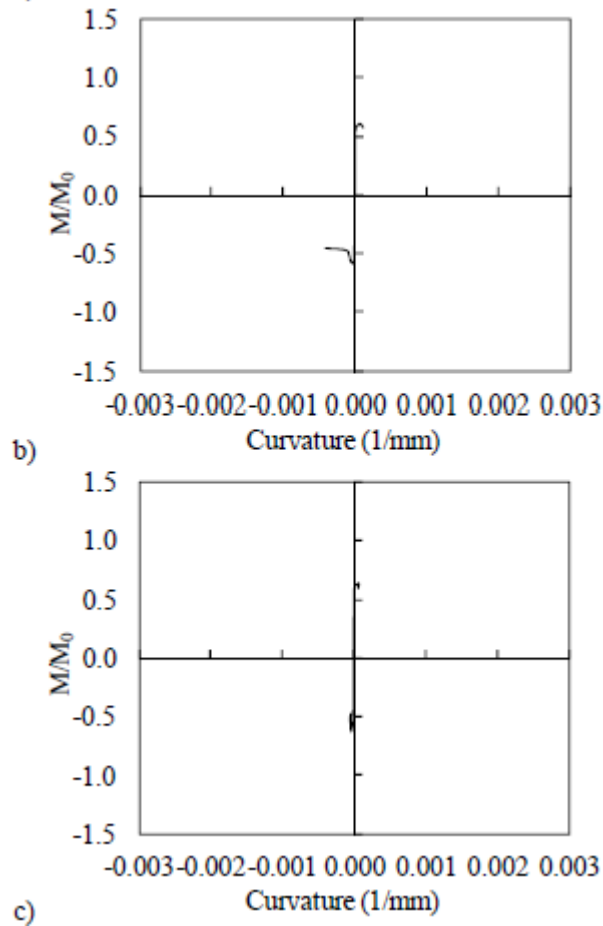
Figure 7.7 : Moment-curvature relationships obtained for a) 0-20 mm, b) 20-150 mm, c) 150-300 mm gauge lengths (Goksu, 2012).

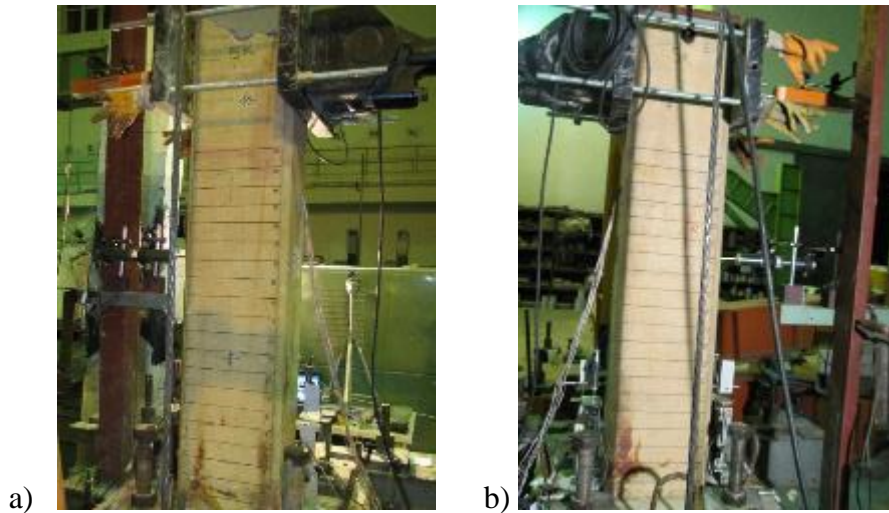
No cracks were observed while loading to target displacements of ± 3 mm (0.25% drift ratio), after ± 3 mm (0.25% drift ratio) target displacement, some vertical cracks were observed. First flexural cracks was observed at both sides of the specimen (A-north, A-south) with 0.1 mm width during loading to target displacement ± 6 mm (0.50% drift ratio). The view of the specimen X26-REF2 after -0.50% drift ratio is shown in Figure 7.10.

Figure 7.10 : a) North, and b) South view of the X26-REF2 specimen after target displacement ± 6 mm (-0.50% drift ratio).

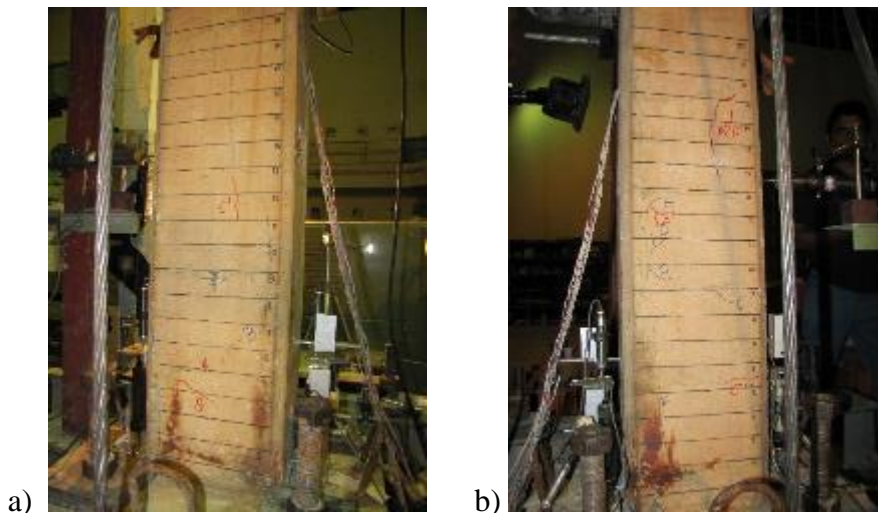
During loading to target displacement -9 mm (drift ratio -0.75%) second flexural crack was observed at interface of the column and footing. The view of the specimen X26-REF2 after target displacement -9 mm (drift ratio -0.75%) is shown in Figure 7.11.

Figure 7.11 : a) North, and b) South view of the X26-REF2 specimen after target displacement -9 mm (-0.75% drift ratio).

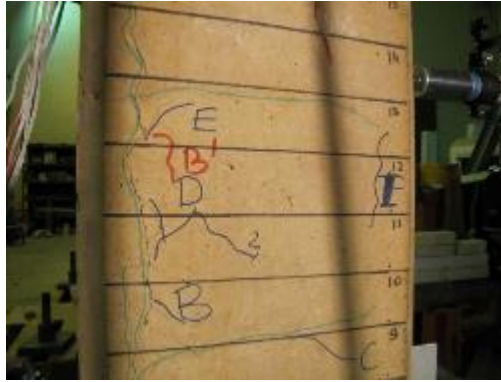
Some cracks were occurred after acceleration corrosion process along the column transverse and longitudinal bars. These cracks was marked with green marker on the pictures. During loading to target displacement -12 mm (-1% drift ratio), size increasing of these cracks and propagation of existing cracks were observed. X26-REF2 after target displacement -12 mm (drift ratio -1%) is given in Figure 7.12.

Figure 7.12 : Cracks because of transverse and longitudinal bars after target displacement -12 mm (-1% drift ratio).

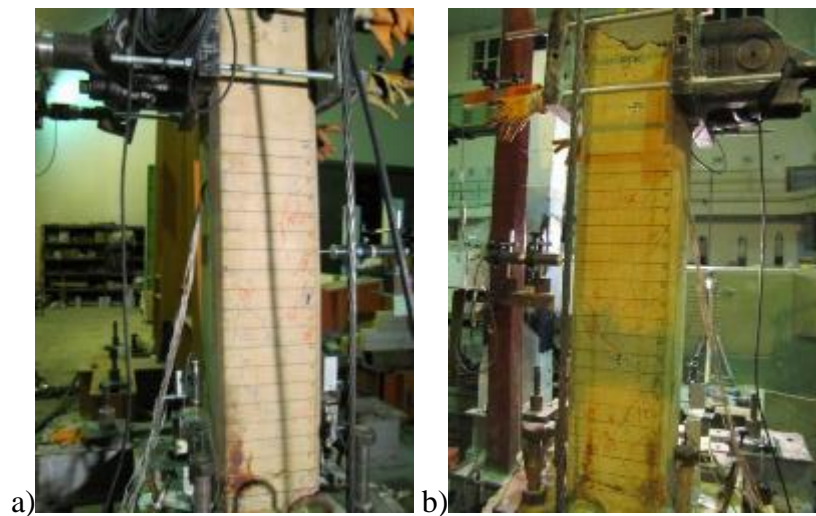
Figure 7.13 : a) North, and b) South view of X26-REF2 after target displacement -18 mm (-1.50 % mm drift ratio).

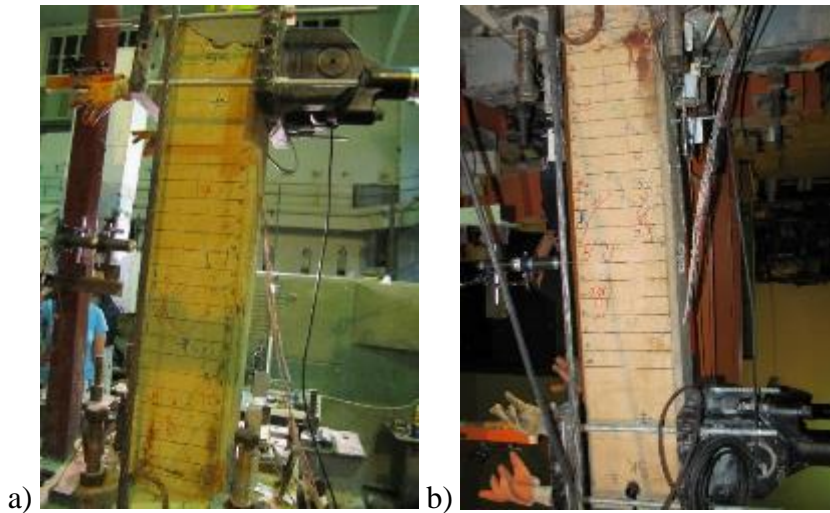
Figure 7.14 : a) North, and b) South view of X26-REF2 after -2.00 % mm drift ratio.

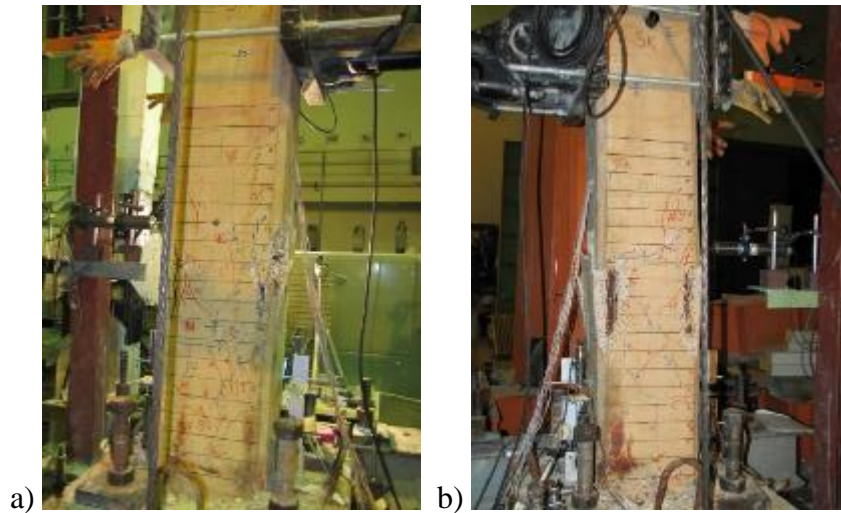
Figure 7.15 : a) North, and b) South view of X26-REF2 after -2.50 % mm drift ratio. During loading to target displacement of -36 mm (drift ratio -3.00%), longitudinal bars of the specimen were buckled due to excessive axial load. North, and south view of X26-REF2 after experiment end was given in Figure 7.16.

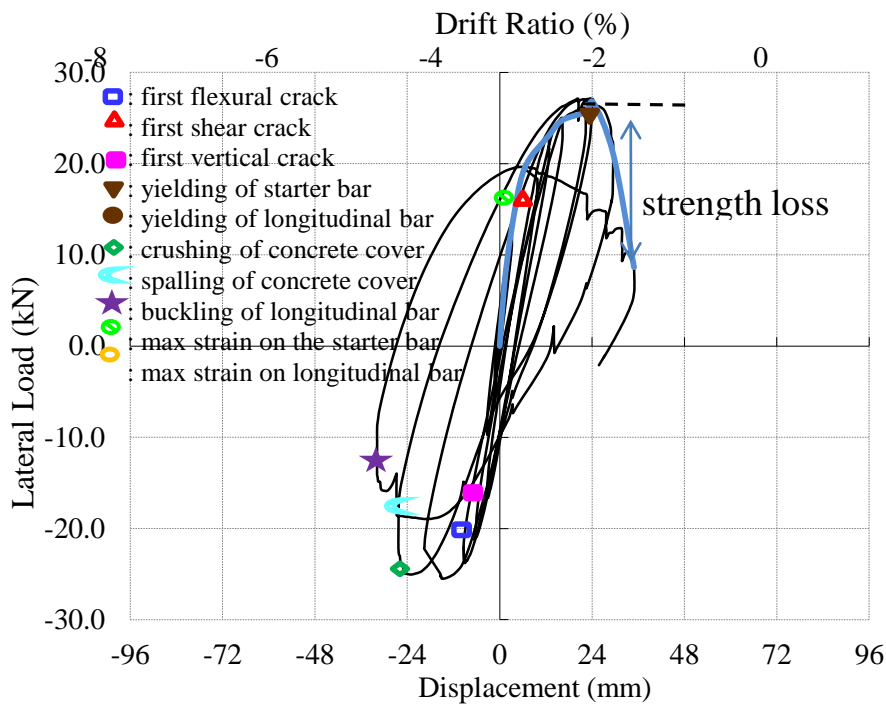
Figure 7.17 : Lateral load versus displacement for X26-REF2.

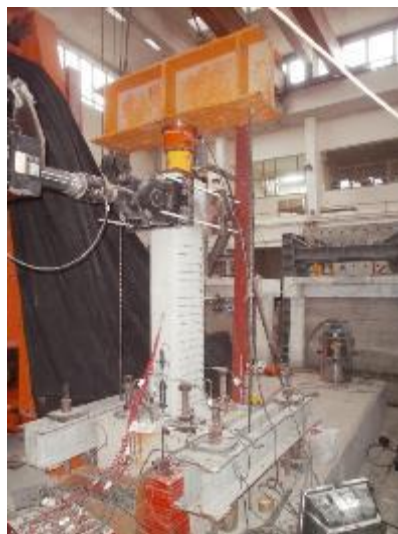
Figure 7.21 : The view of the specimen X26-M before the starting of test

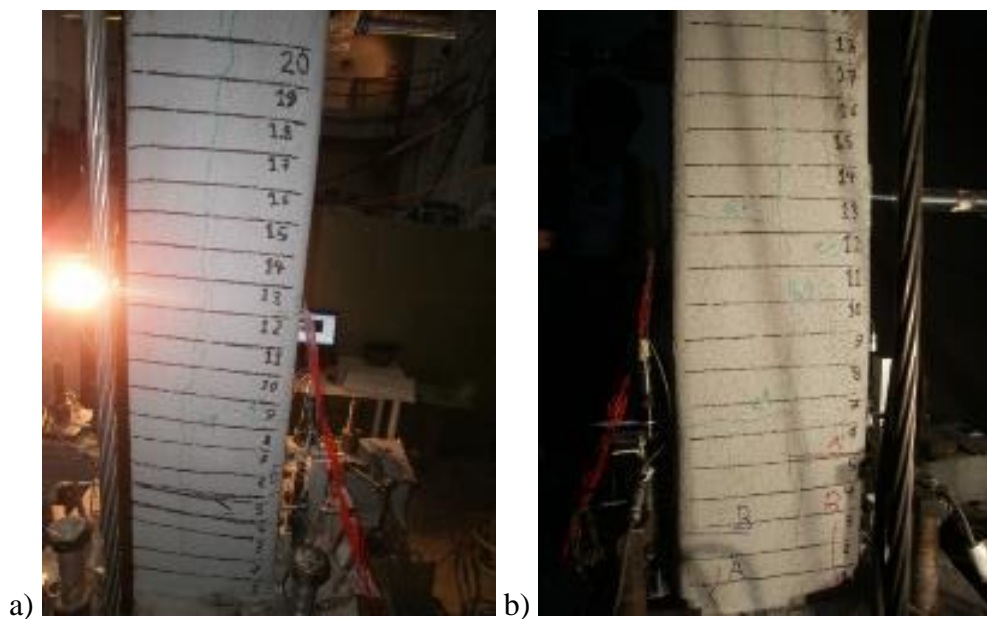
Figure 7.22 : a) North, and b) South view of X26-M after -0.75 % mm drift ratio.

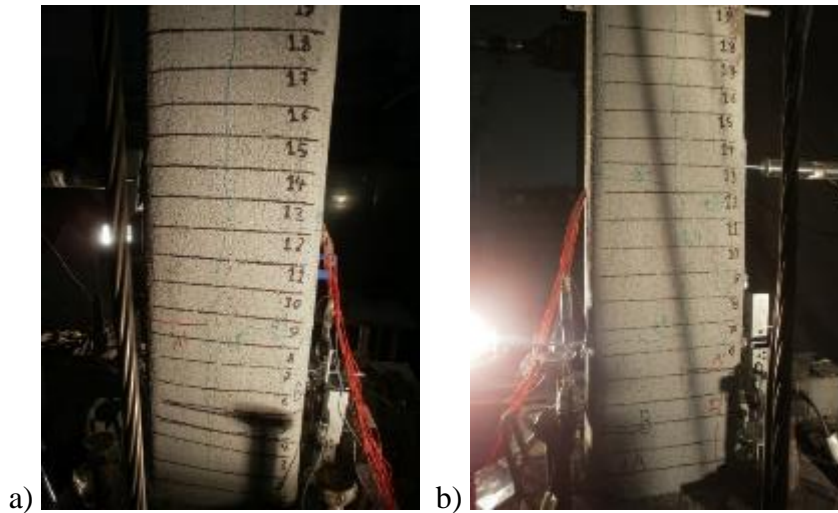
Figure 7.23 : a) North, and b) South view of X26-M after -1.00 % mm drift ratio.

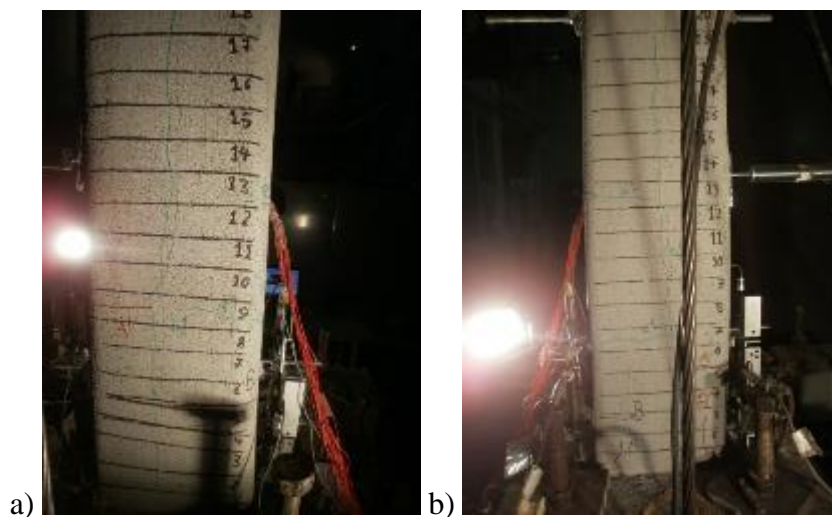
Figure 7.24 : a) North, and b) South view of X26-M after -1.50 % mm drift ratio.

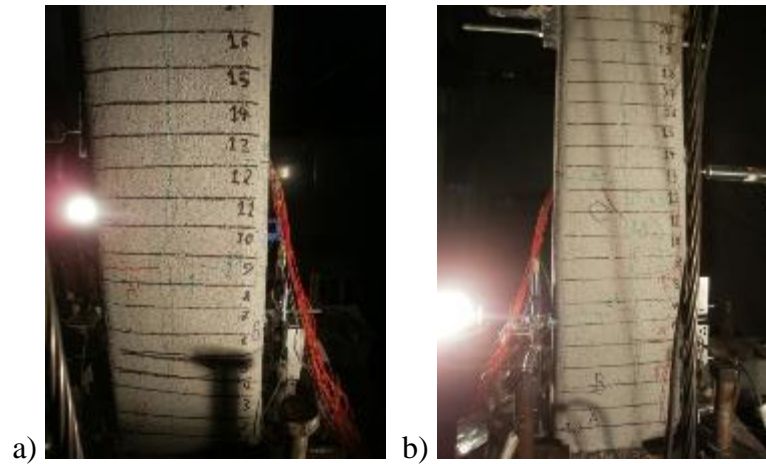
Figure 7.25 : a) North, and b) South view of X26-M after -2.00 % mm drift ratio.

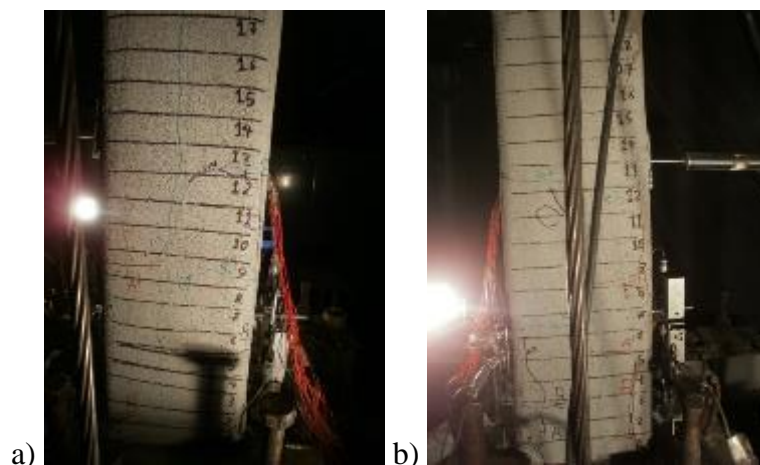
Figure 7.26 : a) North, and b) South view of X26-M after -4.00 % mm drift ratio.

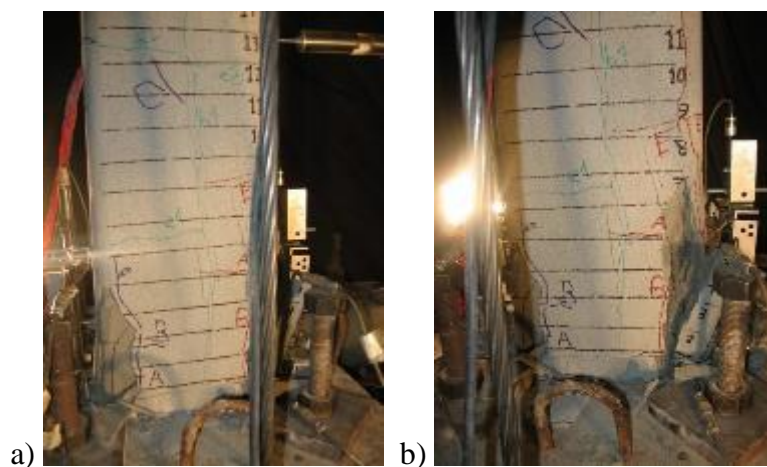
displacement ± 84 mm test was ended due to fallen load capacity. The view of the specimen X26-M after test ended is shown in Figure 7.27.

Figure 7.27 : a) North, and b) South view of X26-M after the test finished.
