**REHABILITATION OF CORROSION DAMAGED SUBSTANDARD RC
COLUMNS WITH USING FRP**

M.Sc. THESIS

Aras KALYONCUOĞLU

Thesis Advisor: Prof. Dr. Alper İLKI

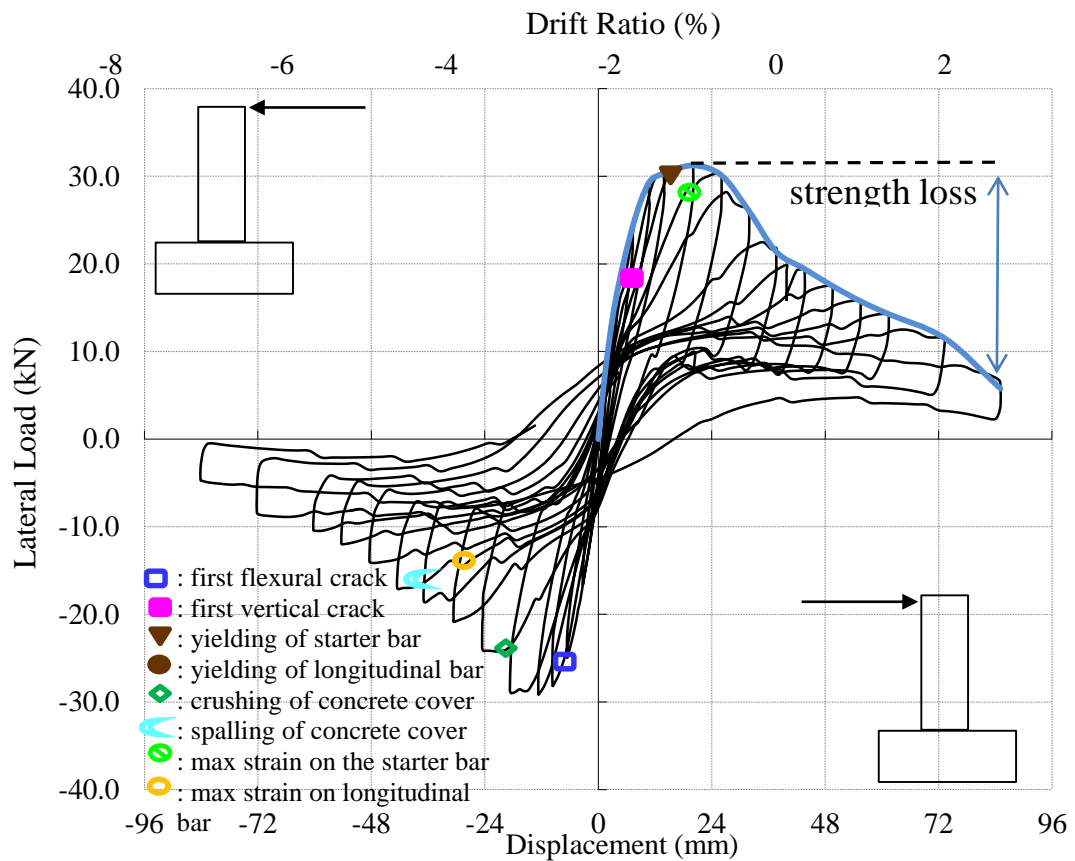
Figure 7.28 : Lateral load versus displacement for X26-M.

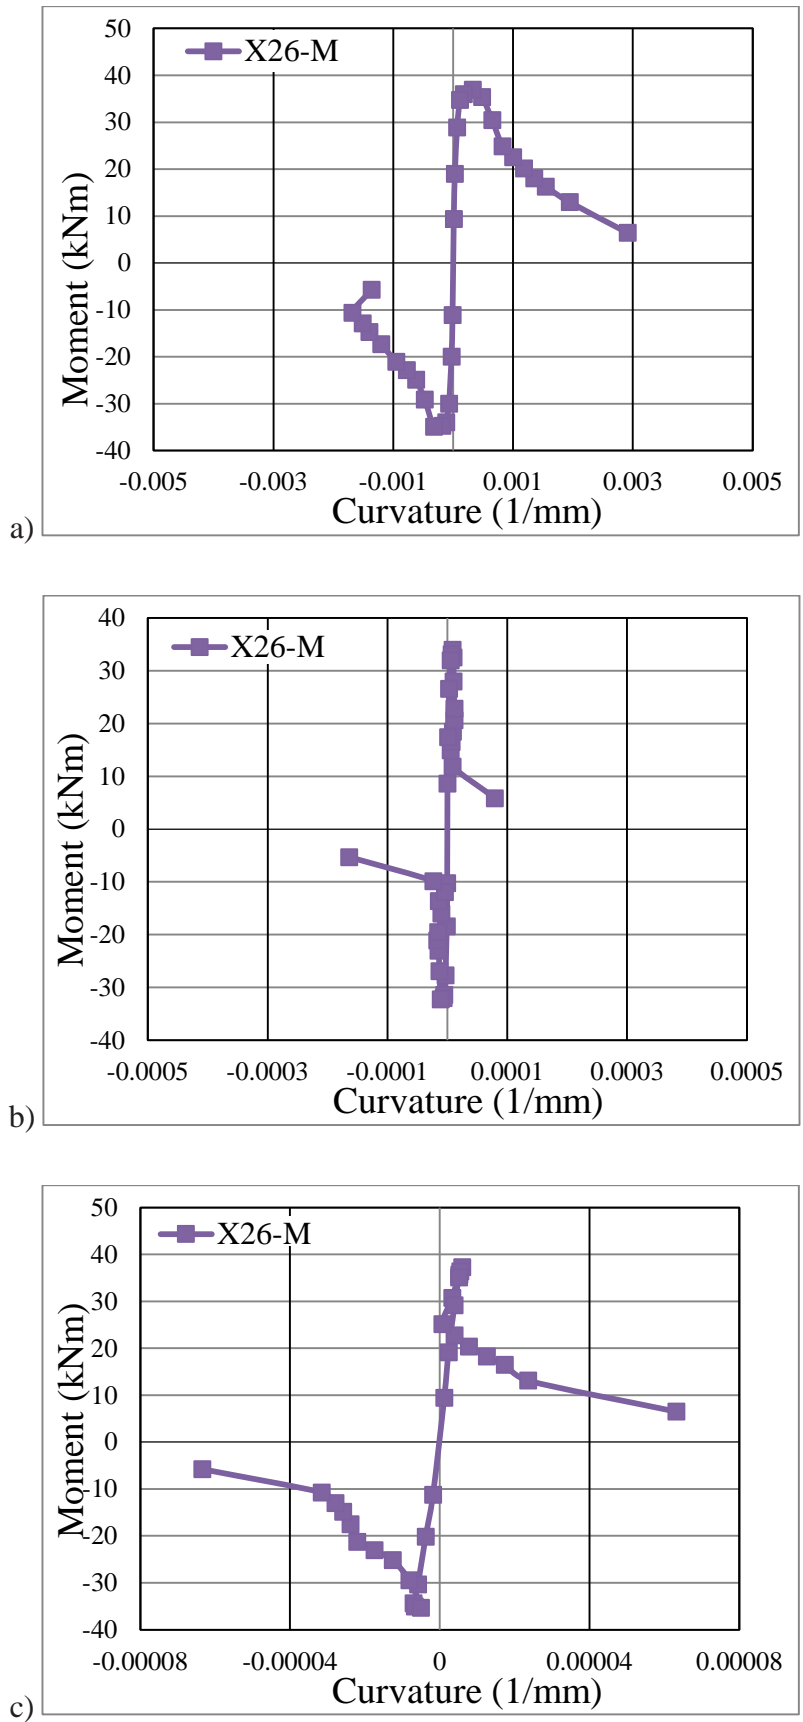
Figure 7.29 : Moment-curvature relationships obtained for a) 20 mm, b) 150 mm, c) 300 mm gauge lengths.

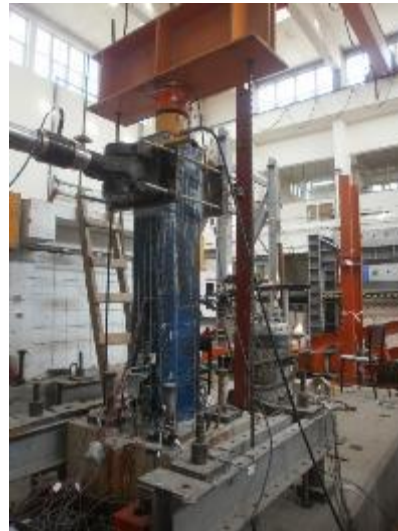
Figure 7.32 : The view of the specimen X47-M-CFRP1

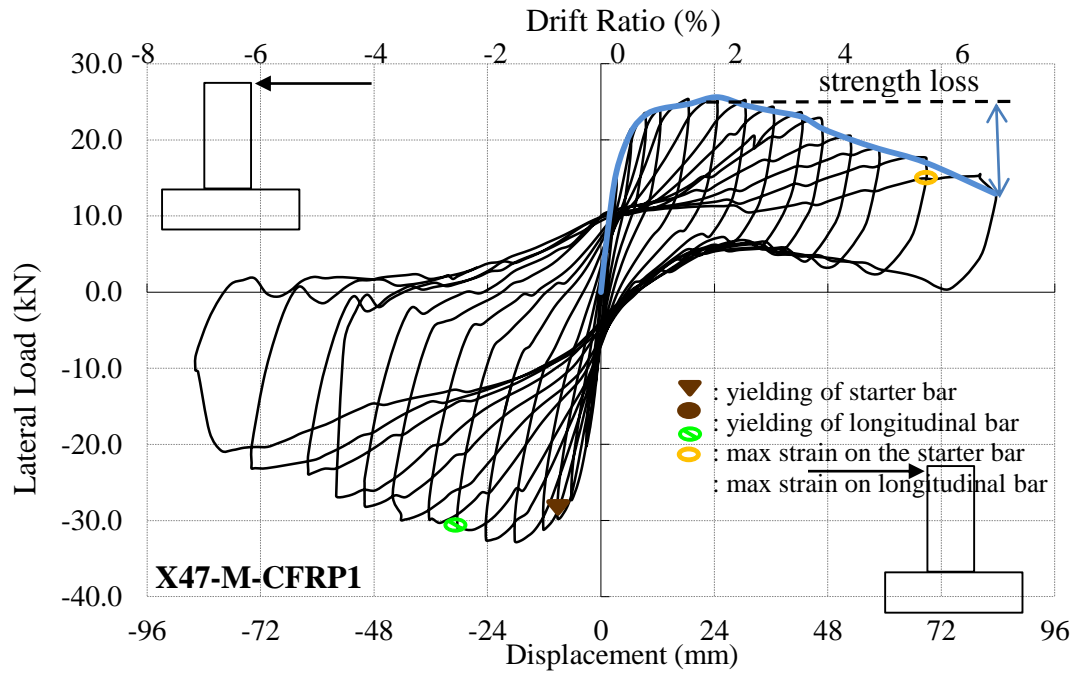
Figure 7.33 : Lateral load versus displacement for X47-M-CFRP1.

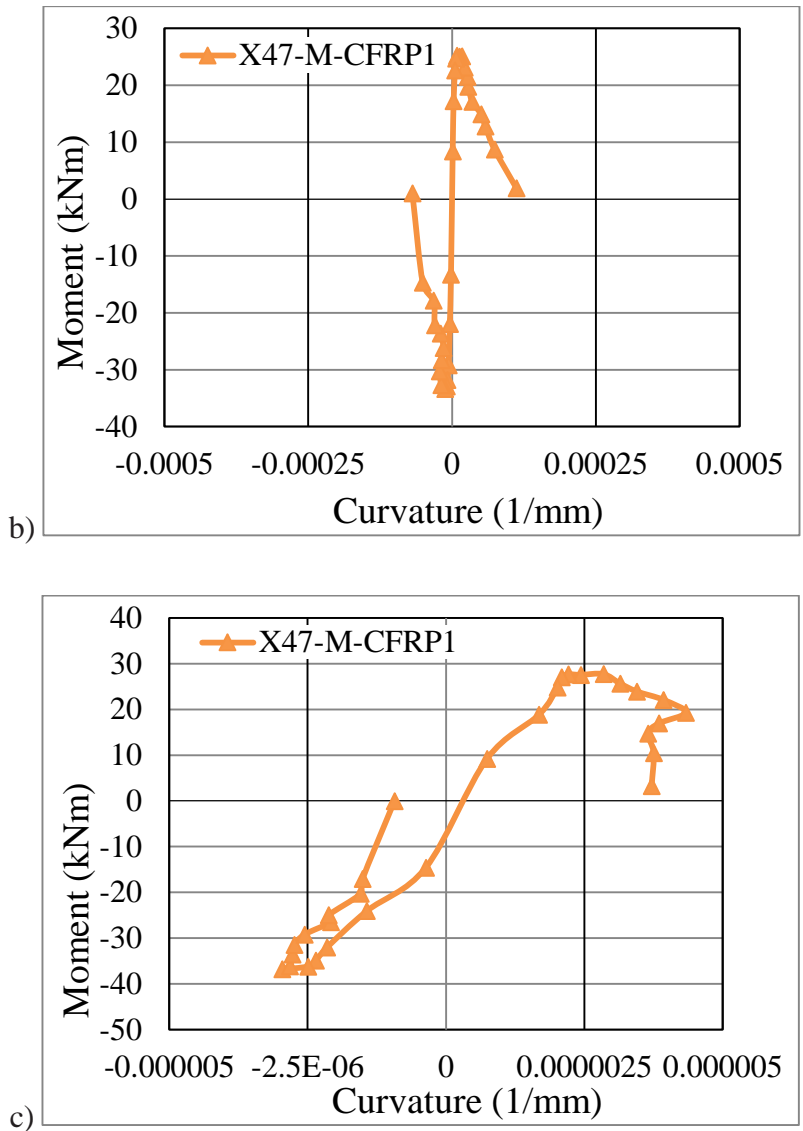
Figure 7.34 : Moment-curvature relationships obtained for a) 20 mm, b) 150 mm, c) 300 mm gauge lengths.

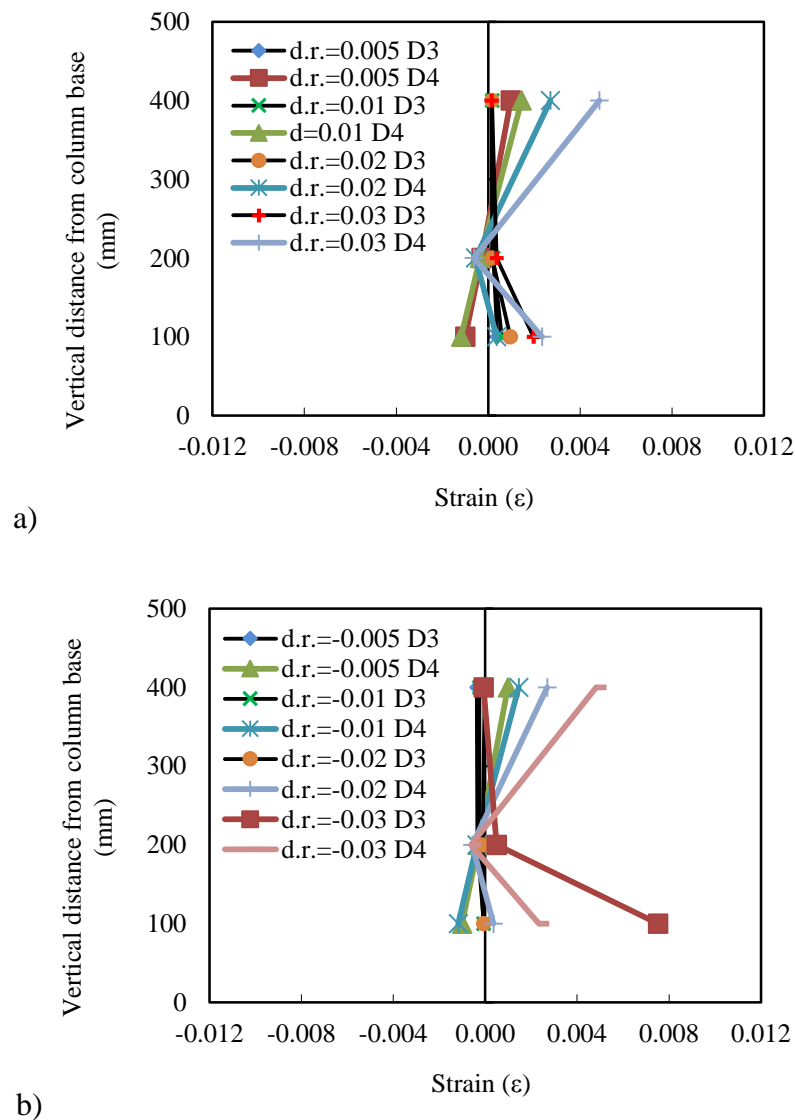
Figure 7.35 : Strain distribution of the starter bars of X47-M-CFRP1 a) while pushing, b) while pulling.

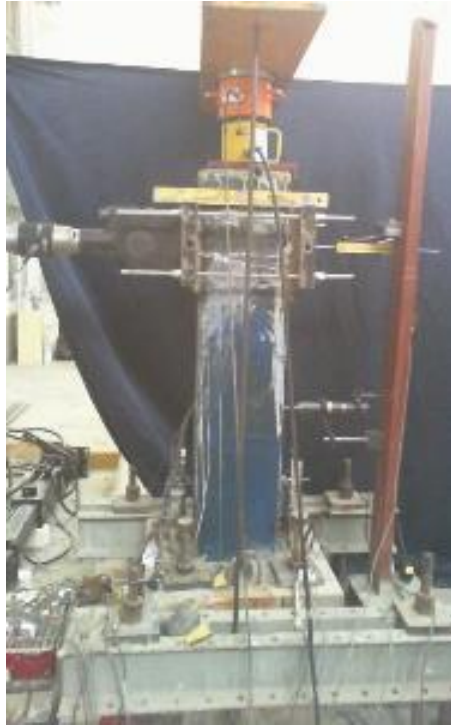
Figure 7.37 : The view of the specimen X43-M-CFRP2 before the starting of test

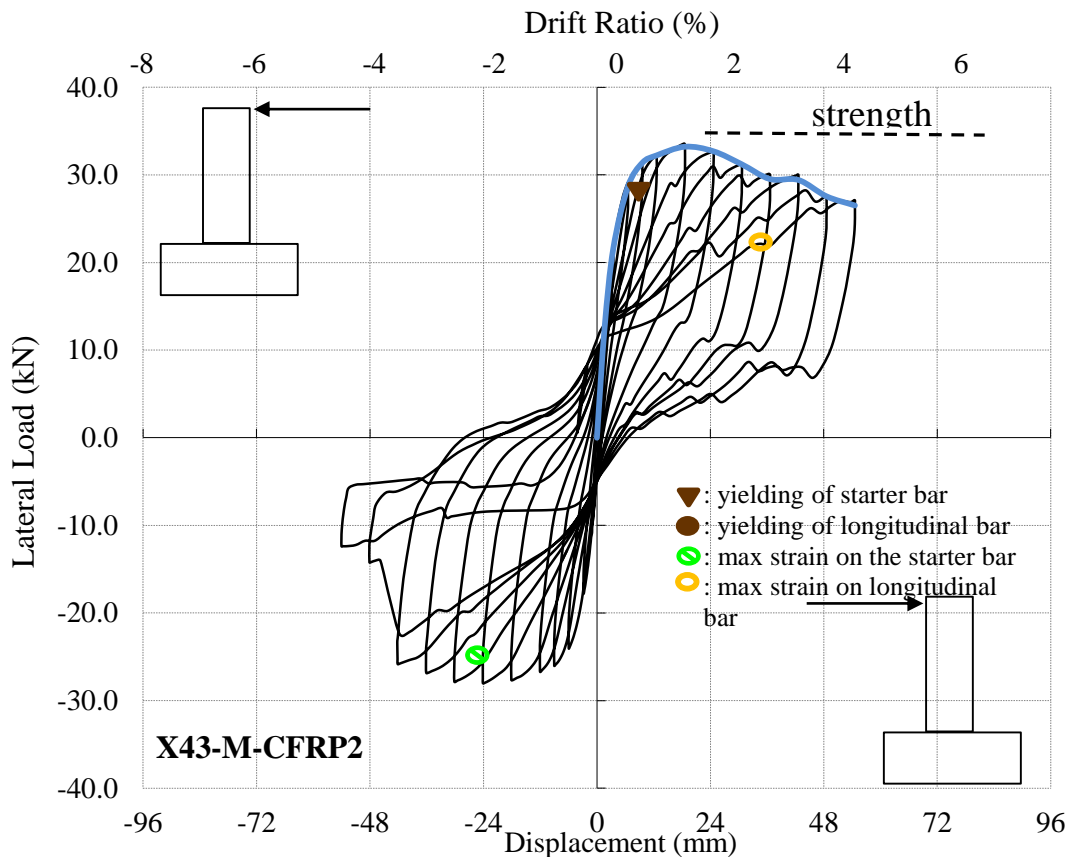
Figure 7.38 : Lateral load versus displacement for X43-M-CFRP2.

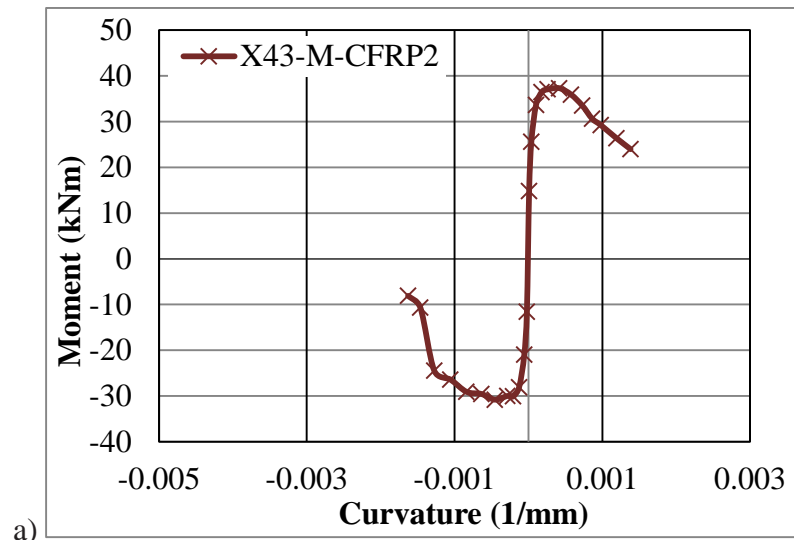
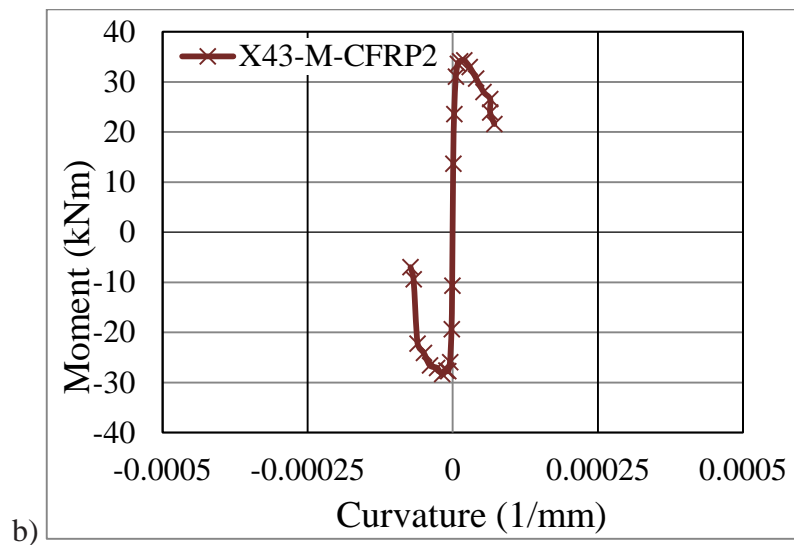
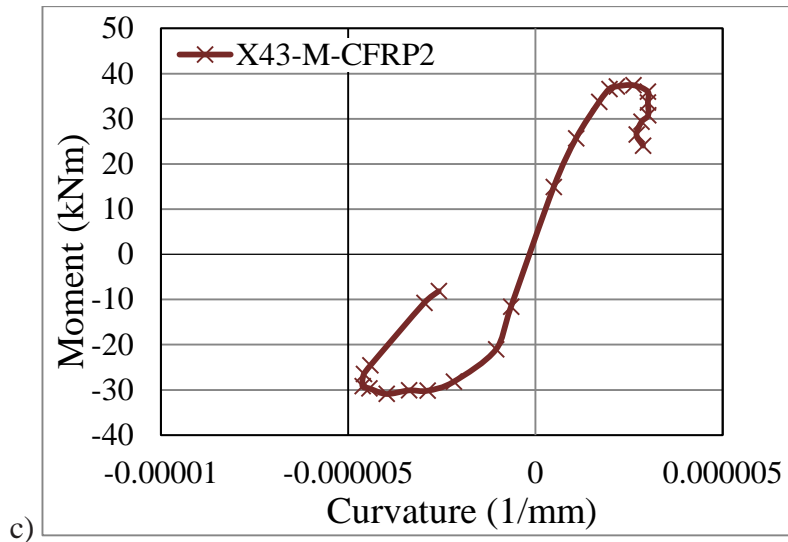
Figure 7.39 : Moment-curvature relationships obtained for a) 20 mm, b) 150 mm, c) 300 mm gauge lengths.

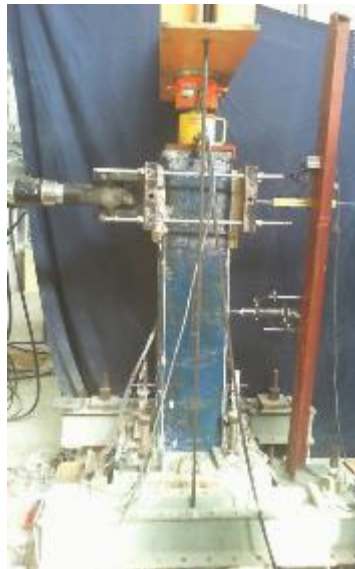
Figure 7.42 : The view of the specimen X44-M-CFRP3 before the starting of test.

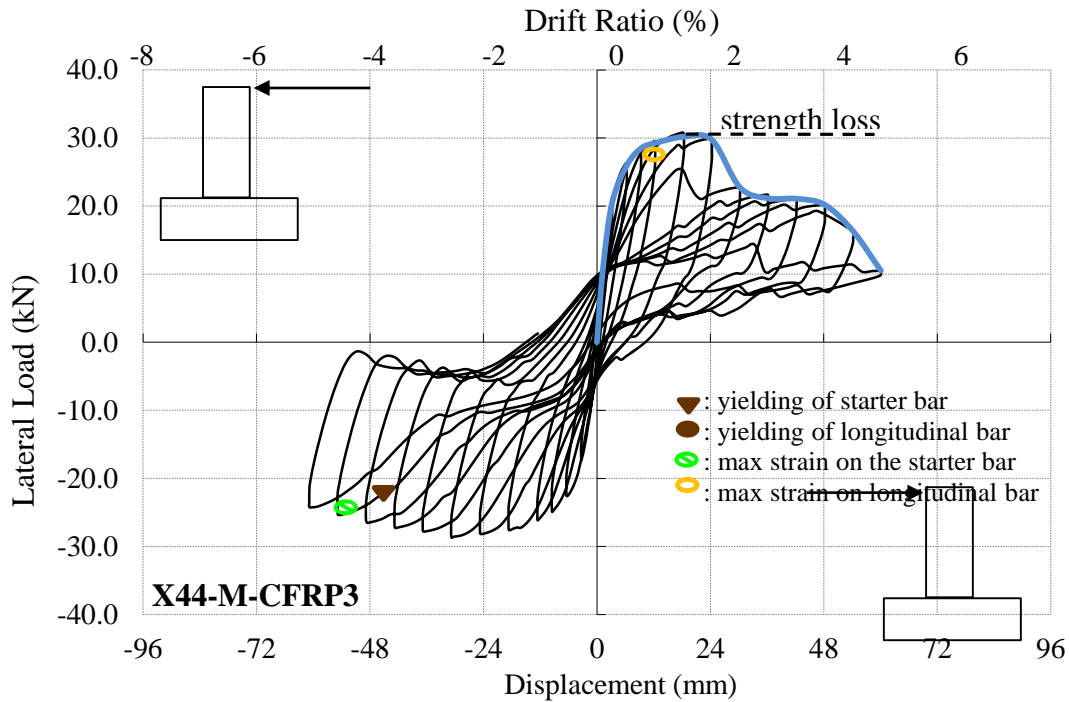
Figure 7.43 : Lateral load versus displacement for X44-M-CFRP3.

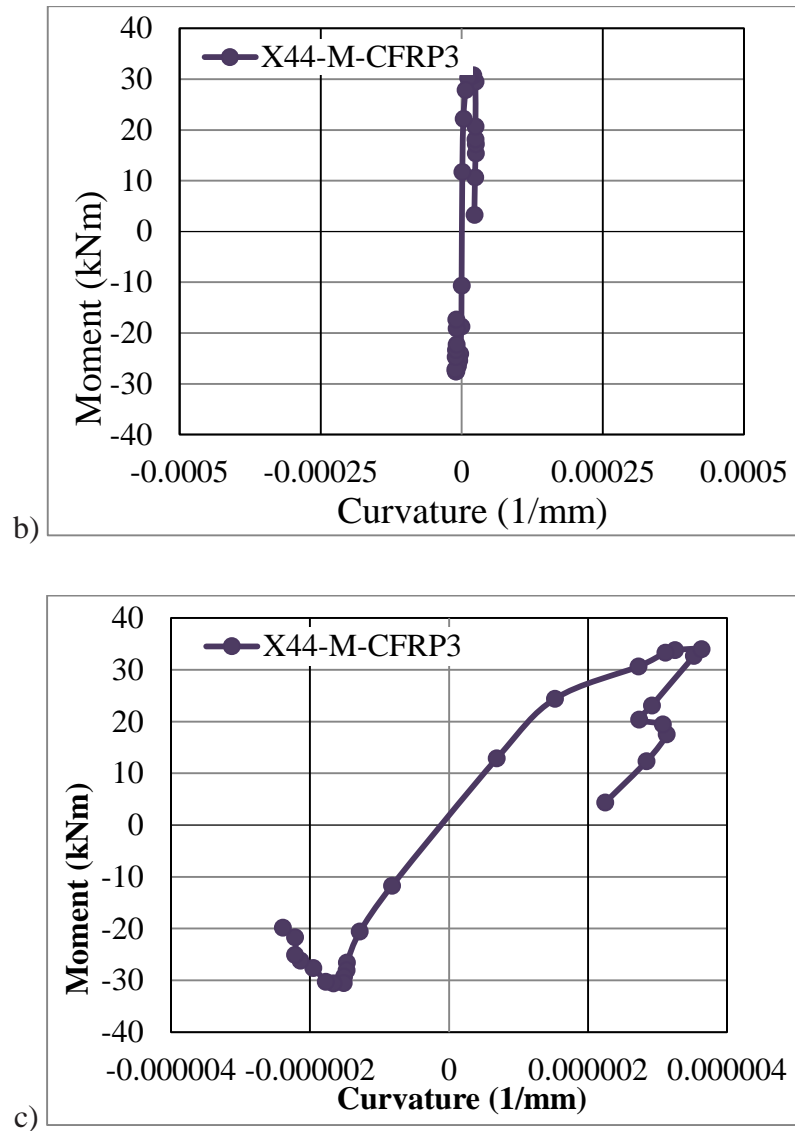
Figure 7.44 : Moment-curvature relationships obtained for a) 20 mm, b) 150 mm, c) 300 mm gauge lengths.

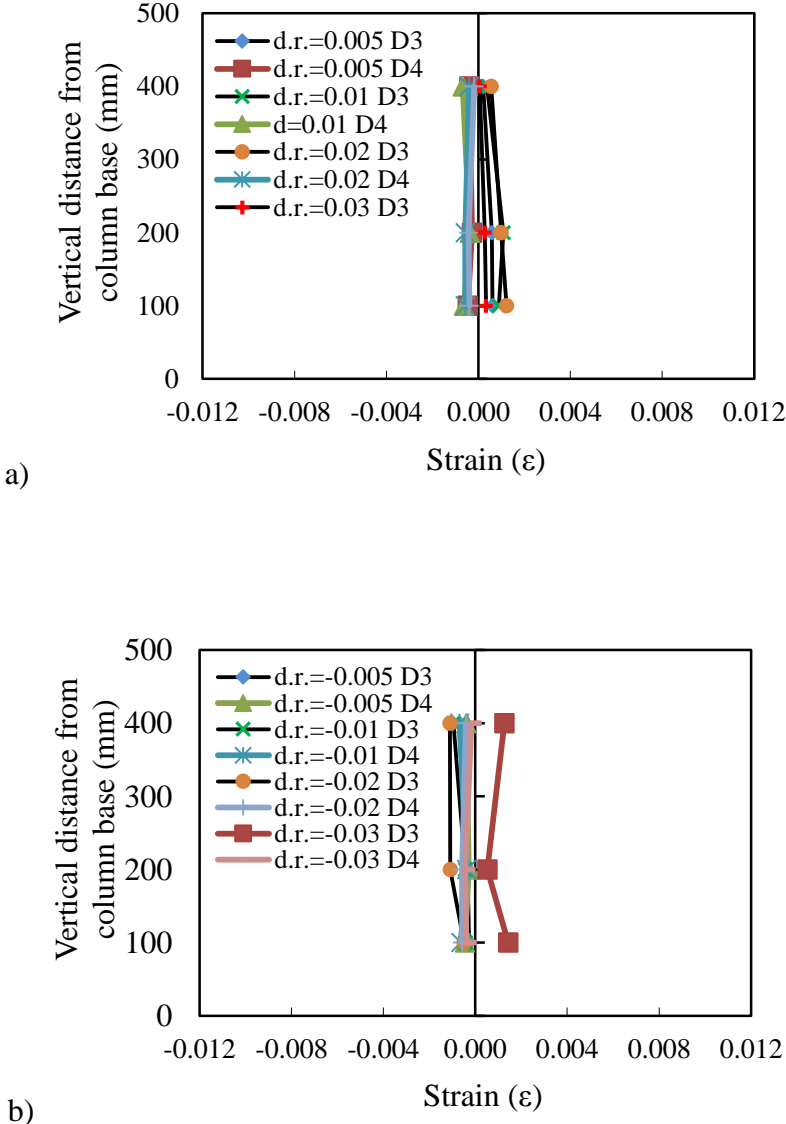
Figure 7.45 : Strain distribution of the starter bars of X47-M-CFRP1 a) while pushing, b) while pulling.

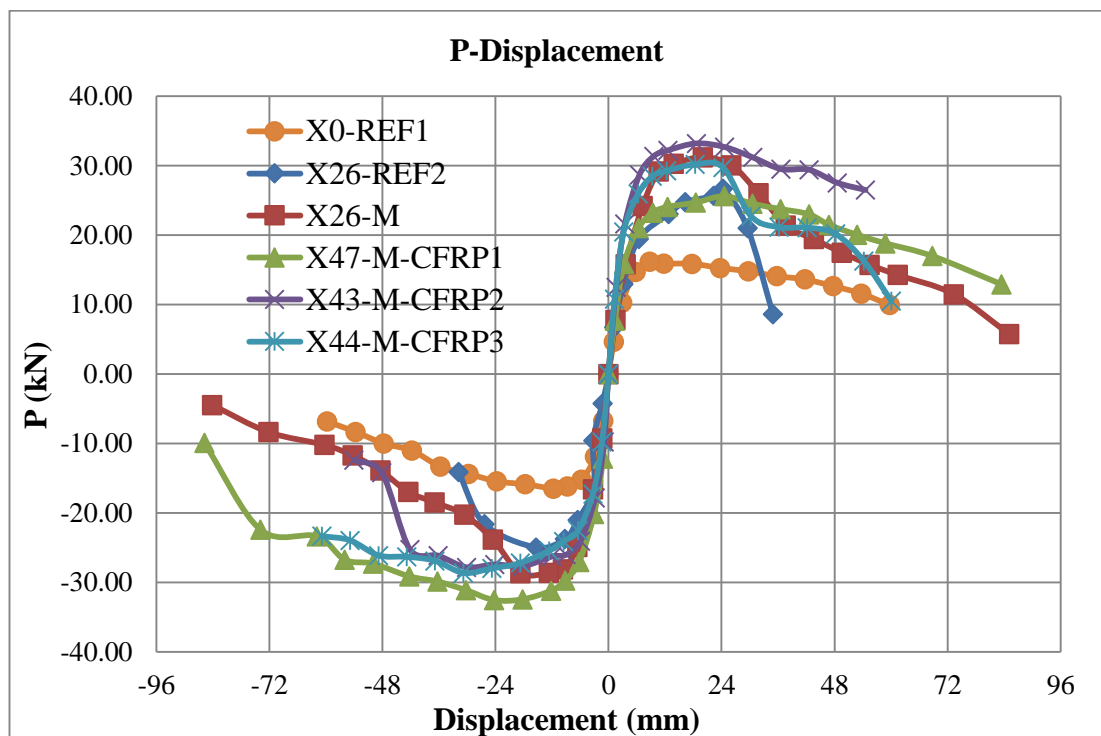
Figure 8.1 : The envelopes of lateral load-drift ratios for the specimens without consideration of the second order effect.

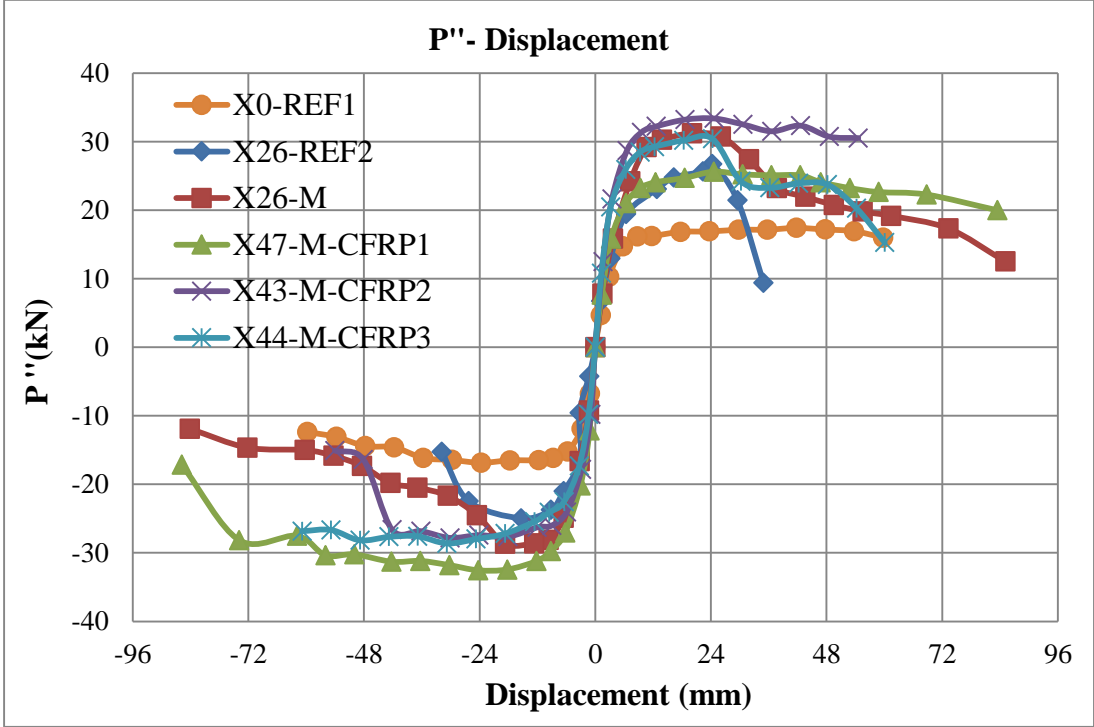
Figure 8.2 : The envelopes of lateral load-drift ratios for the specimens with consideration of the second order effect.

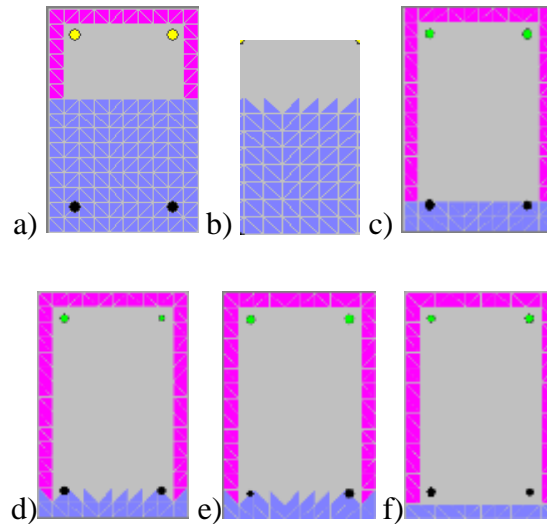
Figure 8.3 : Neutral axis and section of specimens at maximum moment load (a) X0-REF1, b) X26-REF2, c) X26-M, d) X47-M-CFRP1, e)X43-M-CFRP2, f)X44-M-CFRP3.

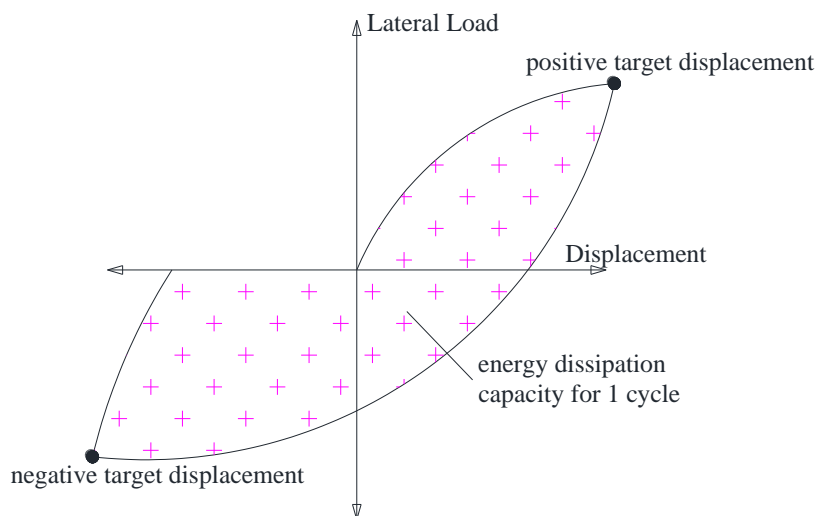
Figure 8.4 : Calculation of energy dissipation capacity.

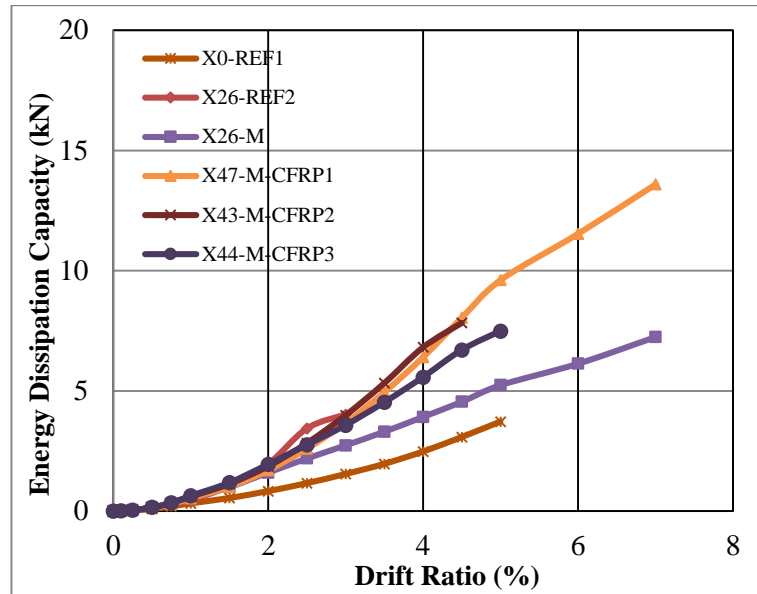
Figure 8.5 : Energy dissipation capacity of the specimens.

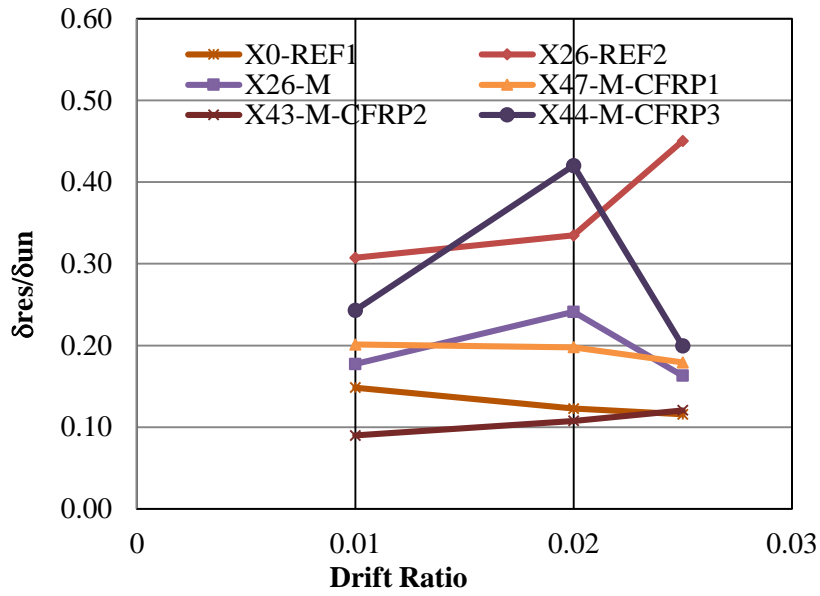
Figure 8.6 : The variation of residual displacement for the specimens.

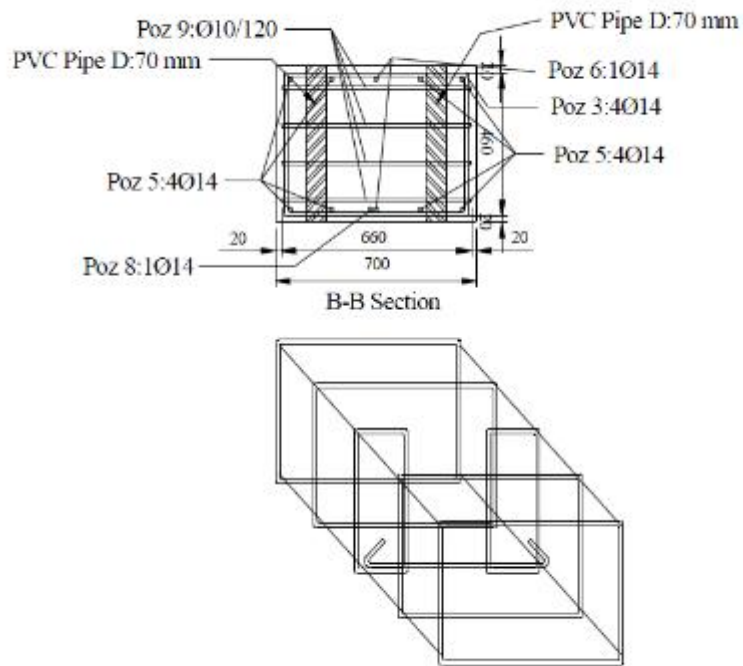
Figure A.1 : Reinforcing cage of the first type specimens (south side).

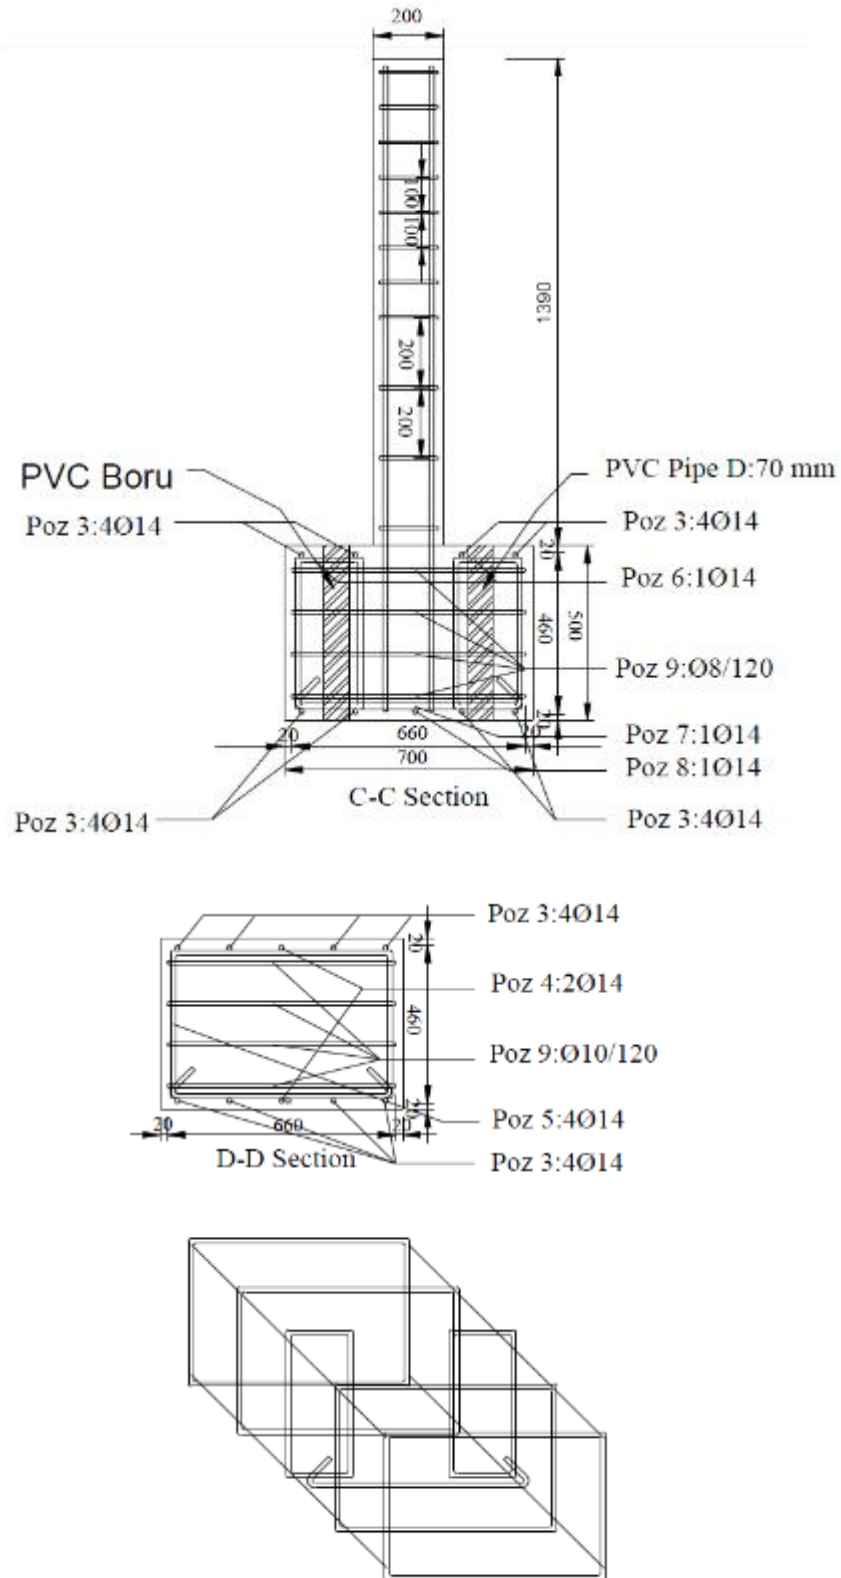
Figure A.2 : Reinforcing cage of the first type specimens(south side).
