IAEG2006 Field Trip Guide Ripon

GYPSUM DISSOLUTION GEOHAZARDS AT RIPON, NORTH YORKSHIRE, UK

Anthony H.Cooper¹¹British Geological Survey, Keyworth, Nottingham, NG12 5GG, e-mail:ahc@bgs.ac.uk

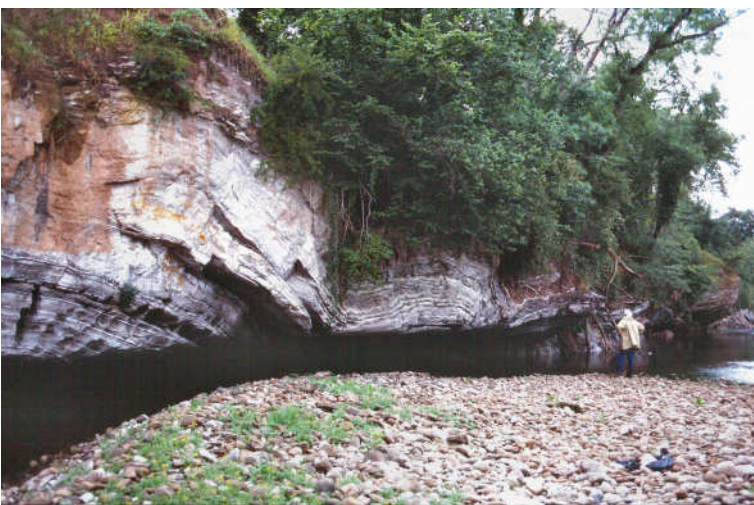
Figure 6. The gypsum cliff in 1990 just before it collapsed showing the complete flow of the River Ure going under the face.

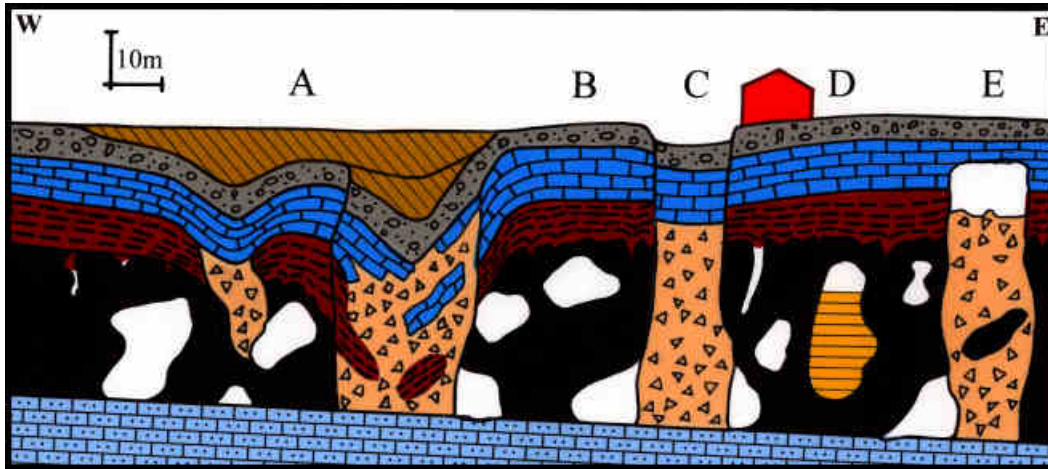
Figure 7. Cross-section through the middle part of the gypsum subsidence belt. See Figure 3 for legend.

Locality 4. Ripon Clock Tower [SE 3133 7182], the site of a small subsidence hollow that occurred in 1987, but is now filled in. This hole is adjacent to a large area of amalgamated subsidence hollows filled with peat and soft clay. The geological situation here equates with A on Figure 7.

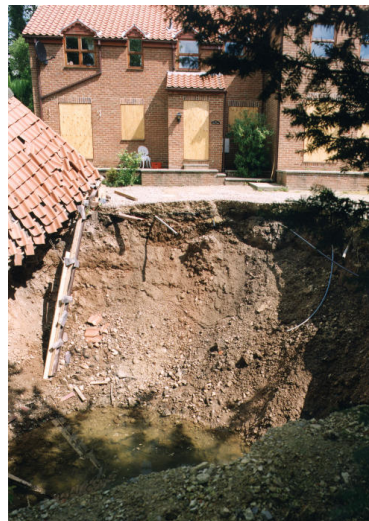
Figure 11. Schematic cross section and photograph of the Ure Bank Terrace collapse in early May 1997.

Locality 15. Subsidence hollow, damaged garages and threatened houses on Ure Bank Terrace [SE 3153 7242]. This hollow started its present phase of subsidence on 15th February 1995. Initially it was about 6m across, now it is 10m across and 5.5m deep. The latest and largest collapse was on 23rd-24th April 1997; It has been filled and collapsed 6 times since 1995. The hole has a long history of subsidence and was noted to have previously moved in 1968 and 1970 (Cooper, 1986). There are still legal problems over the liability for the hole and the responsibility for keeping it filled and moderately stable. A report commissioned by the Council (Cooper, unpublished) suggested filling the hole with granular material that would funnel into any cavities. This would help to support the sides (and the road) and also make any movement obvious. Taking advice from consulting engineers, the hole was filled in late 1999 with 37.5mm, type B, filter drain material which is readily available (Cooper, 2005). The material has continued to funnel into the hole and there is now a conical depression; the hole is in need of refilling, but no one wishes to take the responsibility.

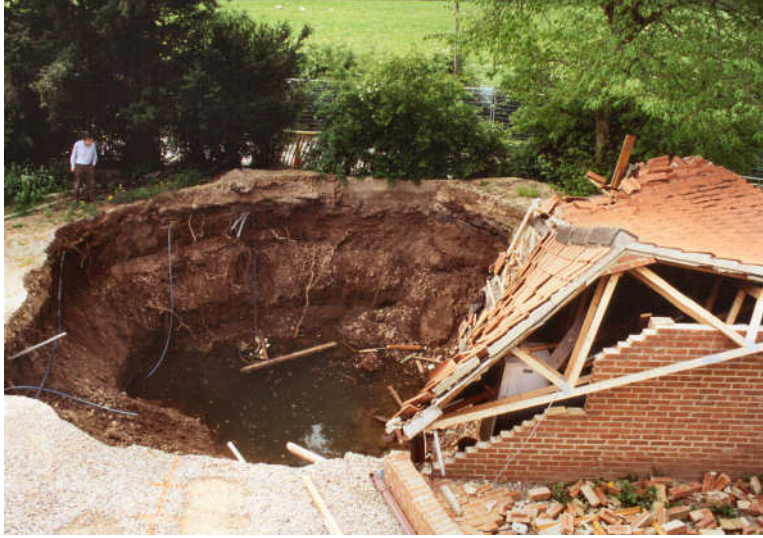
Figure 12. The Ure Bank Terrace collapse in late April 1997 viewed from the upstairs window of the house.
